RECORD OF CONVERSATION

NTSB Case Number: CEN22LA163

- Johnny and his family were in town (Crowell, Texas) for a wedding. Ronny was taking Claburn up for a personal flight in the airplane N789RB (Kitfox Series 7).

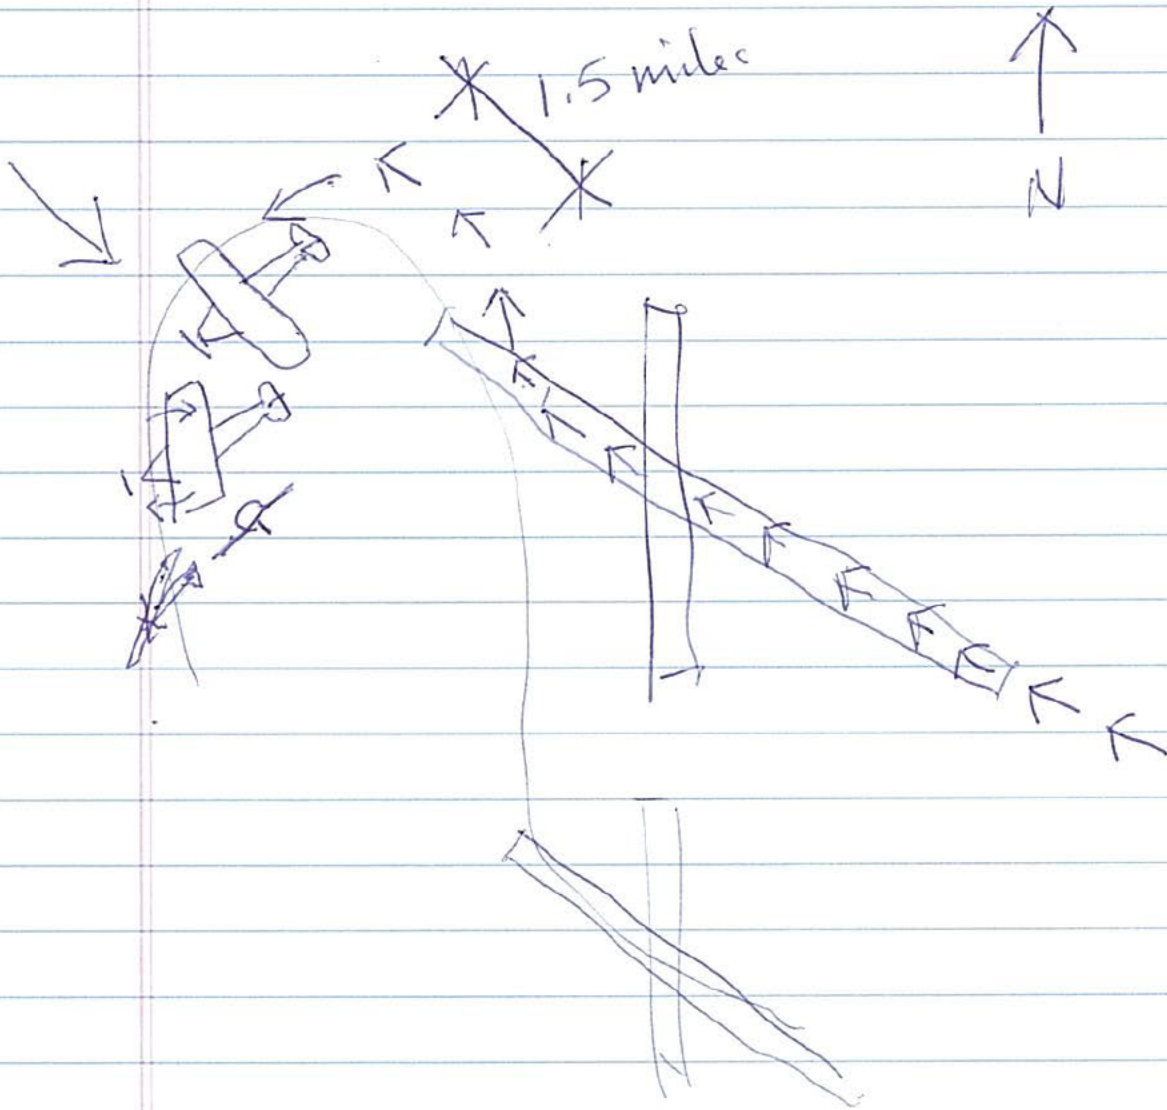
After Runway Fly over went to
Left - 600/700' Lost Airspeed
Plane stalled Left Down, NOISED
over into Ground.
