Michael J. Hodges Investigator-In-Charge Office of Aviation Safety, Central Regional Office

**Subject:** CEN22LA250

Subject: Re: CEN22LA250 (N78KL, Beech 58) - Propeller Blade Maintenance Question (Late Aircraft Repair)

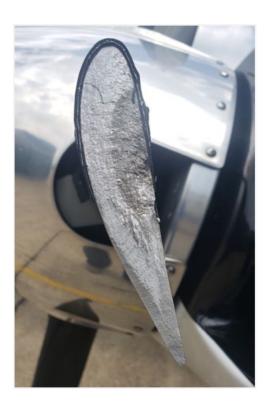
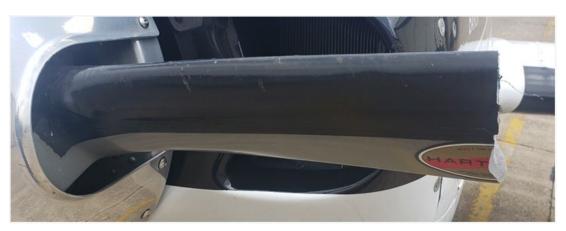
Our materials engineers examined the fracture surfaces on the blade that had the separation. The blade facture surfaces showed signatures consistent with high-cycle fatigue.

Our materials engineers also found that for the area of concern, it appeared to be covered with a thick black paint that had a composition that differed slightly from the thinner layer of black paint on the rest of the blade. It is possible that there might have been some underlying damage to the blade, and it might have been covered up with black spray paint.
