VEHICLE FACTORS GROUP CHAIRMAN'S

Vehicle Attachment – Motorcoach Steering Gear Inspection Report

Mount Pleasant, Pennsylvania

HWY20MH002

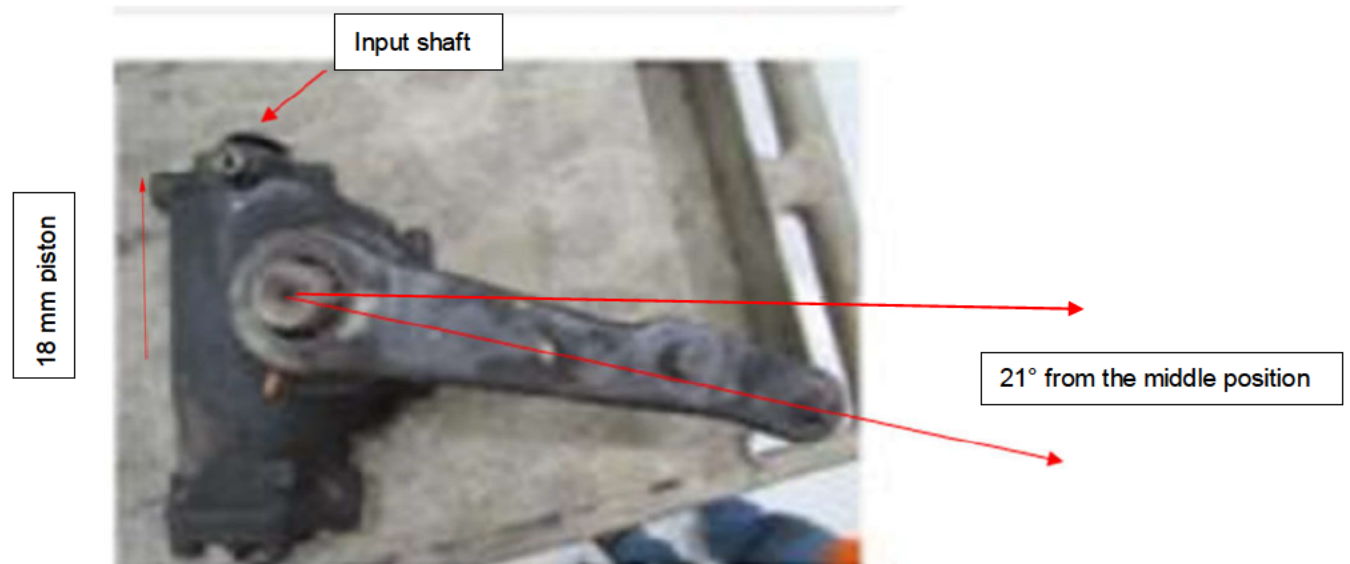
Based on the measurement taken during tear-down (from the end of the worm to the impact damage in the ball circuit of the worm (109 mm), the piston was 18 mm out of middle position in direction to the input shaft.

This is approximately one complete turn of the steering wheel (direct 1:1 from the input spline of the gearbox).

With this 18 mm we have at the sector shaft, the drop arm angle is 21° out of the middle position during this impact (turning left from center position)

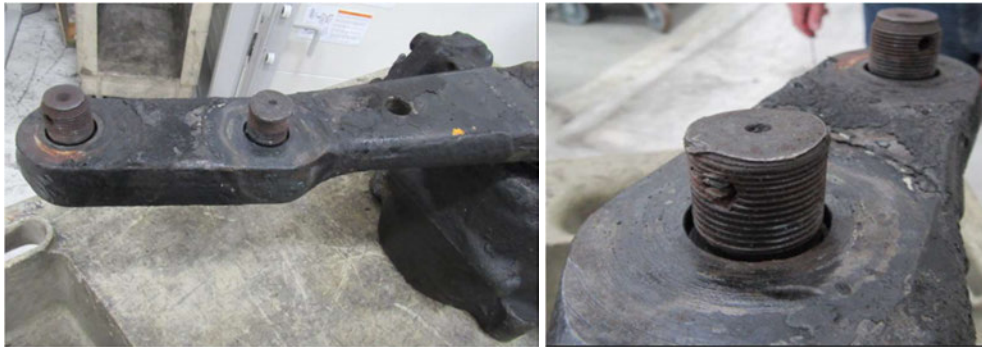
Drop Arm

Note; the steering drop arm retaining nut which is connected to the steering gearbox sector shaft had been removed by a third party, however, the drop arm itself had not been removed.

The Bosch Technician was unable to remove the drop arm from the sector shaft during the investigation. Note this was not detrimental to the functional test and inspection.

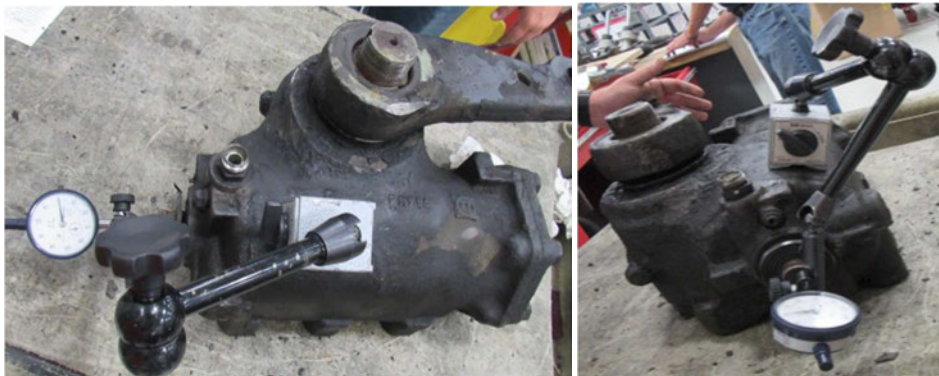
Measure Lash

Steering gear lash was measured .020mm – [REDACTED]

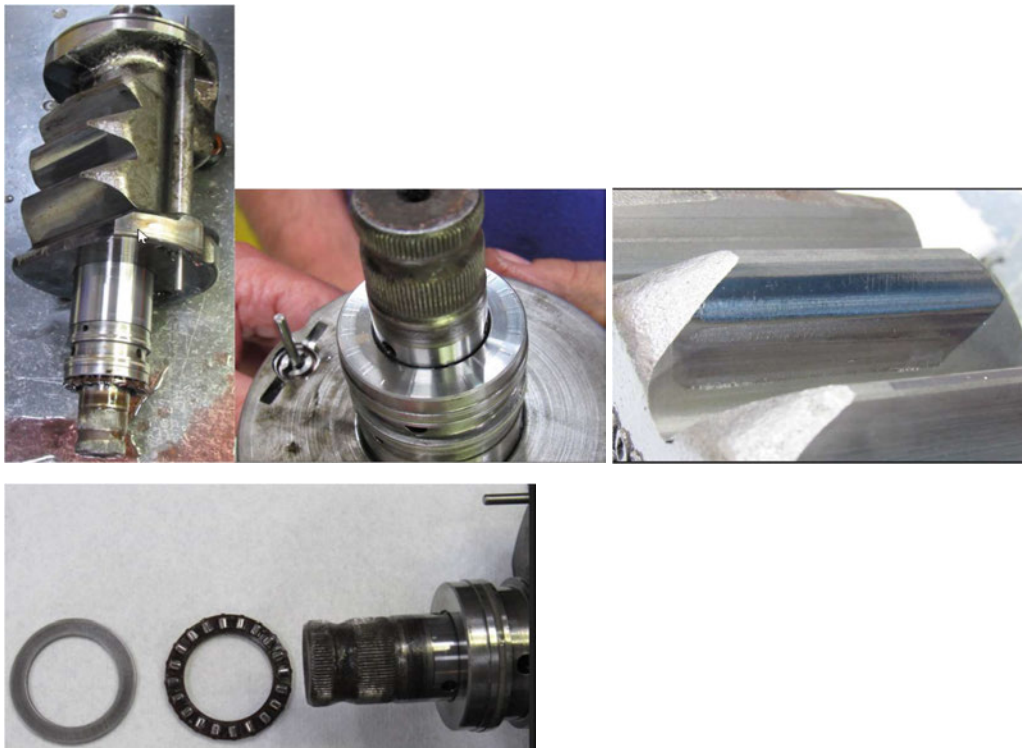
Piston – Light Impact to upper bearing, washer. Middle Piston tooth show wear mark only, no impact damage

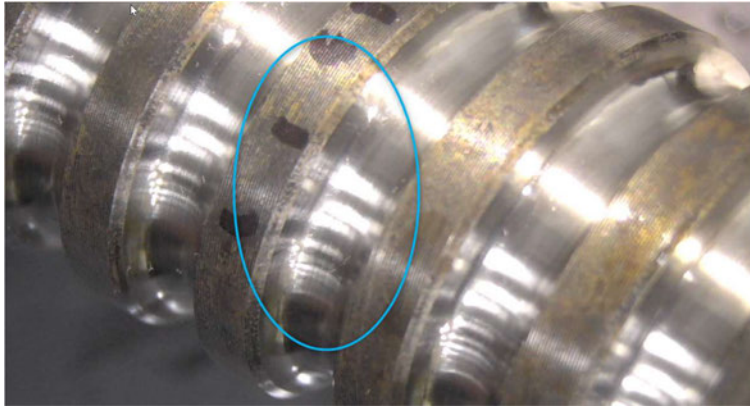
Note, whilst slight impact marks were evident on the piston, worm, upper bearing and washer, we cannot determine if this occurred prior to or during the accident.

Worm: *Light impact*

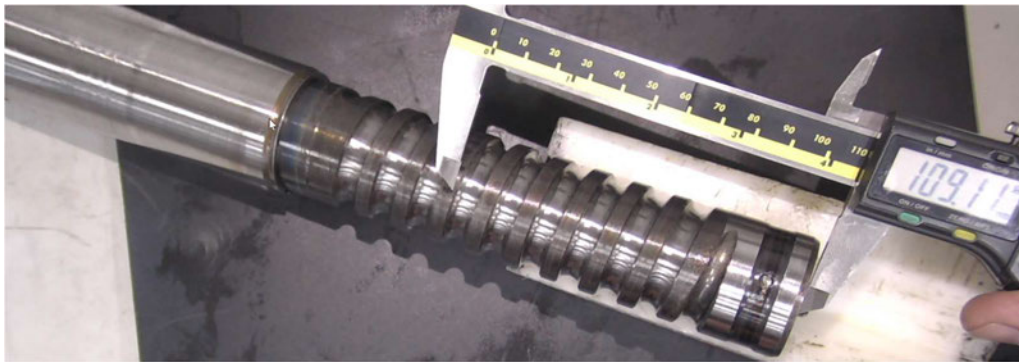
Measurement - *from end of worm to impact area*
