**VEHICLE FACTORS PHOTOGRAPHS**

**Mount Pleasant, Pennsylvania**

**HWY20MH002**

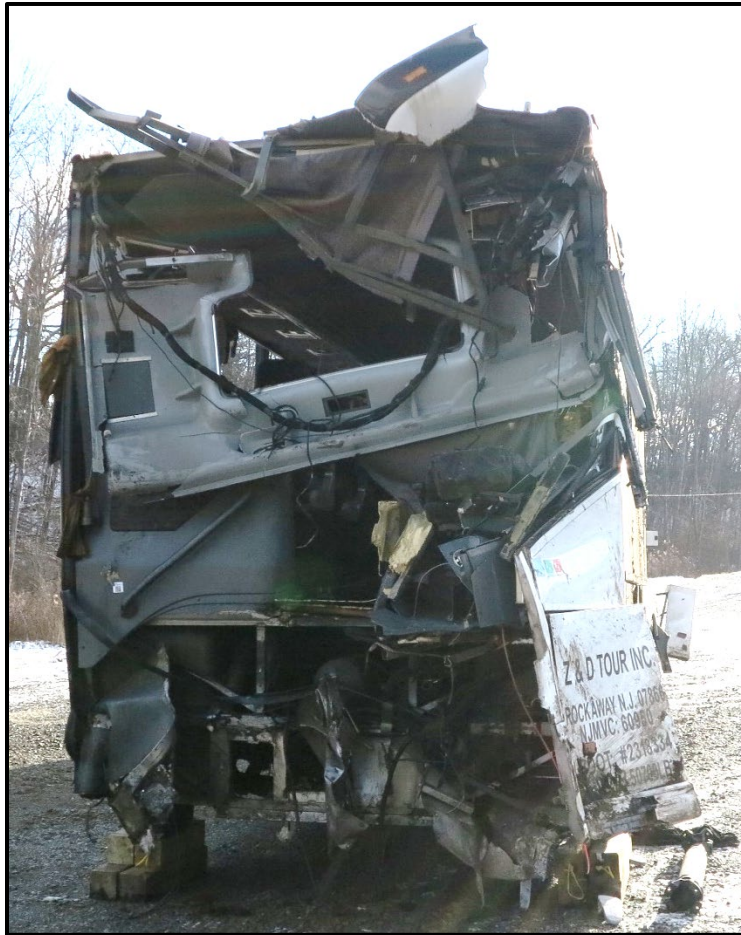
**Photograph 1:** Looking at the damage sustained to the front of the 2005 Van Hool motorcoach.

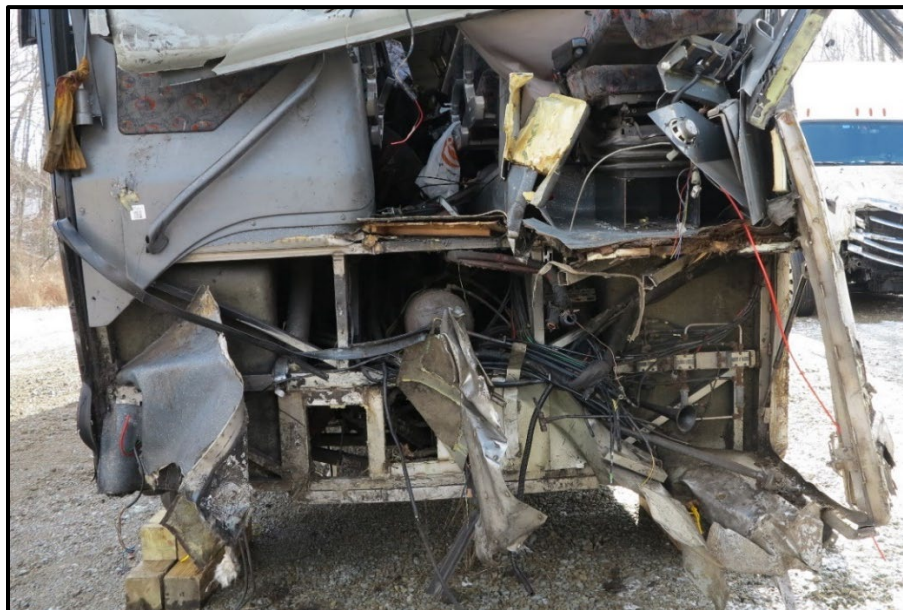
**Photograph 2:** A closer view of the front of the 2005 Van Hool motorcoach – notice the driver's seat.

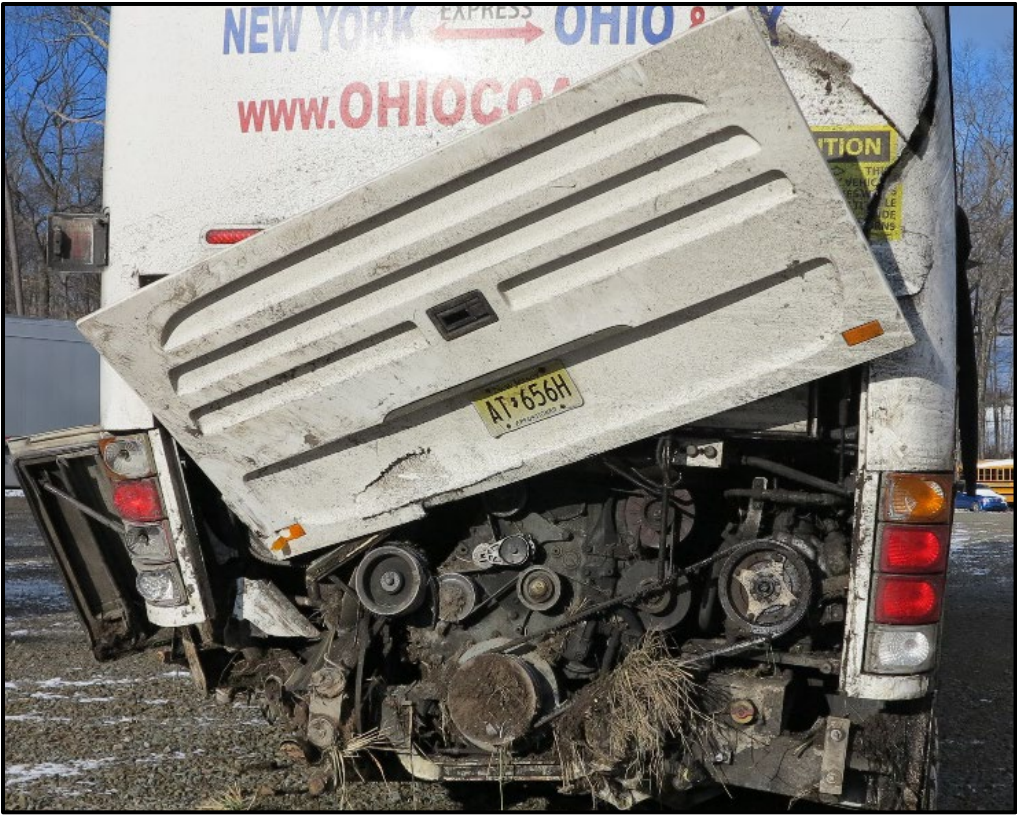
**Photograph 3:** Looking at the engine located at the rear of the 2005 Van Hool motorcoach.

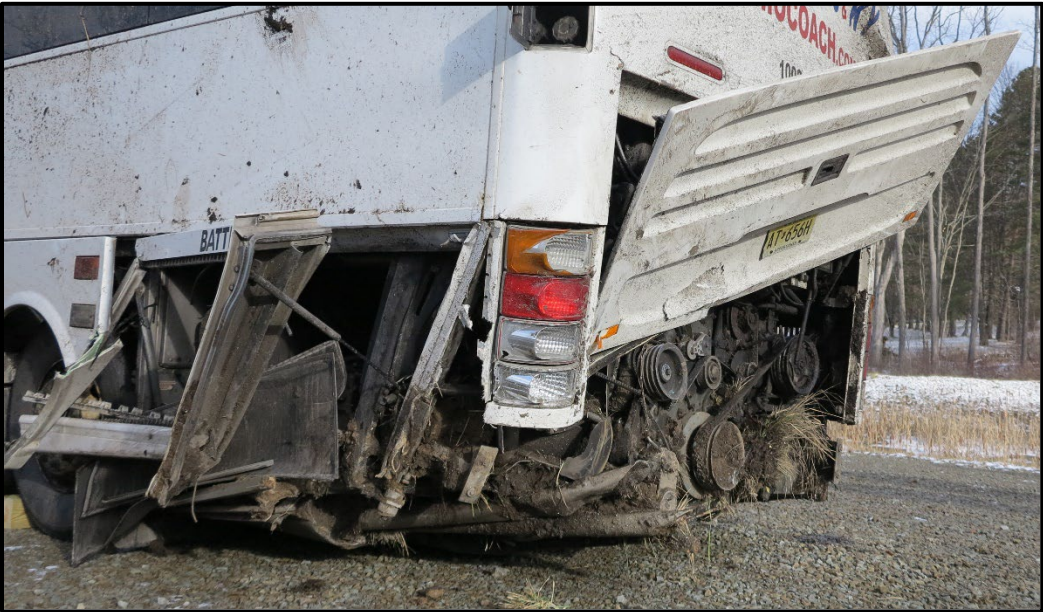
**Photograph 4:** A view of the right-rear corner of the 2005 Van Hool motorcoach

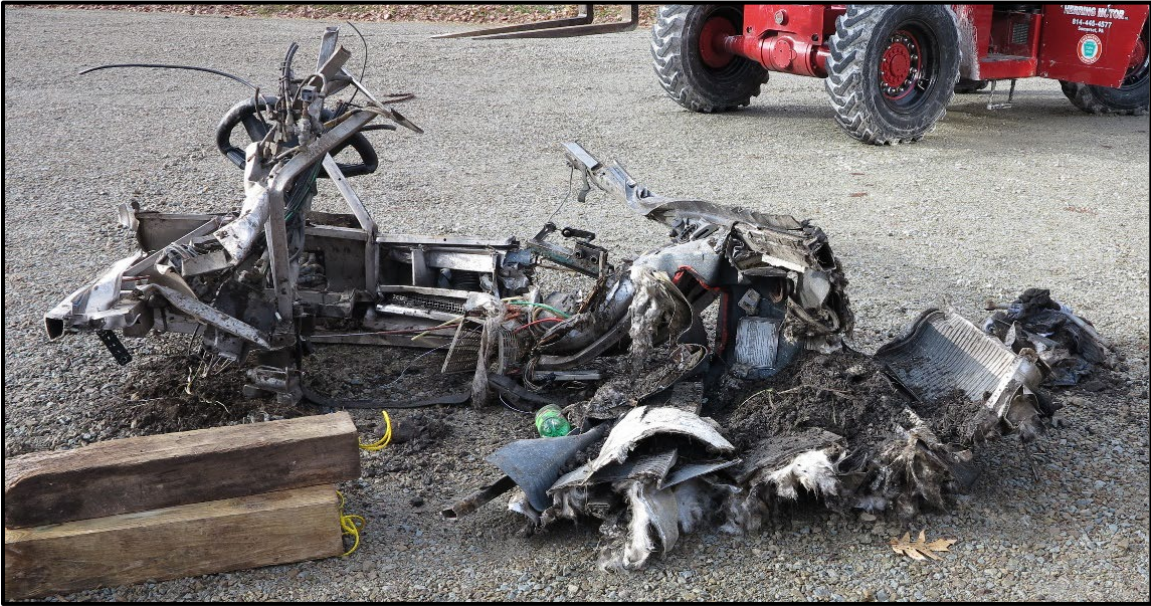
**Photograph 5:** The recovered steering components, dash, and stairwell from the 2005 Van Hool motorcoach.

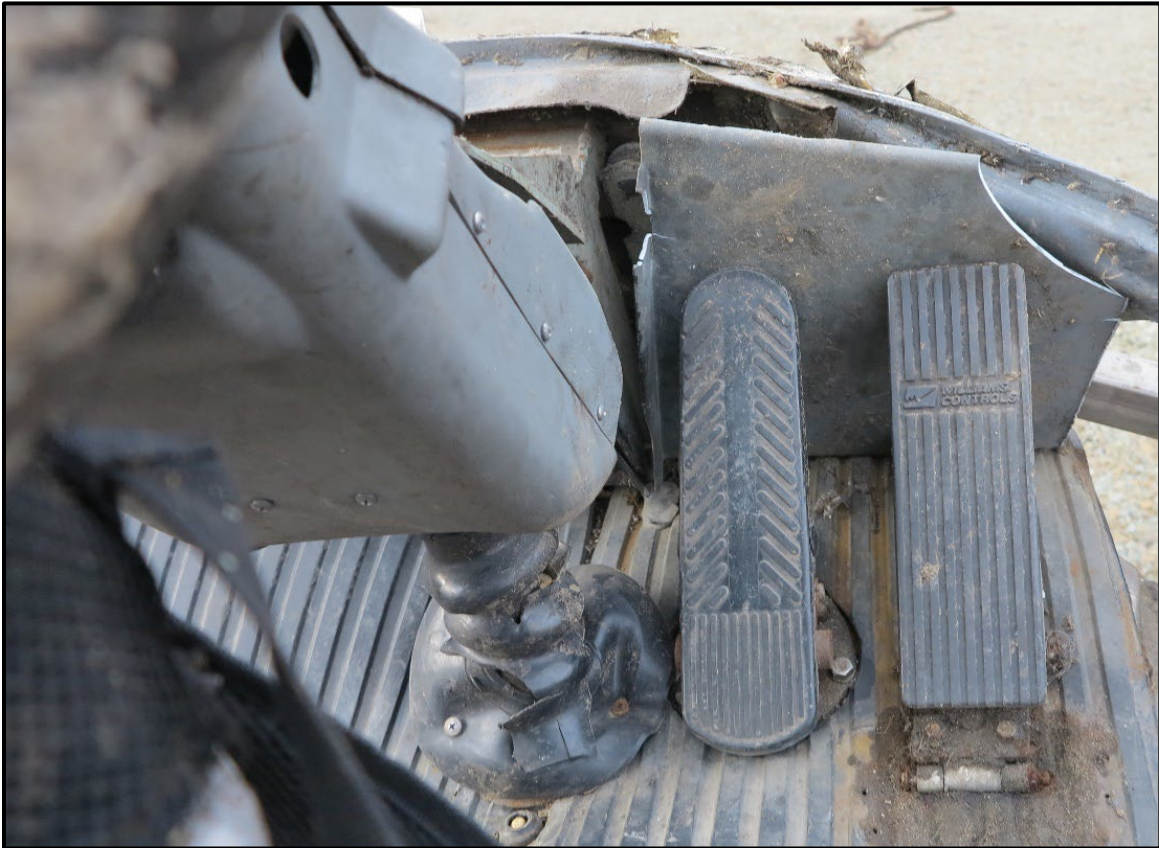
**Photograph 6:** A view of the accelerator and brake pedals from the 2005 Van Hool motorcoach.

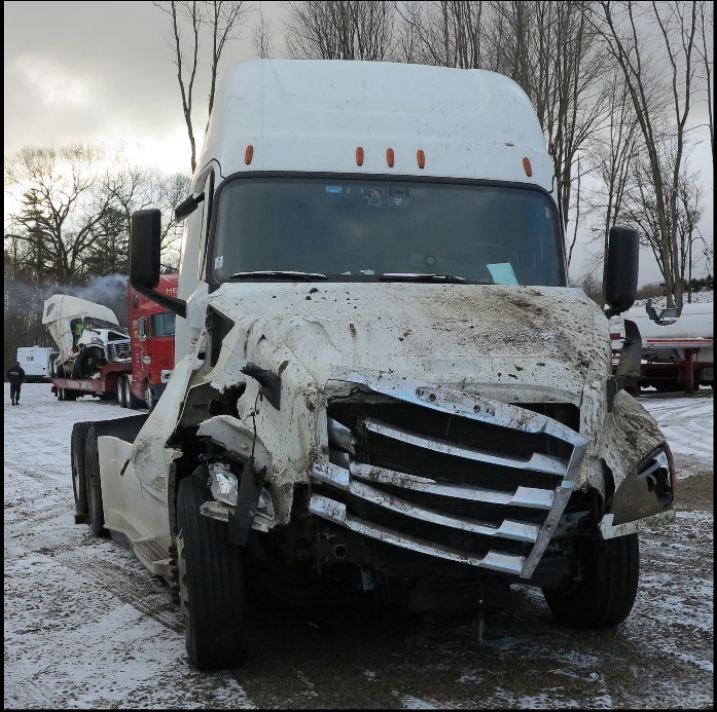
**Photograph 7:** A view of the damage to the right front of the 2018 FedEx truck-tractor.

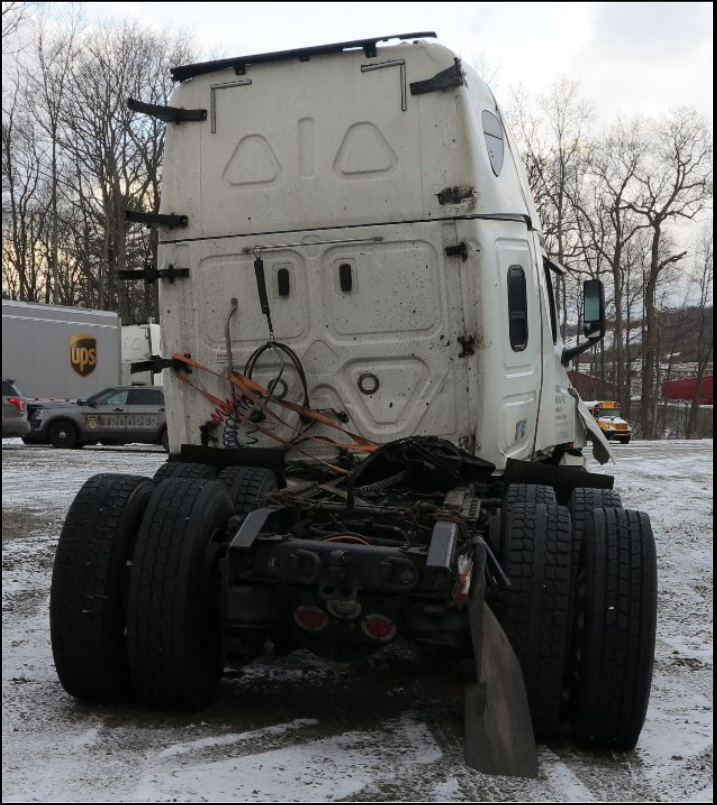
**Photograph 8:** Looking at the rear of the 2018 FedEx truck-tractor and displaced cab.

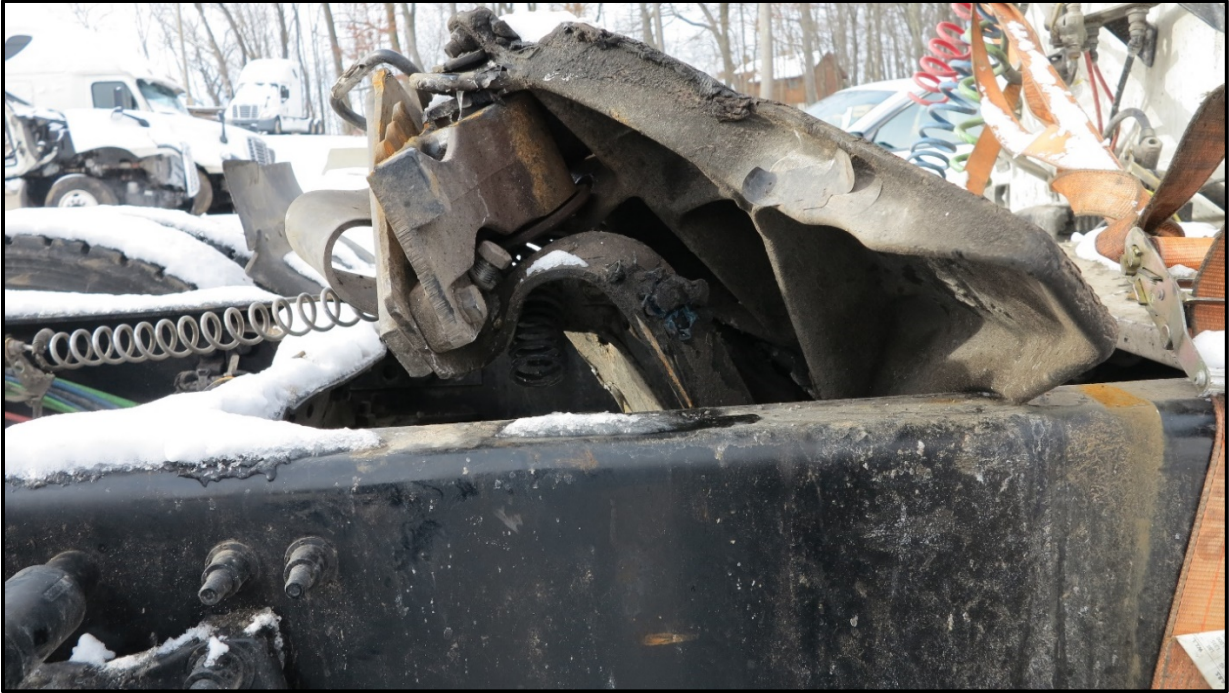
**Photograph 9:** The displaced 5<sup>th</sup> wheel of the 2018 FedEx truck-tractor.

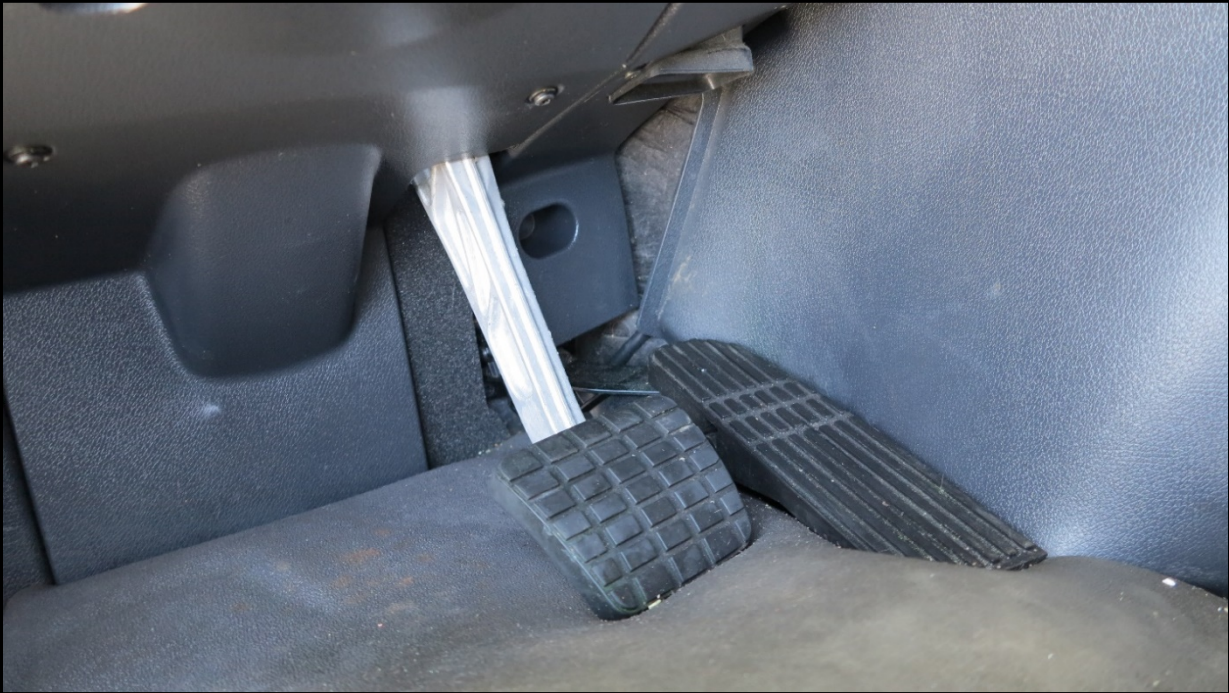
**Photograph 10:** Looking at the trapped brake and accelerator pedals of the 2018 FedEx truck-tractor.

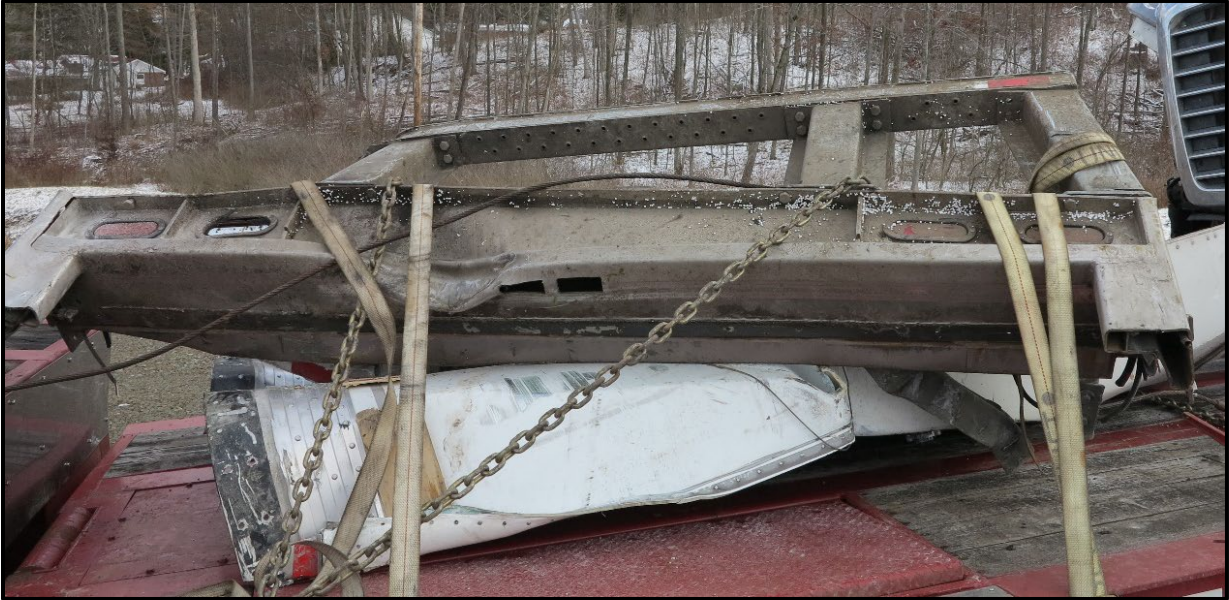
**Photograph 11:** Looking at the damage to the bumper from the 2019 Hyundai semitrailer.

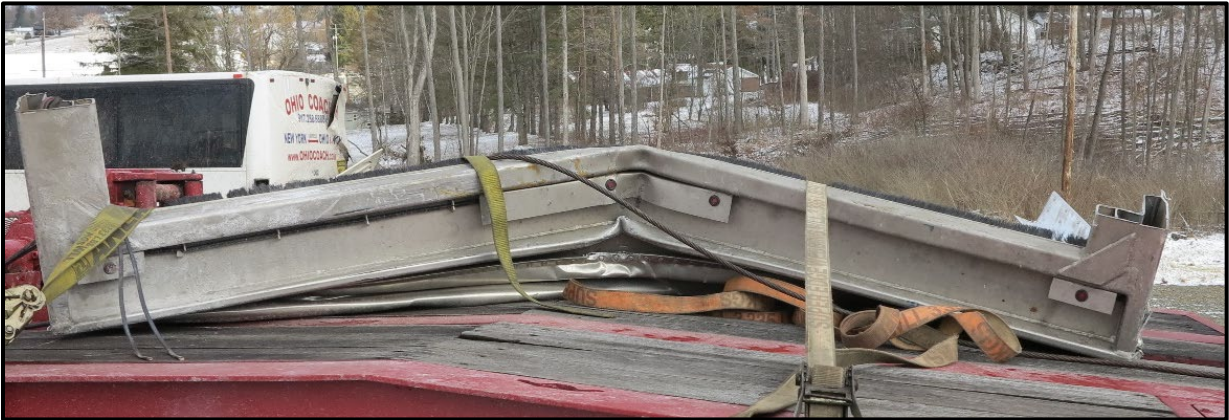
**Photograph 12:** Looking at the damage to the steel frame from above the cargo doors on the 2019 Hyundai semitrailer.

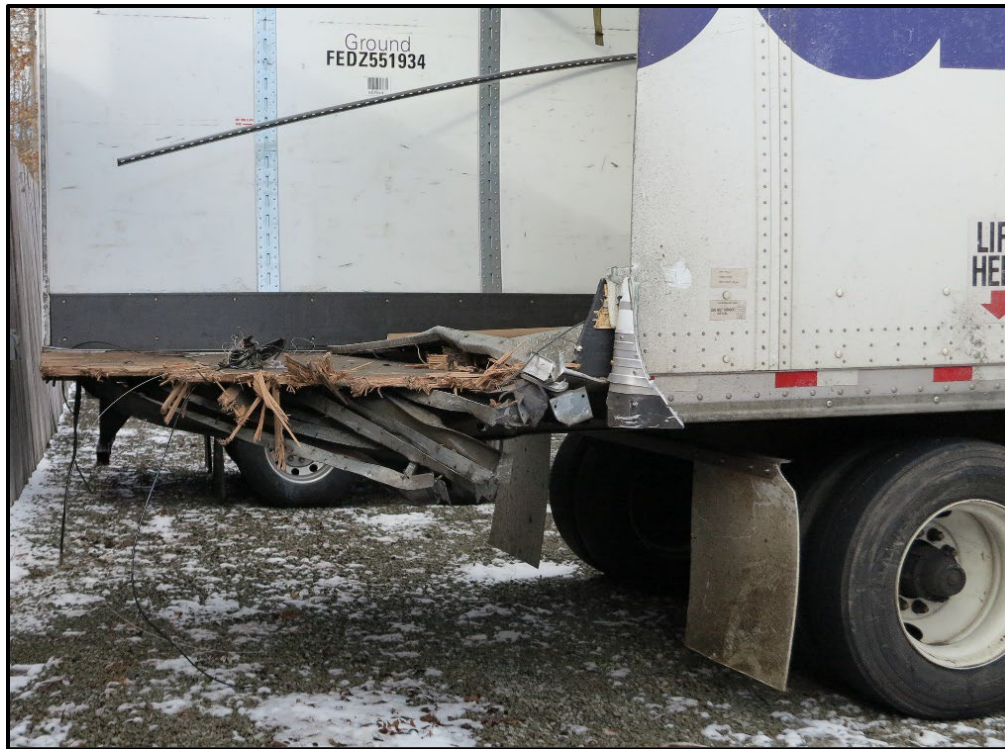
**Photograph 13:** Looking at the right-rear corner of the 2019 Hyundai semitrailer

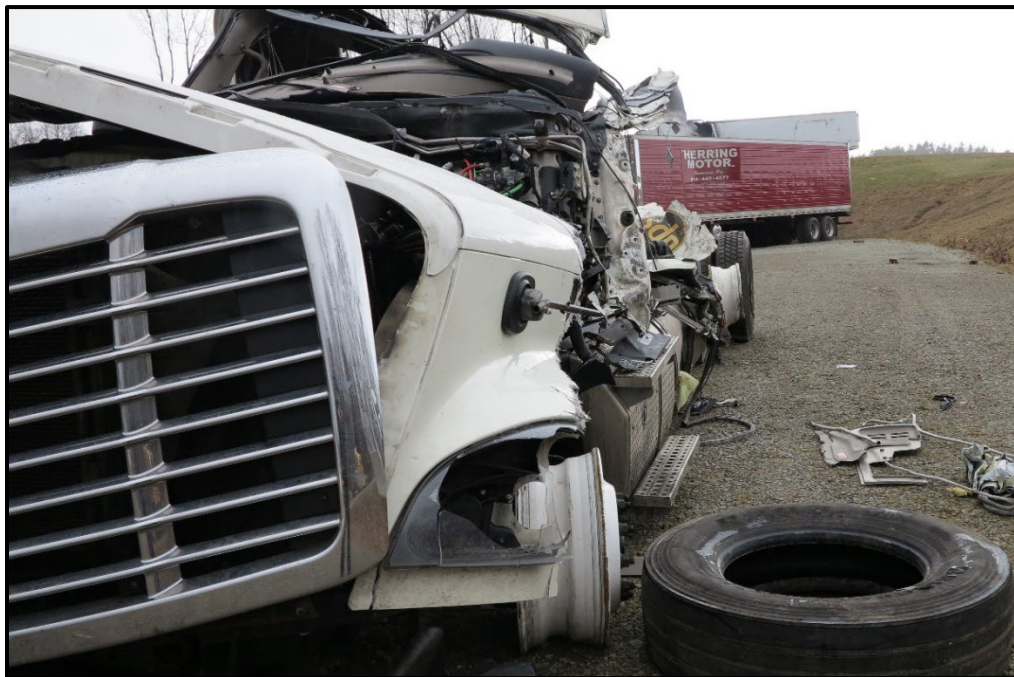
**Photograph 14:** A view looking from the front bumper toward the rear drive axle along the left side of the UPS #1 2018 Freightliner.

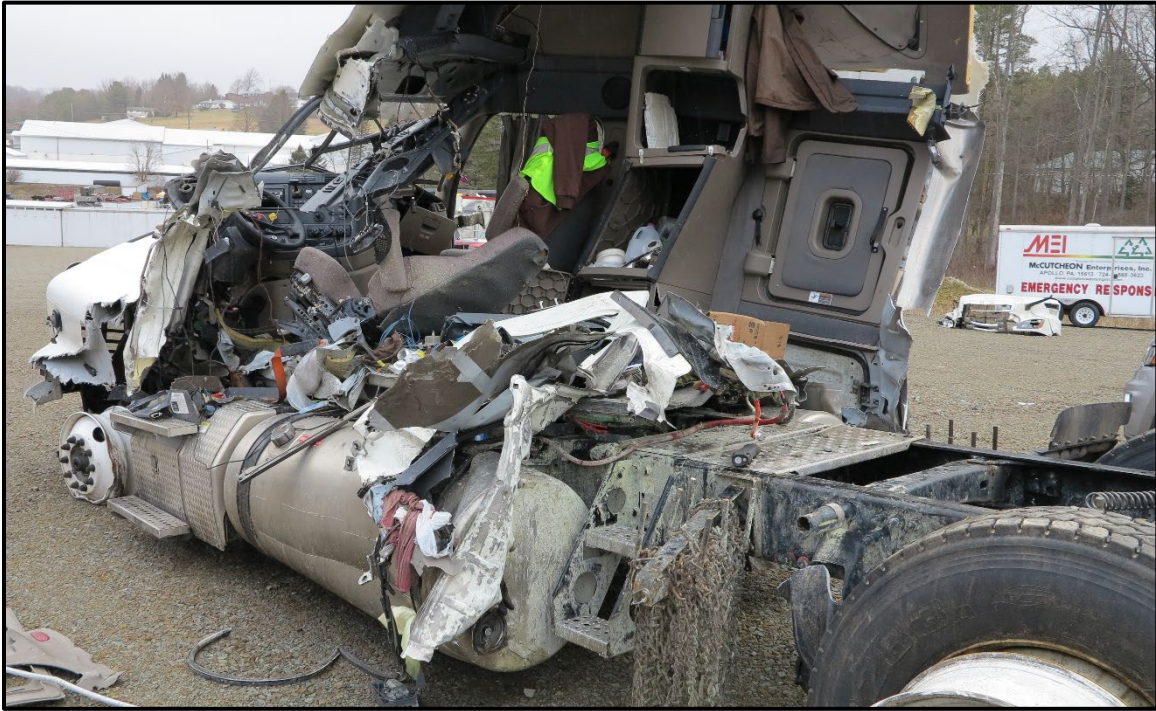
**Photograph 15:** A view of the damage sustained to the left side of the cab and sleeper berth of the UPS #1 2018 Freightliner.

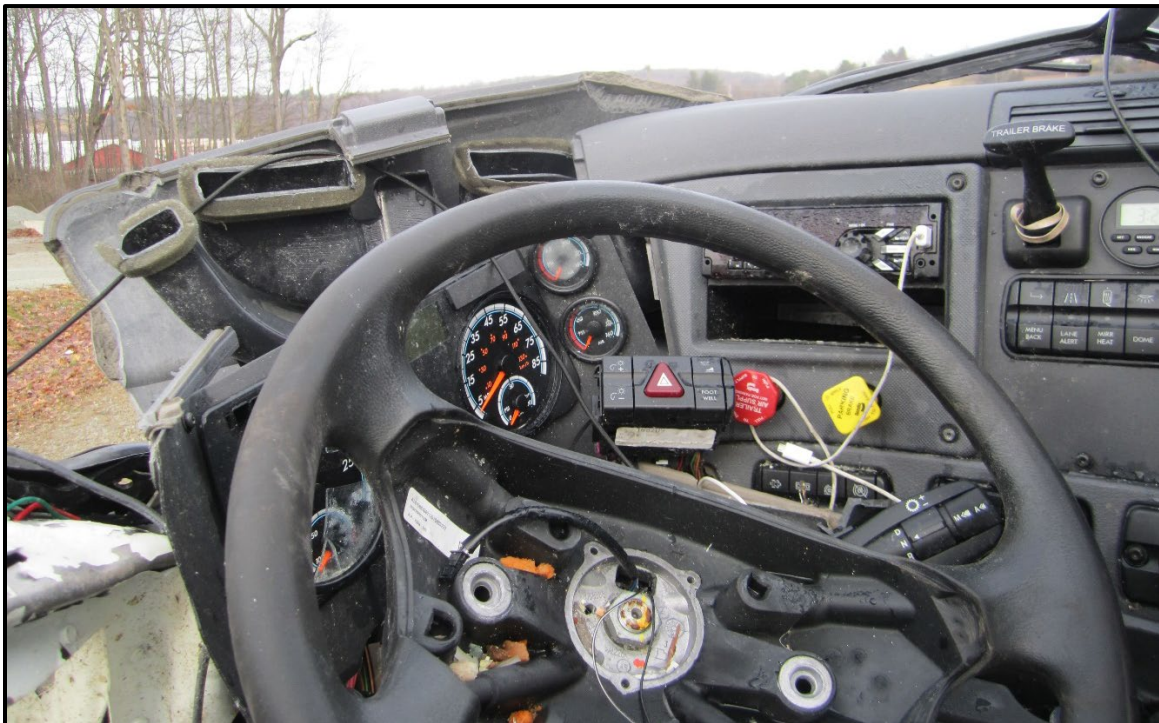
**Photograph 16:** This is a view of the displaced steering wheel and damaged instrument panel from the UPS #1 2018 Freightliner.

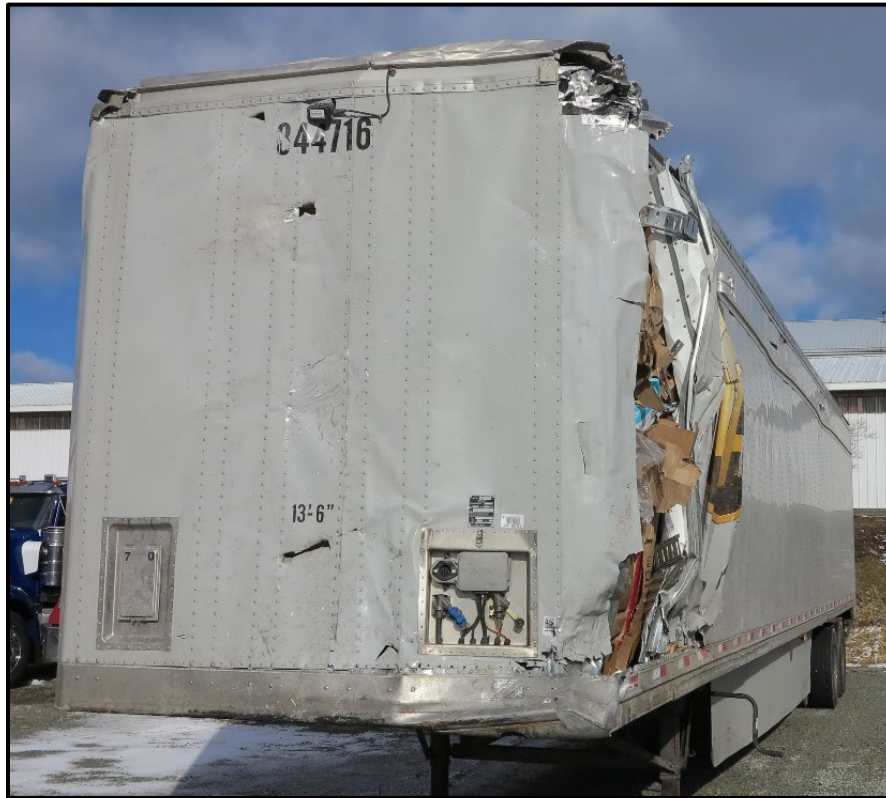
**Photograph 17:** A view of the left-front corner of the 2018 Stoughton semitrailer that had been connected the UPS #1 Freightliner.

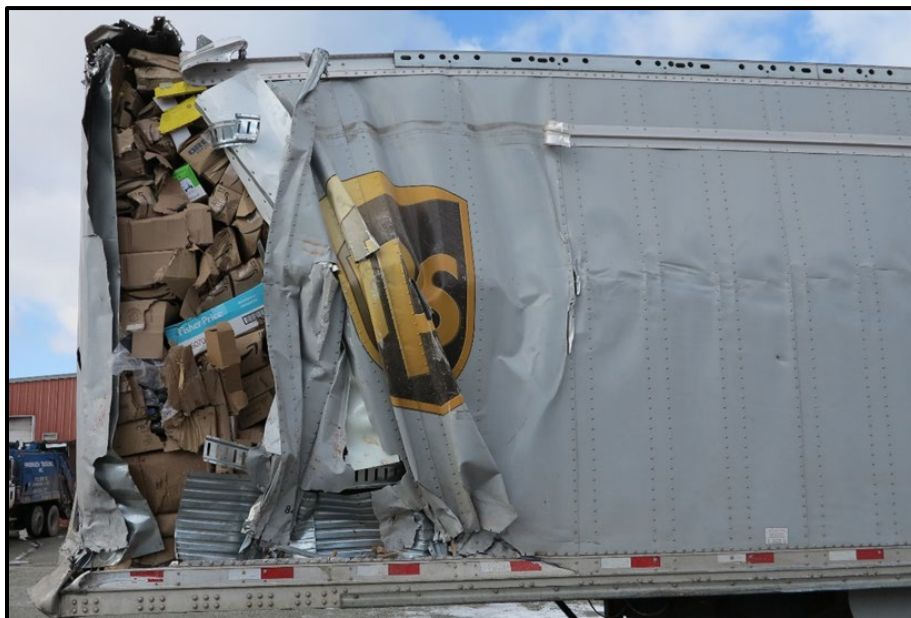
**Photograph 18:** Looking at the damage sustained to the forward section on the left side of the 2018 Stoughton semitrailer

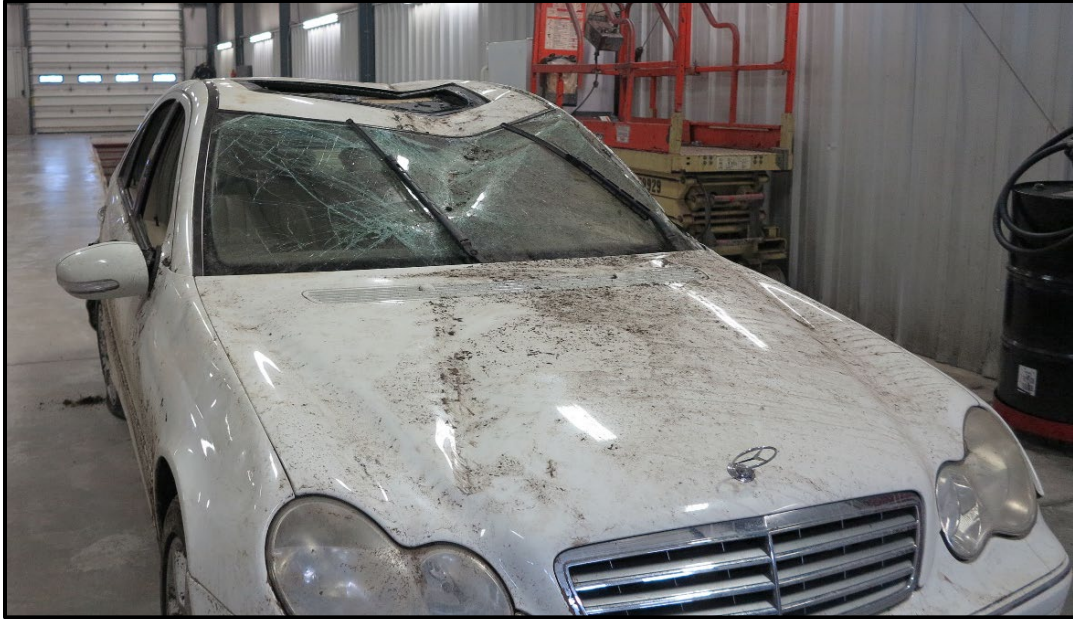
**Photograph 19:** A view of the crease that is on the hood and roof of the 2007 Mercedes.

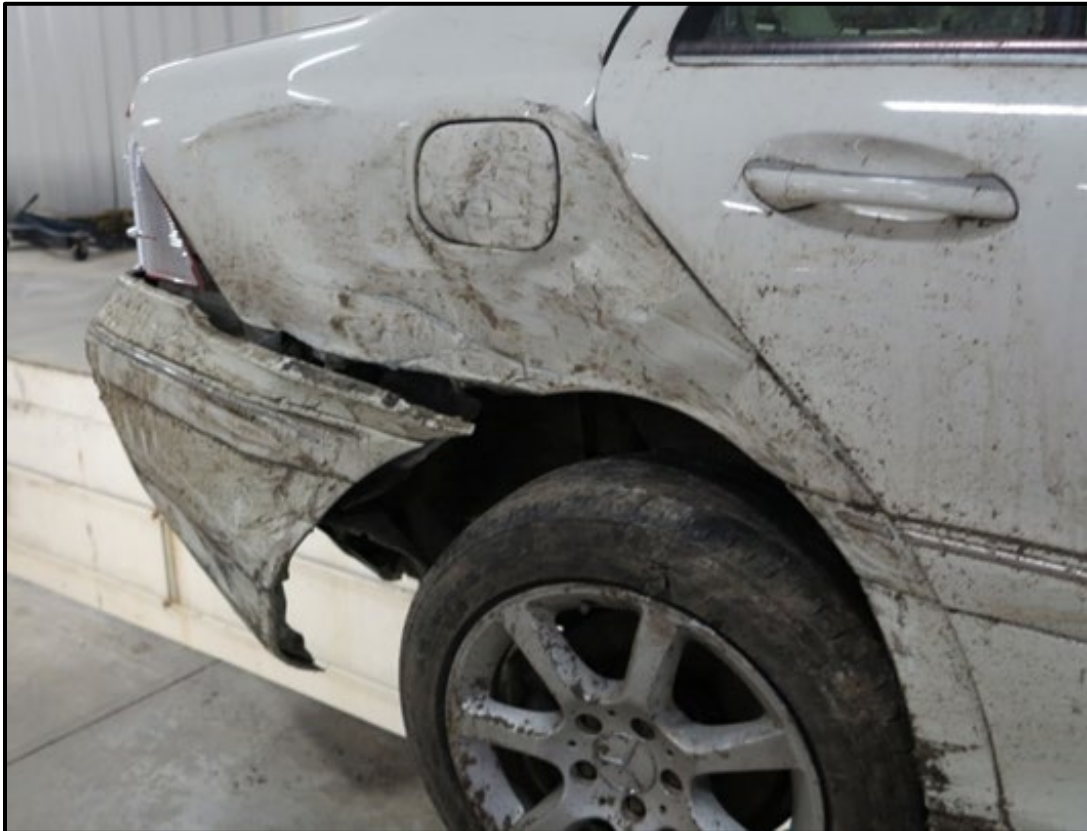
**Photograph 20:** A view of the damage sustained to the right-rear of the 2007 Mercedes.

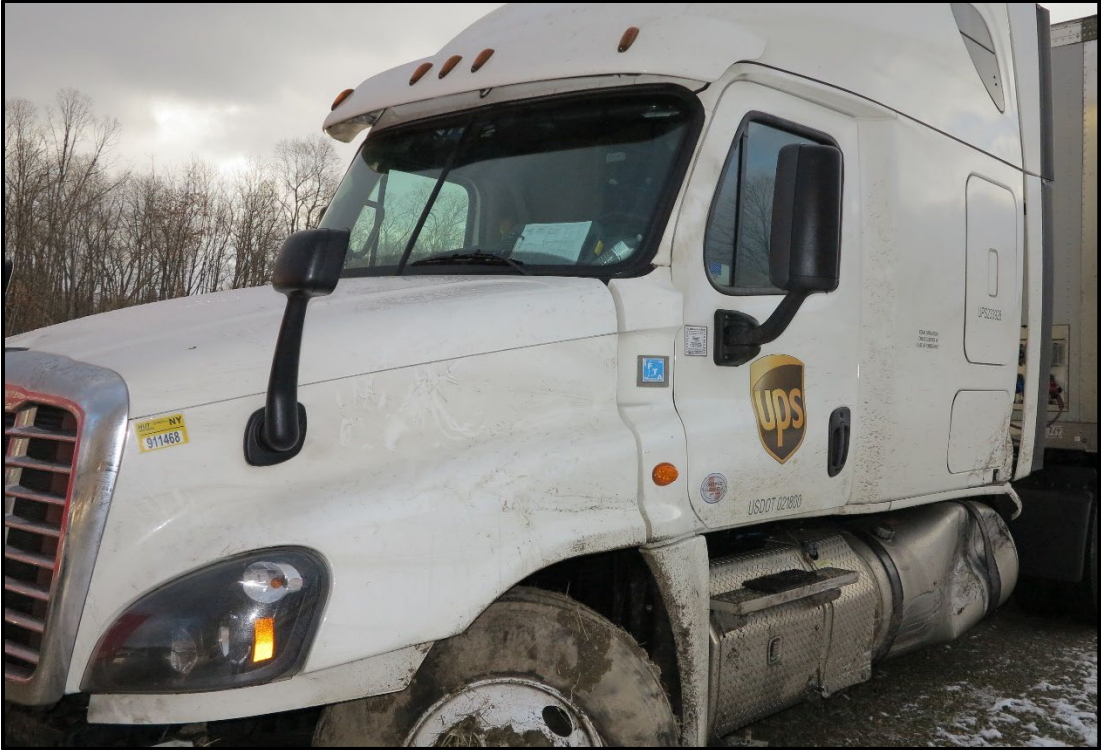
**Photograph 21:** A view of the damage sustained to the left side of the UPS #2 2018 Freightliner.

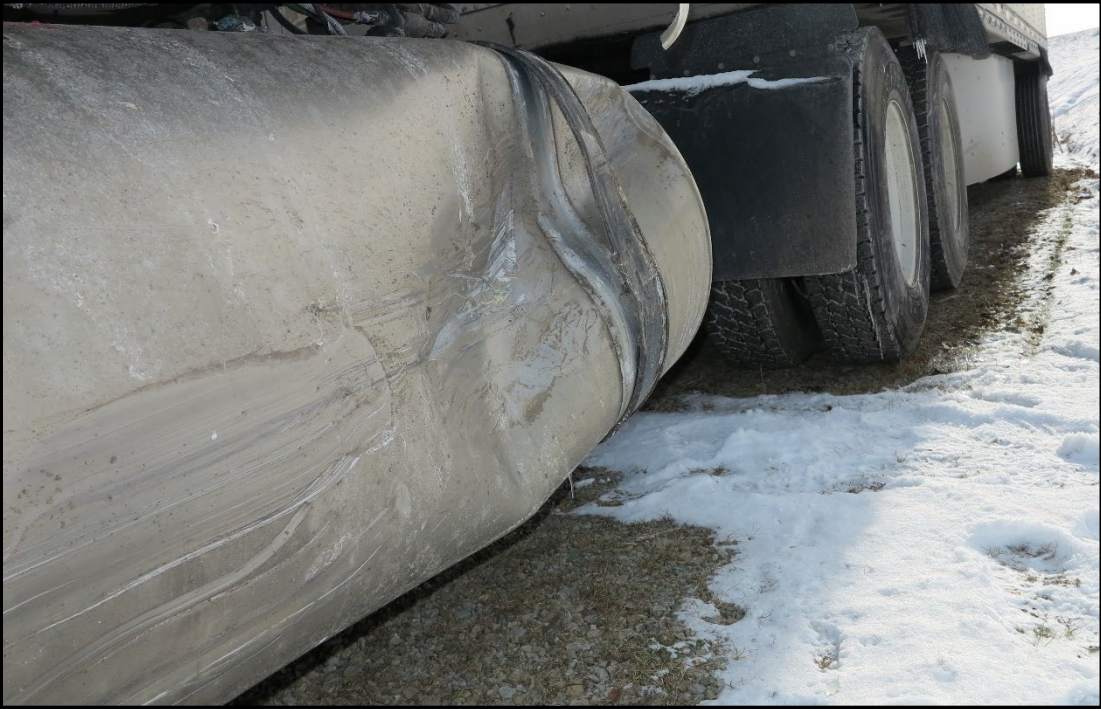
**Photograph 22:** A closer look at the damage to the left-side fuel tank mounted on the UPS #2 2018 Freightliner.
