National Transportation Safety Board

HWY23FH005

VEHICLE FACTORS

Group Chair's Factual Report

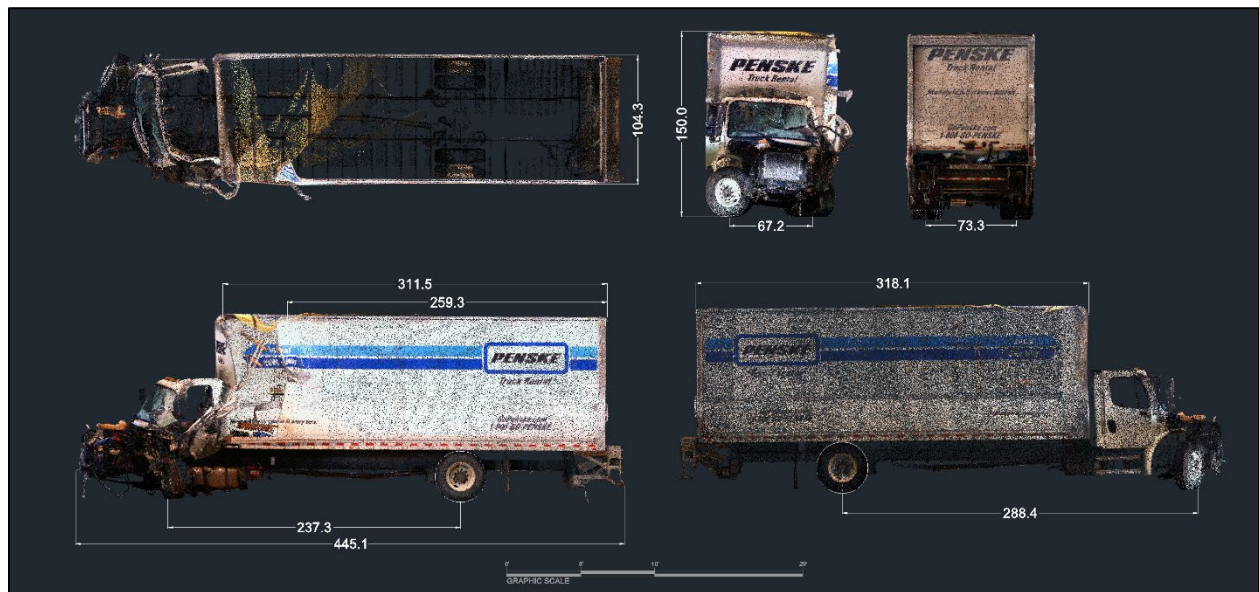
Figure 3: Truck - Damaged Measurements¹⁰

Figure 3 shows the damaged measurements of the subject truck post-collision utilizing the 3D terrestrial laser scans taken during the on-scene inspection.

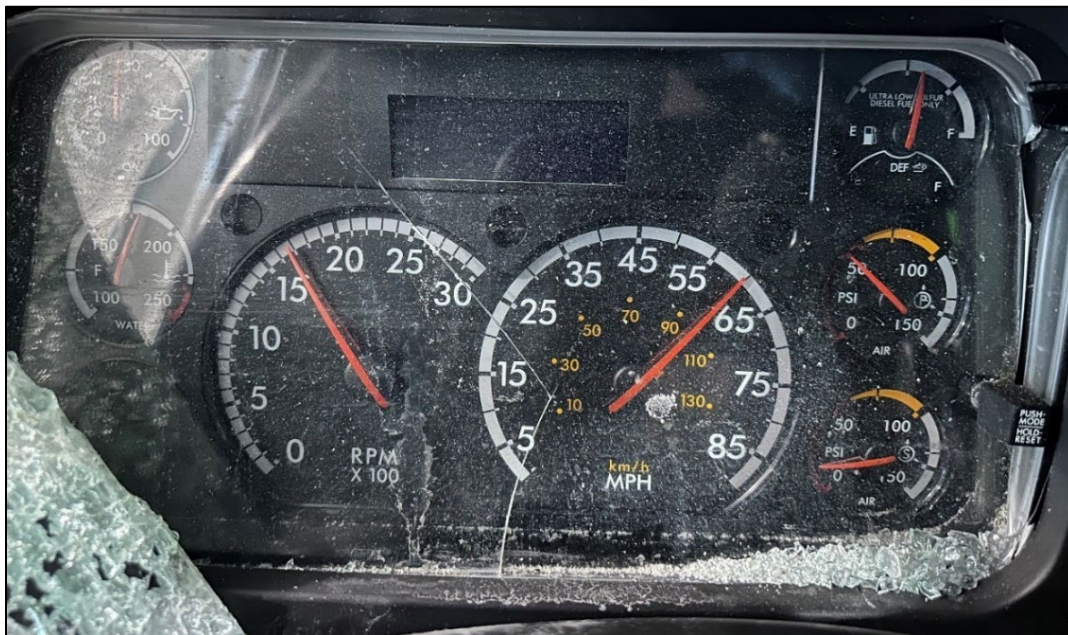
Figure 4: Truck - Frozen Instrument Cluster

The instrument cluster in front of the driver's seat contained numerous gauges, indicator lights, and switches. The gauges included voltage, engine oil pressure, engine speed¹¹, vehicle speed (mph & km/h) with an integrated odometer and hour meter, outside temperature, water temperature and fuel level indicator. Several analog gauges were frozen in place due to the collision related power loss. The speedometer gauge was frozen at approximately 59 mph, as observed in Figure 4. The RPM gauge was frozen between 1,600-1,700 RPM. The gauges for the primary and secondary air tanks were tested by making brake applications and determined to still be functional.

The fuse boxes, located in the upper-left side of the engine compartment, were damaged during the collision sequence. As a result, the truck suffered a power loss at impact. This was further supported by the frozen instrument cluster that was observed inside of the cab of the truck (described further in Section 1.6). Due to the collision related power loss, the remaining electrical system and onboard lighting were unable to be inspected, and a download of the vehicle's ECM was unable to be conducted in-cab through the vehicle's Deutsch connector.

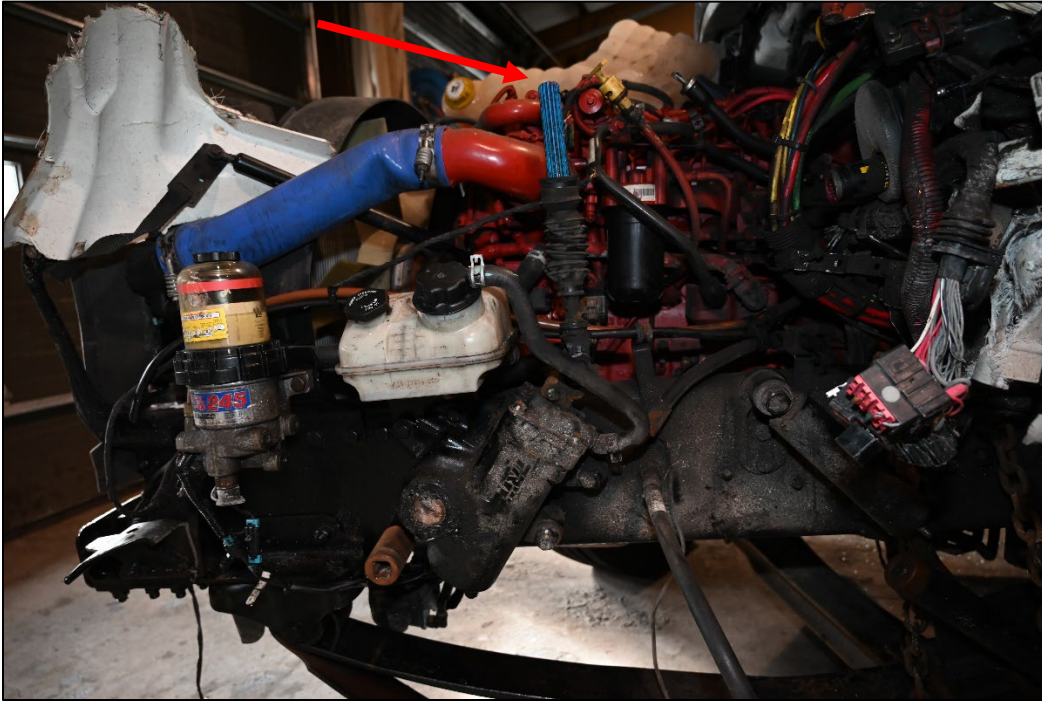
Figure 5: Truck - Lower Intermediate Steering Shaft with Splines Exposed

shaft was lowered to inspect the slip joint splines. The splines were not fractured or stripped, as observed in Figure 5.

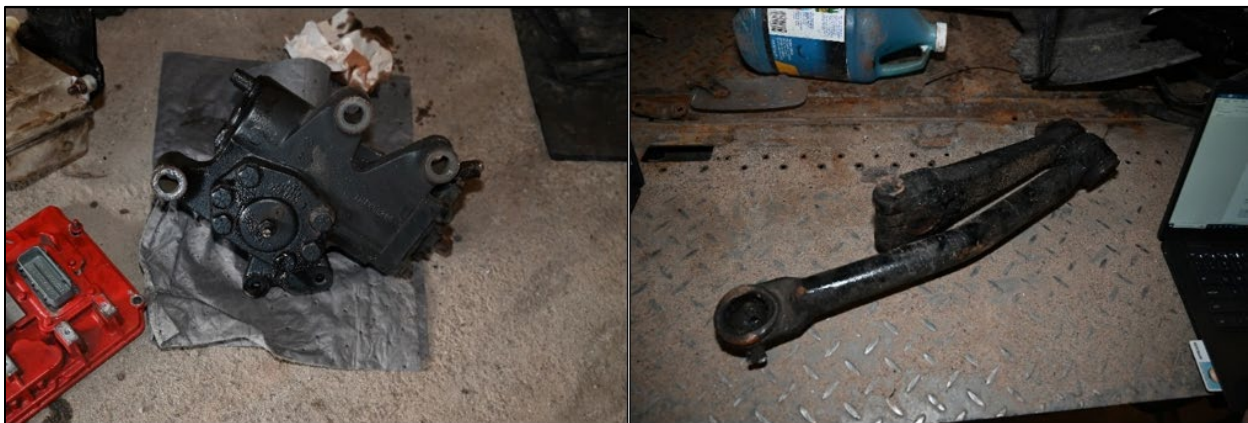
Figure 6: Truck - TRW Steering Gearbox and Pitman Arm

The truck was equipped with a TRW (now ZF) THP-60 series steering gearbox. The pitman arm separated from the gearbox at the sector shaft. The pitman arm remained connected by a ball joint to the drag link, and both were located in the cargo box of the truck along with other crash debris, as observed in Figure 6. The drag link disconnected from the left-steer knuckle during the collision, as observed in Figure 7. The tie rod was separated from the left steering knuckle. The steering gearbox, which was securely attached to the left frame, was removed from the truck by a mechanic at the direction of the NTSB. An external examination of the steering gearbox revealed separation of the pitman arm, however, no damage to the housing.

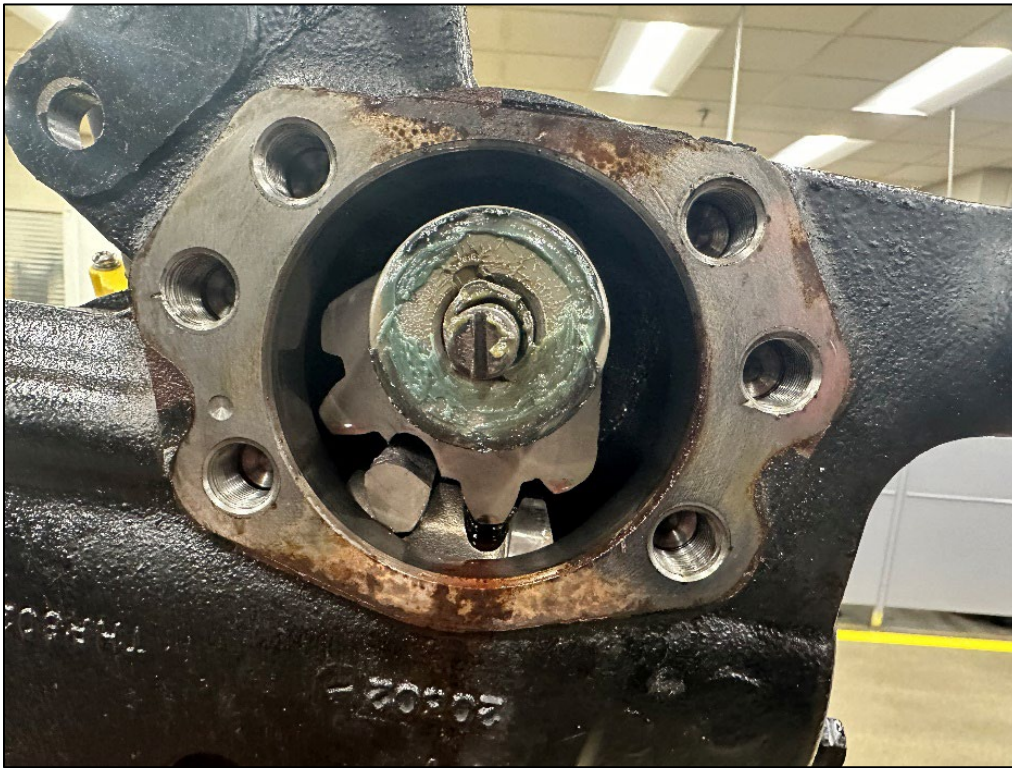
Figure 8: Truck - Center Tooth Fracture of the Sector Shaft

The examination revealed that the steering gearbox received an impact load significant enough to cause Brinell impact marks¹² from recirculating ball bearings onto the internal helical worm gear and to sever the center tooth of the sector shaft, as observed in Figure 8. Brinell marks were also discovered on the sector shaft and were caused by the roller bearing, which indicated a high impact load from the pitman arm pushing against the roller bearing.¹³ The brinelled helix position was closer to the

upper cylinder which indicated that there was slight right steering input at impact. An overview of the disassembled steering gearbox can be observed in Figure 9.

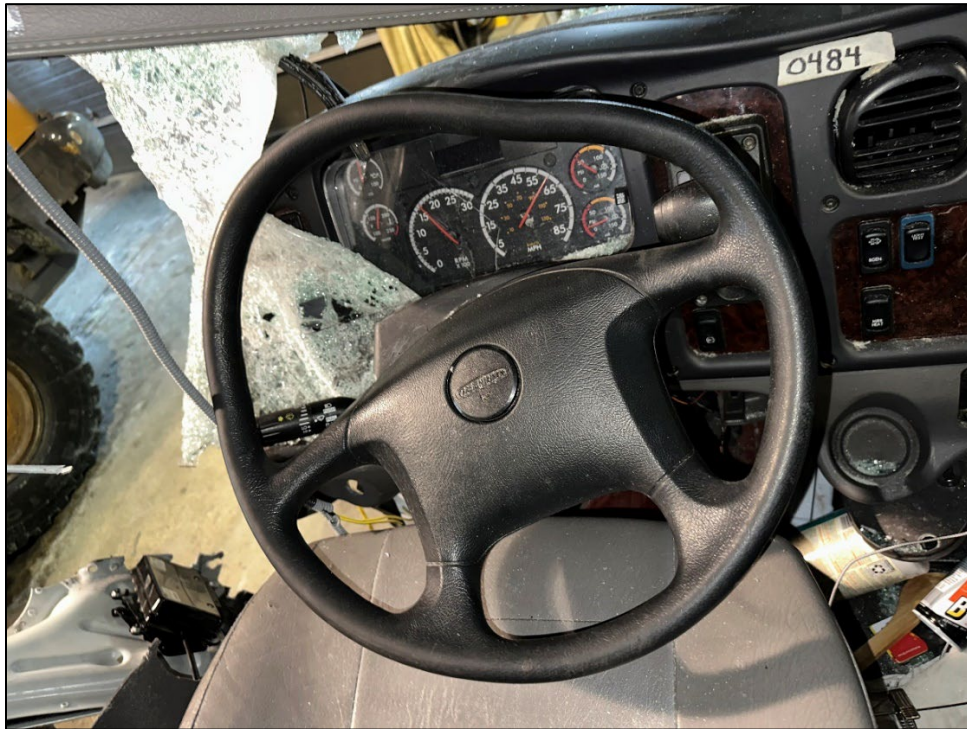
Figure 10: Truck - Steering Wheel and Driver Controls

There was significant deformation to the steering wheel at the 1:00 o'clock position (Figure 10). The driver's seat was pushed forward due to intrusion from the rear of the cab. Please see the docket for more information regarding the occupant intrusion, seatbelt inspection, and steering wheel deformation.

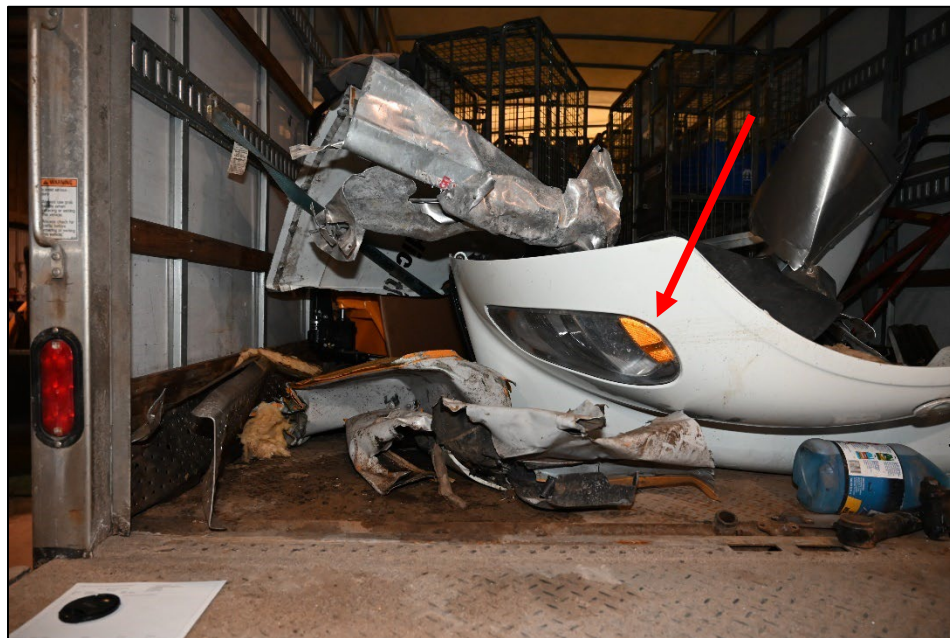
Figure 12: Truck - Right Headlight Assembly

The left-headlight assembly was destroyed during the subject collision and not recovered by the NYSP or the NTSB. The right-headlight assembly was located in the rear of the truck with other crash debris, as observed in Figure 12. The lightbulbs from the right-headlight assembly were inspected, packaged as fragile evidence, and submitted to the NTSB Materials Laboratory for further imaging.

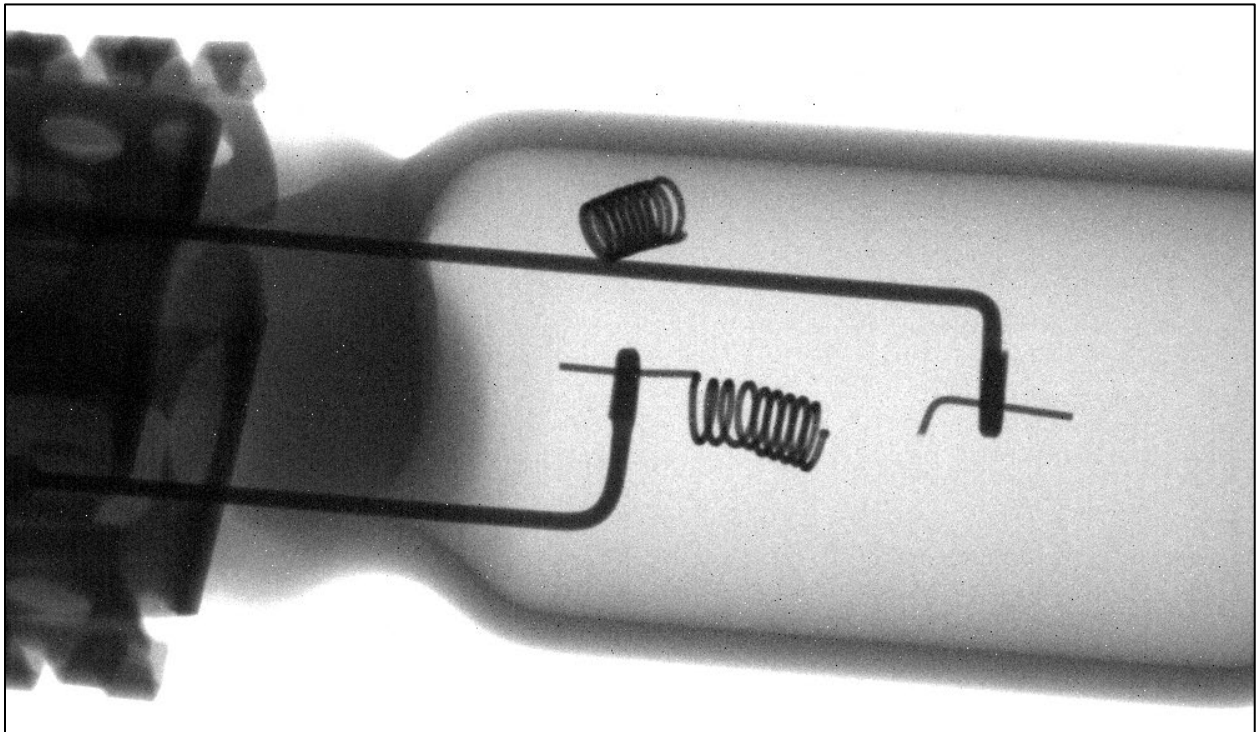
Figure 13: Truck - Upper Headlight Bulb Imaging

The NTSB Materials Laboratory performed radiography imaging on the submitted bulbs. Radiography is an imaging process that uses high-energy radiation to view the internals of an object. Imaging of the headlight upper and lower bulb from the right-headlight can be observed in Figure 13 and Figure 14. The upper headlight bulb contained one filament. Upon inspection, the filament was broken into two pieces, with only half of the filament still connected in its housing. The lower headlight bulb

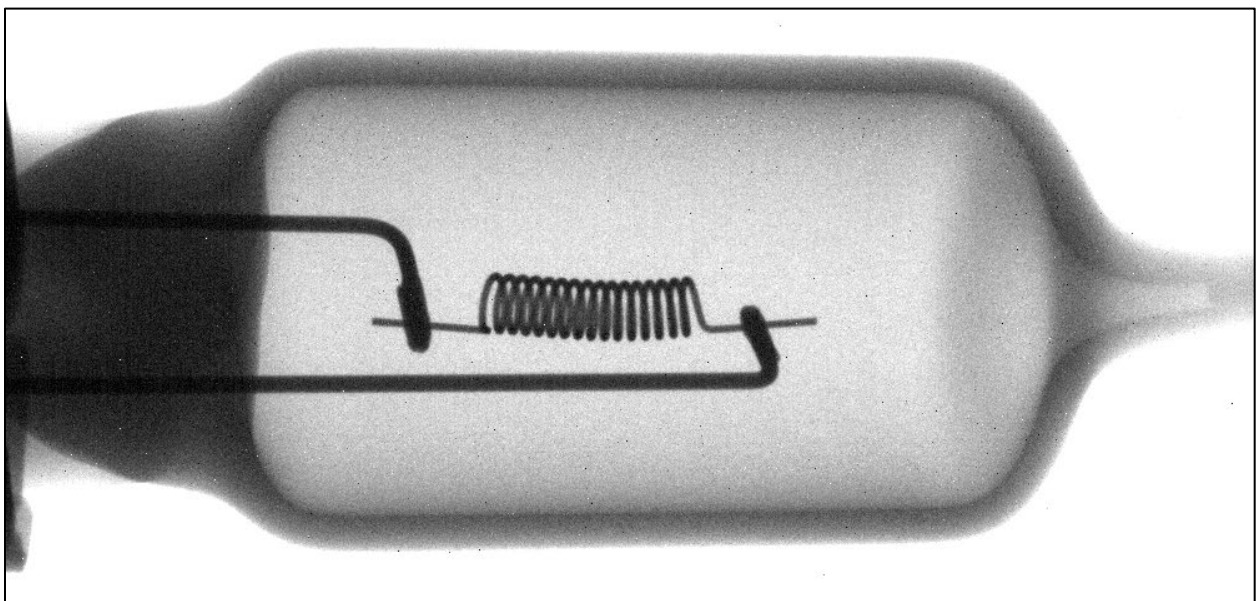
Figure 14: Truck - Lower Headlight Bulb Imaging

contained only one filament that was free from fractures and was contained in its housing.

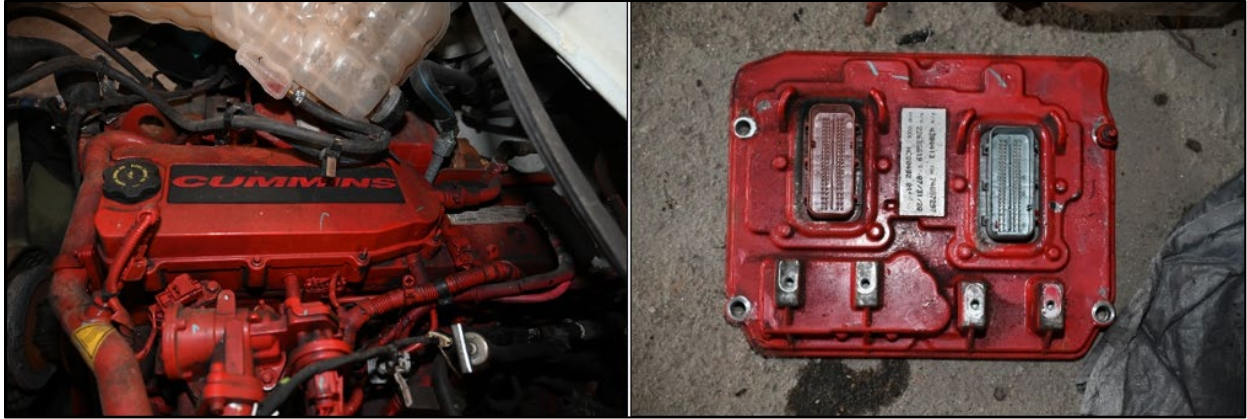
Figure 16: Truck - Cummins B6.7 Engine & ECM

The truck contained a Cummins B6.7 engine, which was equipped with a Continental CM2350 ECM, as observed in Figure 16. Typically, a download of the ECM could be conducted through the Deutsch connector of the truck utilizing a vehicle connection interface using Cummins Insite and PowerSpec software. Due to the collision related damage present to the subject truck, this method for retrieving any potential data recorded by the ECM was impractical. As a result, the ECM was removed from the engine and was shipped to the NTSB Headquarters evidence control room until coordination with Cummins Inc. could be facilitated.

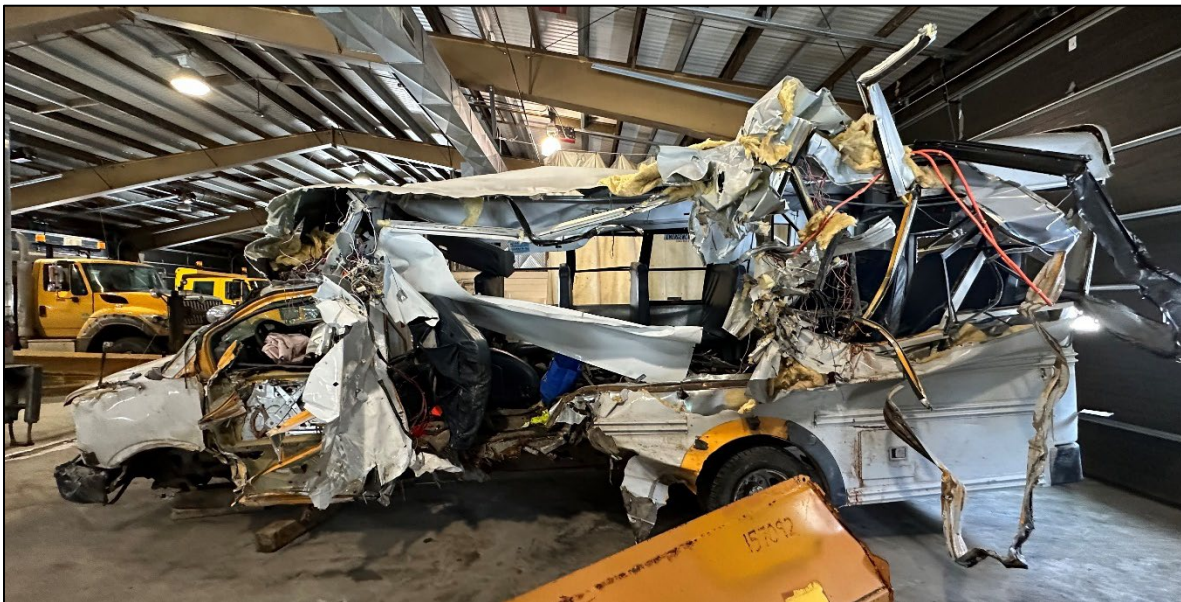
Figure 20: Bus - Left Side Damage

The bus sustained contact damage to the front-left and left side of the vehicle. The left corner of the front bumper received the initial contact from the front of the truck. The bus's front grille, left sealed beam headlight, trim, and turn signal outer covering were all missing from the vehicle. The leading edge of the hood was dented rearward in two distinct locations. The windshield was cracked and significantly damaged on the left side. Both left-side mirrors separated from the vehicle. The left fender was dented inward. The front-left wheel assembly separated from the vehicle and the rear-left tires were flat. The outer skin to driver's door peeled away from the vehicle exposing the door mechanisms and the inboard side of the interior skin.

The bus received contact and induced damaged throughout the school bus body. The upper-front portion of the bus body sustained contact damage on the left side which compromised several vertical pillars and horizontal rails. On the right side of the upper-front portion of the bus, induced damaged in the form of tearing was observed. The left side of the bus received contact damage that compromised the waist rail, seat rail, cant rail, window rail, and other horizontal rails. All left side vertical pillars aft to the B-pillar were destroyed during the collision or significantly compromised, as observed in Figure 20. The combination of the destroyed and compromised horizontal rails and vertical pillars resulted in a large ejection port on the left side of the vehicle.

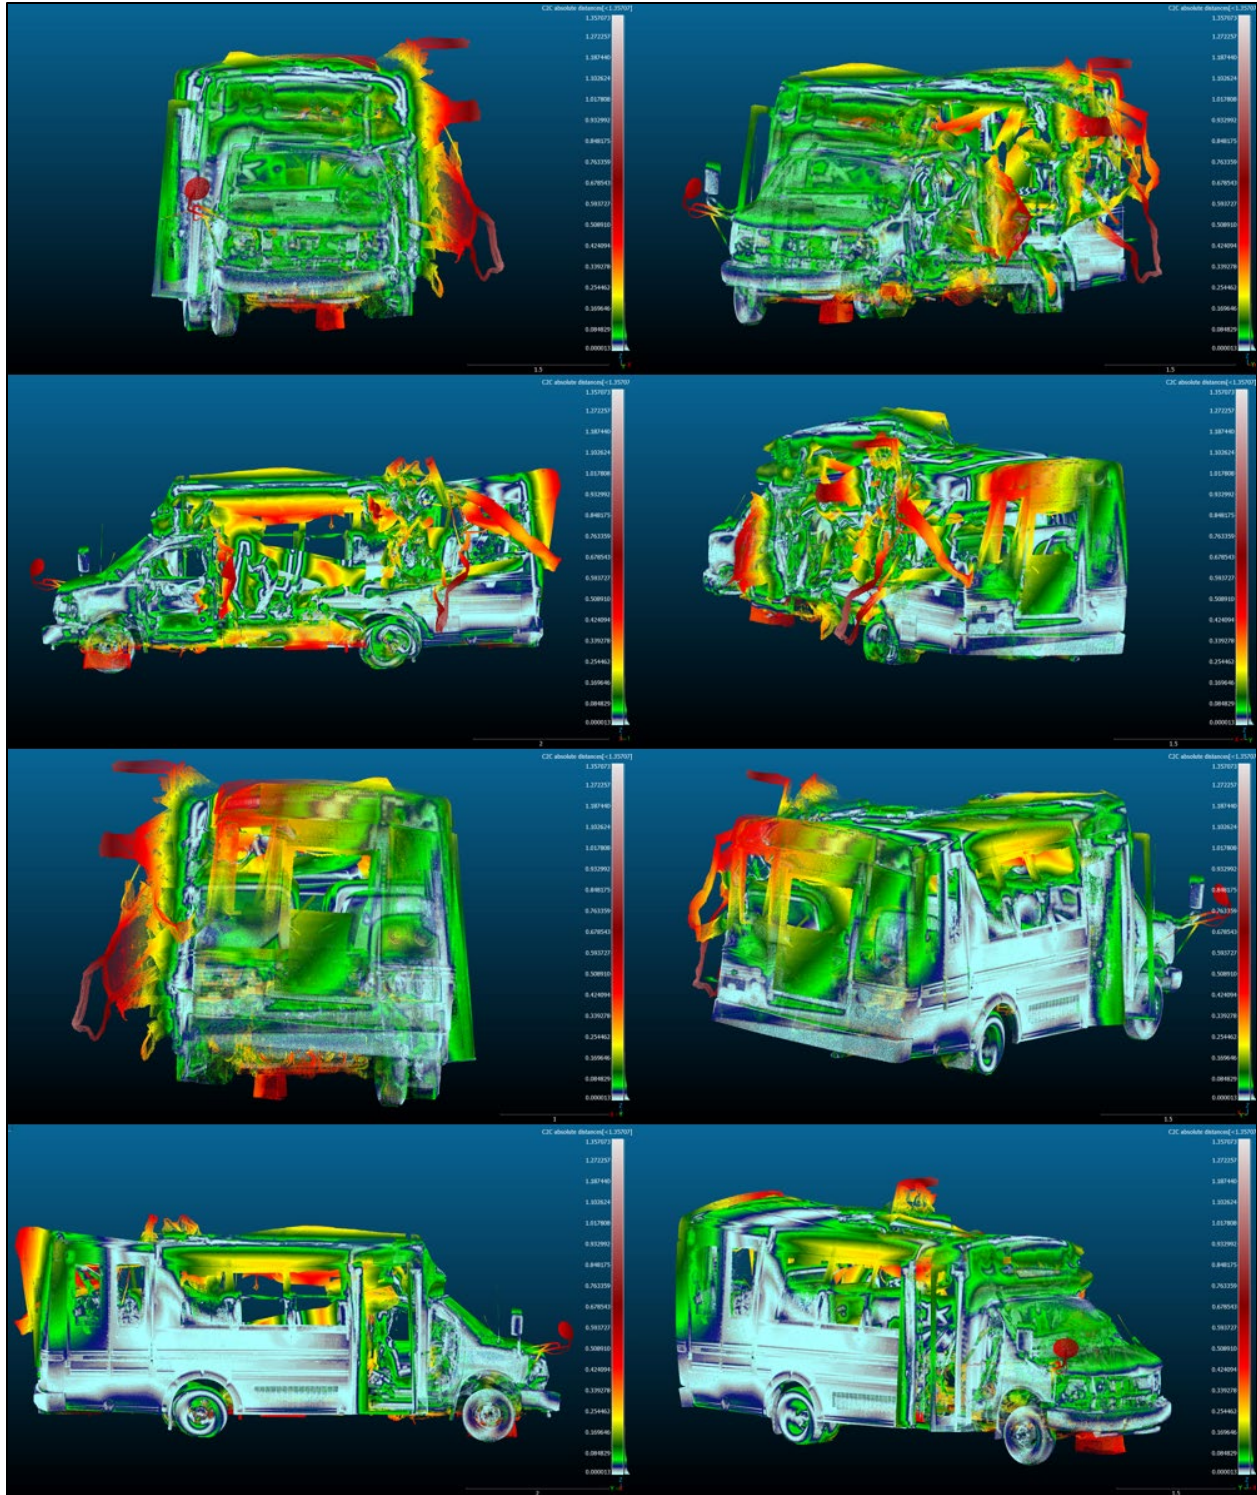
Figure 21: Bus - Intensity Map of Bus Deformation

Utilizing the 3D laser scans of the subject and exemplar bus, an intensity map of the deformation sustained by the bus was created. By comparing the cloud-to-cloud distance between the respective points between the two point clouds, the damaged subject bus deformation, with respect to undamaged exemplar bus can be measured and visualized. Figure 21 shows the resulting visual product of the deformation comparison between the damaged and undamaged bus.

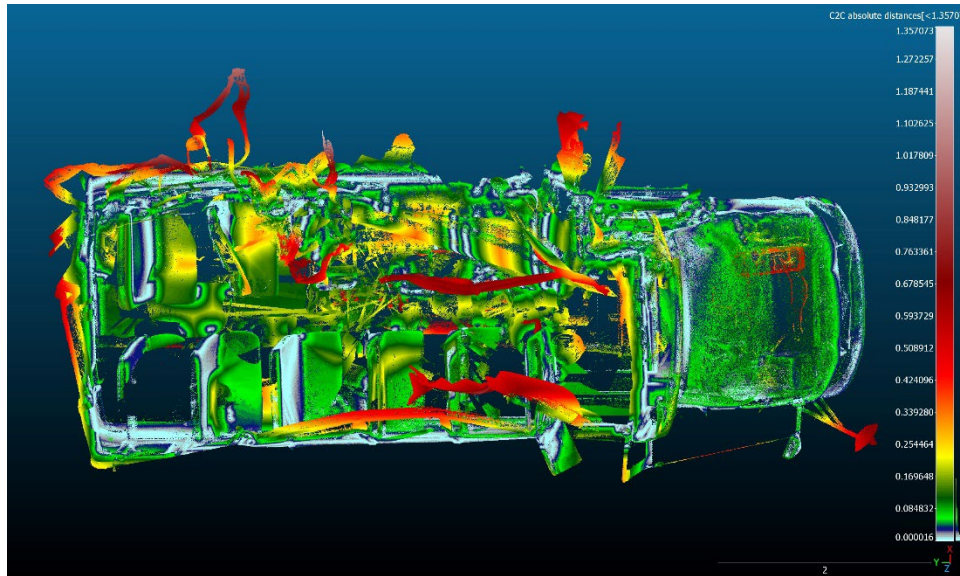
Figure 22: Bus - Top-Down Intensity Map of Bus Deformation

A top-down view of the damage deformation can be observed in Figure 22. Most of the vehicle's roof was removed in the graphic to show the interior of the bus and its corresponding seating arrangement and deformation.

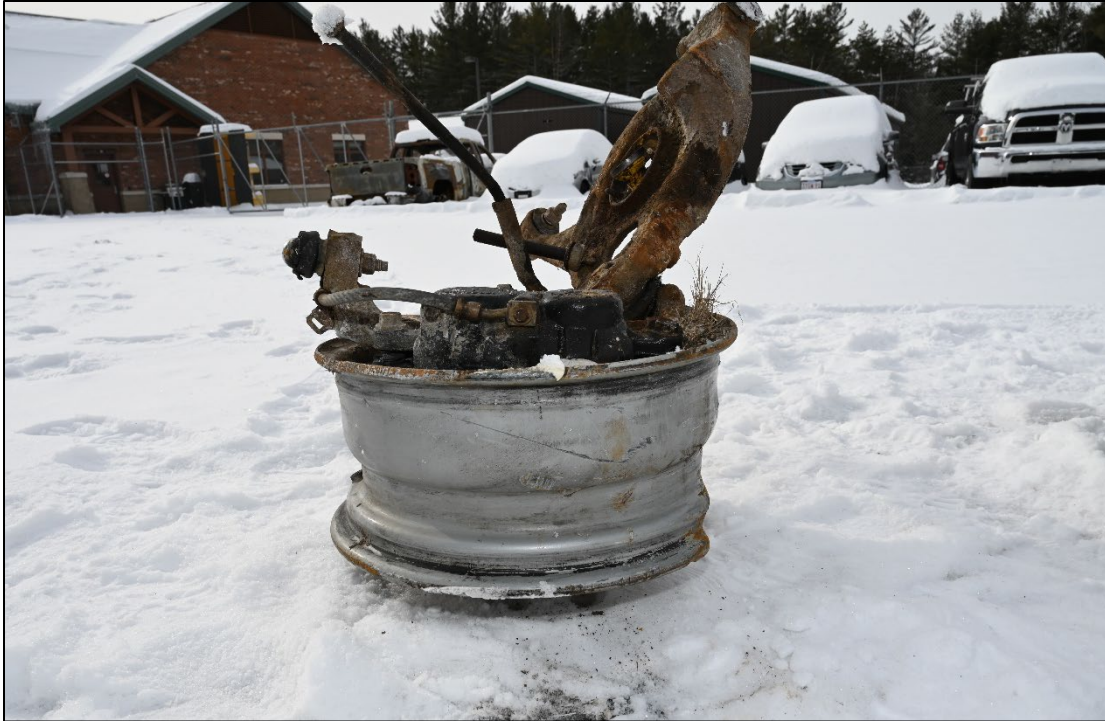
Figure 26: Bus - Left-Front Wheel Assembly

The front suspension consisted of independent short/long arm (SLA) coil springs with stabilizer bar. The rear suspension consisted of a two-stage, semi-elliptic multi-leaf springs and semi-floating rear axle.⁴¹ The front sway bar was still secured to the bus, as observed in Figure 25. The left and right axle-2 sway bar links were broken but still attached to the sway bar. The left-front wheel-assembly that included lower-control arm, hub, steel rim, and brake assembly separated from vehicle at the upper control arm, as observed Figure 26.

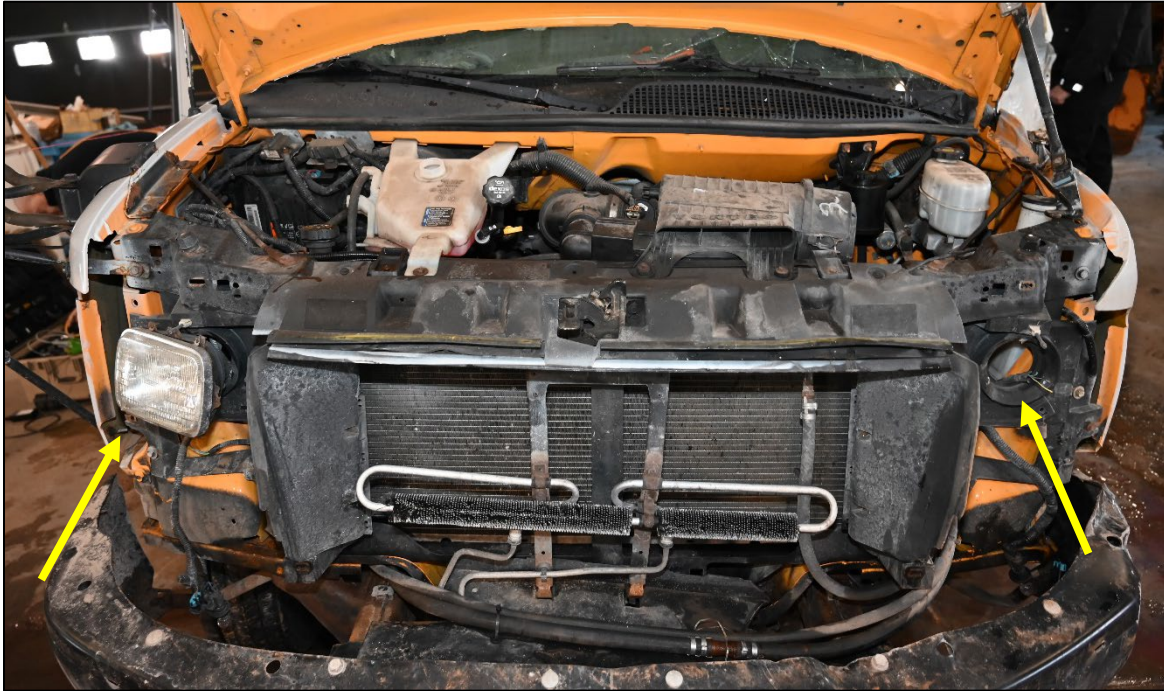
Figure 27: Bus - Headlights

The bus contained sealed beam headlights. The left sealed beam headlight was damaged during the collision and not recovered by the NYSP or the NTSB, as observed in Figure 27. The right sealed beam headlight was recovered and submitted to the NTSB Materials Laboratory for advanced imaging.

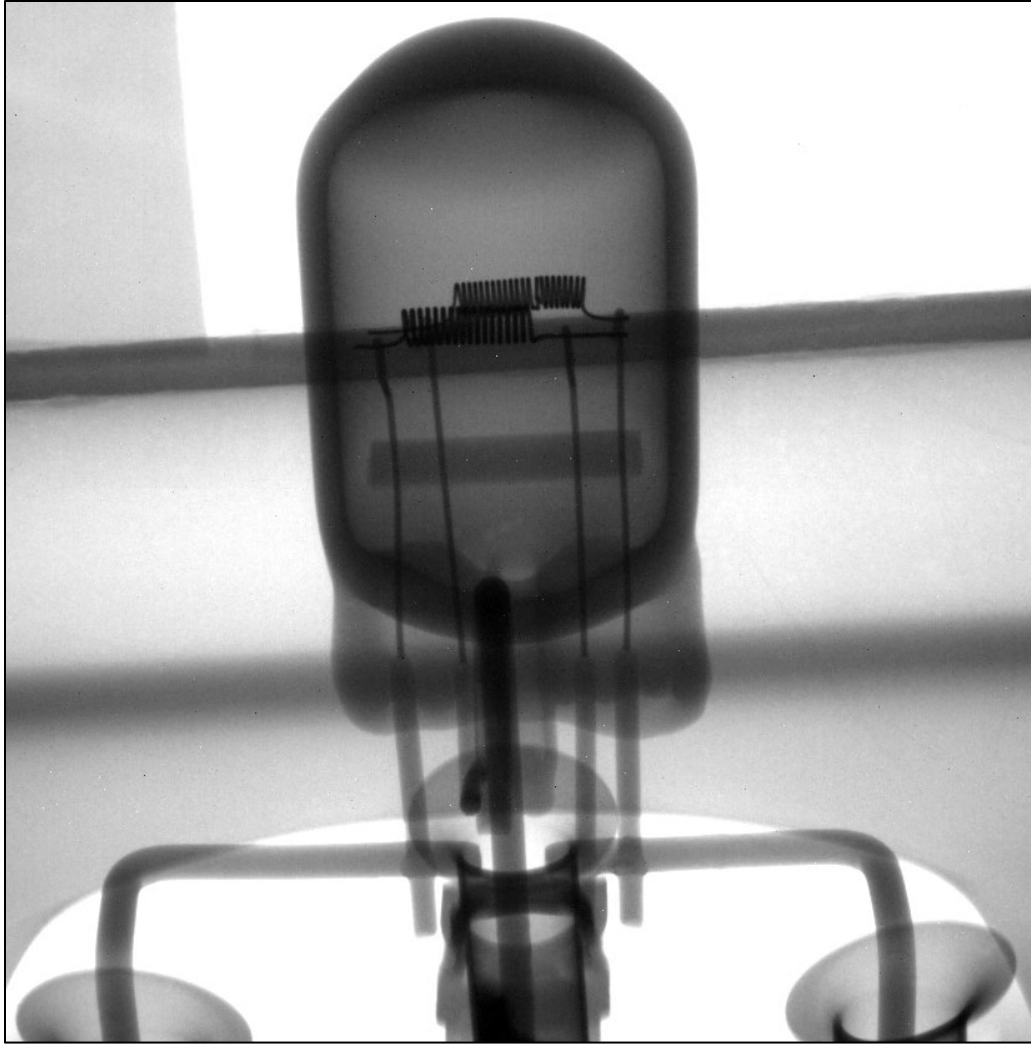
Figure 28: Bus - Right Sealed Headlight Radiography Imaging

Without opening the sealed right headlight, the NTSB Materials Laboratory performed radiography imaging on the headlight. The radiography imaging shows that the right headlight was comprised of two filaments. Using the orientation observed in Figure 28, the lower filament was thicker and larger than the upper filament. The upper filament was thinner than the lower filament and was slightly curved.

The lower filament was consistent with being the high beam filament and the upper filament was consistent with being the low beam filament.

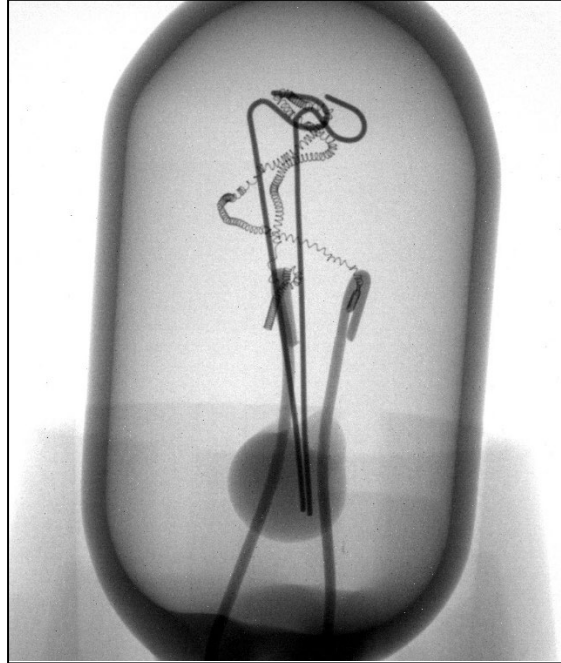
Figure 29: Bus - Left Assembly Bulb

Though the left sealed headlight was not recovered from the bus, other lights were recovered from what remained of the left assembly, as observed in Figure 29.

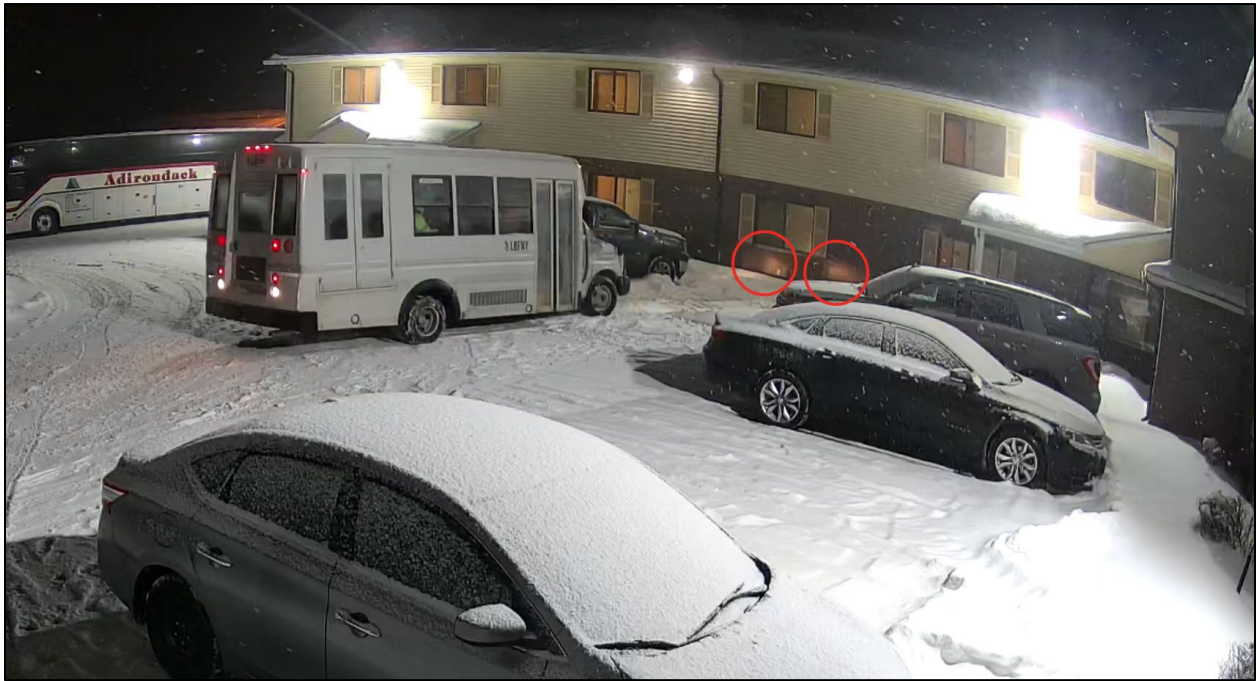
Figure 30: Bus - Surveillance Video from Hotel

Video surveillance footage was obtained of the subject bus leaving the hotel the morning of the collision and was date and timestamped 1/28/2023 5:51 am. The still-frame from the video, observed in Figure 30, was from approximately 11 minutes prior to the collision and shows the bus with fully functional taillights, rear marker lights, reverse lights, and two distinct headlight beams (circled in red).

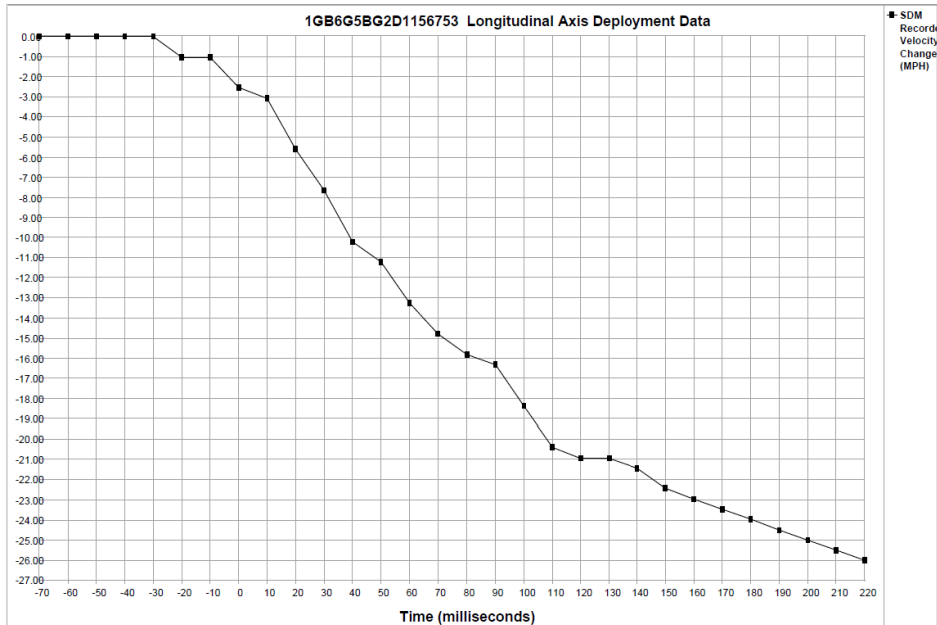
Figure 33: Bus - Longitudinal Delta-V Graph

The maximum cumulative longitudinal change in velocity (Delta-V) that was recorded by the ACM was approximately -26.02 mph, which occurred approximately 220ms after the event trigger, as observed in Figure 33. The negative Delta-V indicates that the bus experienced a forward speed loss during the collision sequence. Due to limitations with the subject ACM, the ACM was only capable of recording a maximum of 220 msec of post-event trigger data and the ACM stopped recording the cumulative Delta-V when the 220 msec elapsed.
