**NATIONAL TRANSPORTATION SAFETY BOARD
OFFICE OF HIGHWAY SAFETY
WASHINGTON, D.C.**

**VEHICLE FACTORS GROUP CHAIRMAN'S
FACTUAL REPORT**

PHOENIX, ARIZONA - HWY21MH008

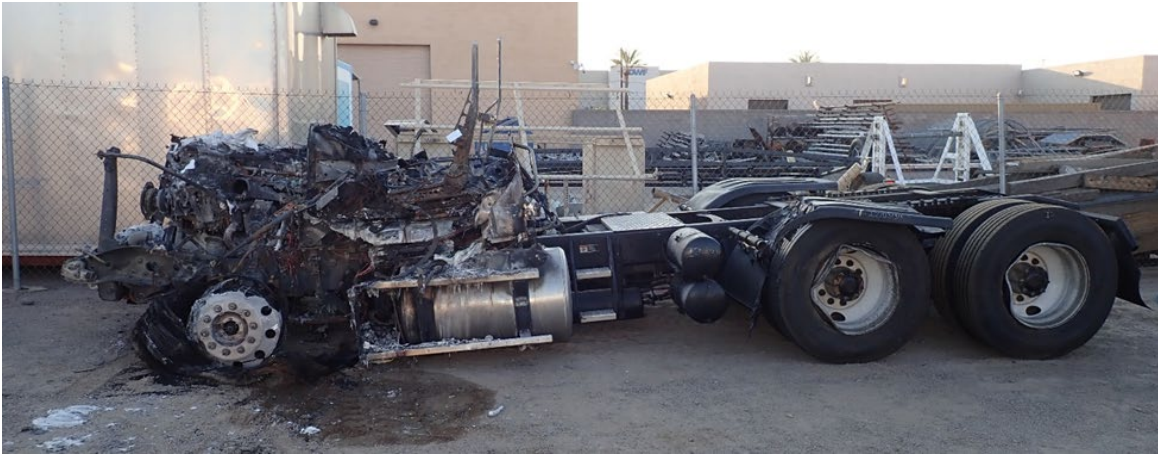
The entire cab and engine were severely fire damaged. The portion of the tractor to the rear of the cab did not sustain severe fire damage, as shown in **Figures 1, 2 and 3**.

Figure 1 - A left-side view of the truck-tractor showing collision and post fire damage.

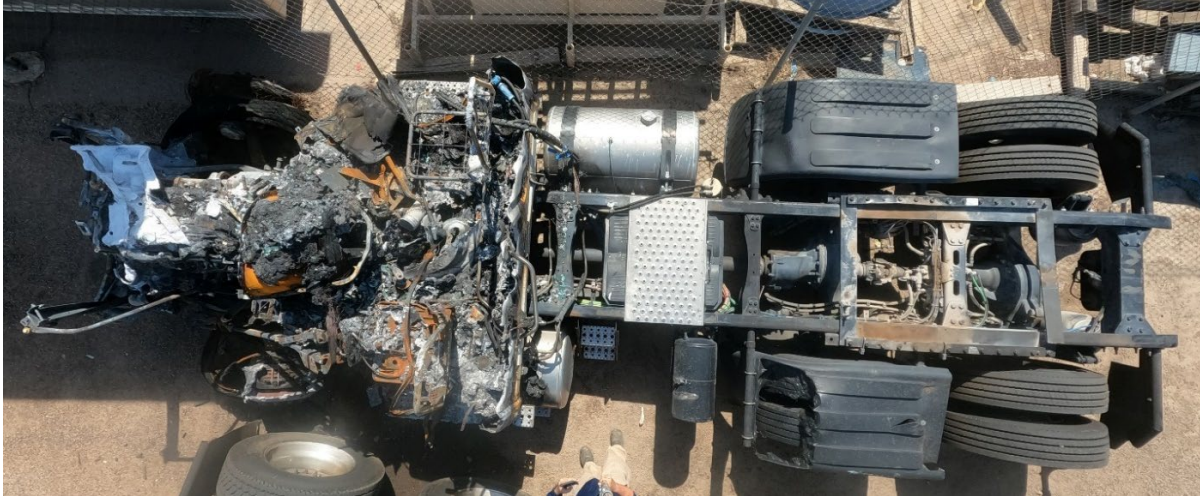
Figure 2 - A top-down view of the truck-tractor, showing collision and post fire damage.

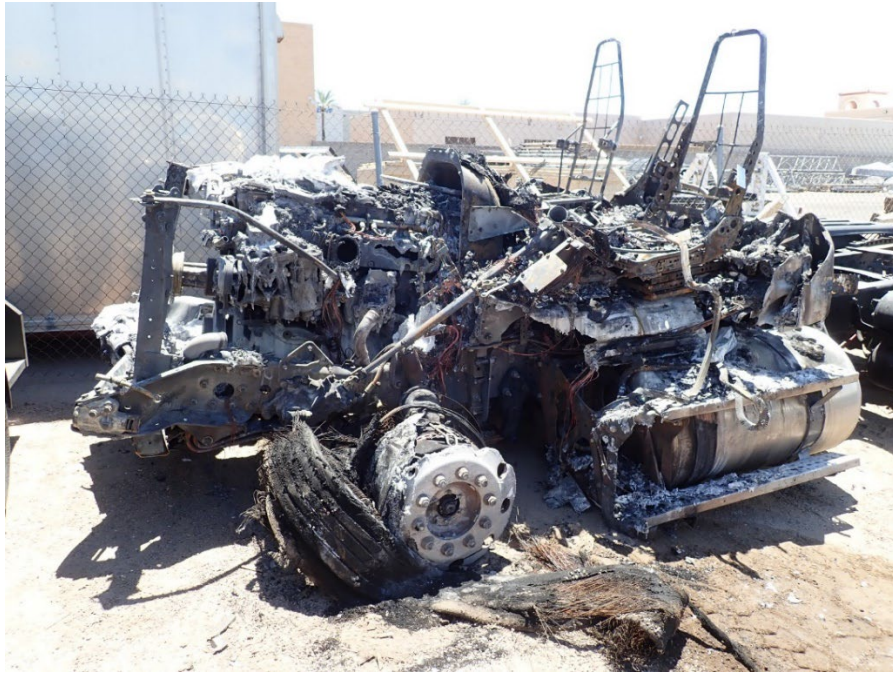
Figure 3 - A left-side view of the truck-tractor showing the entire cab and engine severely fire damaged.

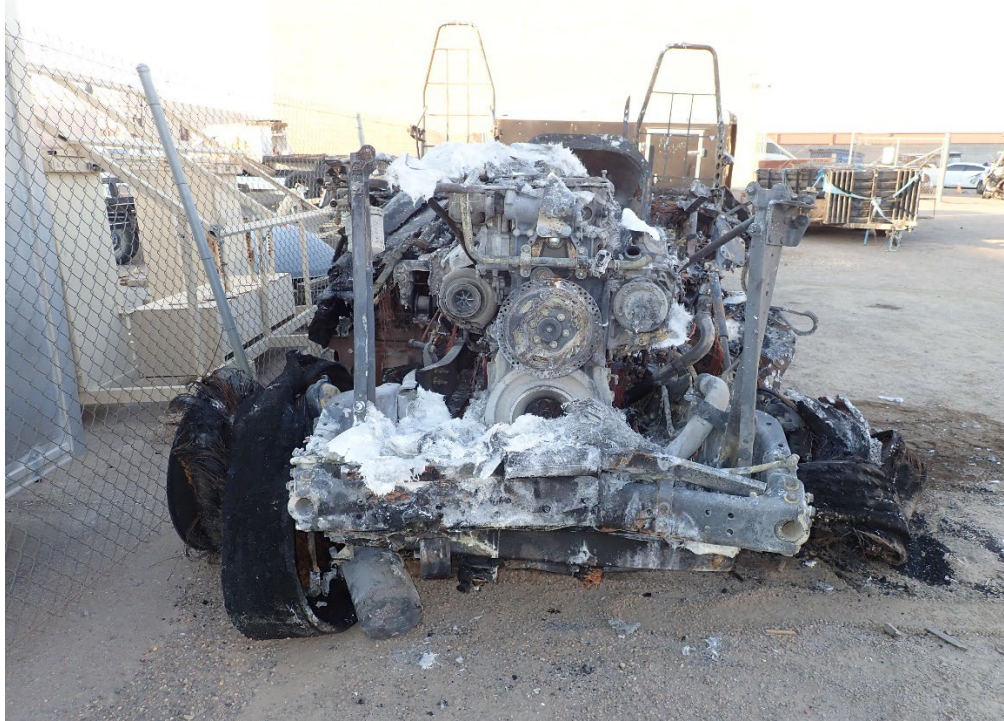
Damage to the truck-tractor from its initial impact with the rear of a passenger vehicle was masked due to the subsequent fire, affecting all major mechanical systems. The tractor's frame rails were displaced outward, and the front frame connector was displaced inwards showing signs of impact with melted and solidified remnants of material present, as shown in **Figure 4**.

Figure 4 - A front view of the truck-tractor, showing collision and post fire damage.

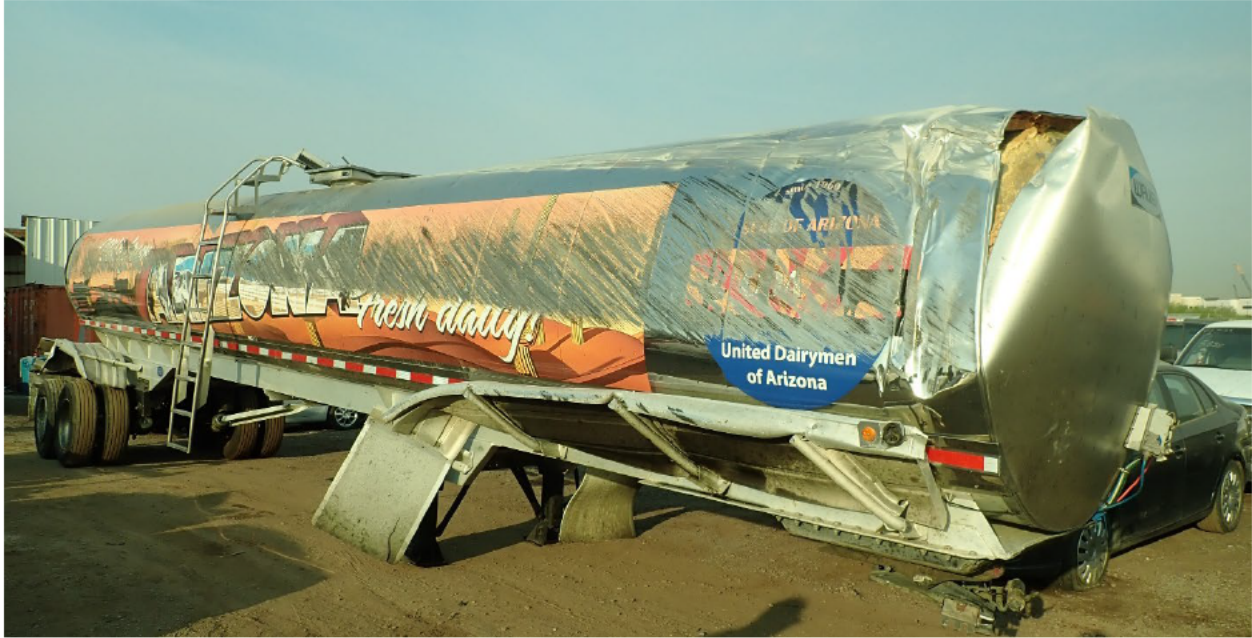
The stainless front cap of the tank-trailer was partially detached from the rest of the stainless trailer cladding at the top, exposing the foam insulation beneath as shown in **Figure 5**.

Figure 5 - The stainless front cap of the tank-trailer was partially detached from the rest of the stainless trailer cladding at the top, exposing the foam insulation beneath.

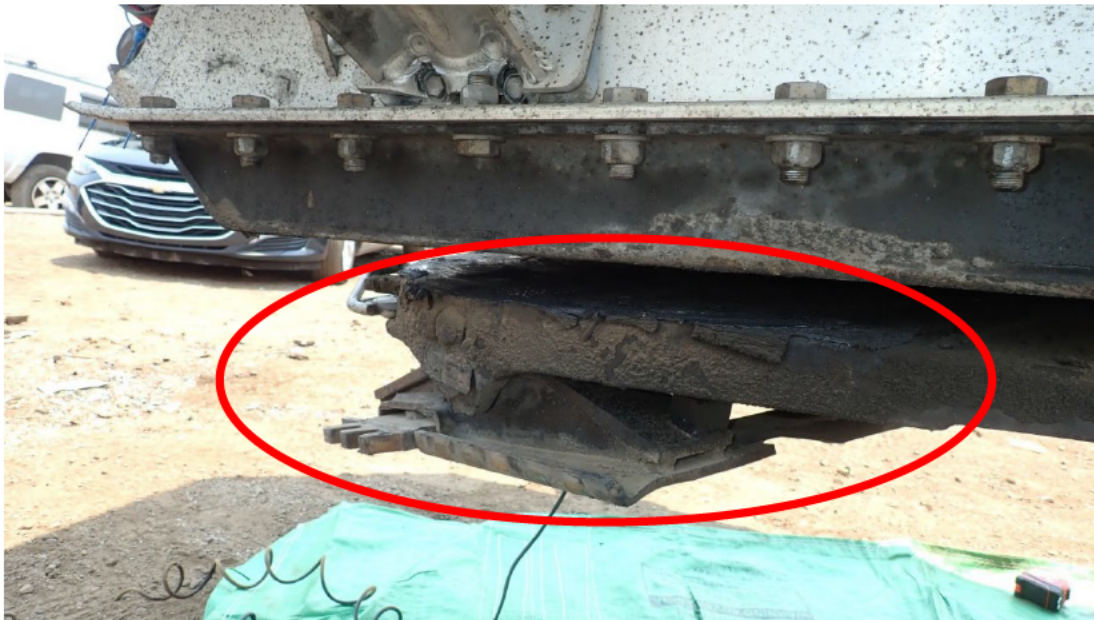
The kingpin located under the tank-trailer approximately 24-inches rearward from the nose still had the 5th wheel plate from the tractor locked to it. During the crash sequence the plate was torn away from the sliding 5th wheel assembly on the tractor as shown in **Figure 6**.

Figure 6 - The 5th wheel plate from the truck-tractor torn from the tractor still attached to the tank-trailer's kingpin.

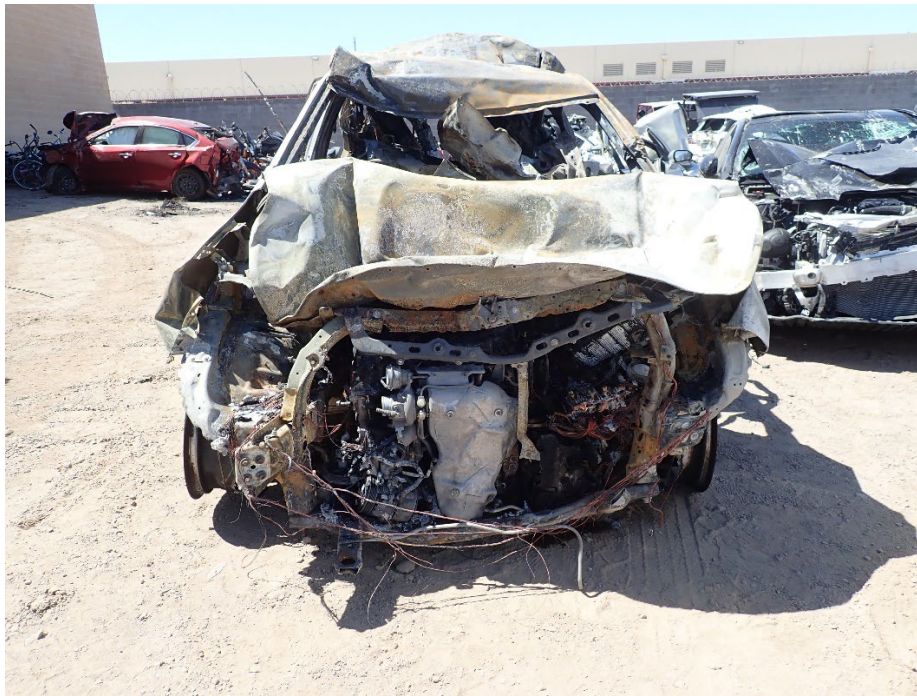
The entire vehicle had extensive fire damage. All tires were consumed by fire and all windows were missing. The entire front had contact damage. The bumper was missing, the radiator was displaced rearward to the front axle and the engine was also displaced rearward into the passenger compartment. The hood was folded at the midpoint and displaced downward onto the engine as shown in **Figure 7**. The front left door had been removed during the extrication process. Both right side doors were in place but missing the door handles. There was contact damage to the entire rear of the Equinox, with the hatchback displaced forward to the second-row seats, as shown in **Figure 8**.

Figure 7 - A front view of the 2021 Chevrolet Equinox LS showing extensive front-end collision and post-crash fire.

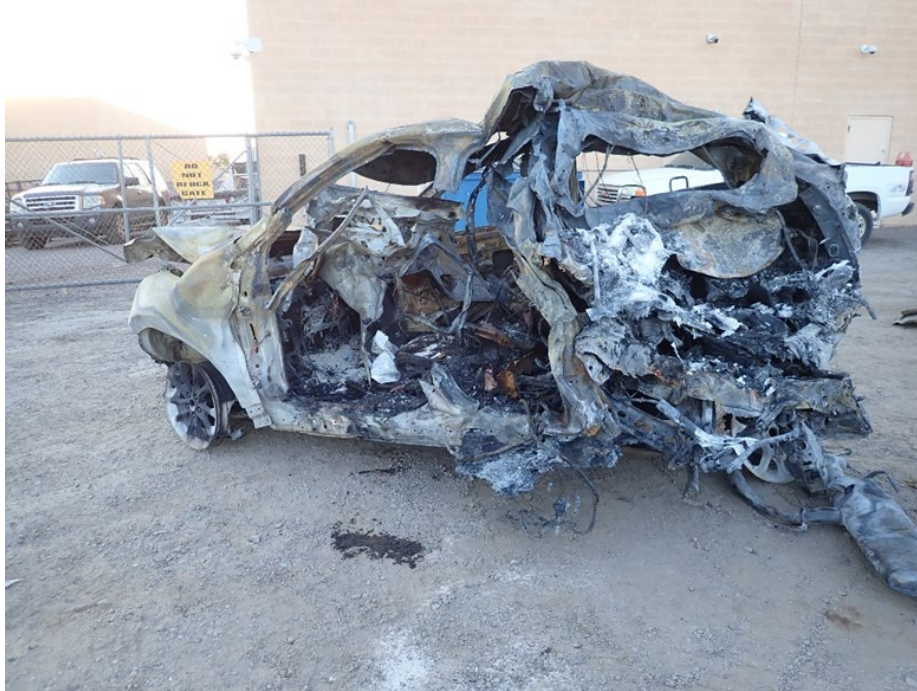
Figure 8 - Left-side and rear view of the 2021 Chevrolet Equinox LS showing extensive collision and post-crash fire damage.

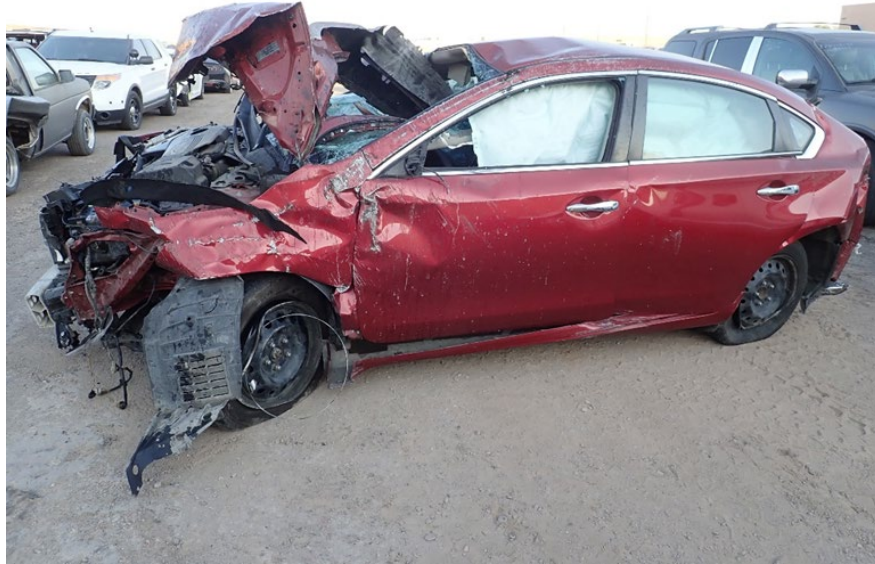
The Nissan sustained damage to both the front and rear. The front bumper fascia was missing as was the underlying foam bumper absorber. The metal bumper reinforcement under the absorber was displaced rearward with the right side displaced farther to the rear. The hood was folded at the midpoint and displaced rearward to the A pillar. The windshield was shattered with portions of it still in the frame. The driver window was missing, the left rear passenger window was in-place. As shown in **Figure 9**, the front passenger window was in place, but the right rear passenger window was missing.

Figure 9 - A left-side view of 2015 Nissan Altima showing front, side roof and rear damage.

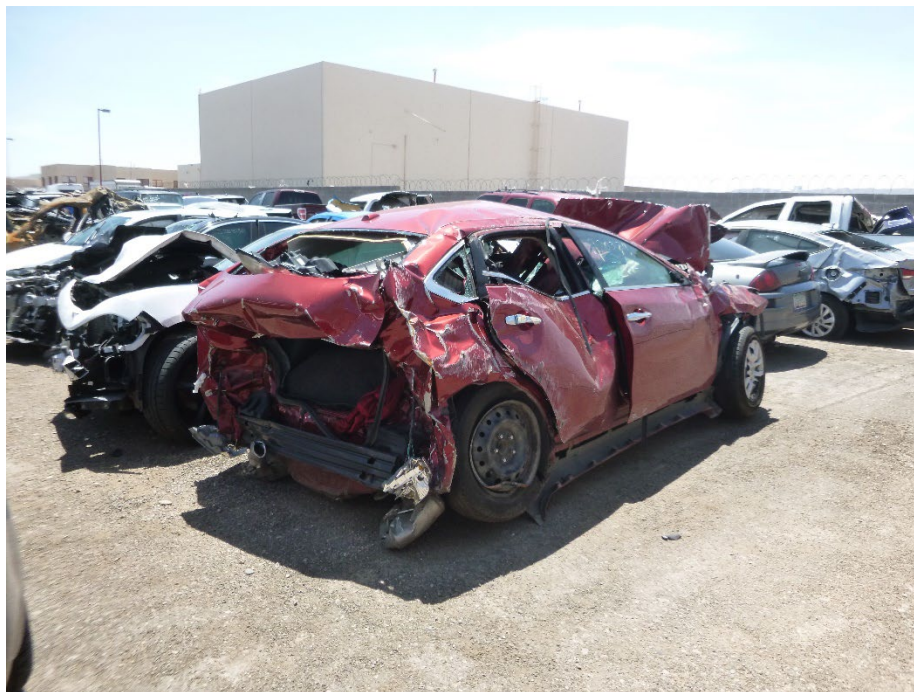
There were scrapes and striations in the paint on the top edges of both the left and right sides of the vehicle. The roof was deformed upward with a fold at the midpoint. The rear bumper fascia was missing as was the underlying foam bumper absorber. The metal bumper reinforcement under the absorber was displaced forward to the rear axle. Both rear fenders were displaced forward to the rear wheel wells. The trunk lid was displaced forward exposing the trunk, and the rear window was missing as shown in **Figure 10**.

Figure 10 – A rear and right-side view of the 2015 Nissan Altima showing rear and right-side collision damage.

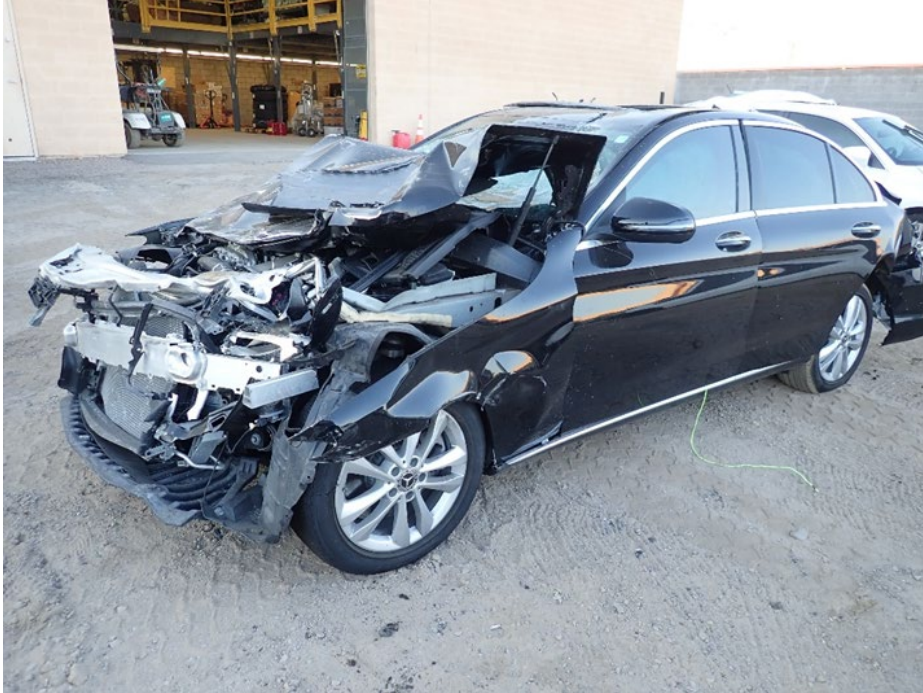
The front bumper fascia was missing as was the underlying foam bumper absorber. The metal bumper reinforcement under the absorber was displaced rearward and upward. The hood was folded rearward into the windshield, which was in place but shattered, as shown in **Figure 11**. The sunroof glass was missing. There were minor marks on the right front rim, but all tires on the vehicle were still inflated. The rear bumper fascia was missing as was the underlying foam bumper absorber. The metal bumper reinforcement under the absorber was displaced forward to the rear axle. Both rear fenders were displaced forward to the rear wheel wells. The trunk lid was displaced forward to the rear window as shown in **Figure 12**.

Figure 11 - A front left-side view of the 2018 Mercedes C300W showing front end and rear bumper collision damage.

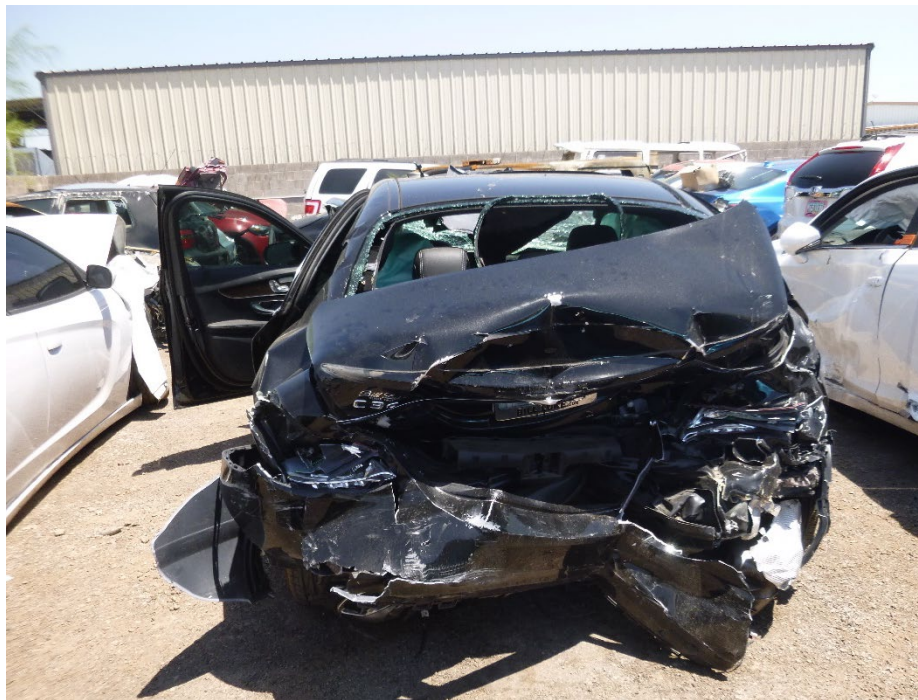
Figure 12 - A rear view of the 2018 Mercedes C300W showing collision damage.

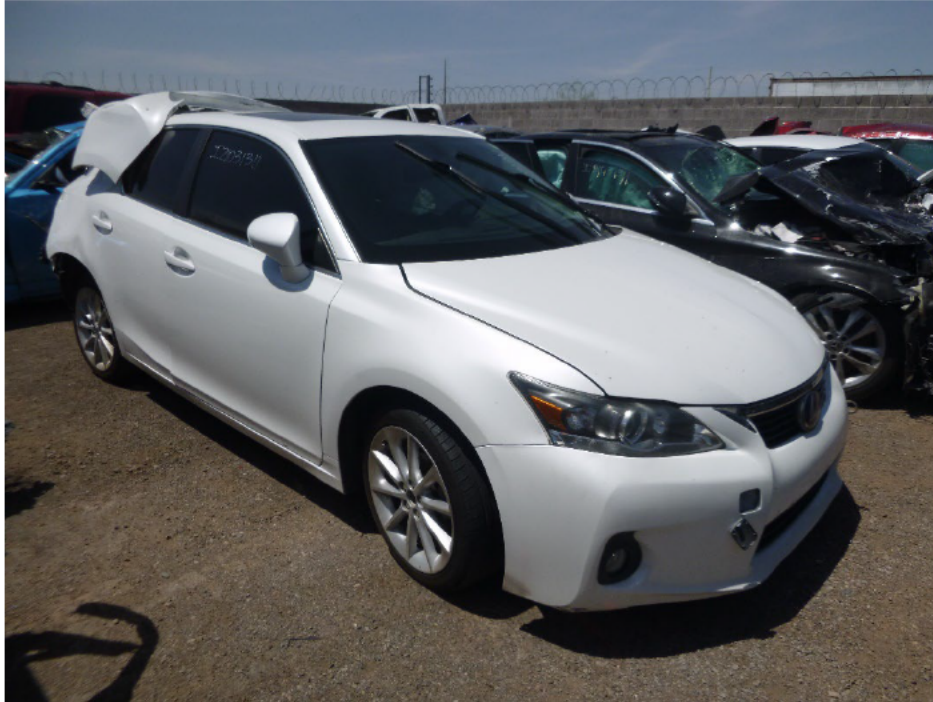
There was no damage to the front of the Lexus as shown in **Figure 13**. The rear bumper fascia was missing as was the underlying foam bumper absorber. The metal bumper reinforcement under the absorber was displaced forward to the rear axle. Both rear fenders were displaced forward to the rear wheel wells. The glass from the hatchback was missing. The right-side brake light assembly was detached from its mount and hanging by connecting wires. The hatchback was displaced forward and deformed at the midpoint as shown in **Figure 14**. The driver's door was displaced to the right approximately 6-inches. The driver's window was missing. The left rear door had a tear in the bottom portion of the sheet metal. Both right-side windows were intact. All four tires were inflated with no damage to the wheels.

Figure 13 – A left-side and front view of the 2013 Lexus CT200H, showing no damage to the front of the vehicle.

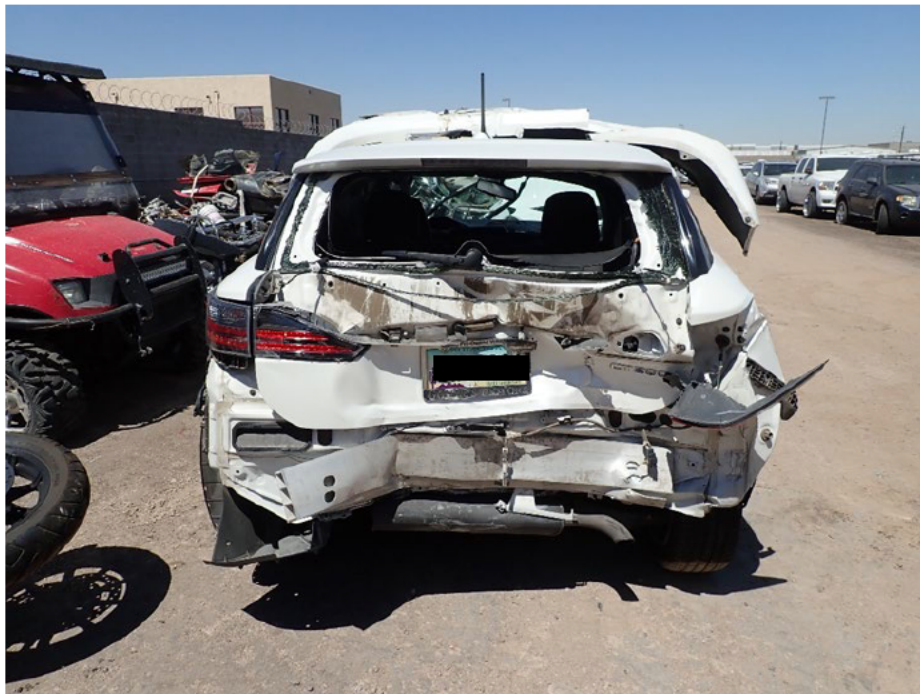
Figure 14 – A rear view of the 2013 Lexus CT200H, showing extensive rear contact damage.

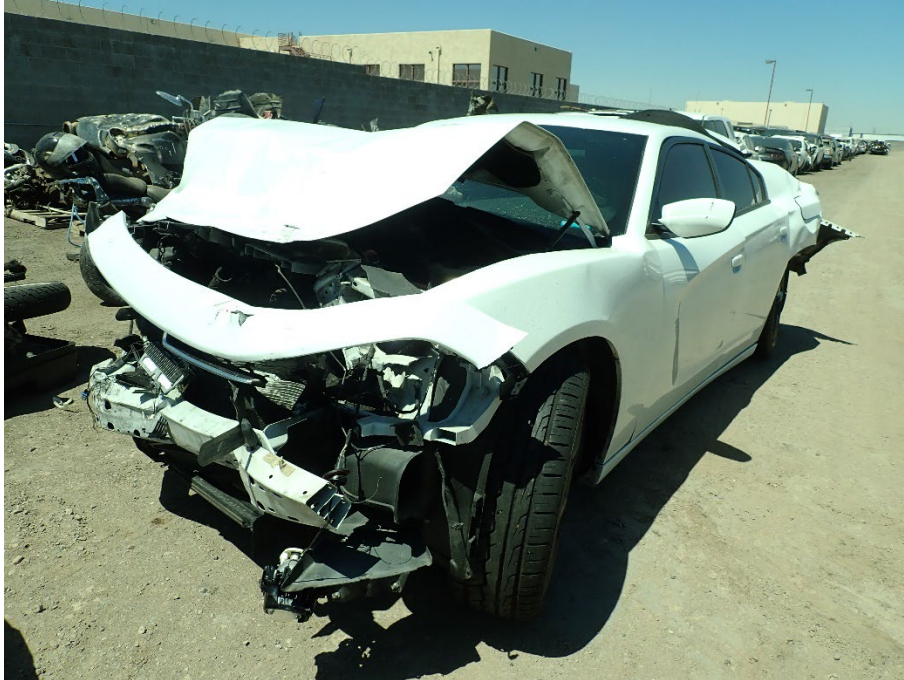
The front bumper fascia was missing as was the underlying foam bumper absorber. The metal bumper reinforcement under the absorber was displaced rearward. The hood was folded rearward at the midpoint as shown in **Figure 15**. The windshield was in place but shattered. The trunk lid was displaced forward into the rear window, which was missing. Both left and right-side windows were intact. The rear bumper fascia was missing as was the underlying foam bumper absorber. The metal bumper reinforcement under the absorber was displaced forward to the rear axle. Both rear fenders were displaced forward to the rear wheel wells as shown in **Figure 16**. The right rear tire was flat, and the spokes of the wheels were all fractured.

Figure 15 - A front and left-side view of the 2015 Dodge Charger showing front end collision damage.

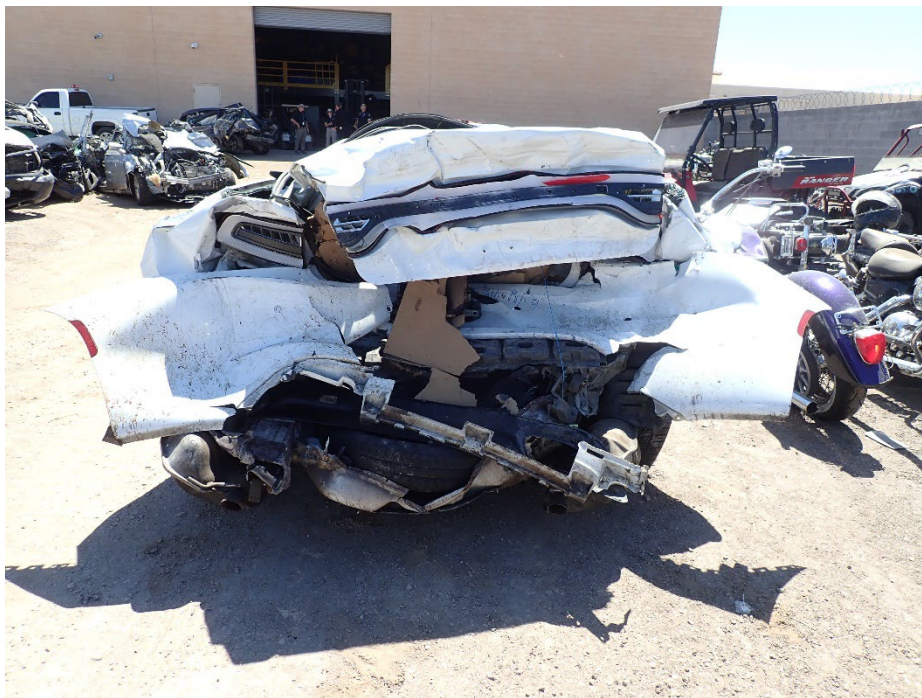
Figure 16 – A rear view of the 2015 Dodge Charger showing rear collision damage.

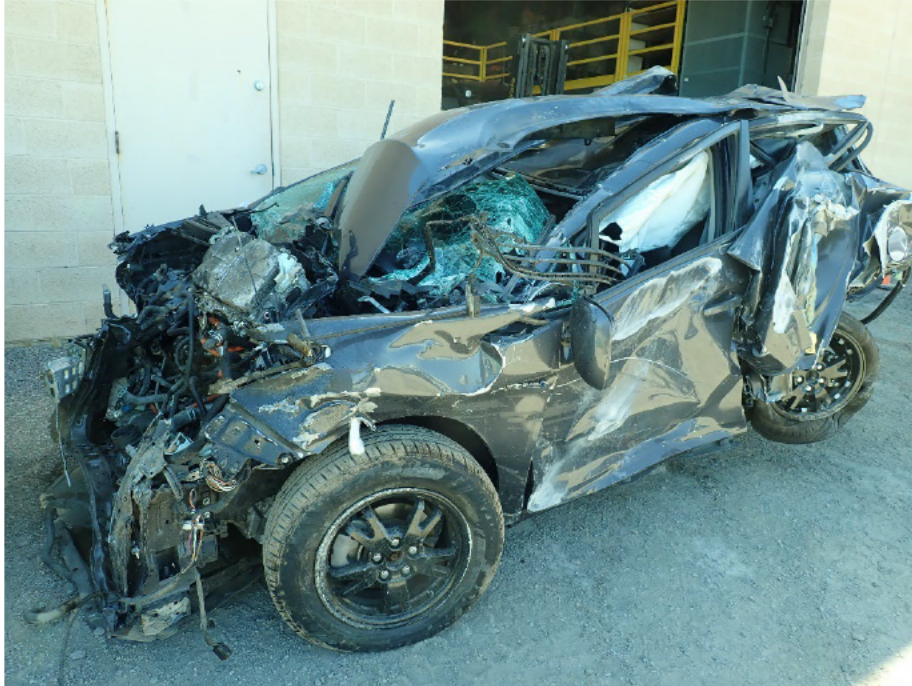
Contact damage to the front of the Prius shifted the radiator and engine rearward to the front axle. The windshield was shattered and folded, but present. The left front door was in place, but damaged and missing its glass. The left rear door was present but folded as shown in **Figure 17**. The rear of the vehicle had contact damage. The rear axle was shifted forward under the rear doors and the hatchback was shifted downward. Both right side doors were in place with minor damage as shown in **Figure 18**. The right front door window was missing. The front portion of the roof was crushed downward to the dash.

Figure 17 - Left-side view of the 2013 Toyota Prius showing extensive collision damage.

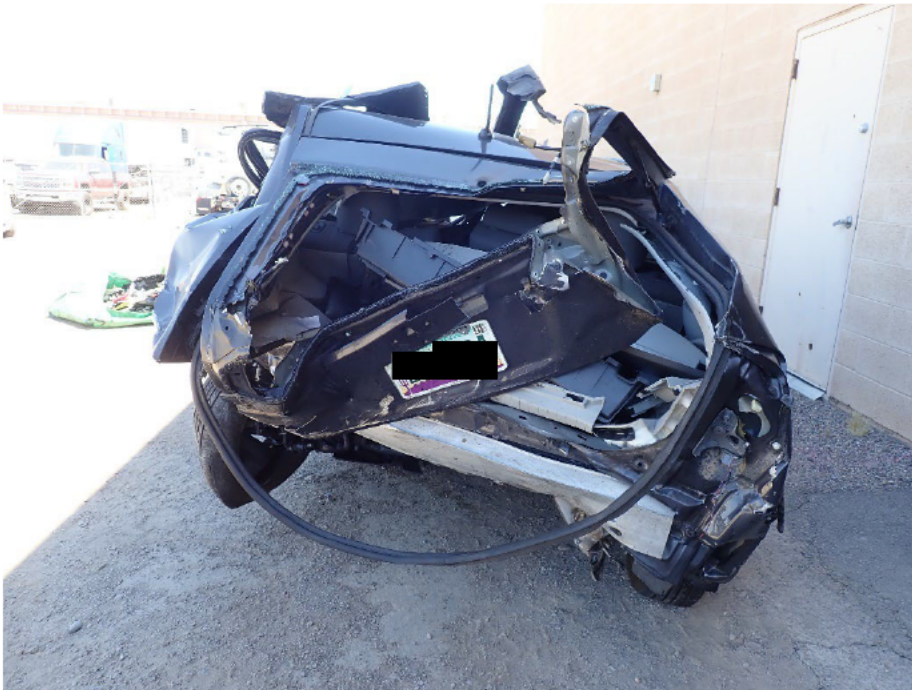
Figure 18 - A rear view of the 2013 Toyota Prius showing collision damage.

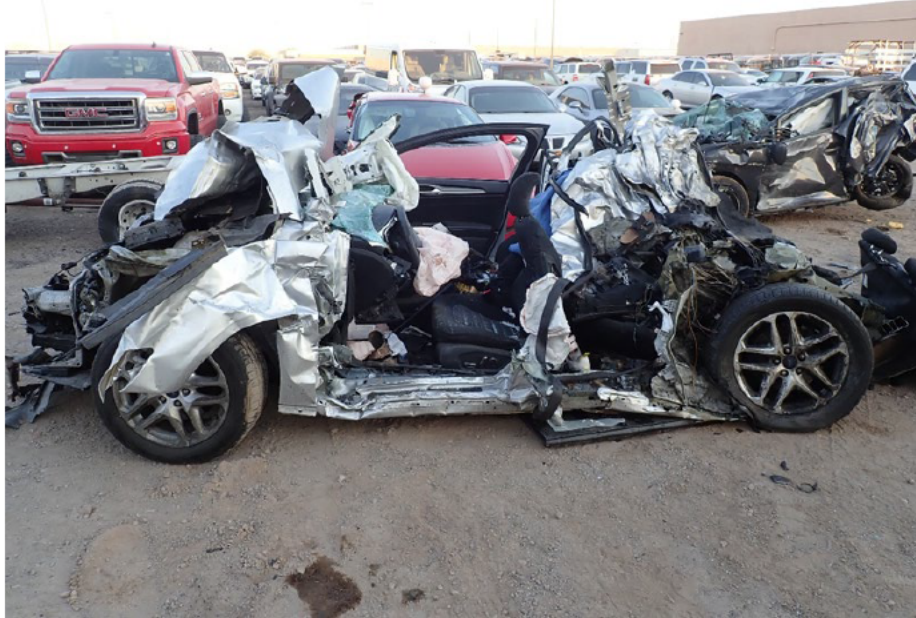
The front of the Fusion was crushed rearward to the front axle. The hood was displaced rearward to the windshield and roof area. The left side doors were missing as was the left side B-pillar. The rear fenders were both missing as was the rear bumper as shown in **Figure 19**. The trunk lid was torn away from its mounts and shifted right. The rear seats had been torn from the vehicle and were found on the ground to the rear of the Fusion as shown in **Figure 20**. The right front door was present, but the B-pillar was also missing.

Figure 19 – A left-side view of the 2016 Ford Fusion showing catastrophic collision damage.

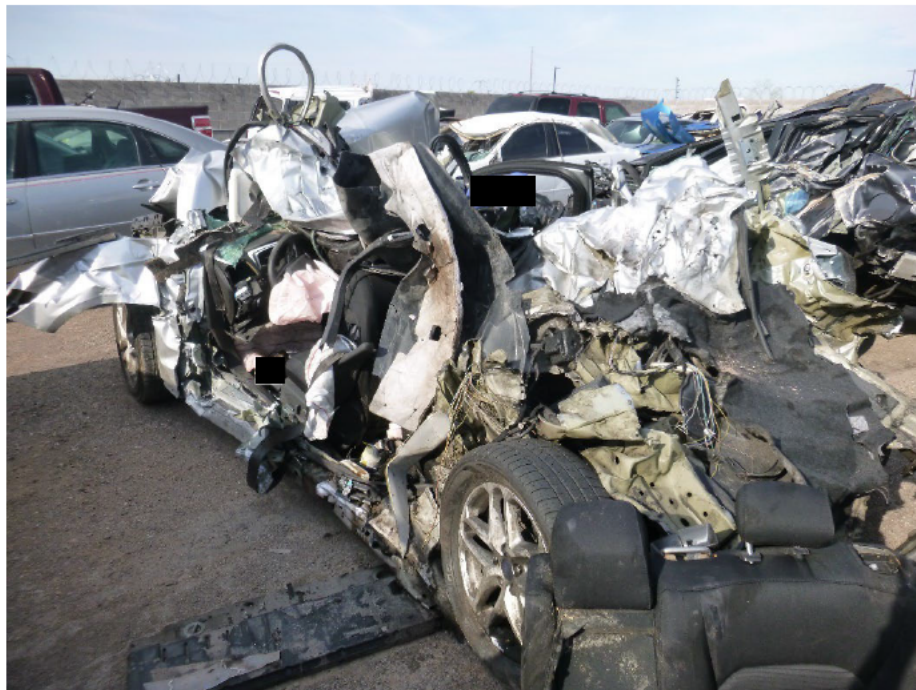
Figure 20 - A left-side and rear view of the 2016 Ford Fusion showing catastrophic collision damage.
