**VEHICLE FACTORS GROUP CHAIRMAN'S  
FACTUAL REPORT**

**MULTIPLE VEHICLE ACCIDENT  
Cranbury, NJ**

**HWY14MH012**

**NATIONAL TRANSPORTATION SAFETY BOARD  
OFFICE OF HIGHWAY SAFETY  
WASHINGTON, D.C.**

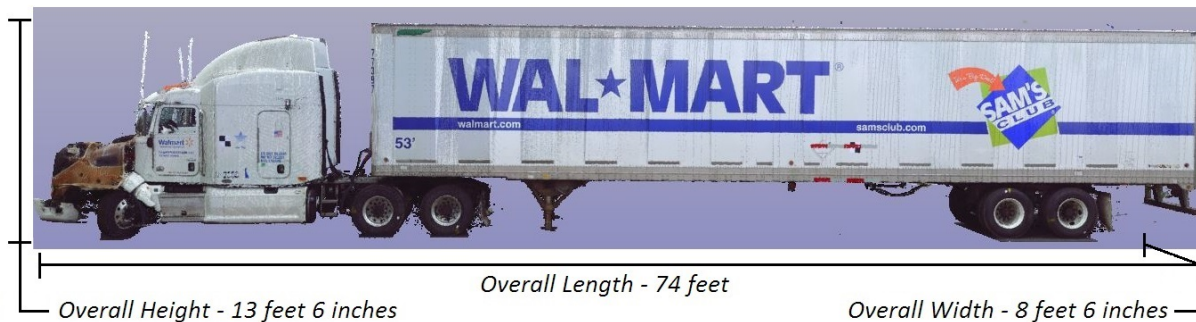
The 2011 Peterbilt truck-tractor sustained extensive front end damage, displacing the hood and fenders.<sup>6</sup> The headlights, turn signals, and forward-mounted marker lights were all destroyed in the crash. Both panes of the windshield were extensively cracked. The front end damage pushed the radiator into the engine fan and belts; damage then continued into the front axle steering and suspension systems. The U-bolts were broken off the leaf spring suspension on the right side of the front axle.<sup>7</sup> The suspension components on the left side of the front axle remained connected but were distorted.<sup>8</sup> At the time of inspection, the wheels on the front axle were noted to be at full left rotation and out of alignment with each other. The left front axle wheel was at an approximate 62-degree angle outward from the left side of the truck-tractor and the right front wheel was at an approximate 46-degree angle inward from the right side of the truck-tractor.<sup>9</sup> Steering wheel rotation did not result in movement of the front axle wheels due to damage at the steering input shaft connection into the steering gear box.

**Figure 1.** Driver (left) side profile from the 3-dimensional model of the damaged 2011 Peterbilt combination unit.

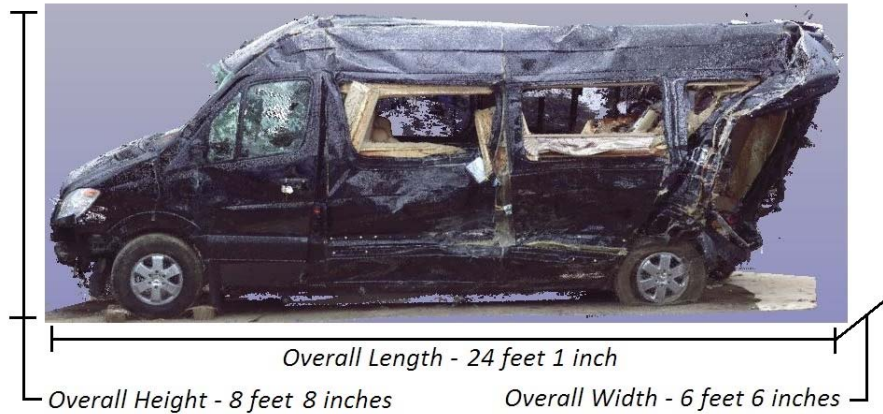
The damage to the 2012 Mercedes-Benz Sprinter van was concentrated at the left rear and left side, with significant damage to the entire rear of the van, aft of the rear wheels. Damage crushed the rear of the van such that the left rear taillight assembly was in the proximity of the left rear wheel and the rear axle and was pushed forward.<sup>27</sup> There was also damage to the front and right front corner of the van. The windshield and left side passenger area window were broken out.

**Figure 2.** Driver (left) side profile from the 3-dimensional model of the damaged 2012 Mercedes-Benz Sprinter van.
