**VEHICLE FACTORS GROUP CHAIRMAN'S FACTUAL REPORT
ATTACHMENT**

Vehicle Photographs

Pala Mesa, California

HWY20FH003

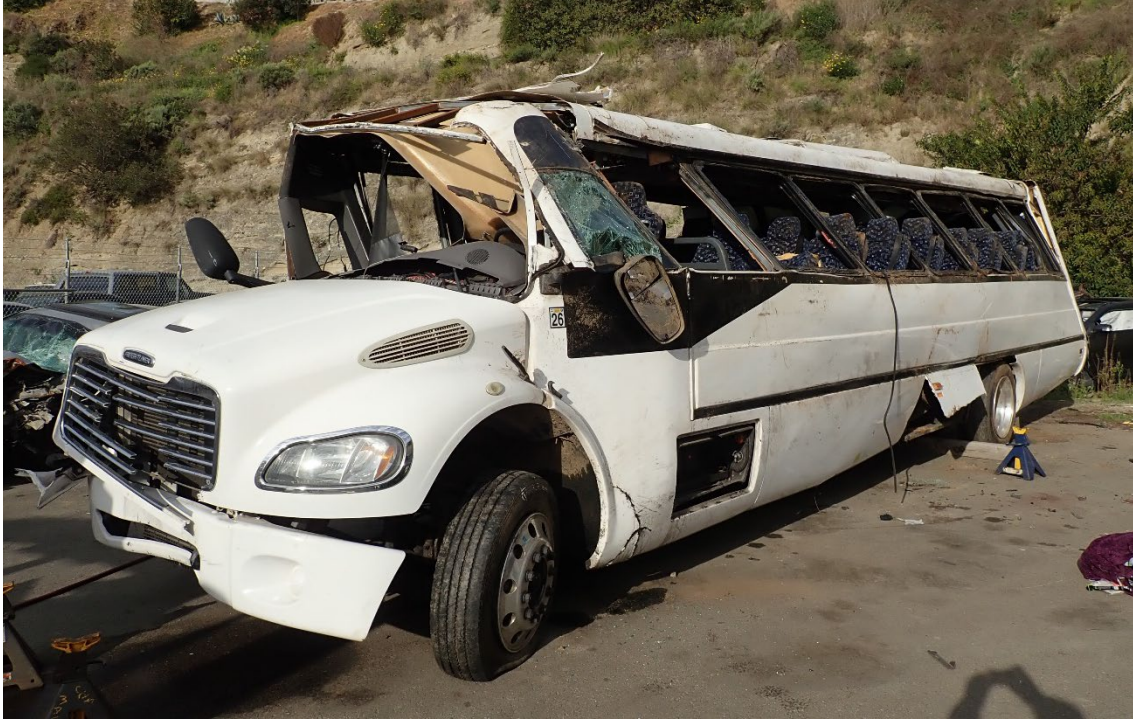
View of the damage to Freightliner bus as photographed from left front corner.

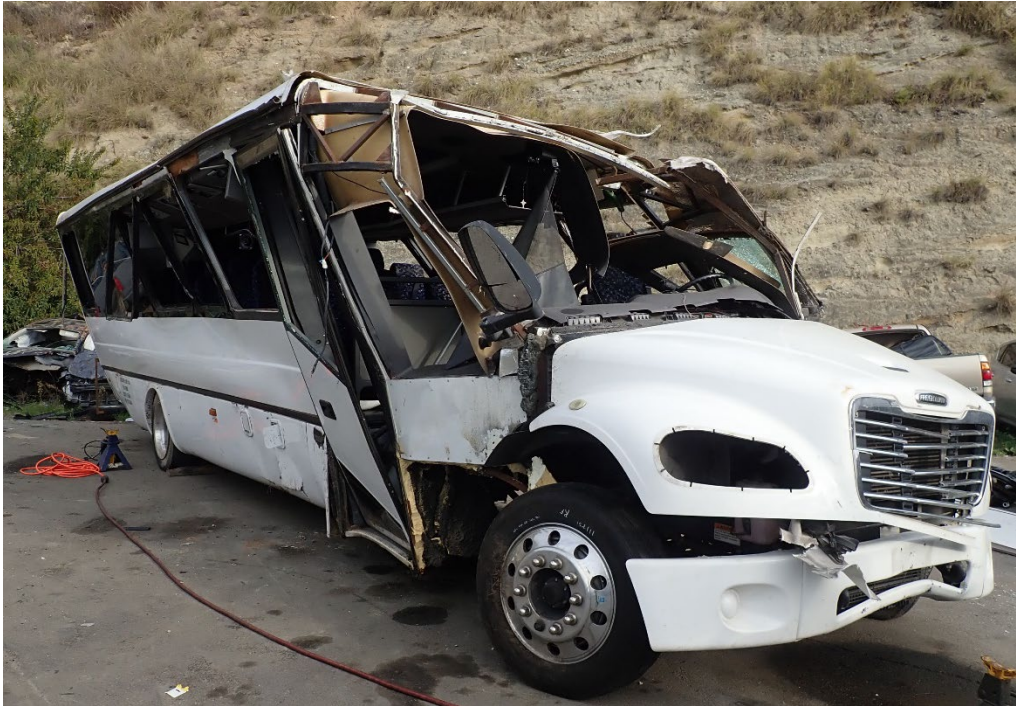
View of damage to the Freightliner bus as photographed from the right front corner.

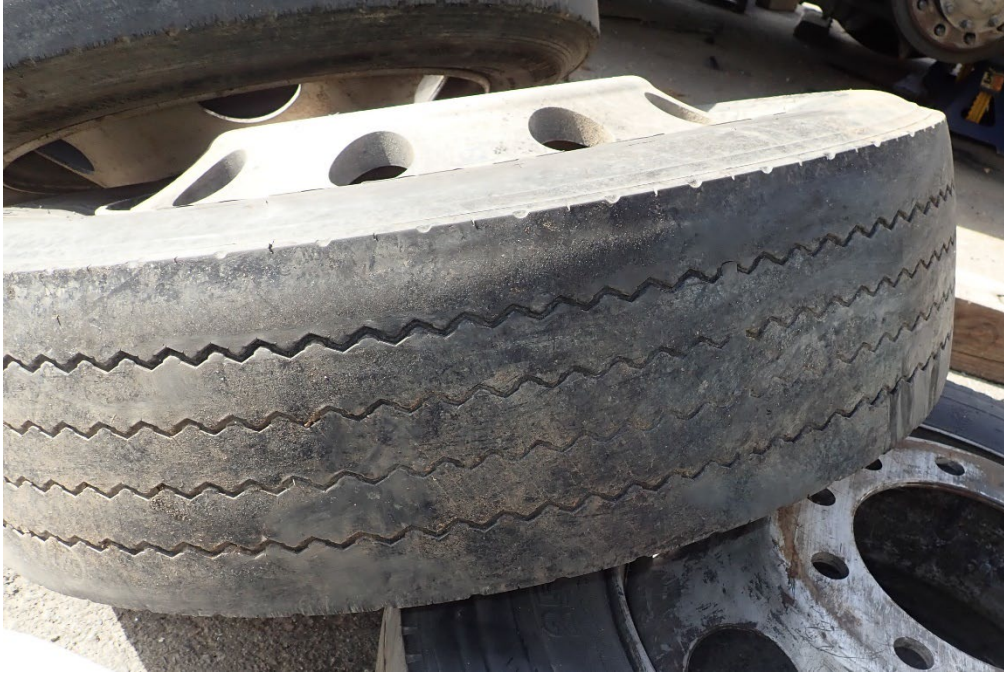
Photo shows the tread wear to the left rear outside dual tire.
