**VEHICLE FACTORS GROUP CHAIRMAN'S FACTUAL REPORT
ATTACHMENT**

Vehicle Photographs

Bryce Canyon City, Utah

HWY19MH012

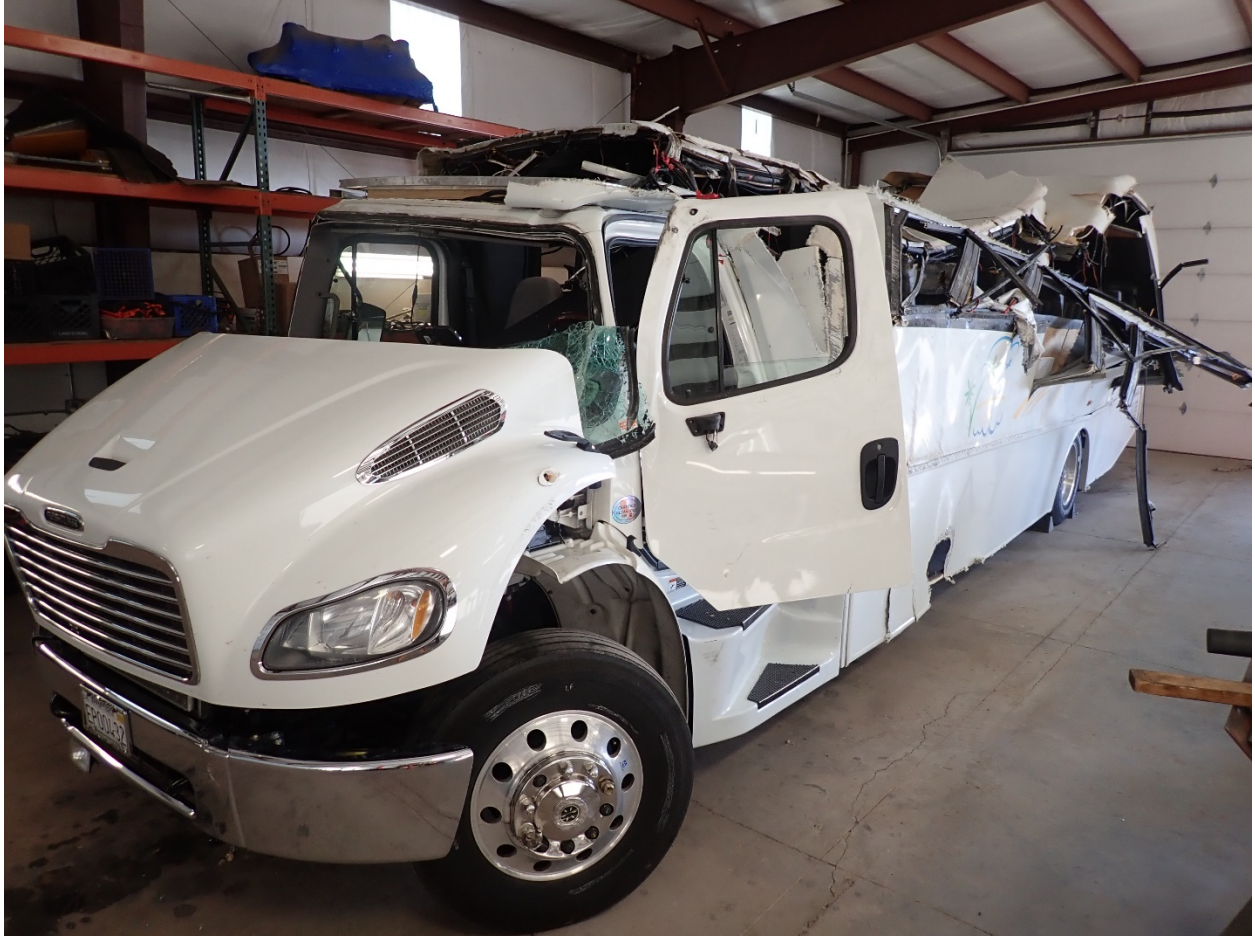
View of damage to Freightliner as photographed from the left front corner

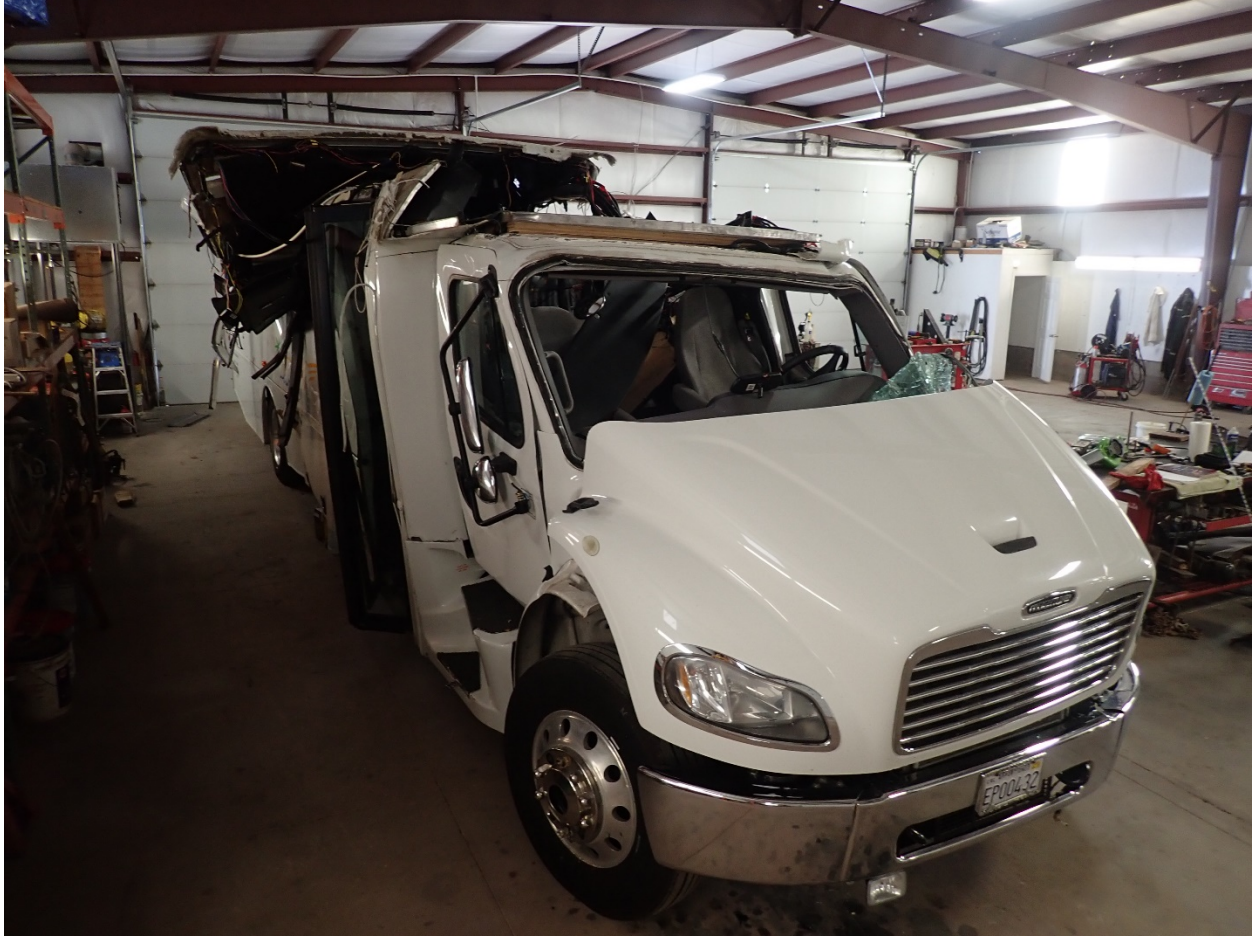
View of the damage to the right side of the Freightliner as photographed from the right front corner

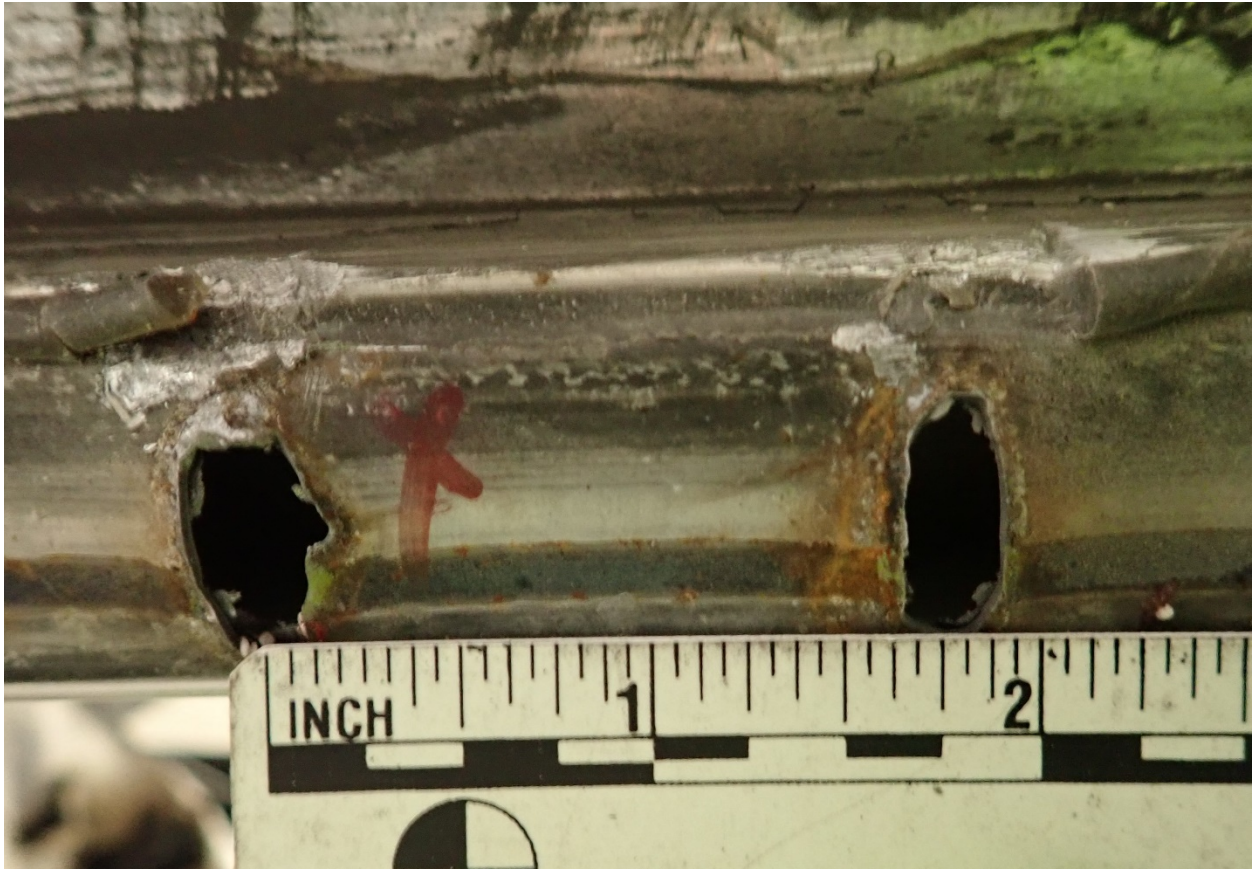
Roof bow weld area on sidewall frame showing where material pulled away at weld

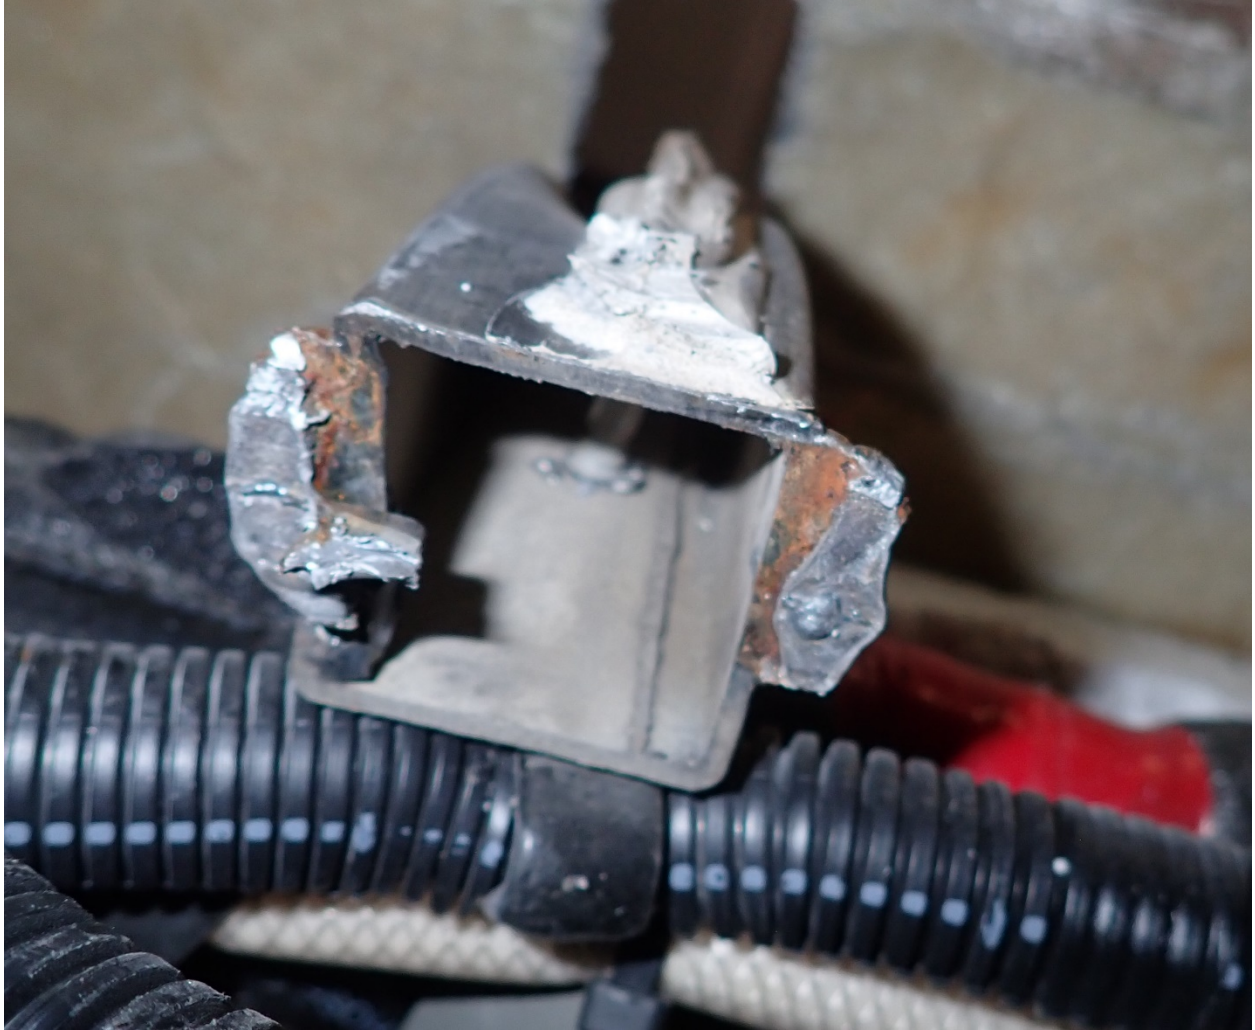
Roof bow showing weld with attached frame material

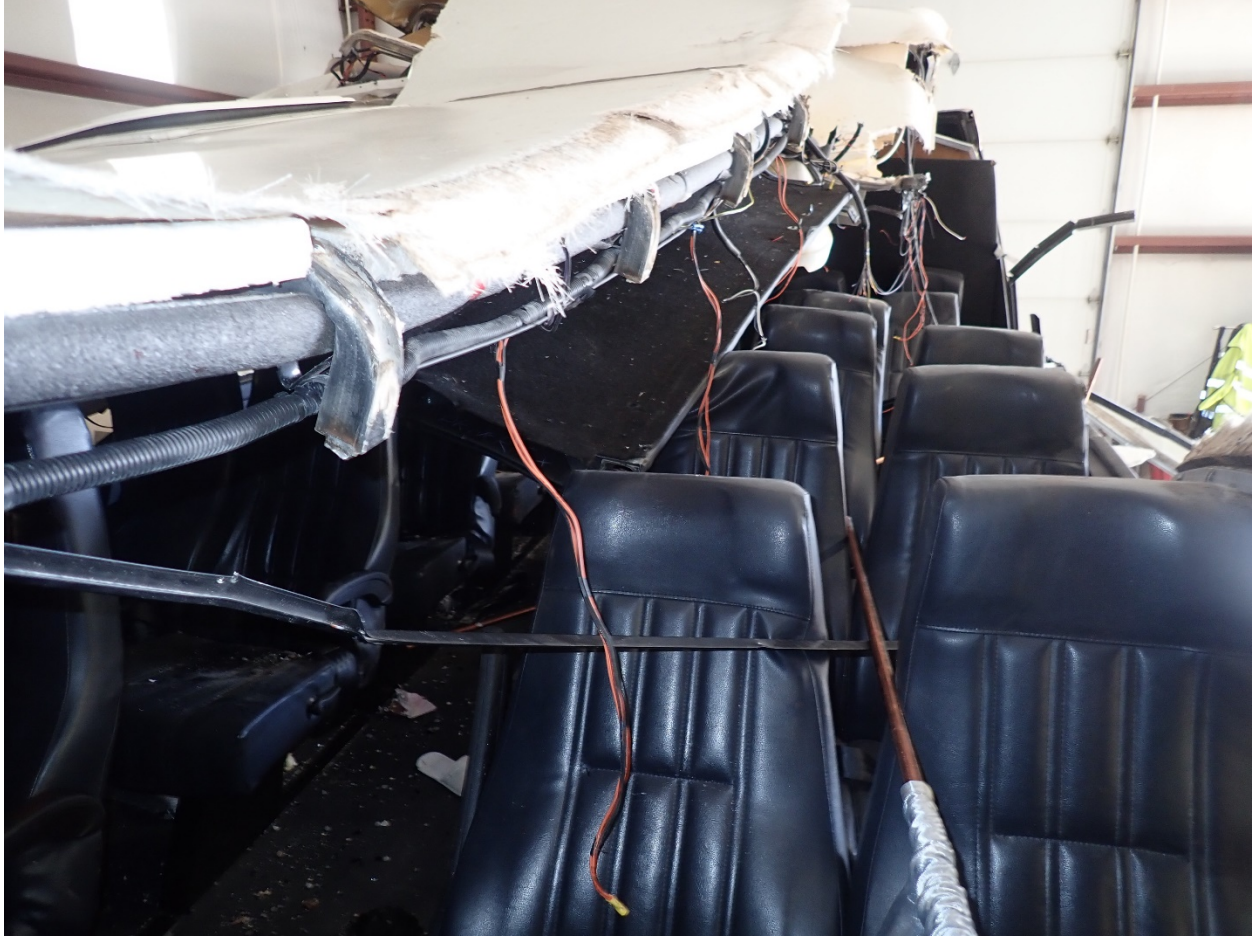
View of the damage to the roof structure as seen from front to rear
