Vehicle Photos

**Cranbury, NJ
HWY14MH012**

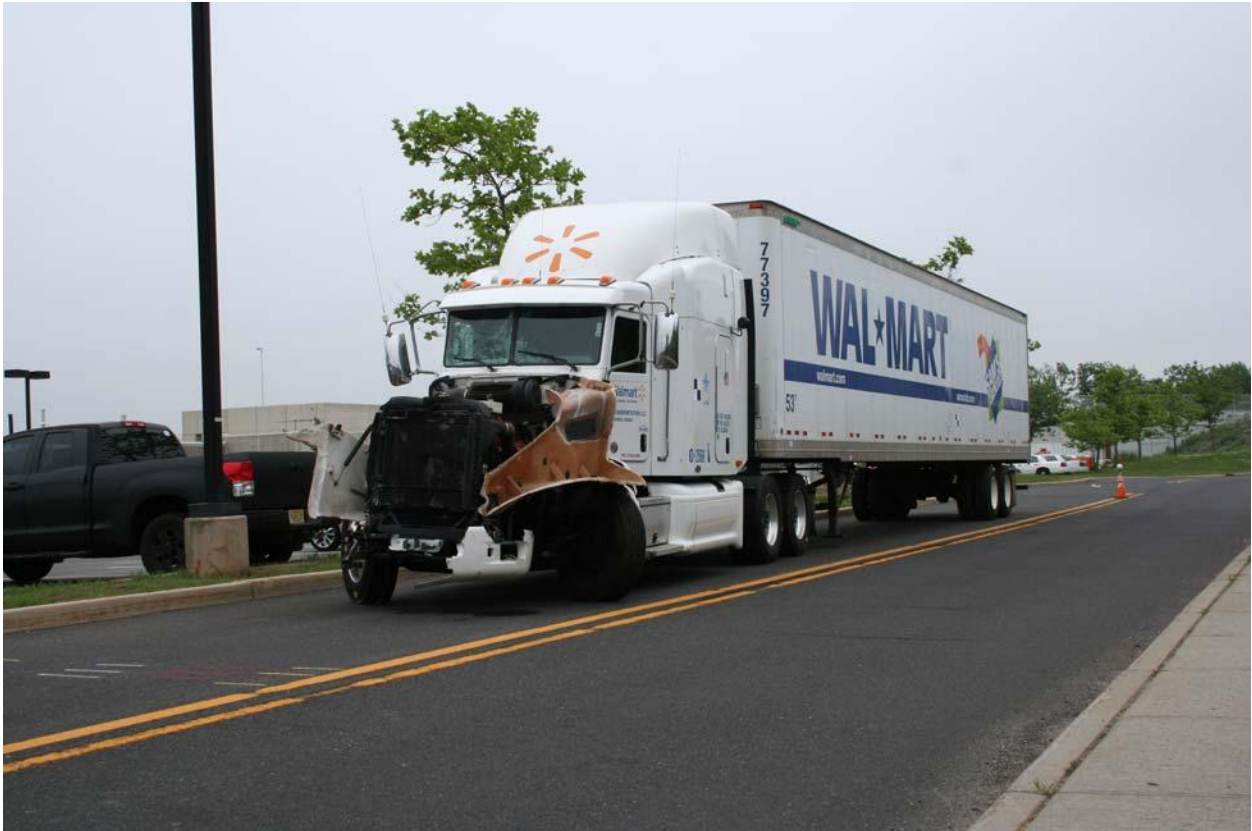
VEH Photo 1. Overall photograph of the 2011 Peterbilt combination unit, left front view.

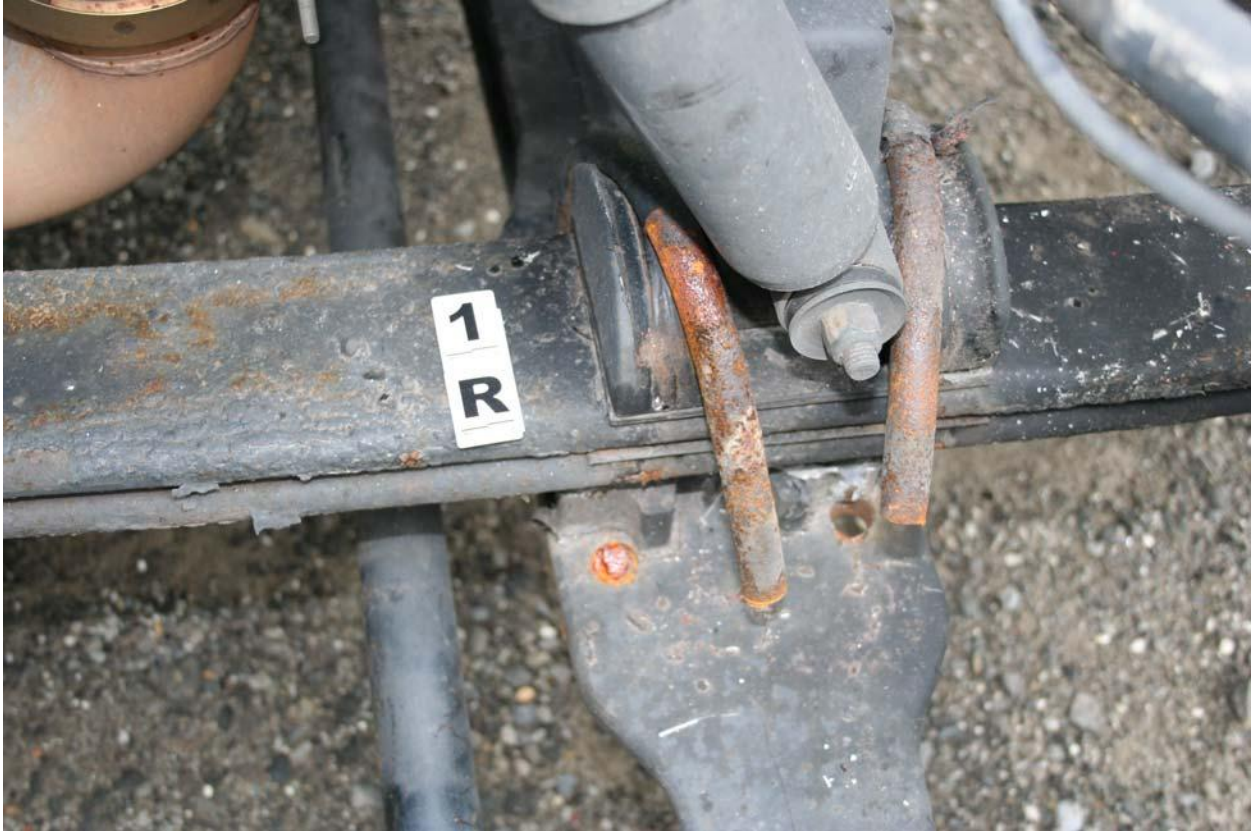
VEH Photo 2. View of the broken right front axle leaf spring U-bolts on the 2011 Peterbilt truck-tractor.

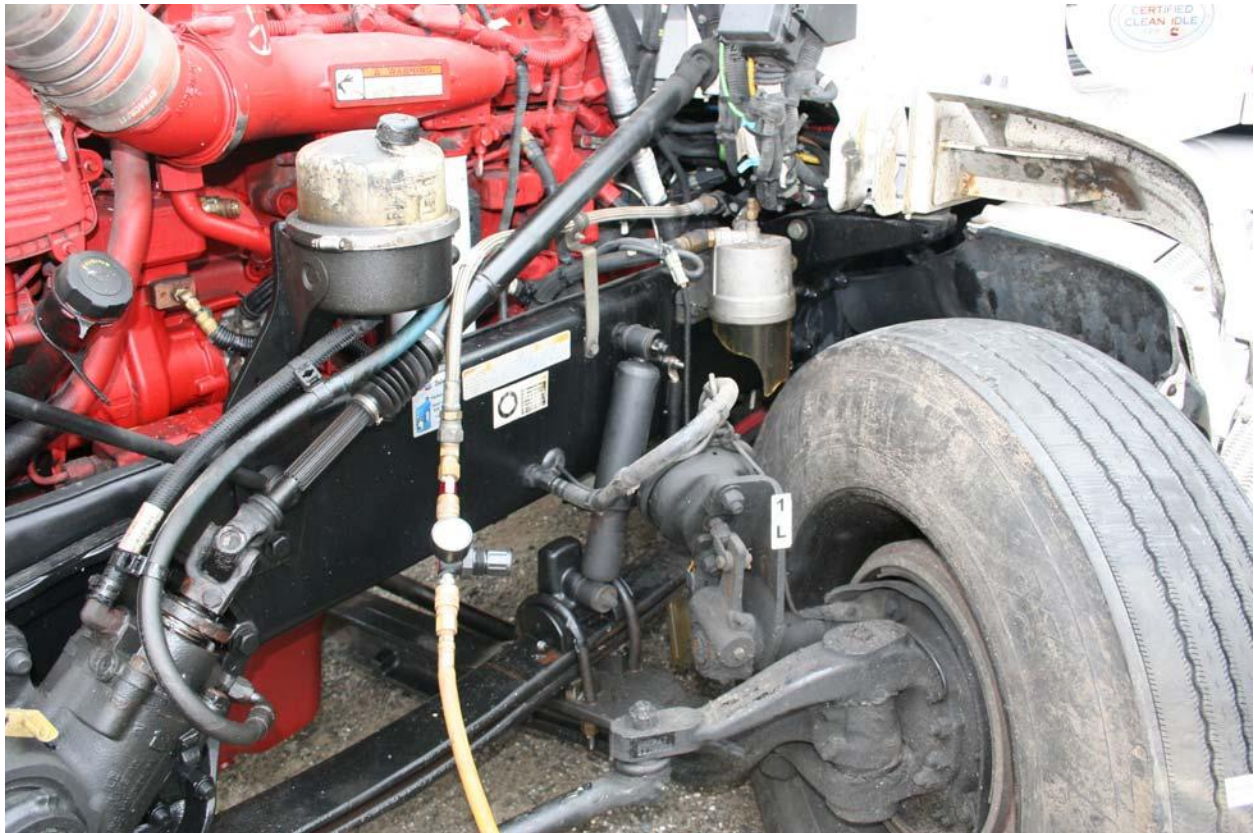
VEH Photo 3. View of the left side engine compartment of the 2011 Peterbilt truck-tractor; the distorted leaf springs and U-bolts can be seen below the frame rail toward the bottom of the photograph.

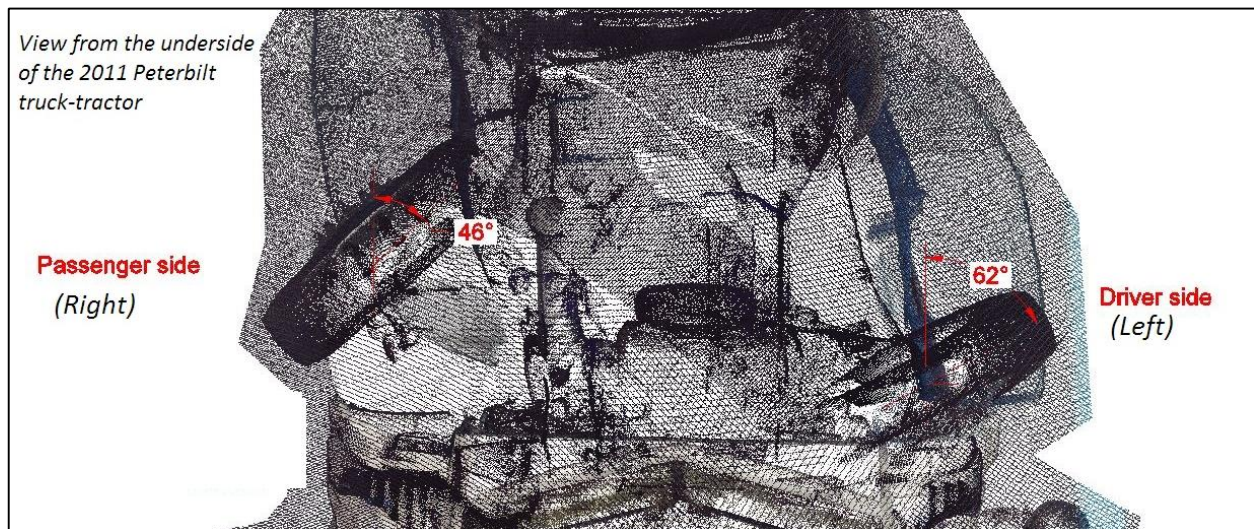
VEH Photo 4. View from the underside of the 2011 Peterbilt truck-tractor, showing the front axle wheel alignment angles noted during the postcrash inspection.

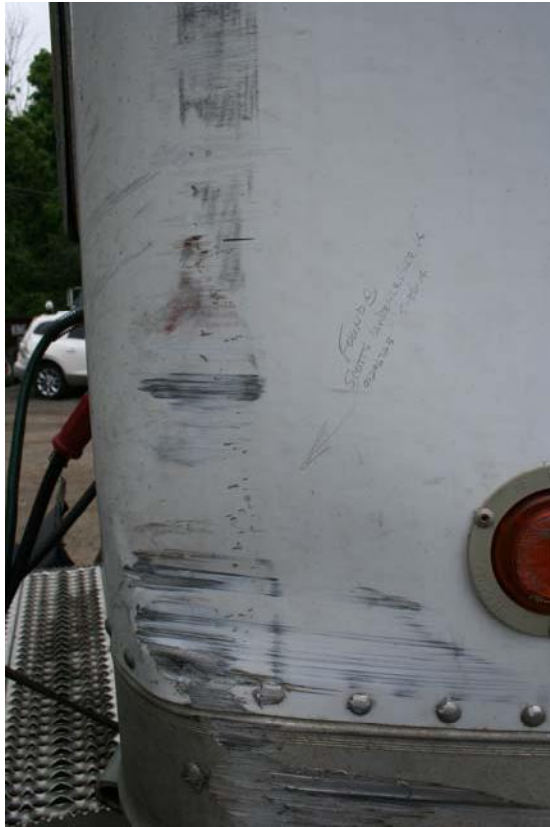
VEH Photo 5. Preexisting left front leading edge damage on the 2003 Great Dane semitrailer.

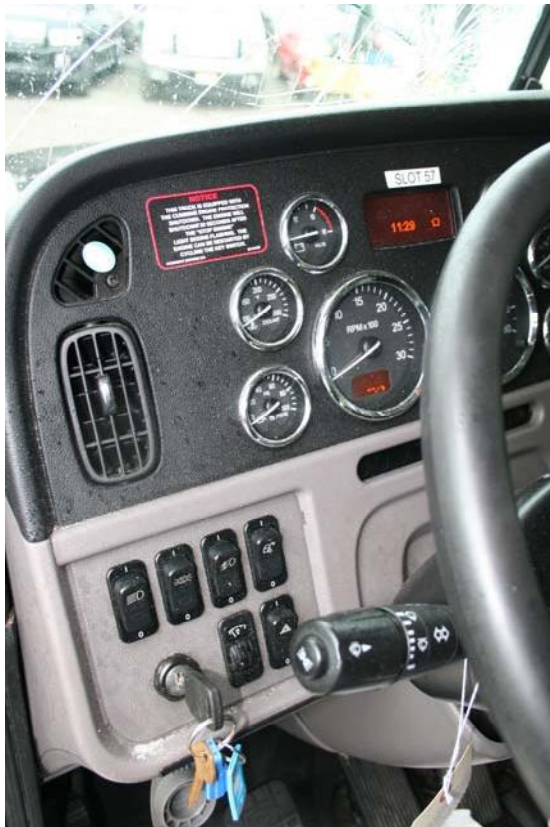
VEH Photo 6. 2011 Peterbilt truck-tractor driver controls to the left of the steering wheel.

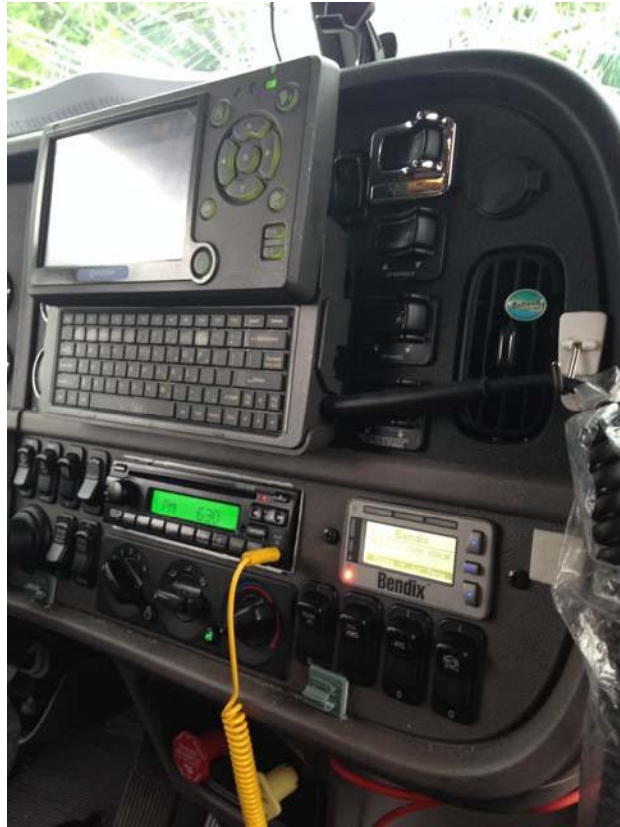
VEH Photo 7. 2011 Peterbilt truck-tractor driver controls to the right of the steering wheel.

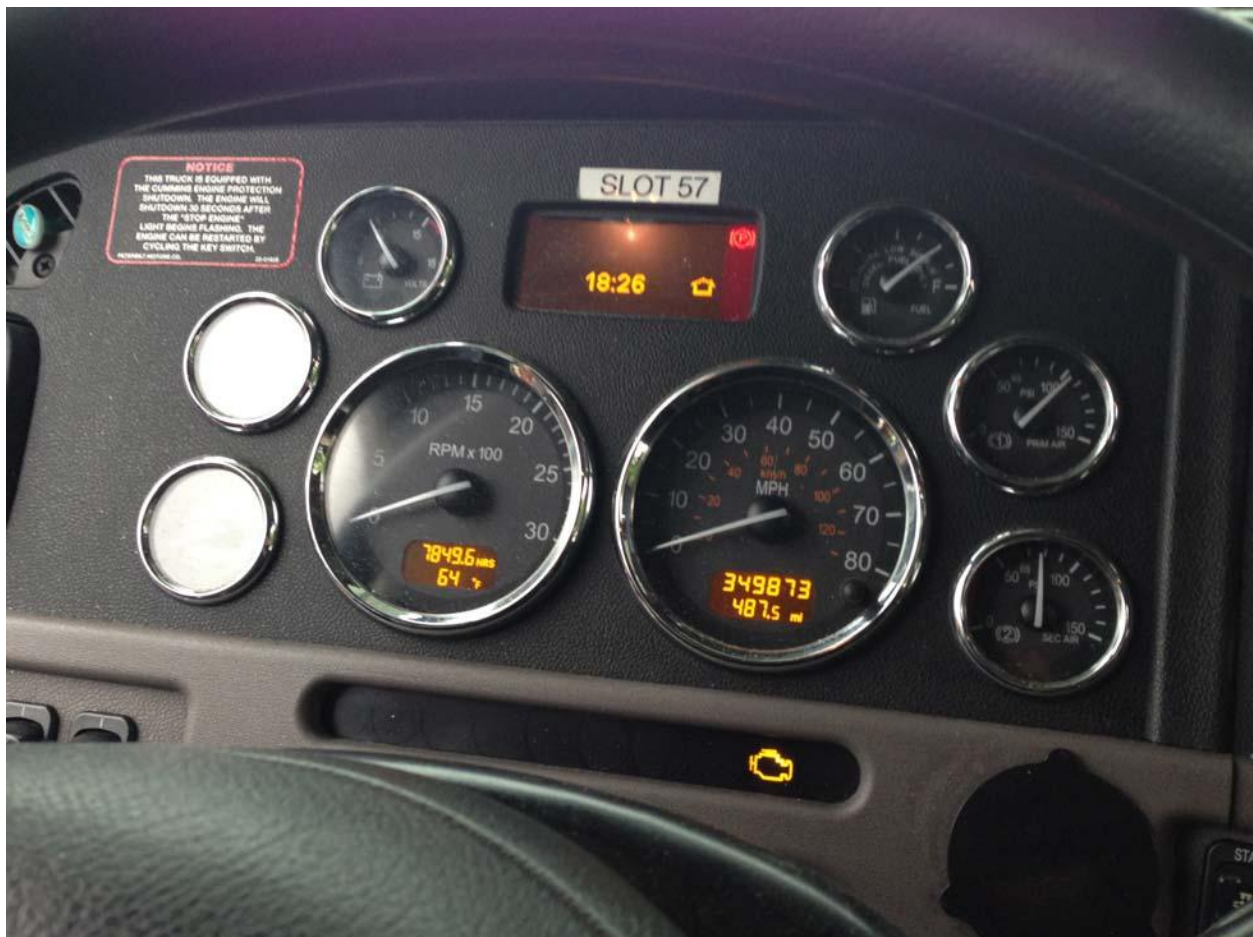
VEH Photo 8. 2011 Peterbilt truck-tractor center dash gauges at postcrash key-on position.

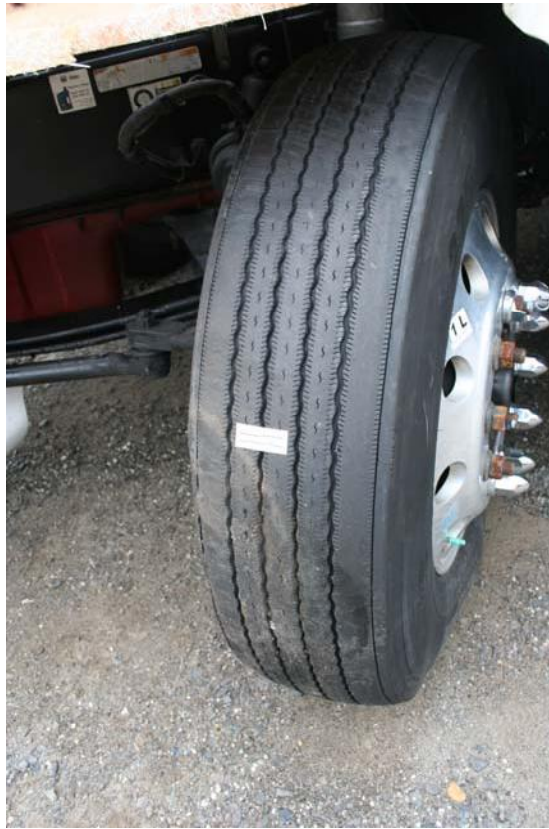
VEH Photo 9. Left front axle tire of the 2011 Peterbilt truck-tractor, showing the area of tire tread scuffing and a 2-inch reference marker.

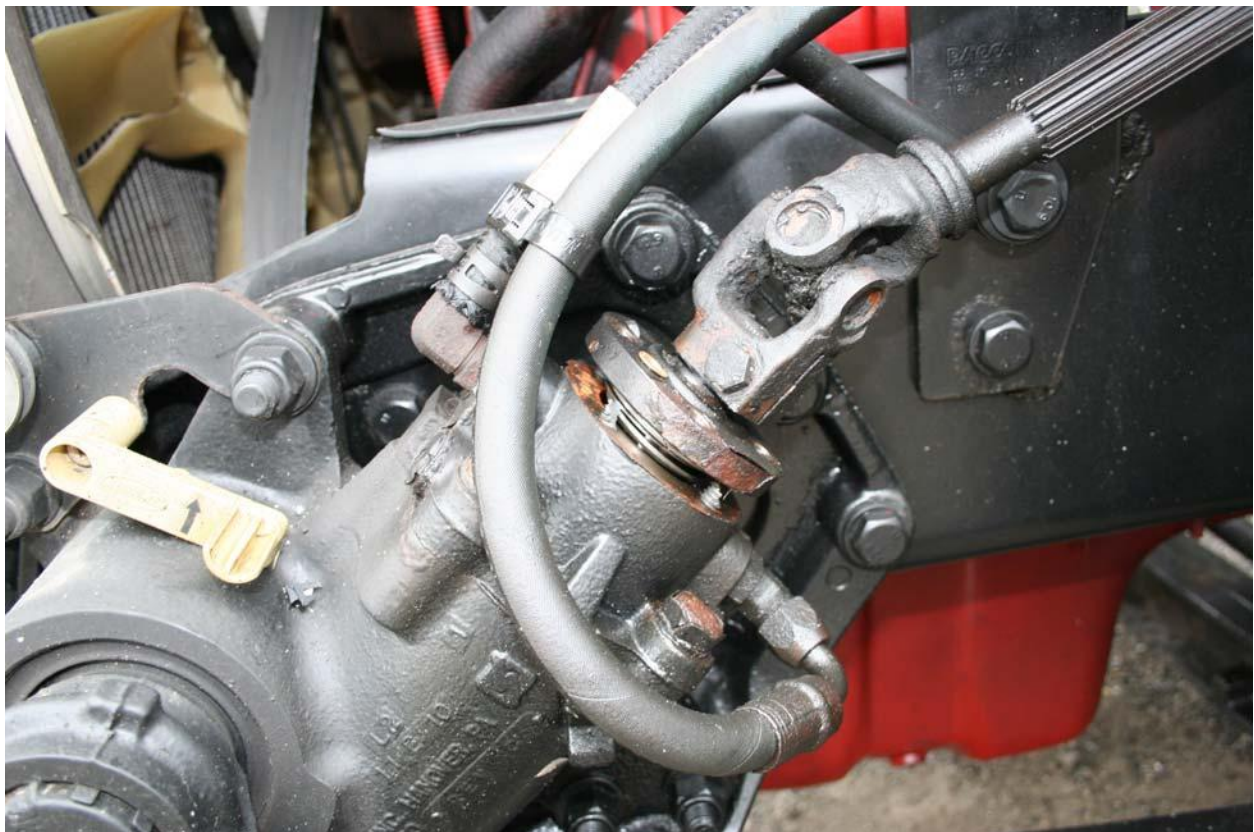
VEH Photo 10. Showing the damaged input shaft connection into the steering gear box and sheared bolts at the input bearing cap.

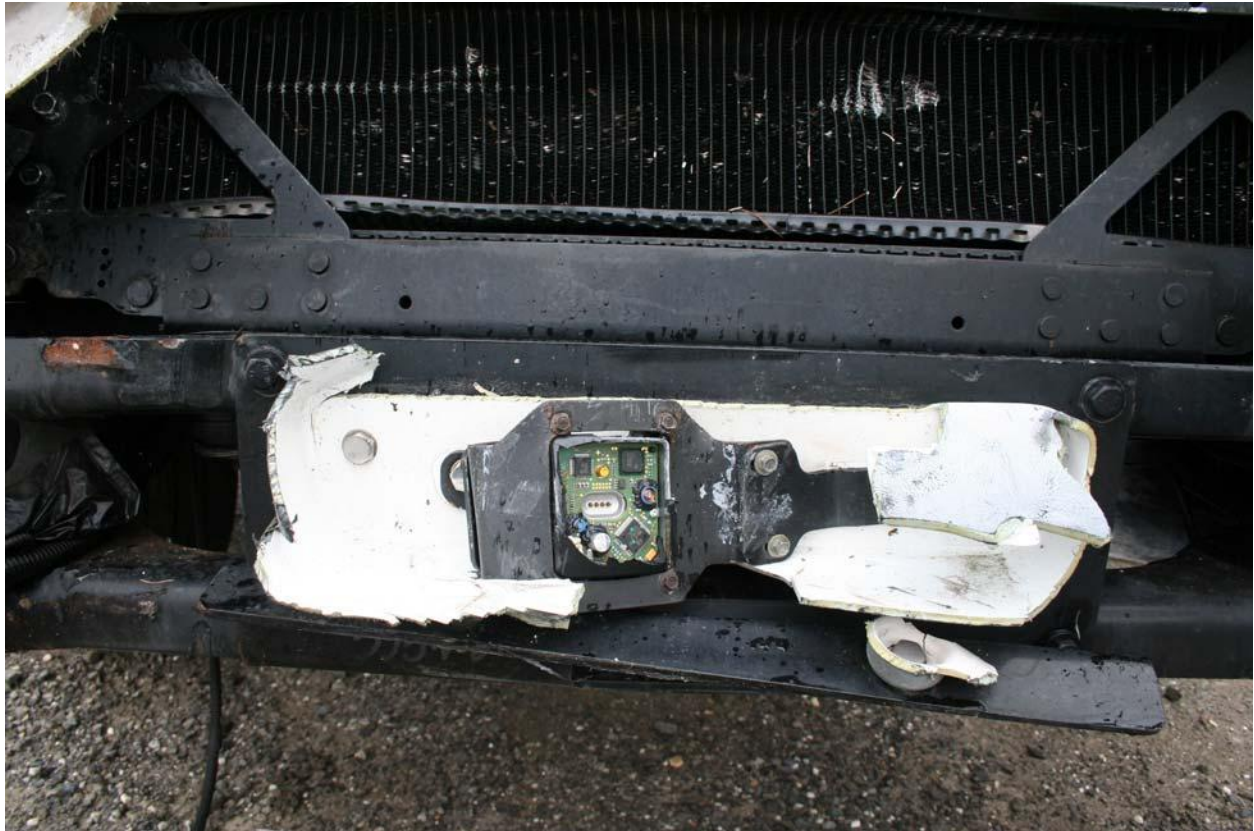
VEH Photo 11. Showing damaged Bendix radar module on the front bumper of the 2011 Peterbilt truck-tractor.

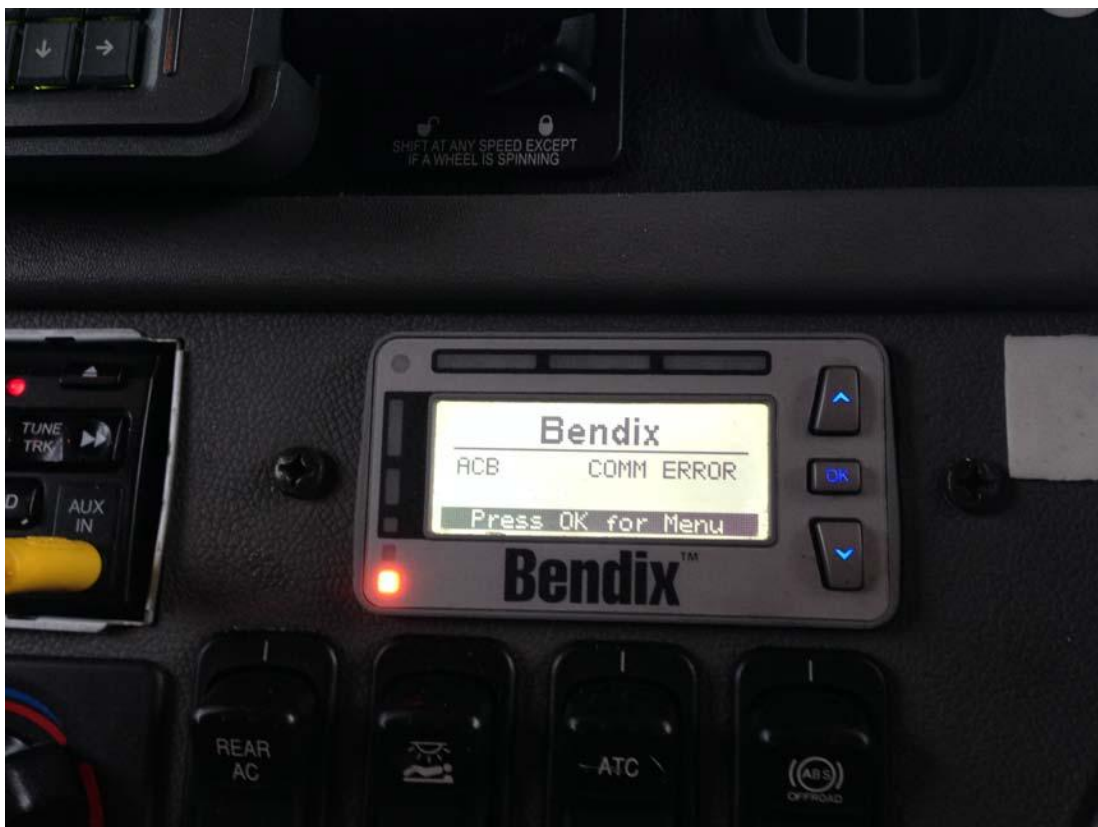
VEH Photo 12. Showing postcrash Bendix display unit and error message in the cab of the 2011 Peterbilt truck-tractor.

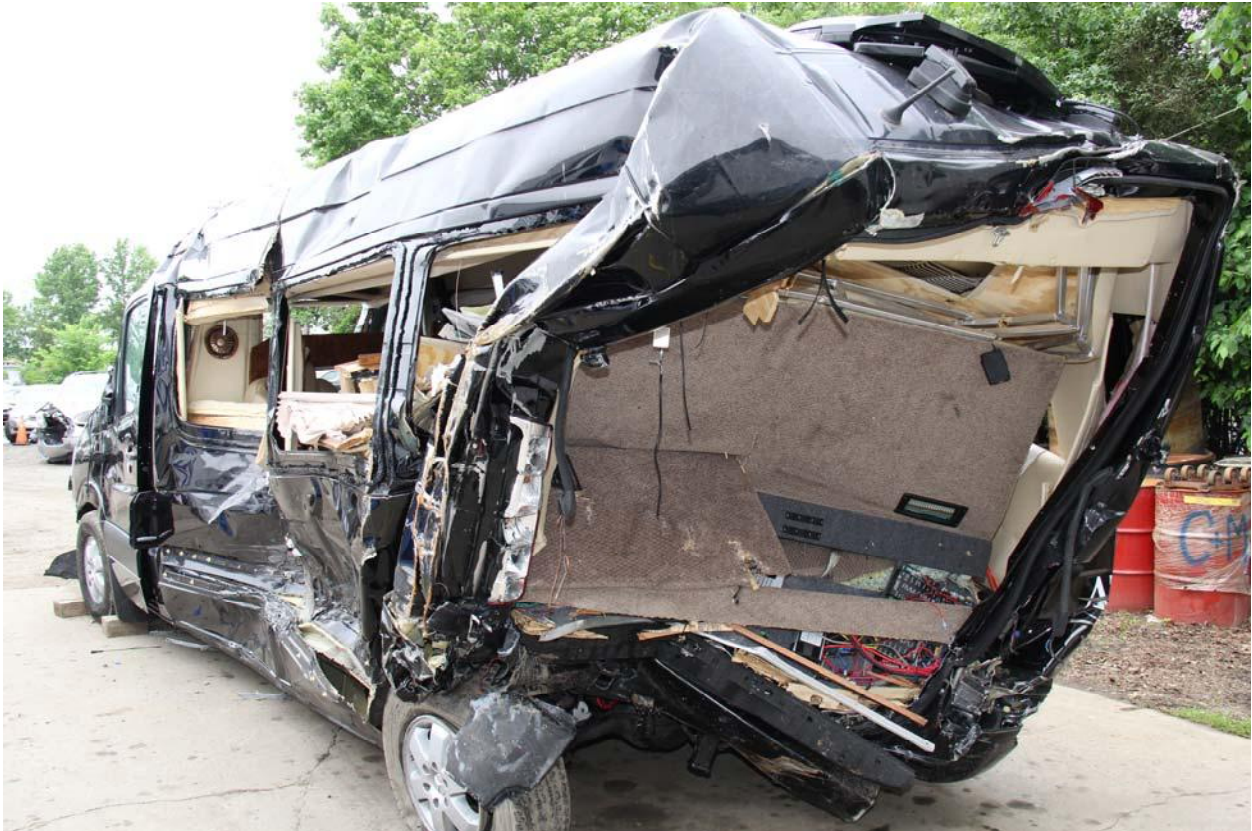
VEH Photo 13. 2012 Mercedes-Benz Sprinter van, view of left rear corner damage.

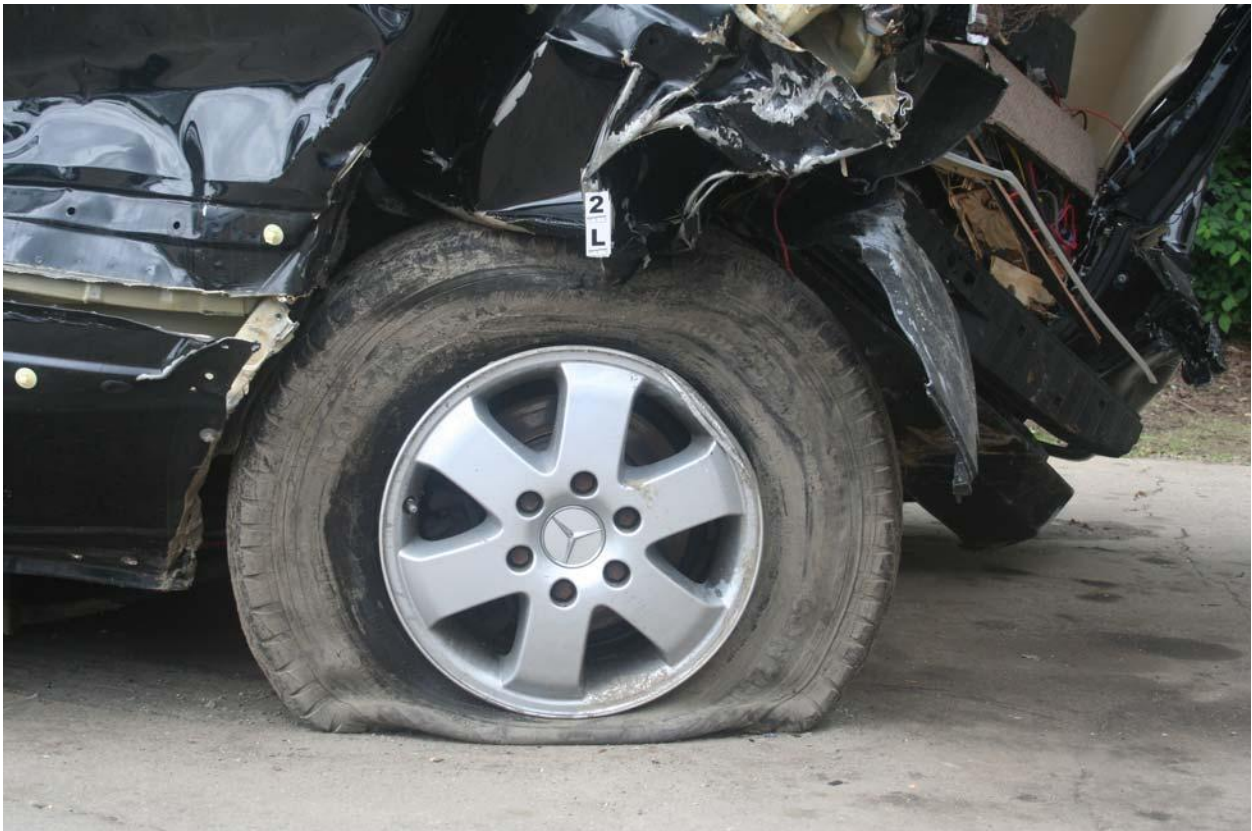
VEH Photo 14. Showing the deflated left rear tire and left rear wheel damage in contact with the crushed-in rear portion of the van.

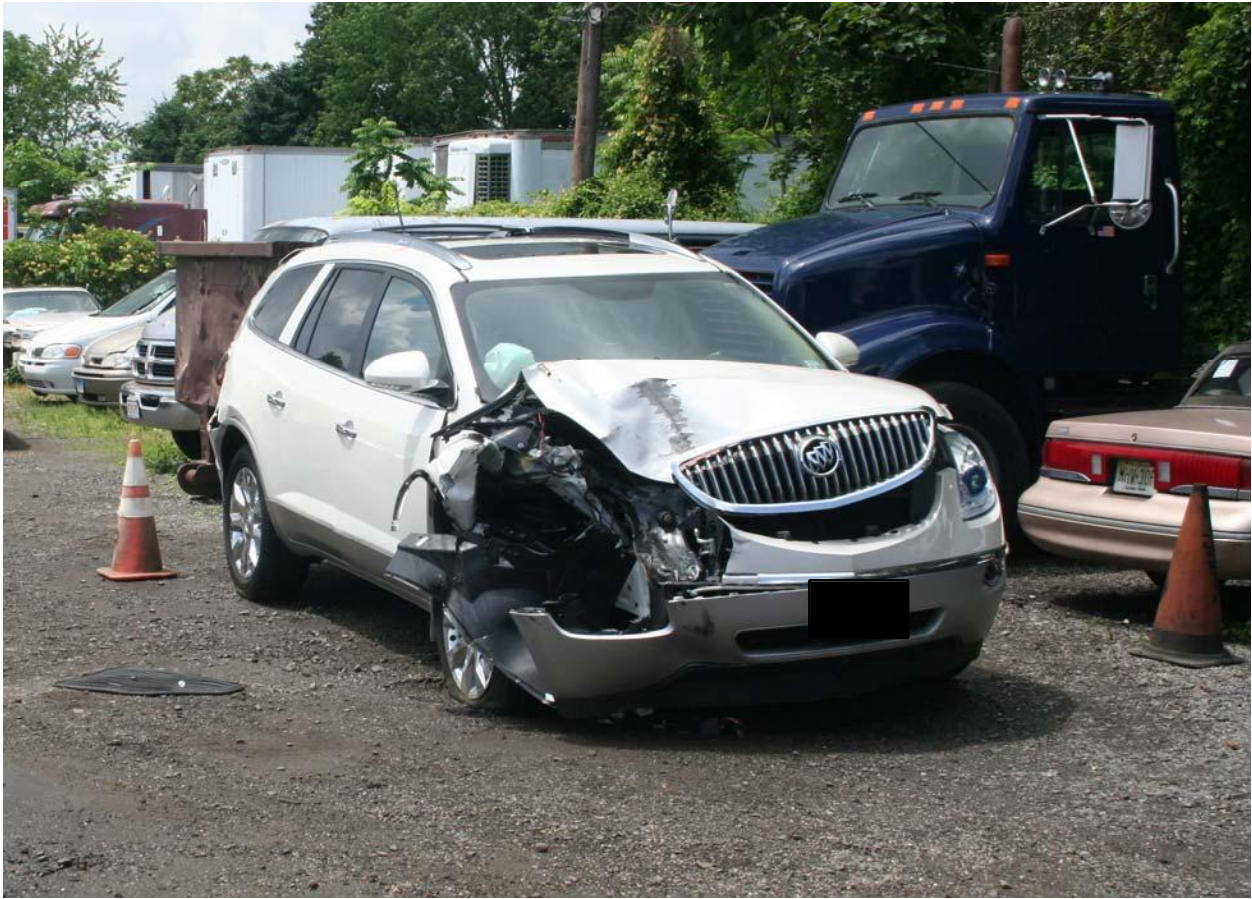
VEH Photo 15. 2011 Buick Enclave, showing right front corner damage.

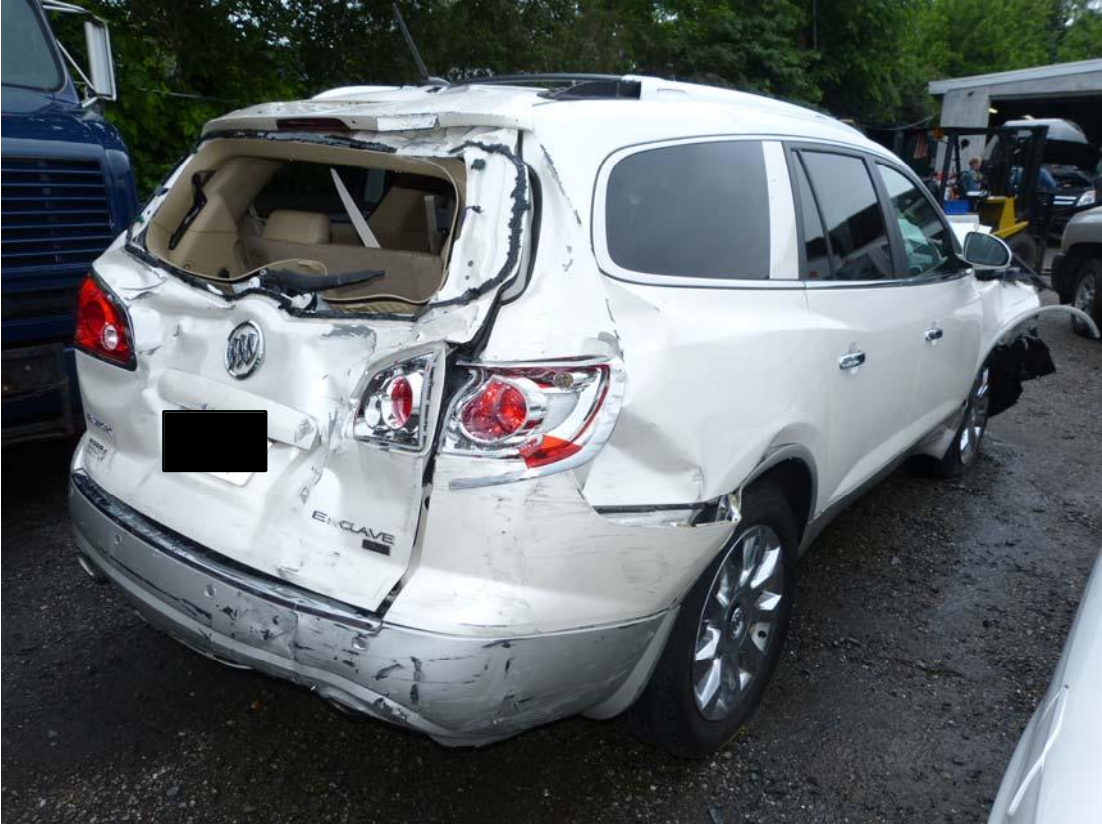
VEH Photo 16. 2011 Buick Enclave, showing rear damage.

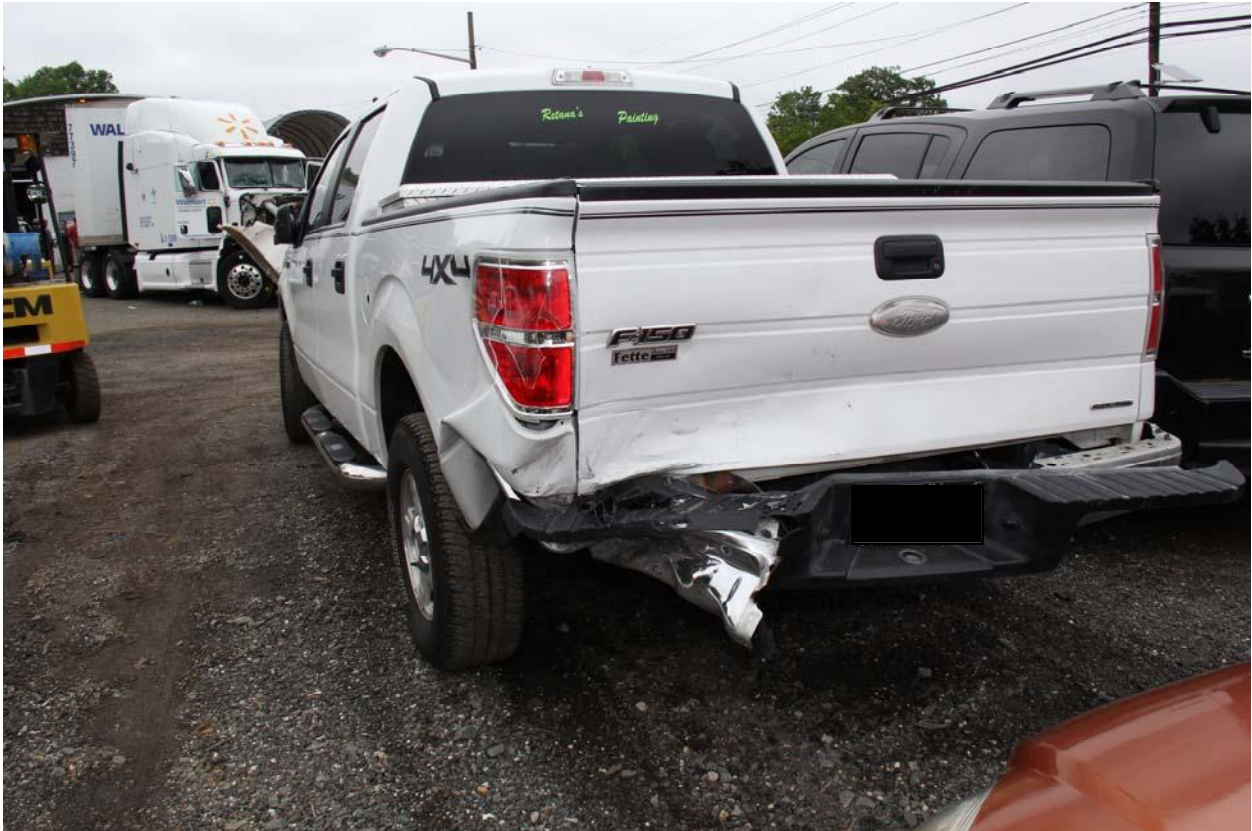
VEH Photo 17. 2011 Ford F-150, showing rear damage.

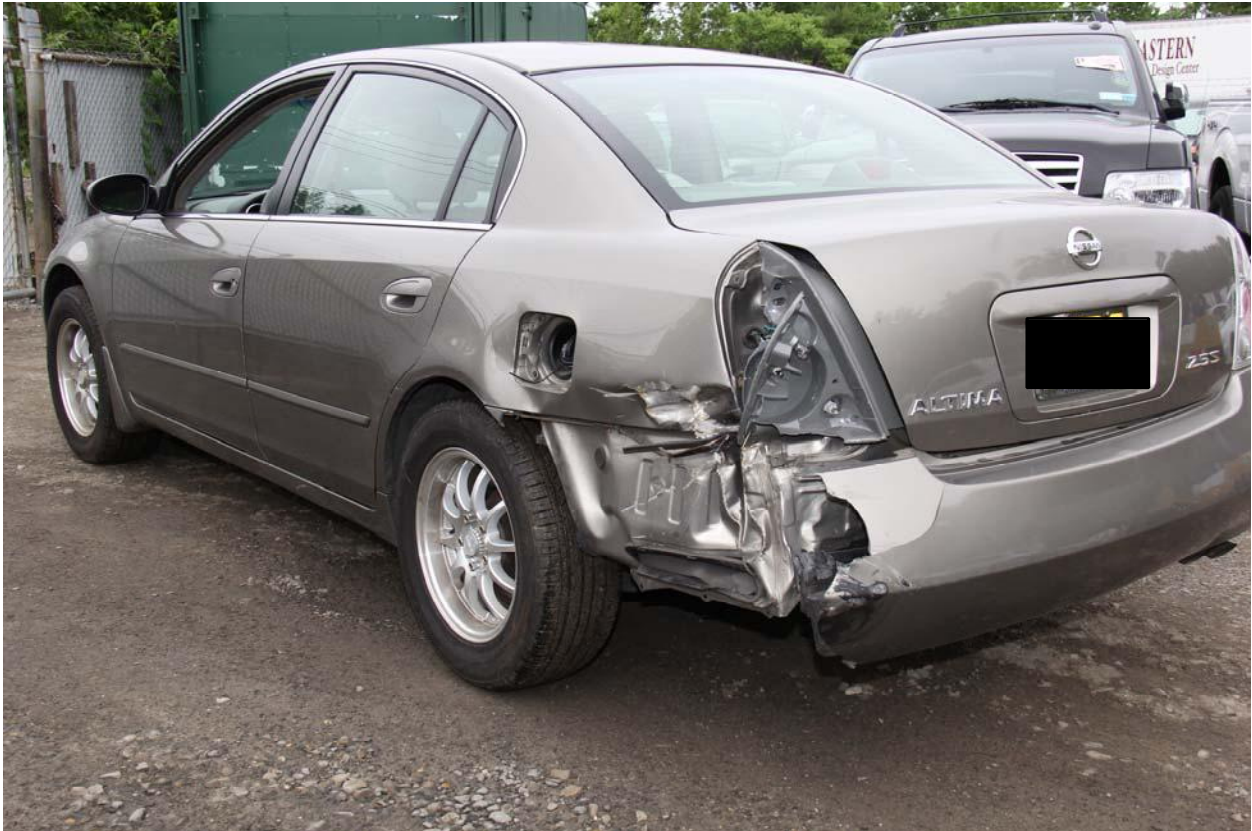
VEH Photo 18. 2005 Nissan Altima, showing left rear corner damage.

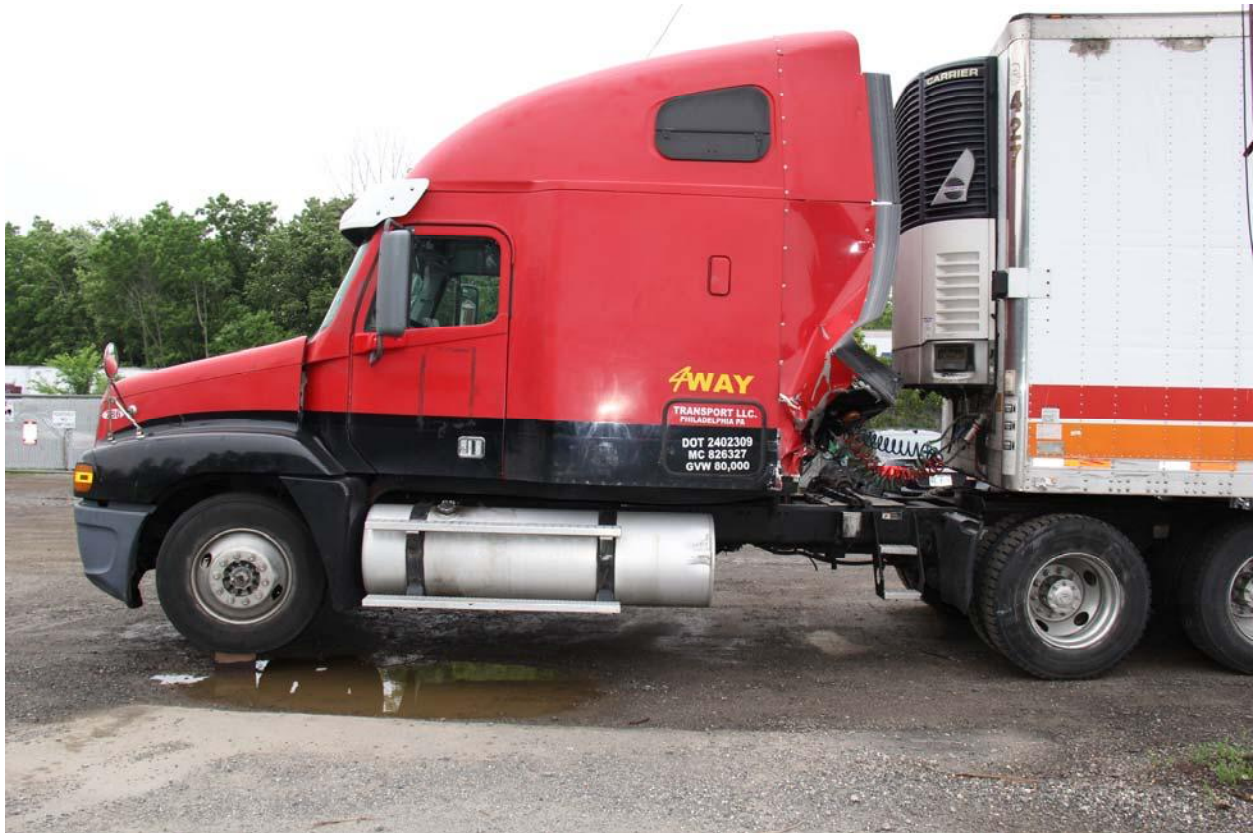
VEH Photo 19. 2006 Freightliner combination unit, showing damage to the left side of the truck-tractor.
