## Victory 2 Work report 15.1.2025

**CUSTOMER:** Victory Cruise lines  
**VESSEL:** Victory 2  
**MAIN ENGINE:** CATERPILLAR 3516 B  
**ENGINE LOCATION:** STDB  
**Engine serial no:** 9AN00185  
**Engine hours:**

## Work report block and crankshaft replacement

Work performed September 2<sup>nd</sup> -14<sup>th</sup> 2024 in Portland Maine

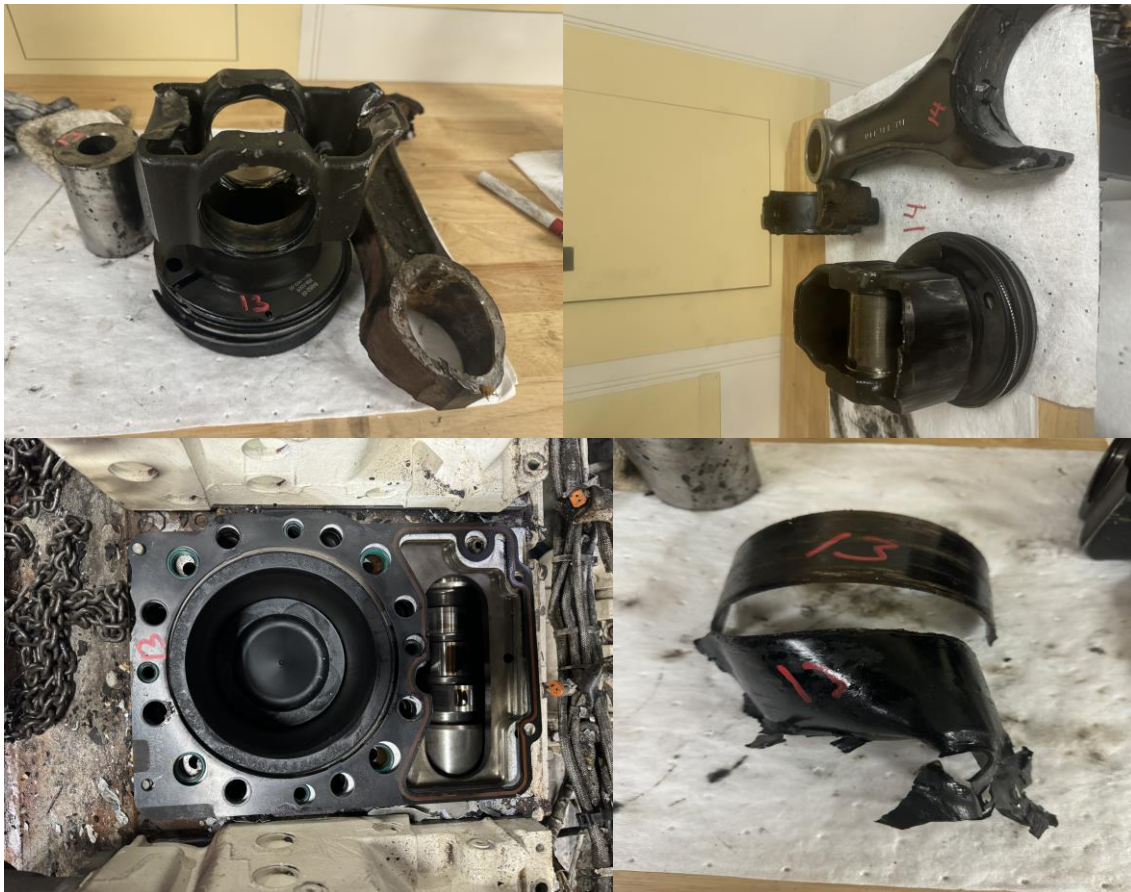
All the pistons were dismantled. Cylinders 13 and 14 totally destroyed

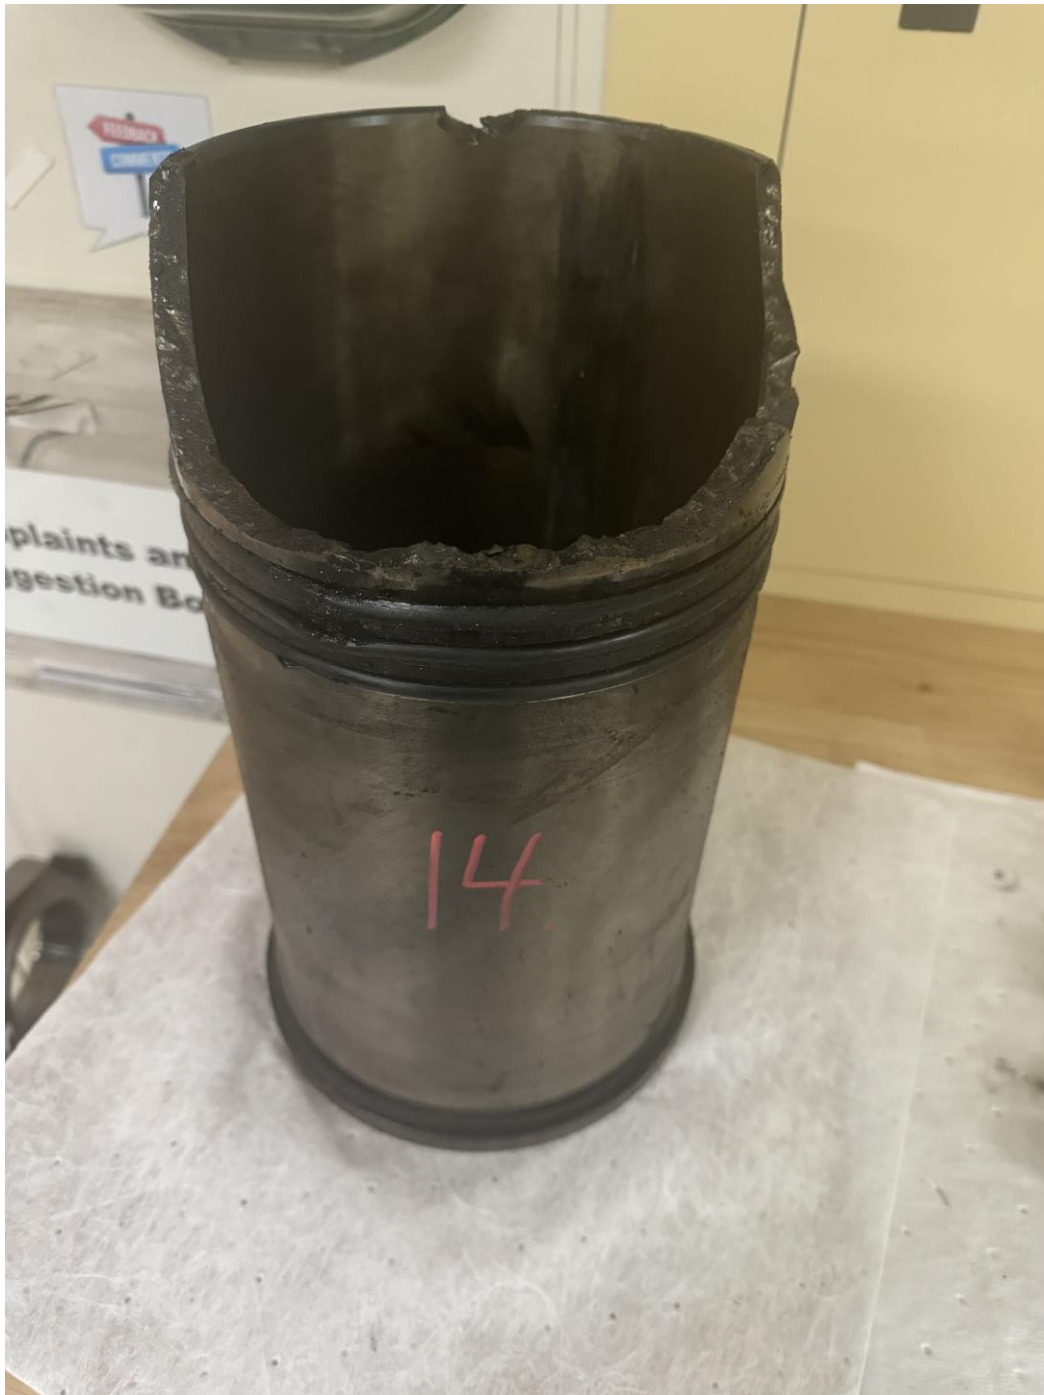
All liners were pulled out. Except no 13 which was badly stuck.

Cylinders 13 and 14 were totally damaged but all other cylinders were in normal condition

The water side of the liners were in good condition , but cylinder side you can see marks of wearing.

Agreed that all new cylinder packs to be ordered

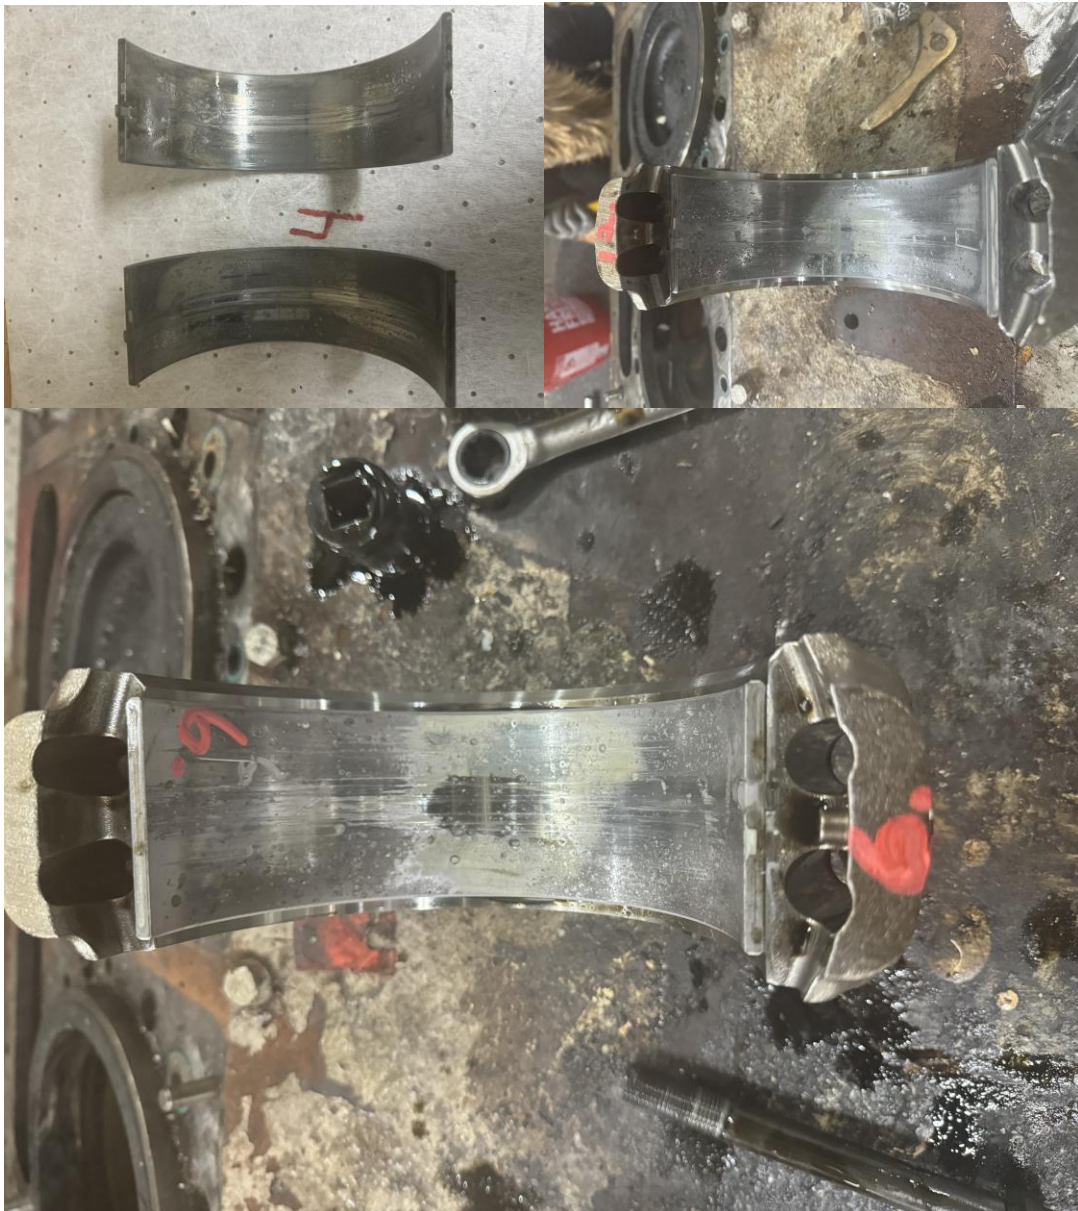
All connecting rods were removed and big end bearings were inspected. Really bad bearings were found. It is common for a high RPM engine to have cavitation marks on the bearings, but these were really bad conditions All of them.

Our opinion is that broken bearing causes failure. There were also a lot of white metal particles on the other crankshaft journals. Removed from the bearings.

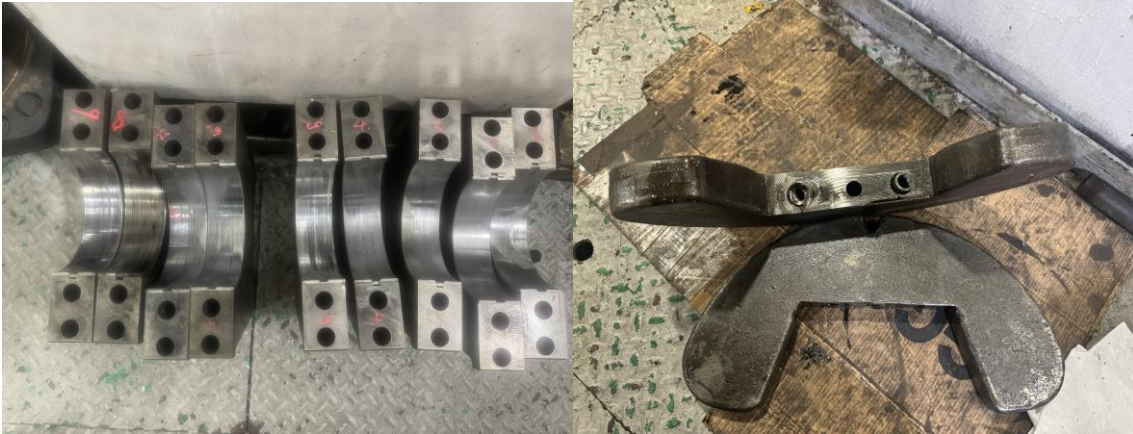
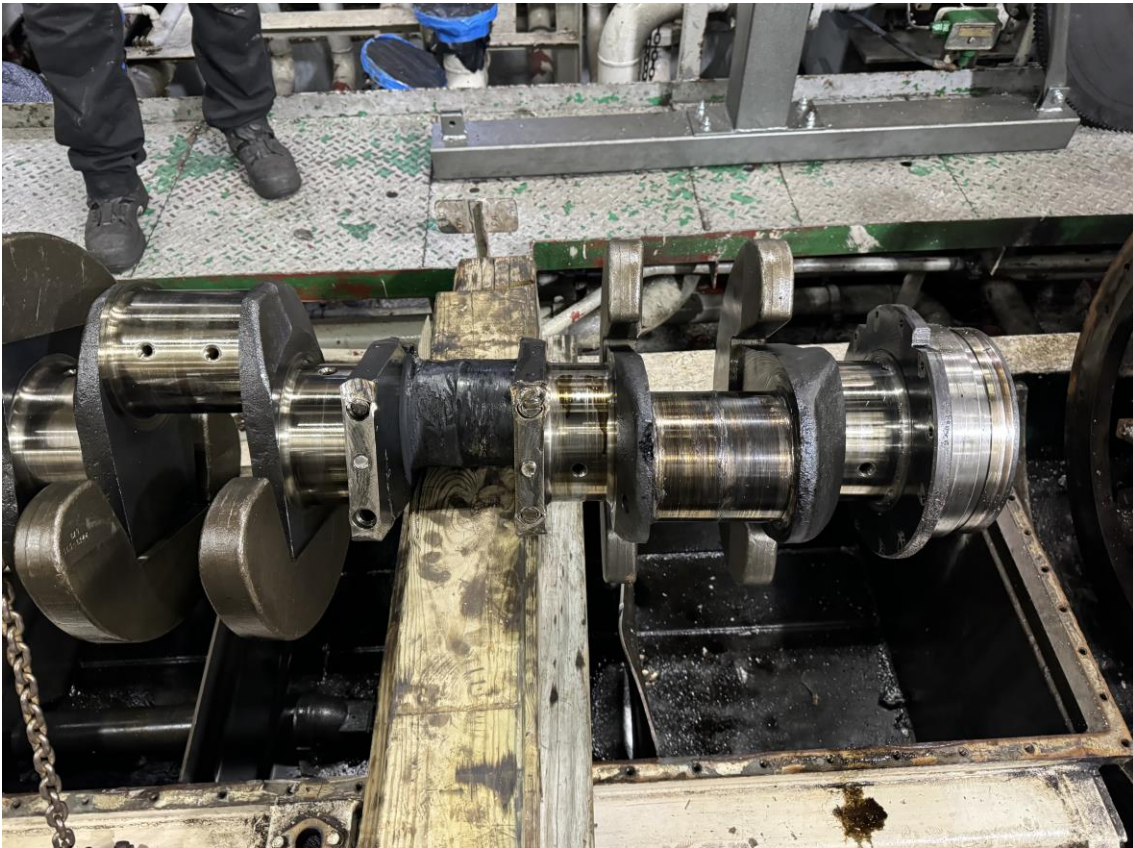
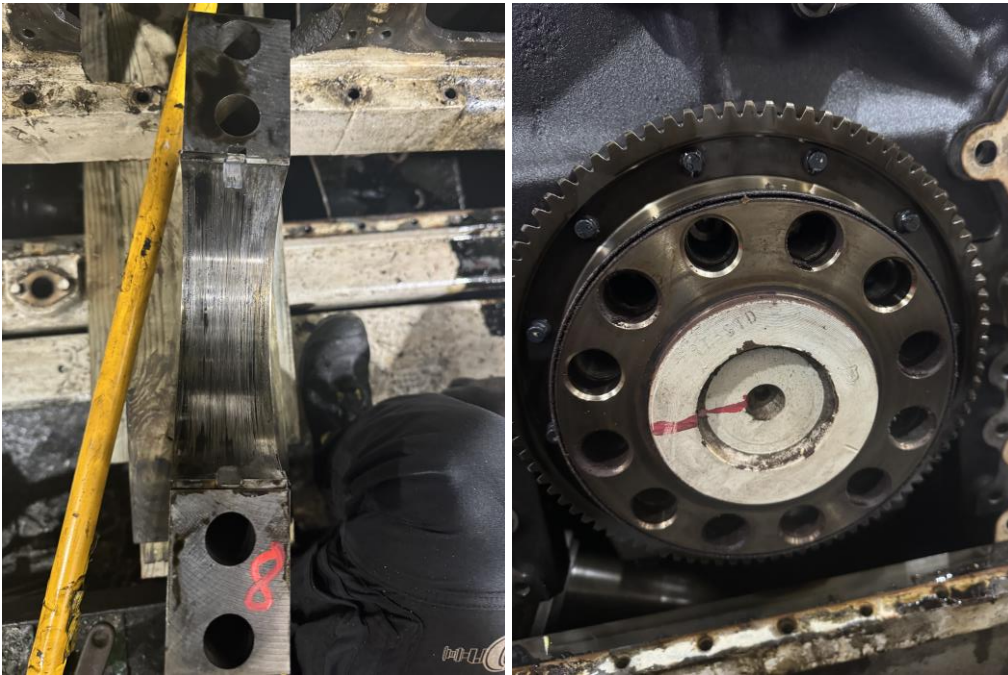
COUNTERWEIGHT, BEARINGS AND DAMAGED SHAFT

Crankshaft was dismantled and all bearings were inspected. Bearing no 8 was in the worst condition.

Counterweights of connecting rod 13 and 14 had broken from their bolts and found from the oil pan

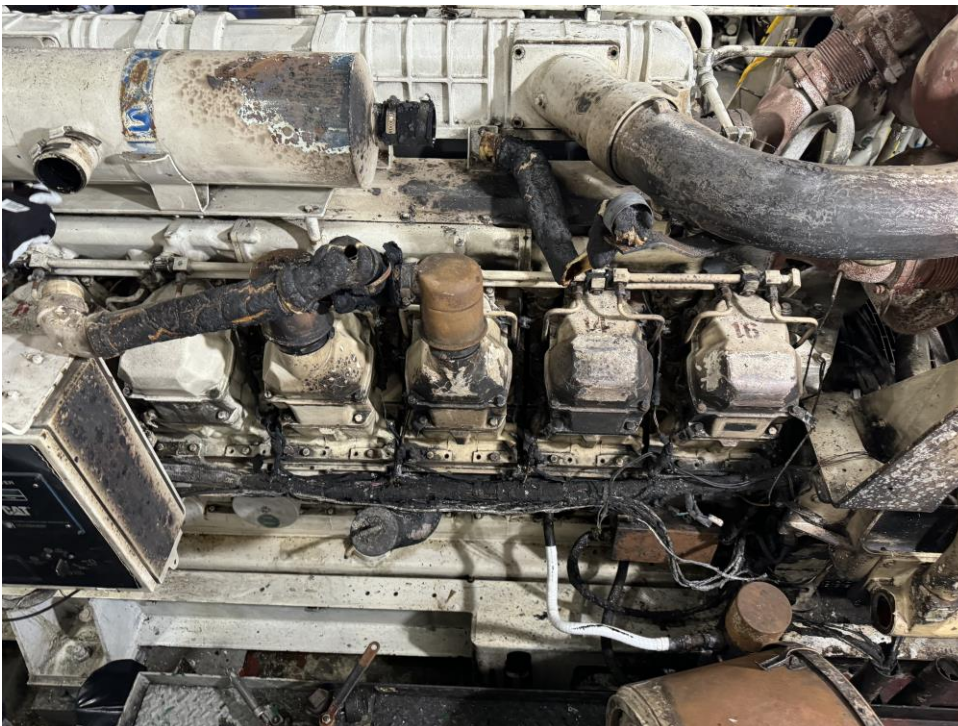
Main wiring harness and exhaust temperature harness was damaged in a fire and need to replace

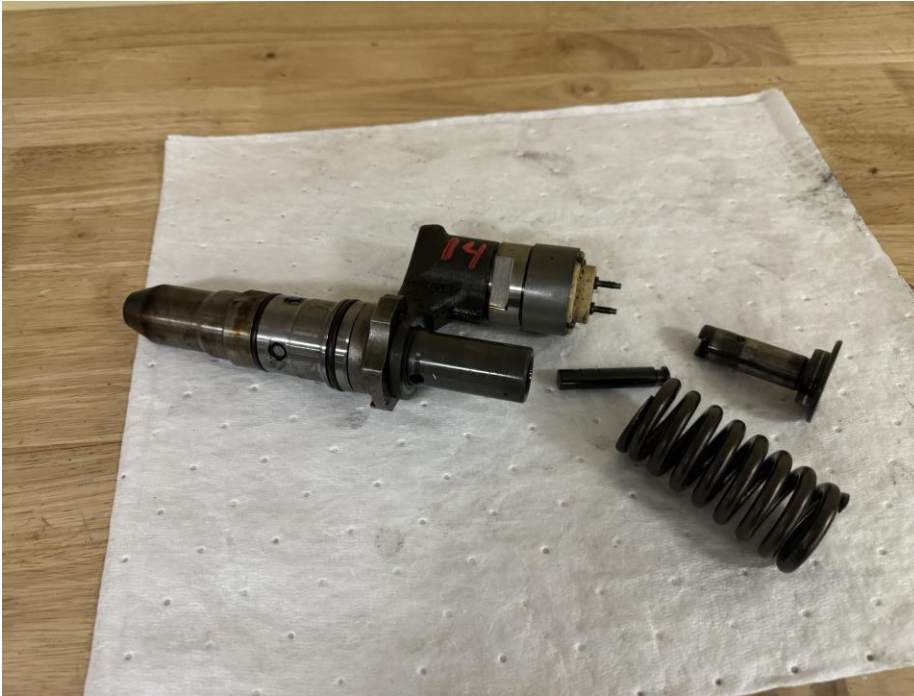
Removed injectors for the engine . Visual inspected injectors ,  
No 14 were broken

BROKEN FUEL INJECTOR Cyl 14.

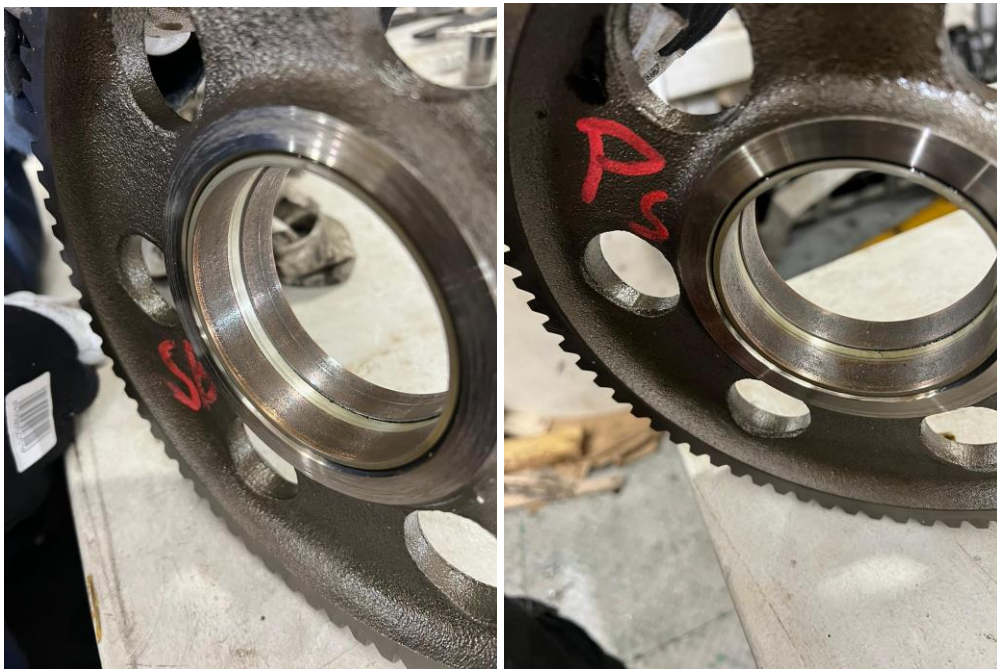
The Rear housing was removed, housing and gears were visually inspected  
Bearings for idle gear was not so good condition and recommend changing

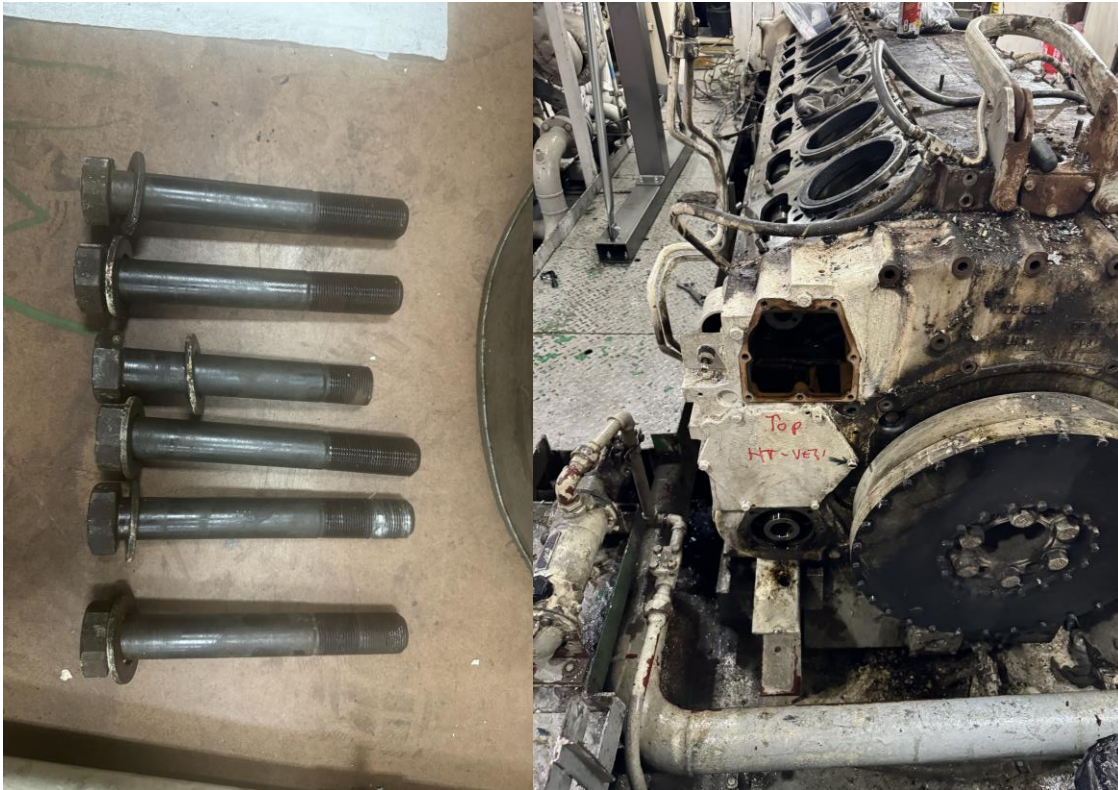
Removed damper from the engine. All the bolts were stuck, and one went broke when opened. Agreed that all new bolts will come and damper to be overhauled locally

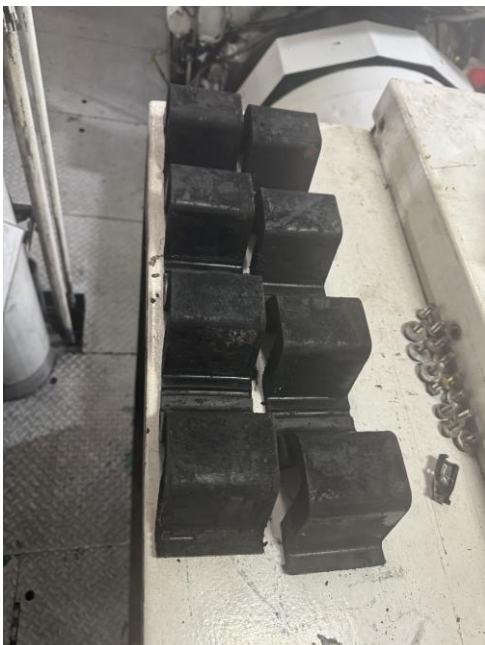
Inspection of condition of coupling showed old and agreed that it will change for new ones
