Multivehicle Crash Near Mt. Pleasant Township, Pennsylvania

Multivehicle Crash Near Mt. Pleasant Township, Pennsylvania, January 5, 2020

Collision Sequence and Video Event Recorder Systems

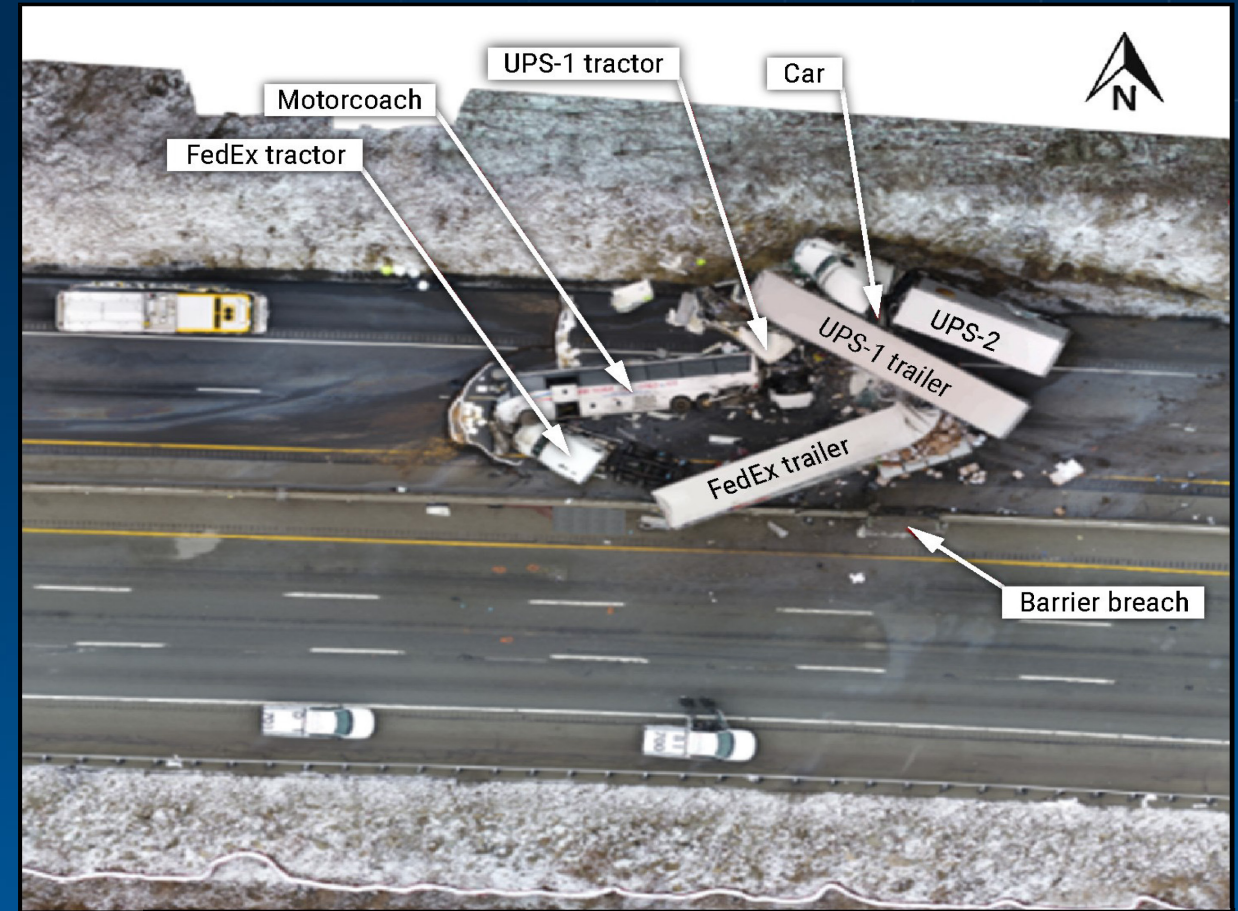
Crash Vehicles

- Final rest positions of vehicles
 - Motorcoach
 - FedEx tractor & trailer
 - UPS-1 tractor & trailer
 - Passenger car
 - UPS-2 tractor & trailer

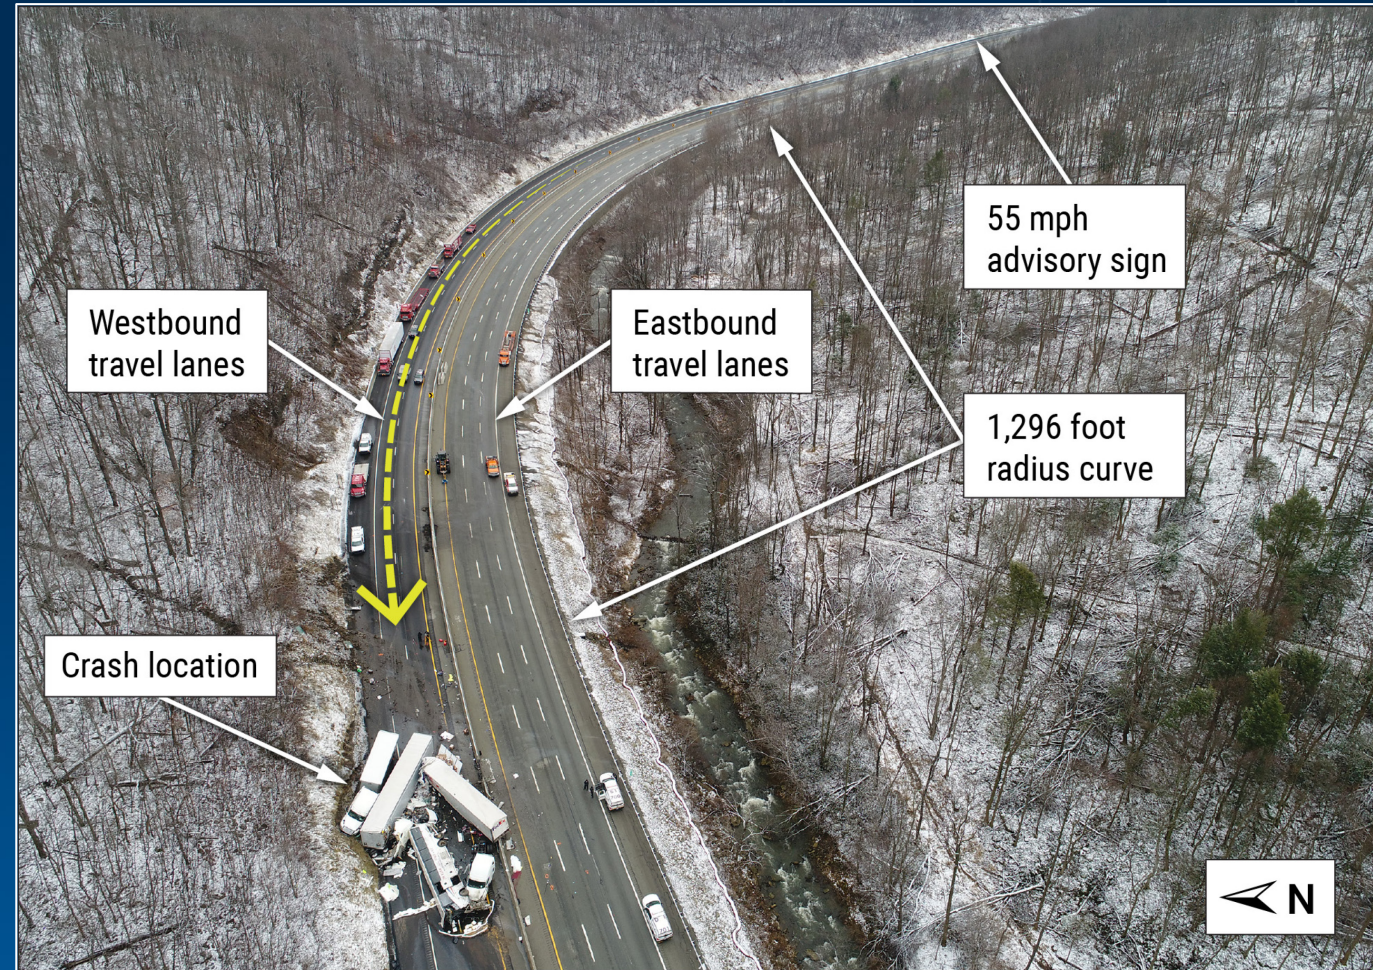
Crash Scene

- Vehicles at final rest
- Left-hand curve
- East and westbound lanes
- 55-mph warning sign

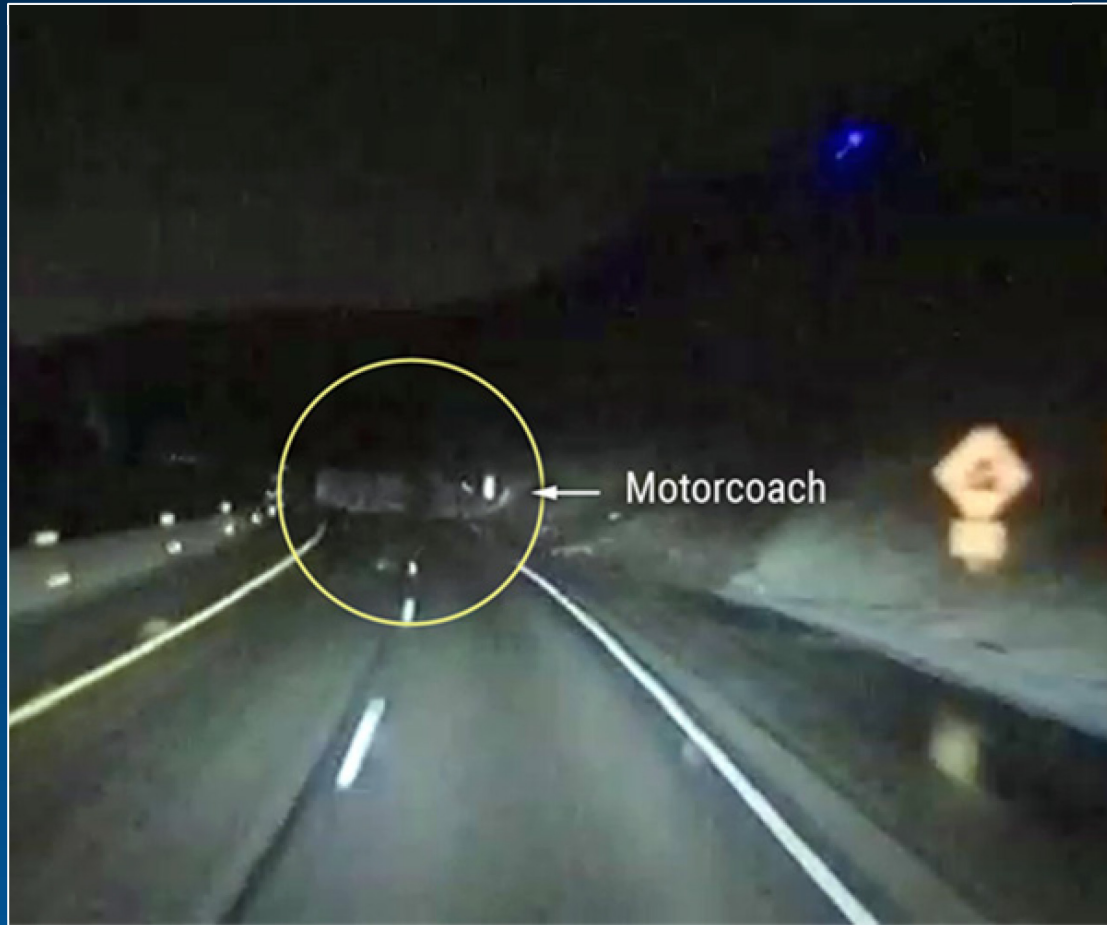
Overtaken Motorcoach

- Initial position of rest was blocking both travel lanes and shoulders
- Entered curve at 77 mph
- Light braking upon entering curve decreased speed to 70 mph
- After brakes released vehicle speed changes not associated with braking or throttle occurred
- Speed changes consistent with vehicle yawing from excessive steering inputs
- Sufficient roadway traction existed for normal travel

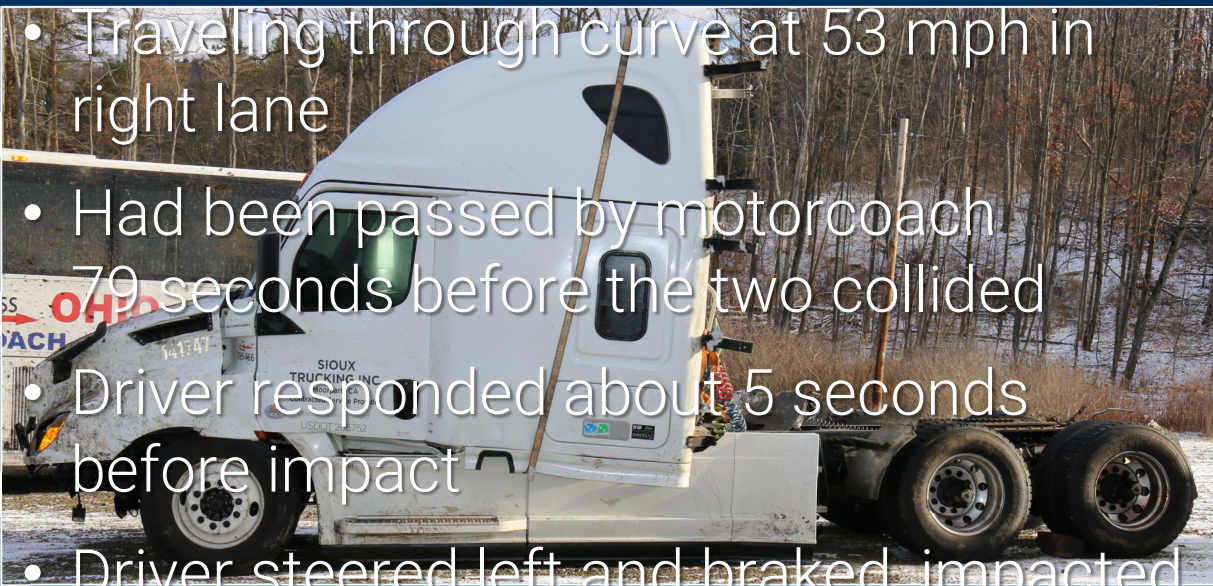
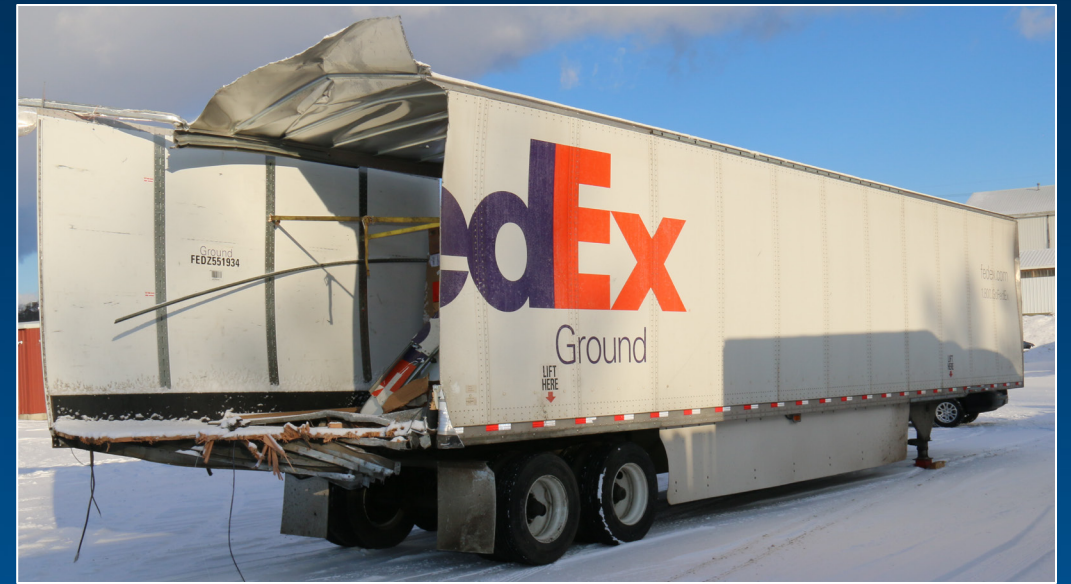
FedEx Combination Unit

- Traveling through curve at 53 mph in right lane
- Had been passed by motorcoach 79 seconds before the two collided
- Driver responded about 5 seconds before impact
- Driver steered left and braked, impacted motorcoach at about 21 mph

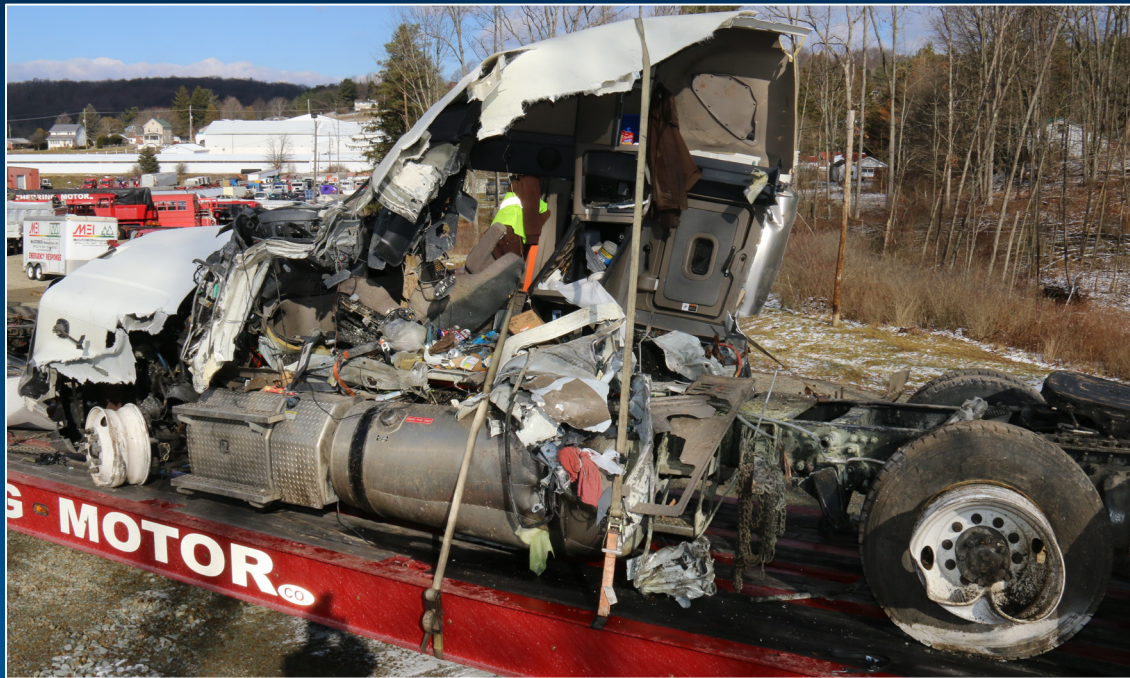
UPS-1 Combination Unit

- Entered curve at 71 mph, traveling in left lane
- Evidence that driver braked and swerved to the right
- Tractor collided with right rear of FedEx trailer
- Average speed 67 mph during preceding two hours of travel on turnpike

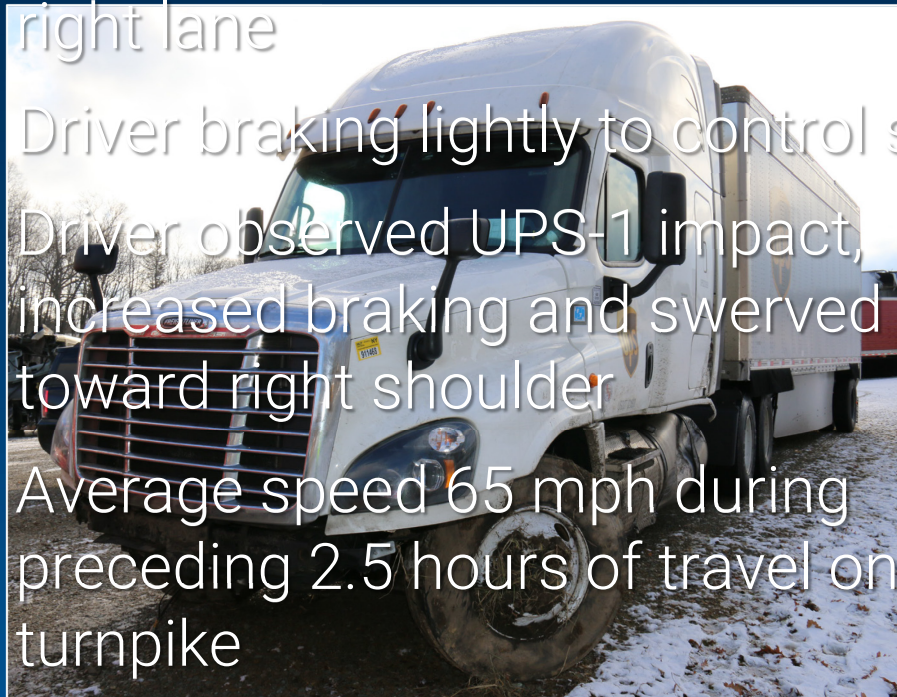
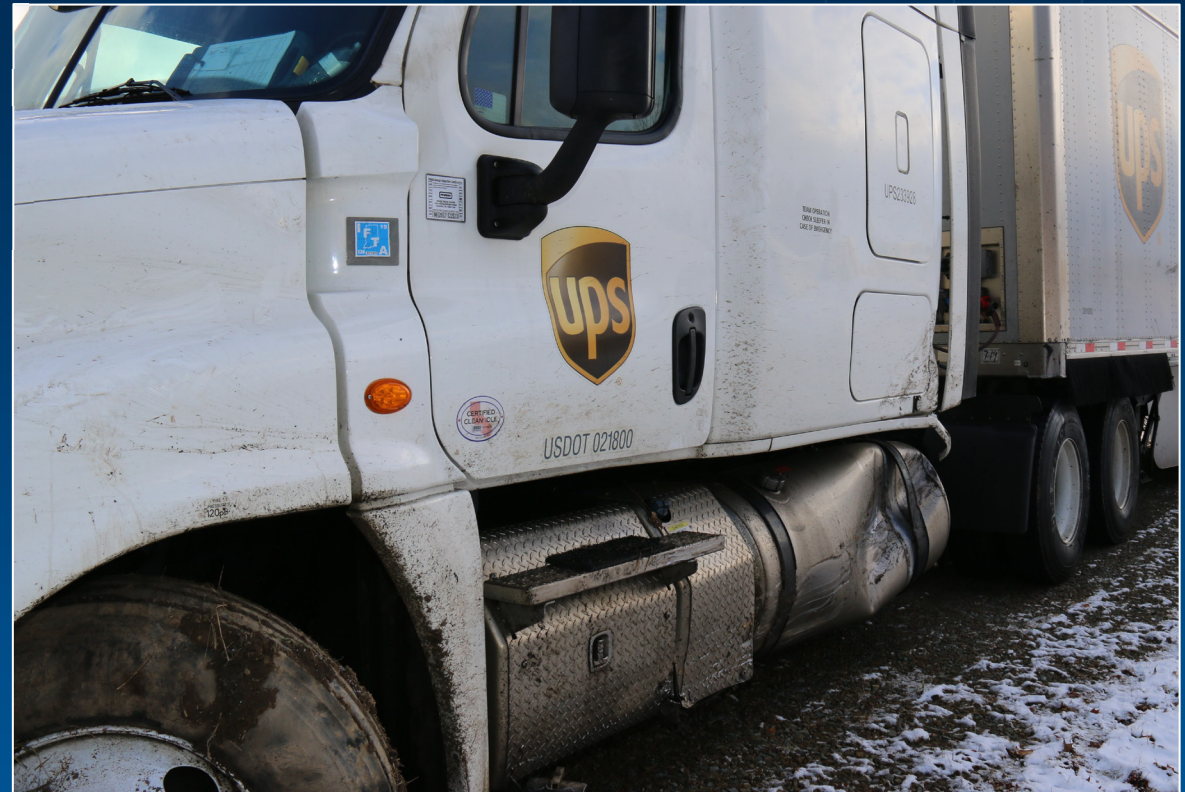
UPS-2 Combination Unit

- Entered curve at 69 mph, traveling in right lane
- Driver braking lightly to control speed
- Driver observed UPS-1 impact, increased braking and swerved toward right shoulder
- Average speed 65 mph during preceding 2.5 hours of travel on turnpike

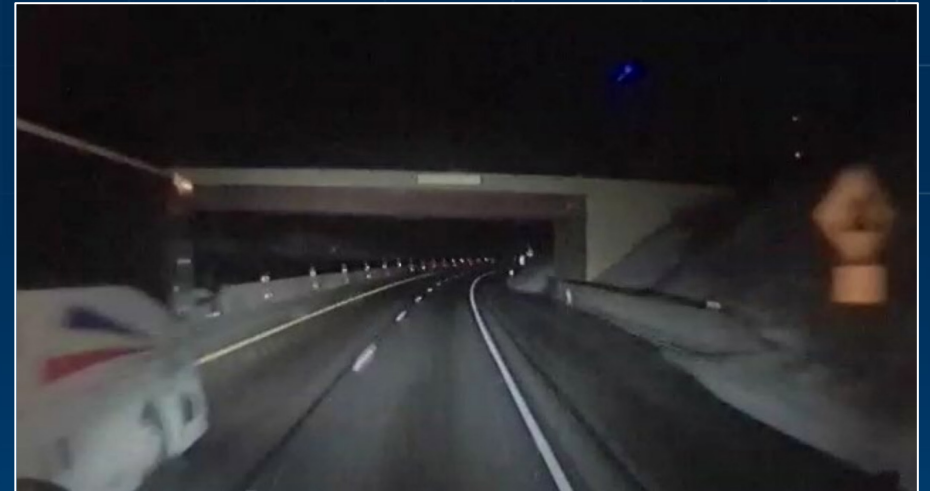
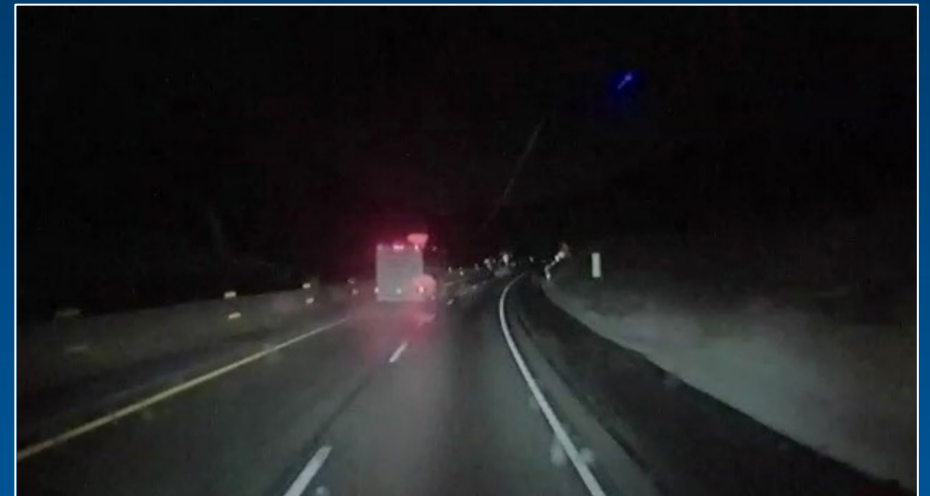
Onboard Video Event Recorders

- FedEx truck video system provided key information:
 - Motorcoach speed and lane position when passing
 - Position and visibility of overturned motorcoach on roadway
 - FedEx driver reacted quickly to hazard
 - FedEx truck speed and crash severity

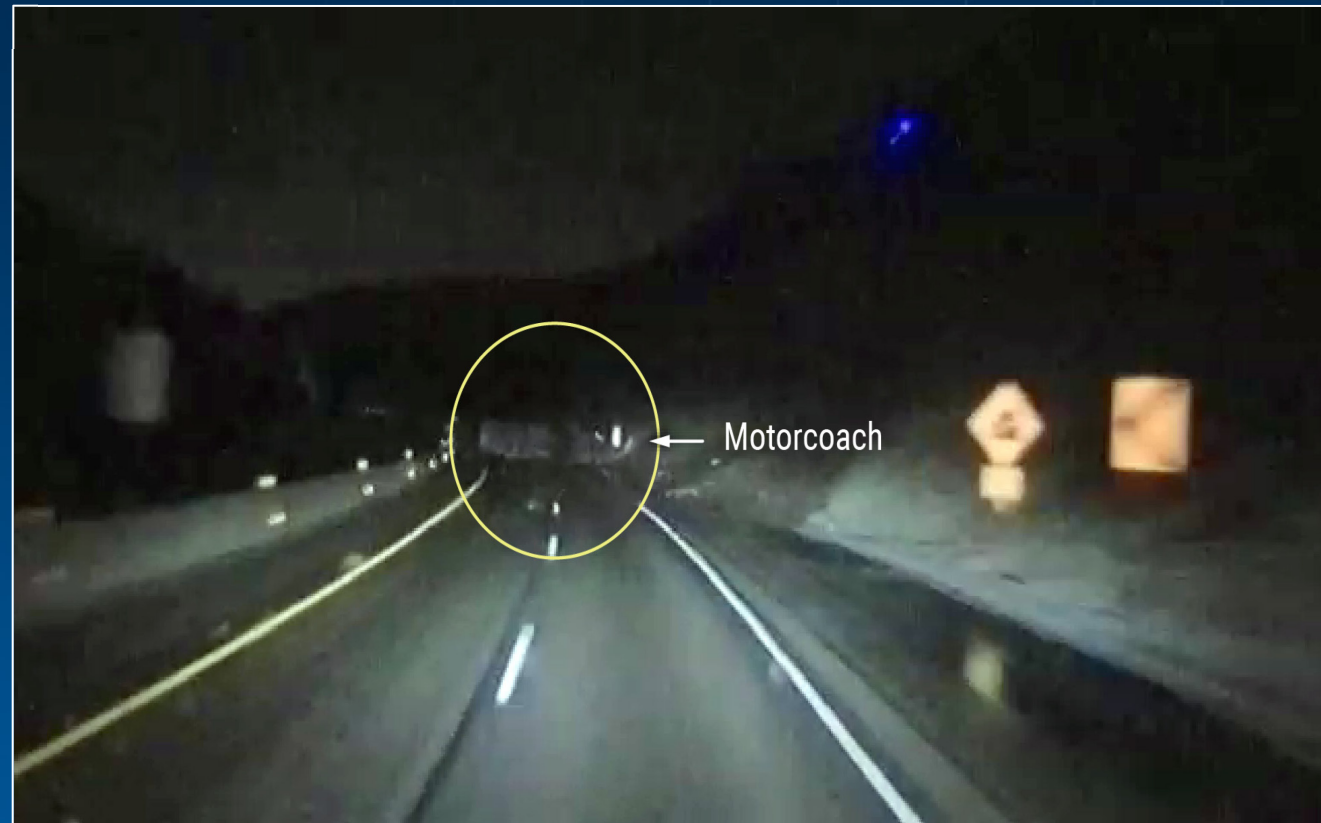
FedEx Driver Response

- FedEx truck entered curve at 53 mph
- Driver steered to left, applied brake
- Driver reacted within 0.3 seconds
- FedEx truck slowed to 21 mph

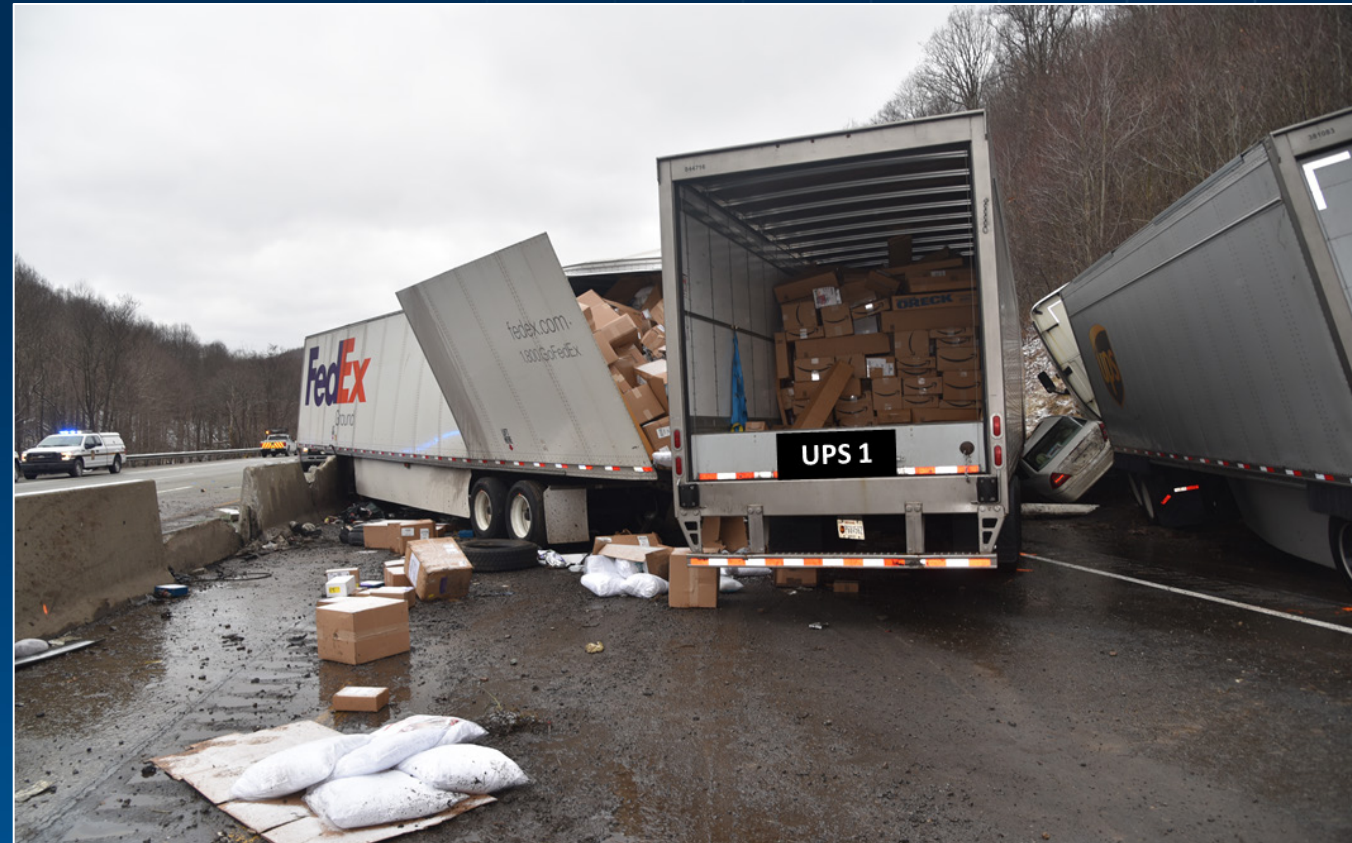
UPS-1 Driver Response

- UPS-1 entered curve at 71 mph
- FedEx truck had begun slowing
- Driver applied brakes, steered right
- UPS-1 collision occurred at 56 mph

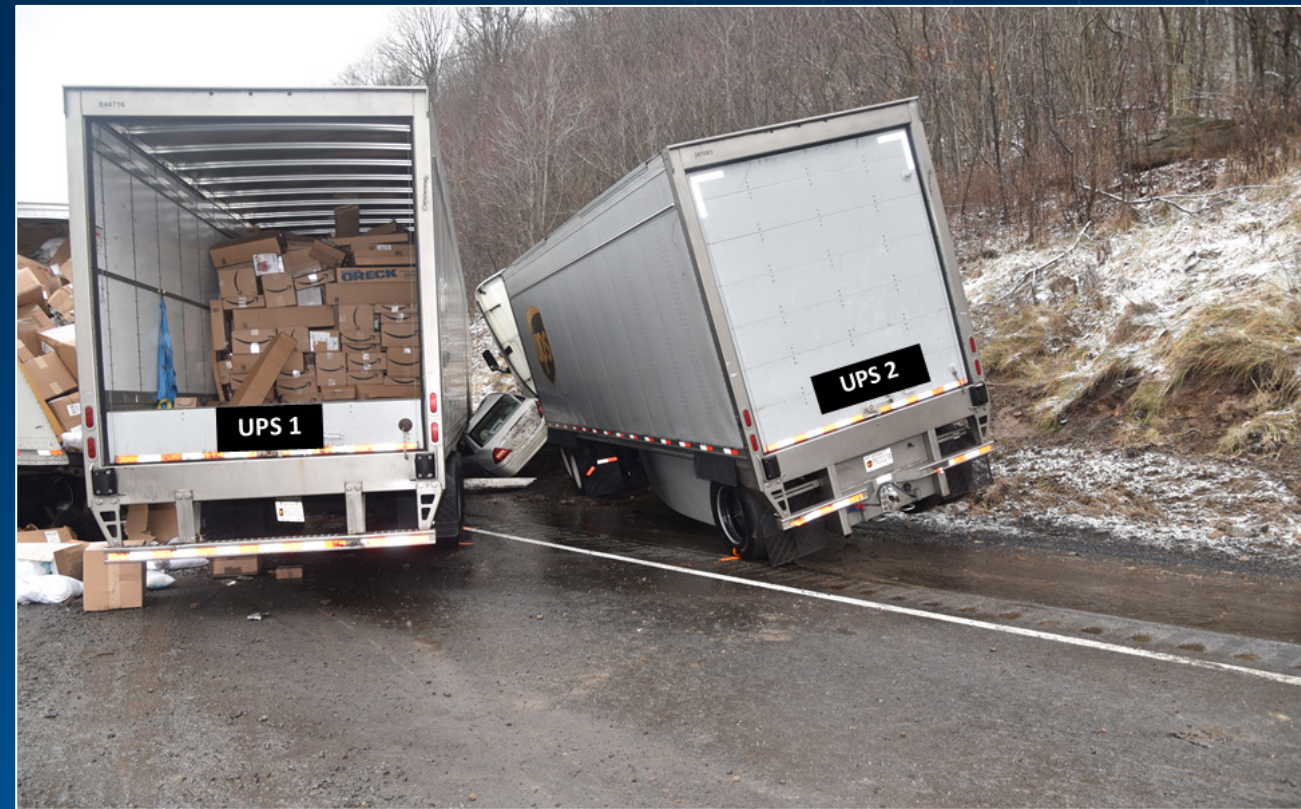
UPS-2 Driver Response

- UPS-2 entered curve at 69 mph
- UPS-2 3–5 seconds behind UPS-1
- Driver observed UPS-1 collision
- Driver applied brakes, steered right
- UPS-2 came to rest next to sedan

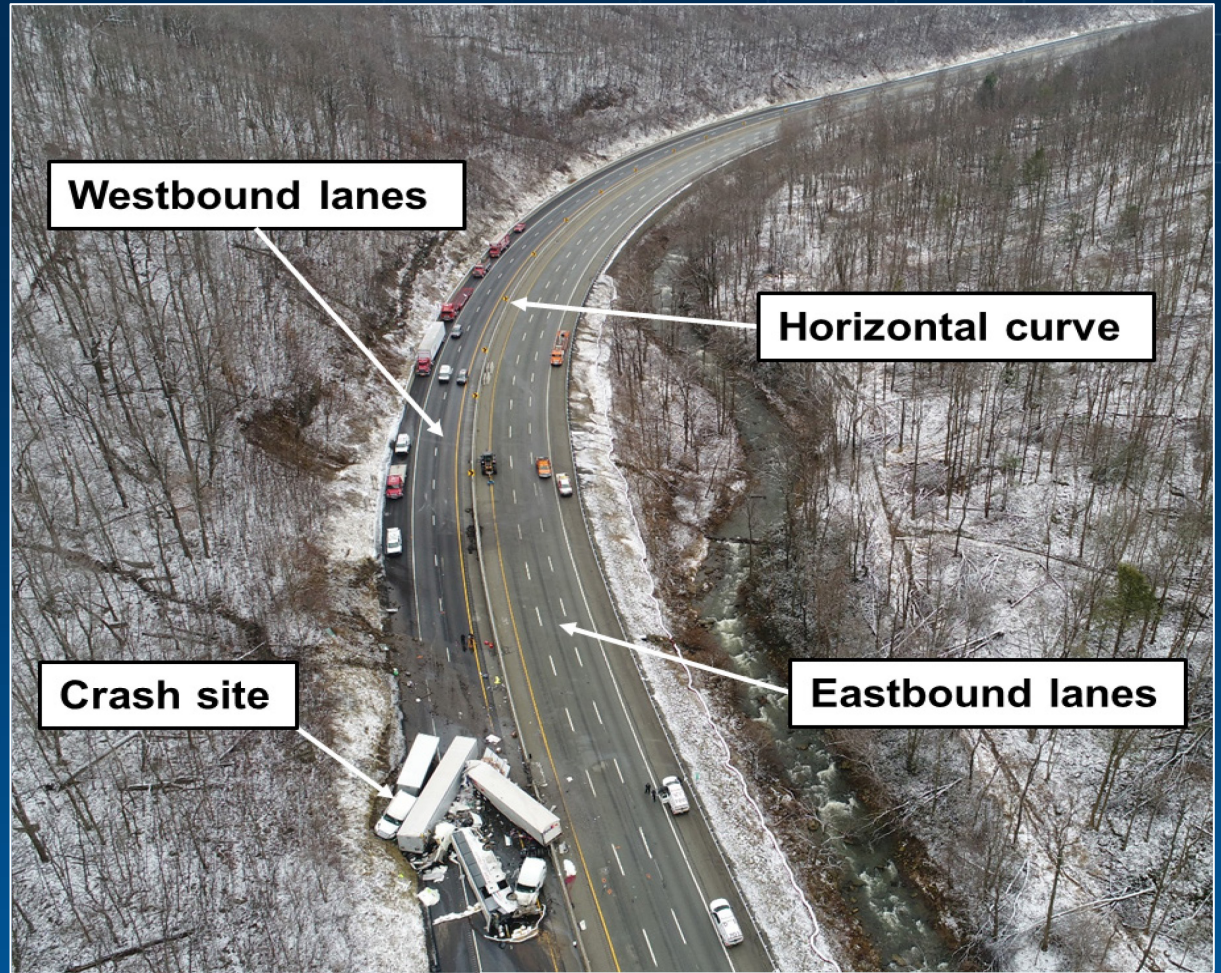
Highway Characteristics

- Turnpike
 - Built in 1940
 - Numerous horizontal curves
 - Crash occurred in westbound lanes
- Horizontal curve
 - Downgrade slope of 3 percent
- Grooved rumble strips
- Resurfaced in September 2019

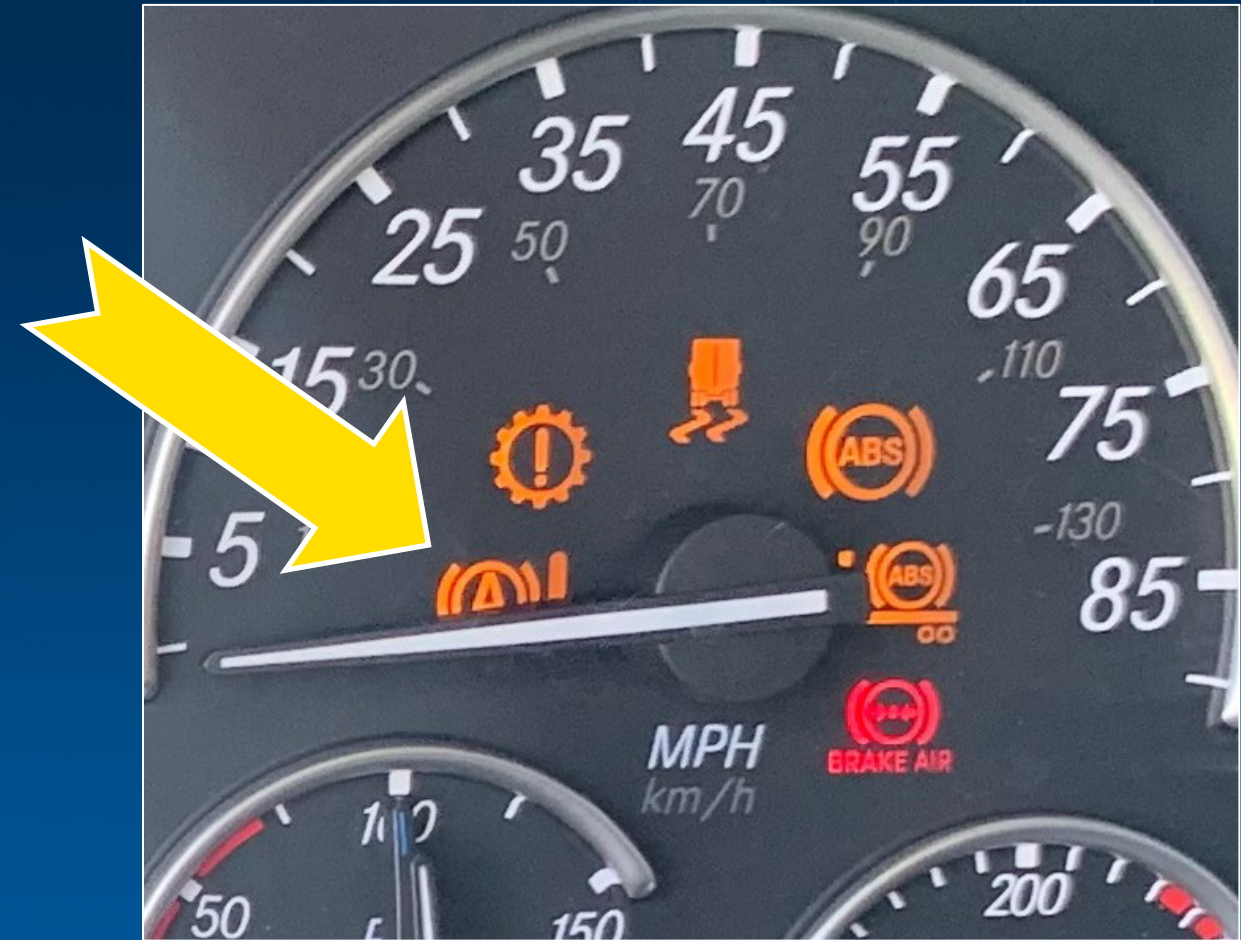
Driver Vehicle Inspection Reports from UPS Truck 1

- UPS Truck 1 – misaligned radar sensor
- Error code and warning since June 2019
 - Detected by Penske in July 2019
 - Noted several times on maintenance records
 - No Driver Vehicle Inspection Report (DVIR) entry by driver

- Penske
 - Places vehicle with Forward Collision Avoidance System defects out of service
 - Lessor receives notification email
 - Between May 2020 and December 2021, over 6,300 vehicles affected
- UPS
 - Changed driver training
 - Changed check ride form to account for advanced safety systems
