## **NATIONAL TRANSPORTATION SAFETY BOARD**

# **AIRFRAME AND ENGINE EXAMINATION**

**WPR16FA036**

Location: Hurricane, Utah  
Date: December 10, 2015  
Aircraft: Amateur Built – Experimental Barnett Allen RV7,  
N307AB, Serial #: 73395  
NTSB IIC: Albert Nixon

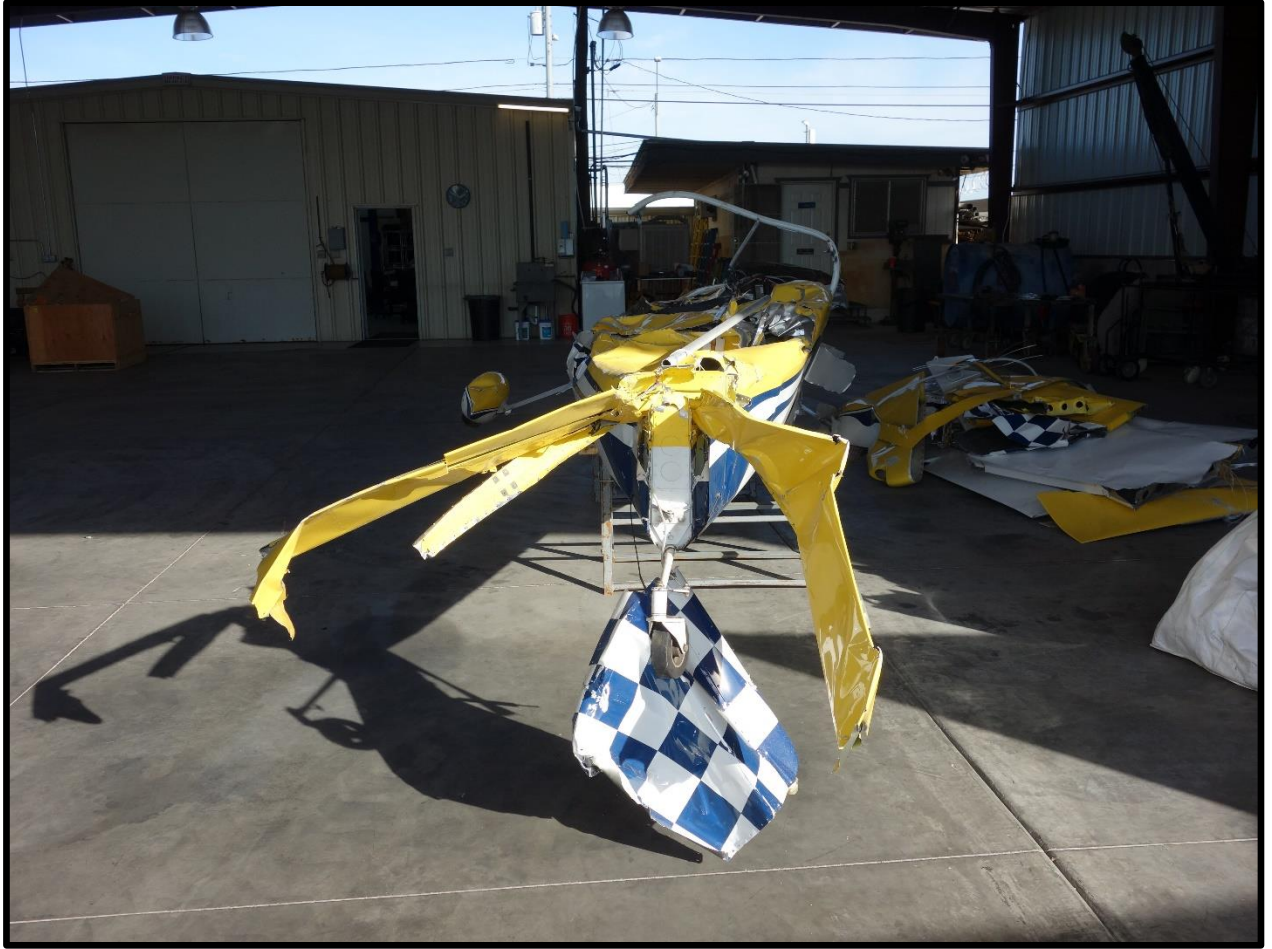
Examination of the airframe revealed the wings were removed for recovery. The fuselage was crushed from the top. The left wing was separated about mid-span and wrinkling and deformation was observed on most of the wing. The right wing was mostly intact and wrinkling was observed throughout the wing. The main gear struts remained attached and the right landing gear strut was bent aft. On the empennage section, the horizontal stabilizers were bent downwards. Flight control continuity was established through the cables.

**Figure 1: View of empennage section.**

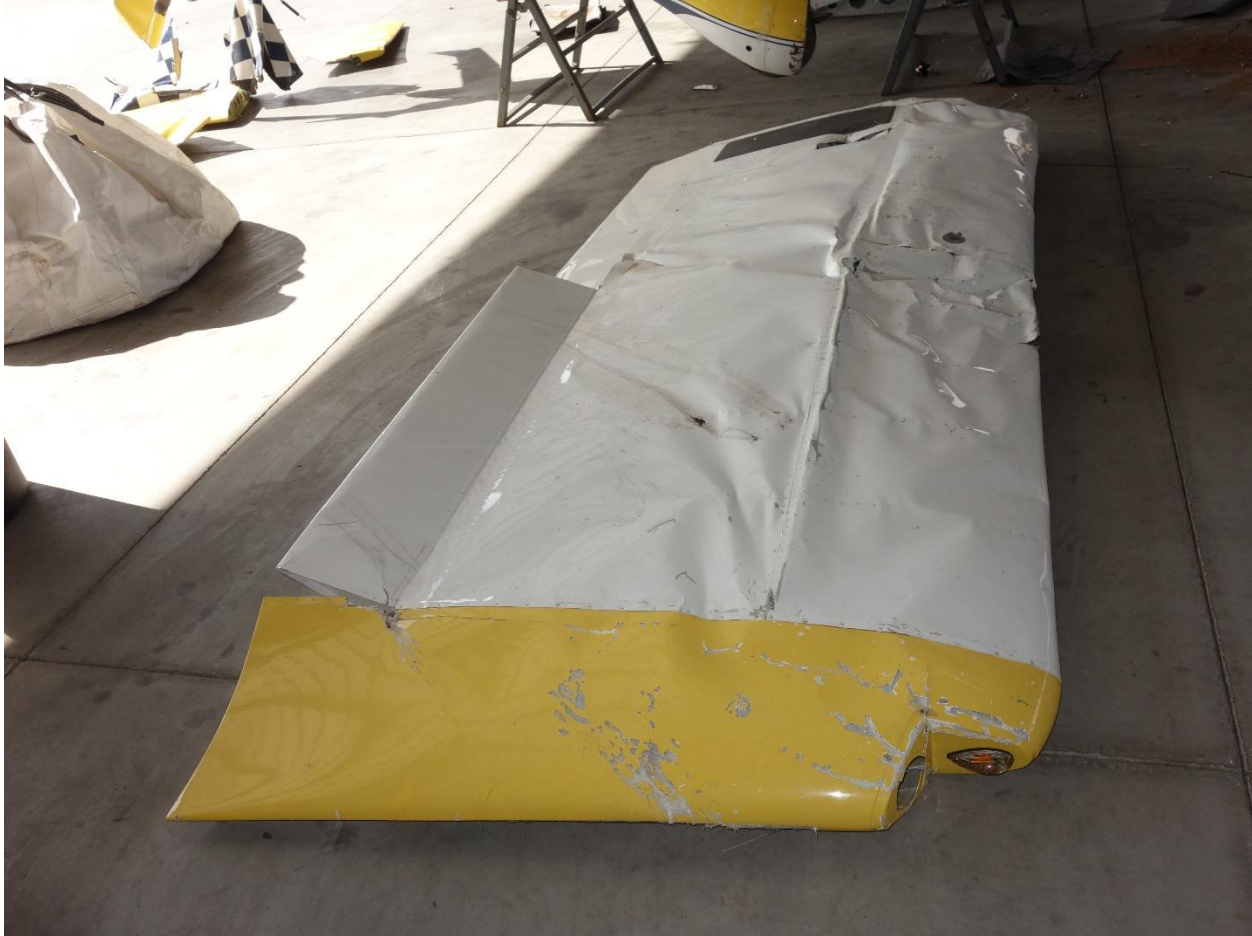
**Figure 2: View of the right wing.**

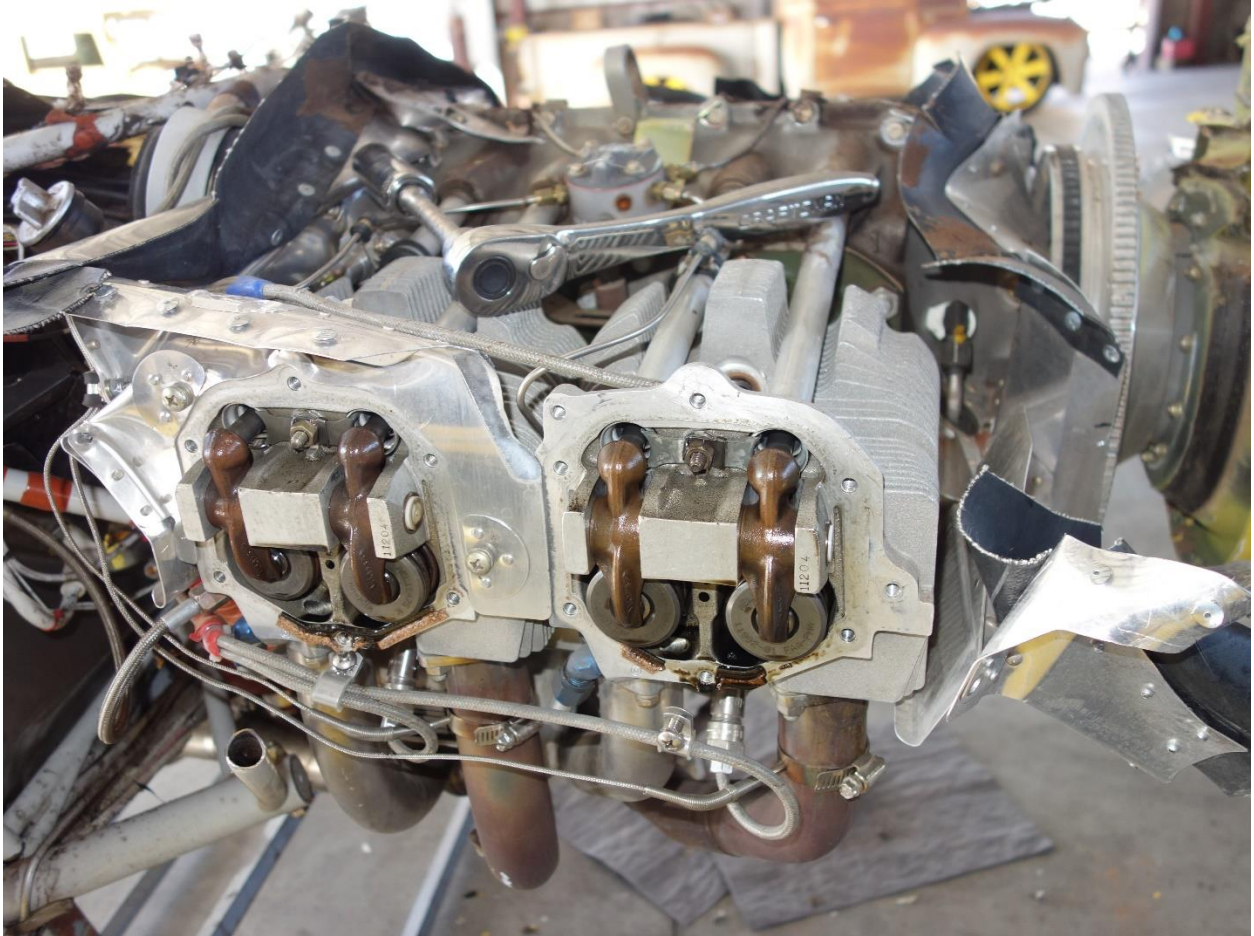
Examination of the ECI/Titan IO-360 engine, serial number 09-70 revealed that it remained attached to the airframe by the engine mounts. The engine accessories remained attached to the engine via their respective mounts. All rocker covers were removed and the cylinder overhead areas were lubricated and unremarkable. The oil quantity stick read about 3 gallons. The crankshaft was unable to be rotated by hand utilizing the propeller due to impact damage to the top of the engine. A borescope inspection of the cylinders revealed evidence of normal operational conditions.

**Figure 3: View of engine from the right side.**

The examination of the engine revealed no evidence of mechanical malfunctions or failures that would have precluded normal operation. No additional anomalies were observed on the airframe, than those that were noted at the accident site.
