NATIONAL TRANSPORTATION SAFETY BOARD

Group Chairman's Factual Report

WPR16FA036

**Appendix A – Figures
(5 pages)**

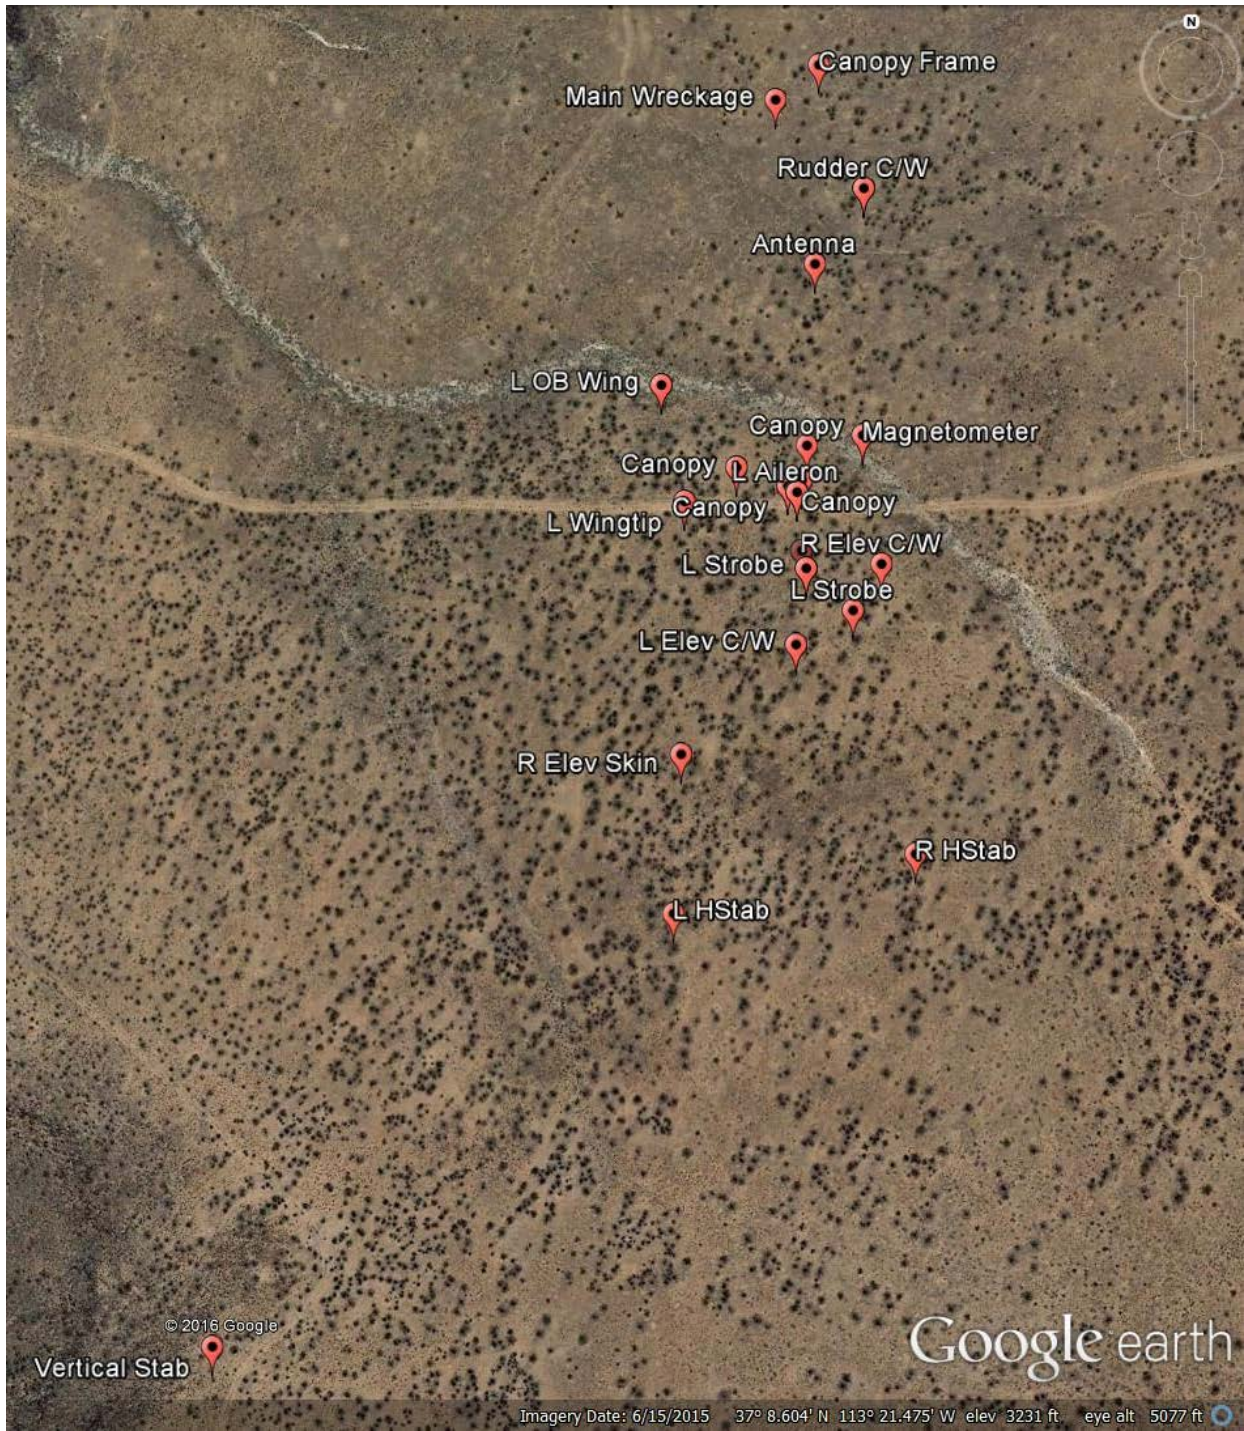
Figure 3 – N307AB Debris Field

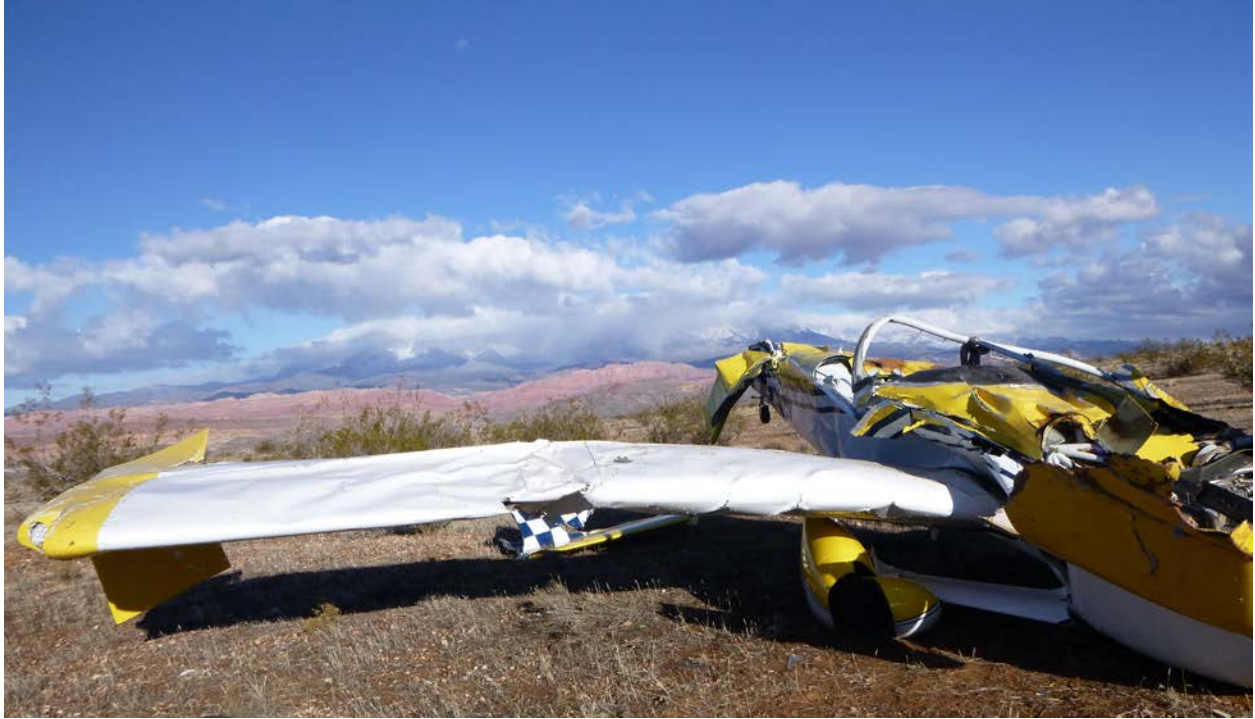
Figure 4 – Right wing deformation

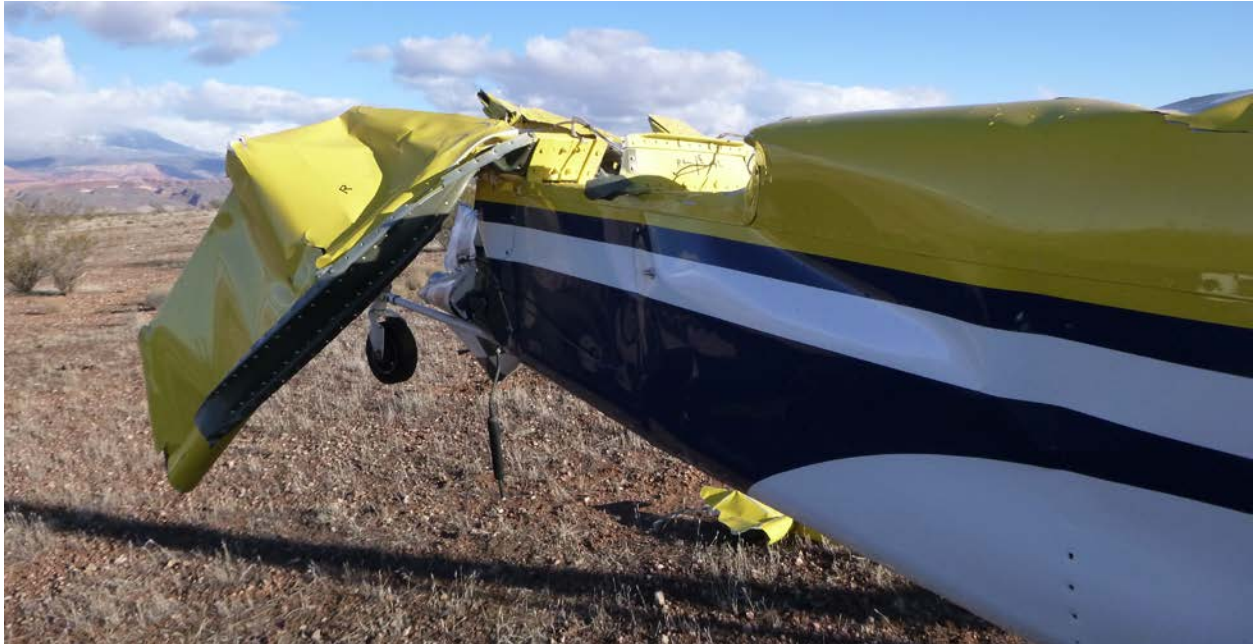
Figure 5 – Right side of empennage

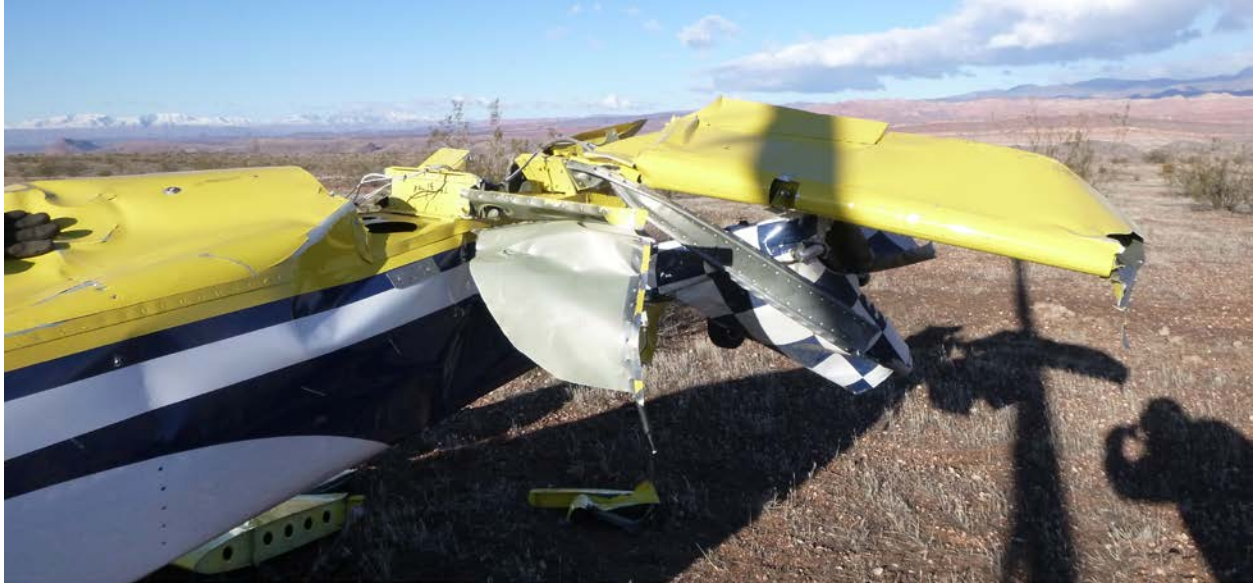
Figure 6 – Left side of empennage
