# National Transportation Safety Board

WPR16FA036

Structures Group Chair's Factual Report - Addendum

Location: Hurricane, Utah  
Date: December 10, 2015  
Time: 1347 Mountain Standard Time (MST)  
2047 Coordinated Universal Time (UTC)  
Airplane: Van's Aircraft, Inc. RV-7

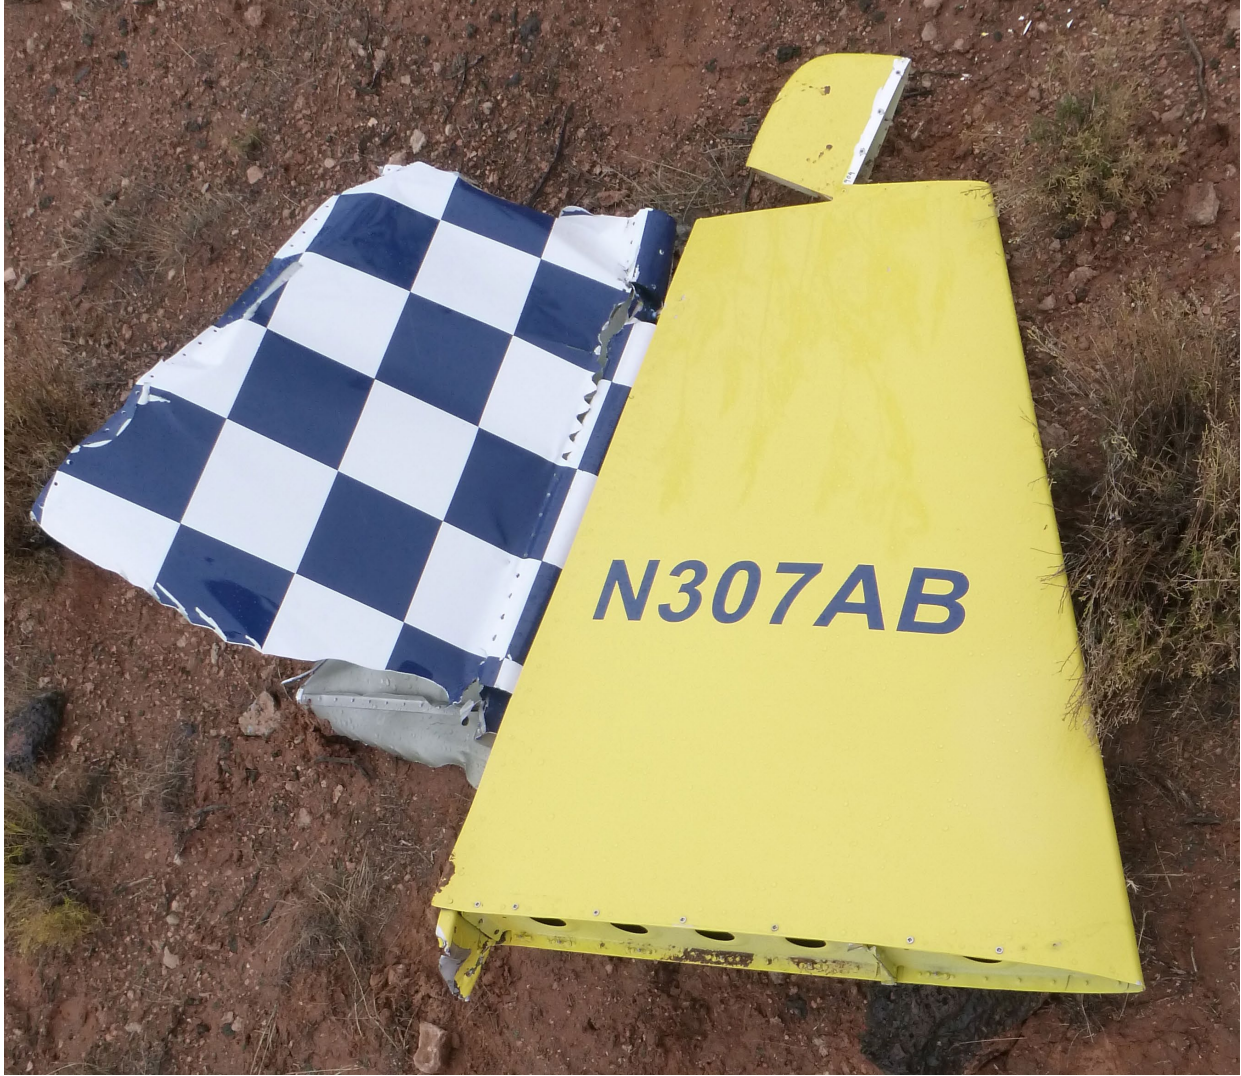
The vertical stabilizer separated from the airplane during the accident sequence and had the upper portion of the rudder attached (Figure 1). The vertical stabilizer was mostly intact with little damage. The composite tip cap remained partially attached to the upper end. The forward spar was fractured just above its attachment to the horizontal stabilizer front spar. The rear spar was fractured and twisted just above the stabilizer shelf consistent with the vertical stabilizer separating leading edge left. Most of the upper half of the rudder remained attached at the upper and center hinge points. The rudder trailing edge was splayed open, and the trailing edge strip remained attached to the left rudder skin. There was evidence of sealant between the rudder skins and trailing edge strip. The rudder was fractured spanwise just below the center hinge. The rudder counterweight was separated from the upper end of the rudder just above the upper skin stiffeners (Figure 2). The lower half of the rudder remained attached to the empennage and both rudder cables were attached. The trailing edge was splayed open, the trailing edge strip remained attached to the left rudder skin, and there was evidence of sealant between the rudder skins and trailing edge strip.

**Figure 1.** Separated vertical stabilizer and upper rudder (NTSB photo)

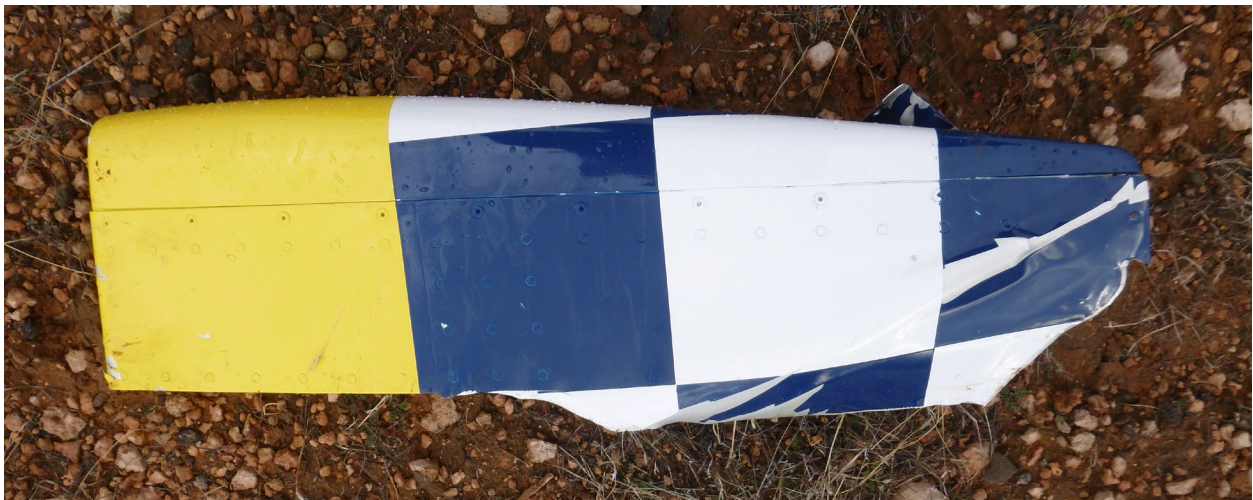
**Figure 2.** Separated rudder counterweight (NTSB photo)
