# National Transportation Safety Board

WPR16FA036

## **ONBOARD IMAGE RECORDER**

Location: Hurricane, Utah  
Date: December 10, 2015  
Time: 13:47 mountain standard time (MST)  
Airplane: Van's Aircraft RV7, N307AB

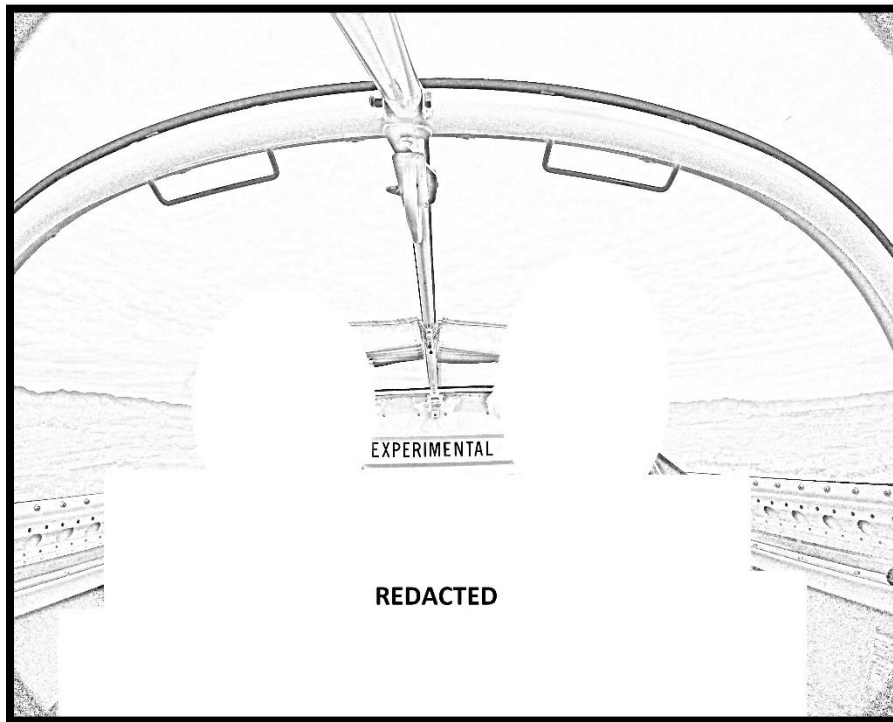
**Figure 1.** A digital illustration based on one of the images captured in the sequence. The occupants have been redacted.

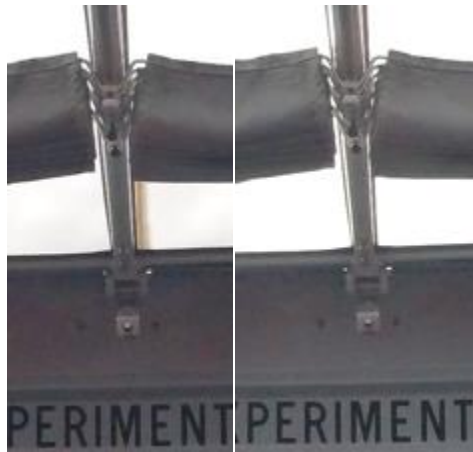
- Airplane roll attitude was about 25° left bank.
- Airplane pitch attitude appeared nose down with horizon intersecting aft left canopy rail on left side.
- The yellow vertical stabilizer was not visible on the left side of the center canopy bow. Figure 2 shows the location of the vertical stabilizer in photo 26, next to it is a screen shot of the same location in photo 27. The photo has been cropped in such a way that the occupants have been redacted.
- Terrain was visible out the left side.
- Pilot and passenger both looking forward with eyes open.

**Figure 2.** A comparison of the location of the vertical stab in photo 26 (left) and photo 27 (right). In photo 26, the yellow vertical stab is visible, in photo 27 it is absent.
