NATIONAL TRANSPORTATION SAFETY BOARD
Vehicle Recorder Division
Washington, DC 20594

Onboard Image Recorder

Specialist's Factual Report
By Sean Payne

Location: Hurricane, Utah
Date: December 10, 2015
Aircraft: Vans Aircraft RV-7, N307AB
Operator: Private
NTSB Number: WPR16FA036

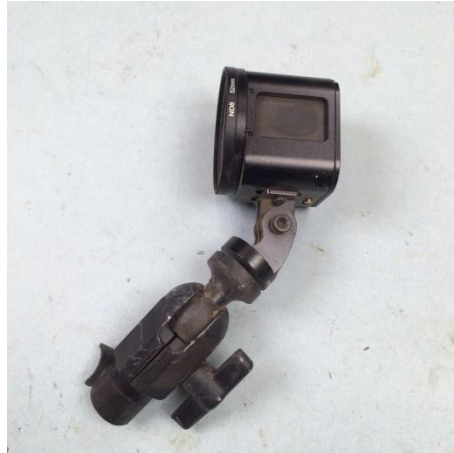
Upon arrival at the NTSB Vehicle Recorder Division, it was evident that the GoPro Hero 4 Session and the associated mounting hardware had sustained significant impact damage (figure 1). The associated mounting hardware was broken at the attach point. The associated circular filter was shattered. The Hero 4 Session was extracted from the mounting hardware and found to be intact (figure 2). The 64 GB micro SD card was found intact and seated securely in the device's memory card slot (figure 3). The micro SD card is shown extracted from the device in figure 4.

Figure 1. The GoPro Hero 4 Session in the associated mounting hardware.

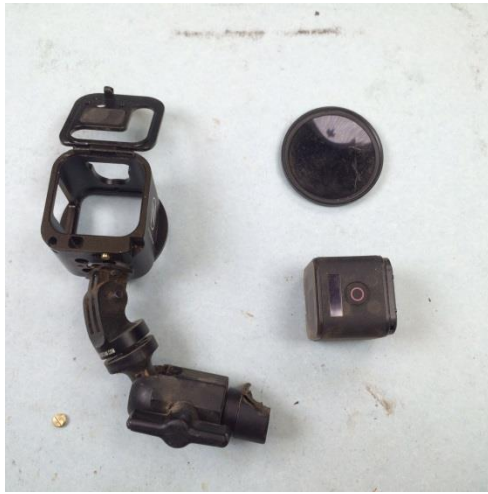
Figure 2. The GoPro Hero 4 Session removed from the mounting hardware.

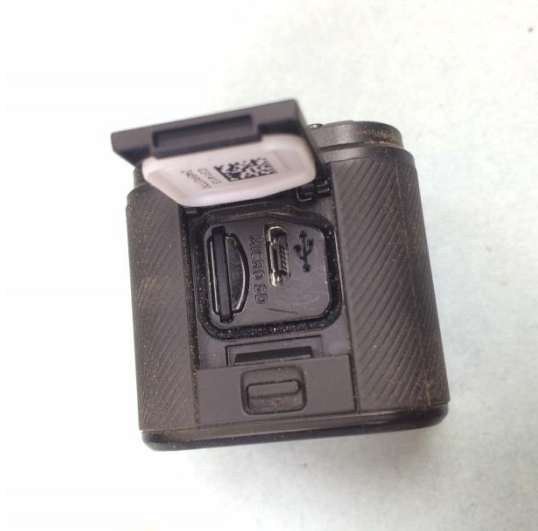
Figure 3. The micro SD card as recovered, seated properly in the device.

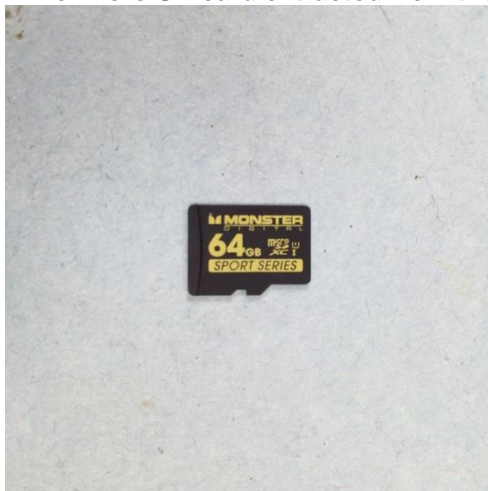
Figure 4. The micro SD card extracted from the device.
