NATIONAL TRANSPORTATION SAFETY BOARD  
Office of Aviation Safety  
Washington, D.C. 20594

**SURVIVAL FACTORS SPECIALIST'S FACTUAL REPORT**

Aircraft : Airbus EC130 T2 [N11VQ]  
Operator : Blue Hawaiian Helicopters  
Location : Kauai, HI  
Date : January 17, 2016  
Time : 1435 Hawaii standard time (HST)<sup>1</sup>  
NTSB # : WPR16FA055

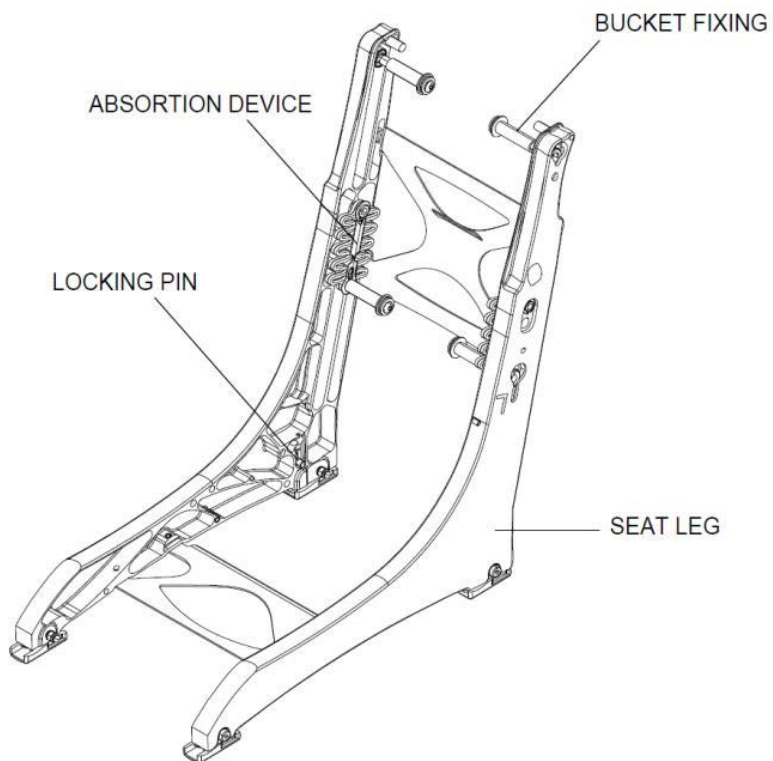
**Figure 4. Structural elements of the seat legs and seatback supports.**

Both T198 and T284 seats consisted of a composite bucket affixed to a structural frame composing both the seat legs and seatback supports. The seatback supports contained energy absorbing features in order to meet the requirements referred to in 14 CFR sections 27.785, 27.561, and 27.562. Corrugated absorption devices and fuses<sup>4</sup> were built into either side of seatback supports (total of two in each seat) to absorb energy in event of high vertical loading (see figures 4 and 5). The composite seat bucket was affixed to the seat frame on a set of tracks via two “bucket fixings” and plastic bushings (rollers). When subjected to high vertical loads, these features allowed the bucket to move downwards while the absorption devices deformed (i.e. stretched) and absorbed vertical energy (see figure 6). The undeformed dimension of the absorption devices was 10.7cm.

<sup>4</sup> Fuses were metal links that fractured once a specified amount vertical force was experienced allowing the seat to stroke downward.

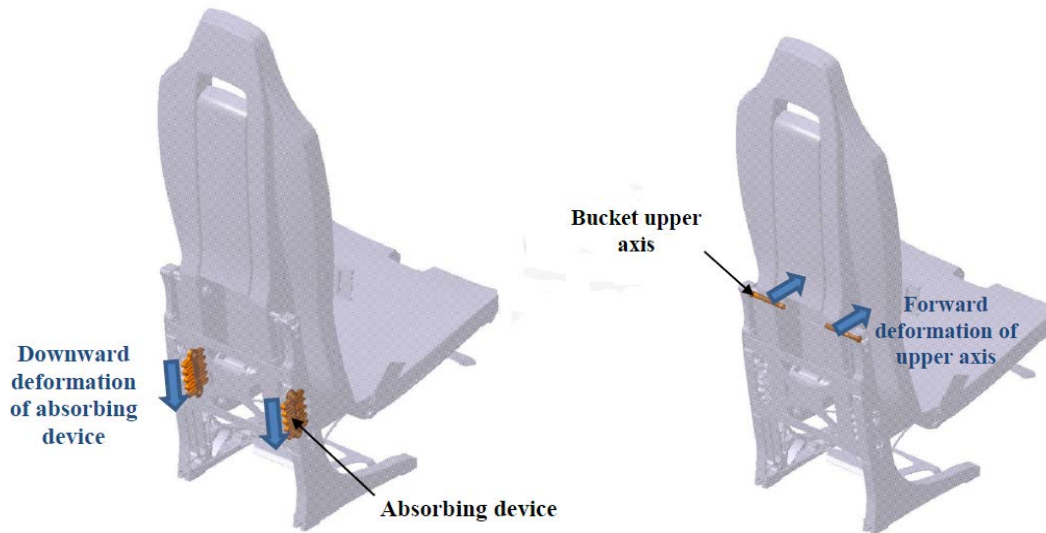
**Figure 7. Two types of deformation observed during the accident.**

The seats were documented in situ and then removed from the helicopter for additional examination. All seats were correctly installed according to Airbus and Zodiac technical representatives. Two major types of deformation were observed: downward deformation affecting the length of the absorption devices and forward deformation of the upper seat axis (see figure 7).

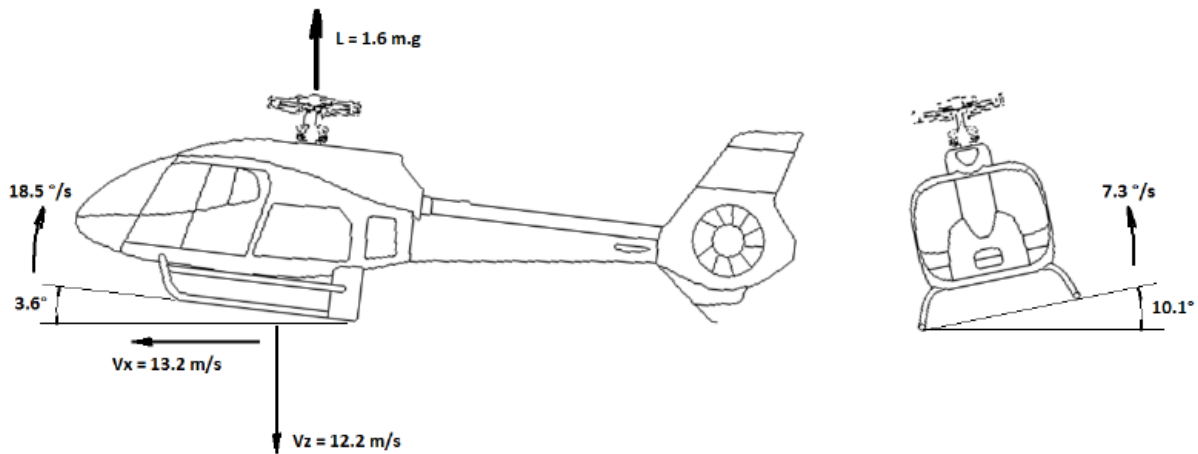
**Figure 10. Initial impact conditions based on GPS data and Appareo 1000 data.  
(Courtesy: Airbus)**

Airbus provided the NTSB with the results of an in-depth simulation of the helicopter's impact with the sand. According to the simulation the helicopter likely experienced two impacts. The helicopter initially struck the sand with a vertical velocity of 40 feet/second (12.2 meters/second) with a 10.2 degree right roll and 3.6 degree nose-up attitude (see figure 10).

Analysis of on-scene photographs indicated that the right skid deformed and dug into the sand approximately 50 cm. The simulation indicated that the helicopter then likely rebounded and bounced approximately 21.3 feet (6.5 meters) at a 16-degree angle. Load factors at the center of gravity for the initial impact were determined to be 9g horizontal, 4g lateral, and 24g vertical. The load factors of the second impact (after the bounce) were determined to be 7g horizontal, 1g lateral, and 19g vertical.

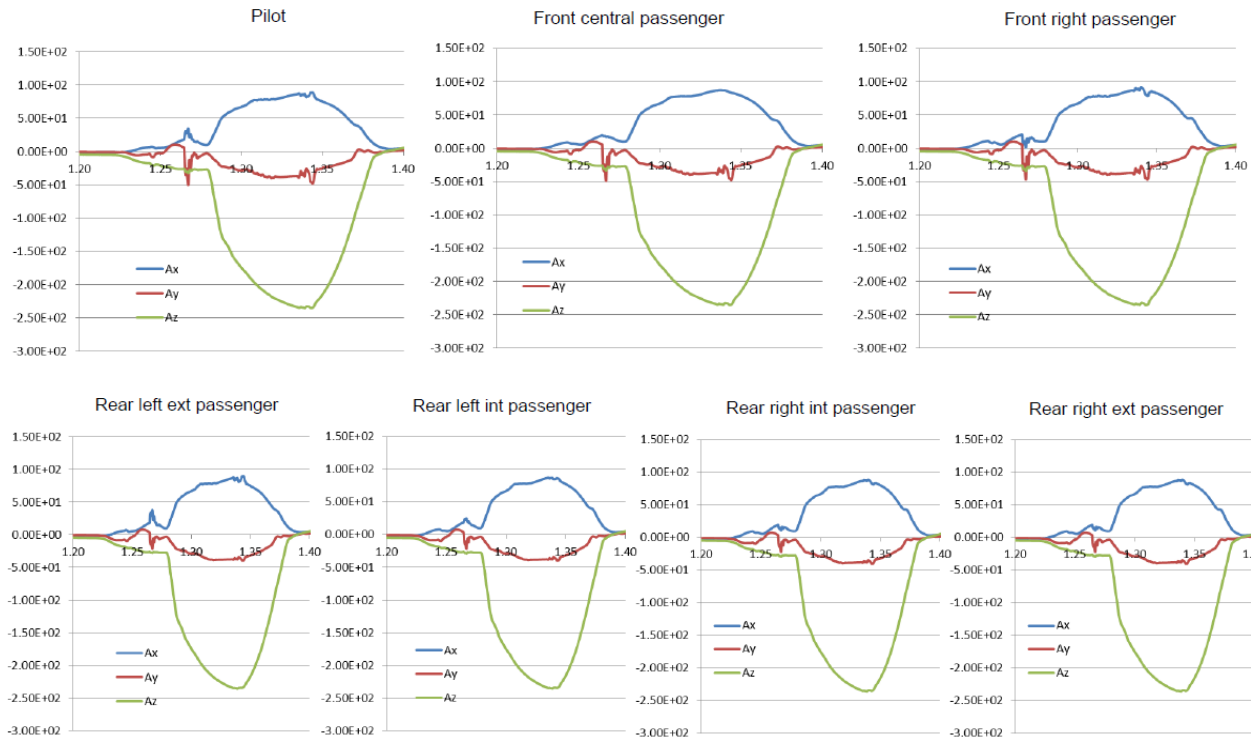
**Figure 11. Calculated occupant accelerations during impact (Courtesy: Airbus)**

Based on this simulation, Airbus also produced plots of the occupants' acceleration in the different seating positions of the helicopter (see figure 11).
