NATIONAL TRANSPORTATION SAFETY BOARD

Accident Site Examination Report

WPR18FA211

Location: Santa Ana, CA
Date: August 5, 2018
Aircraft: Cessna 414, Registration Number: N722RP, Serial #: 414-0385
NTSB IIC: Albert Nixon

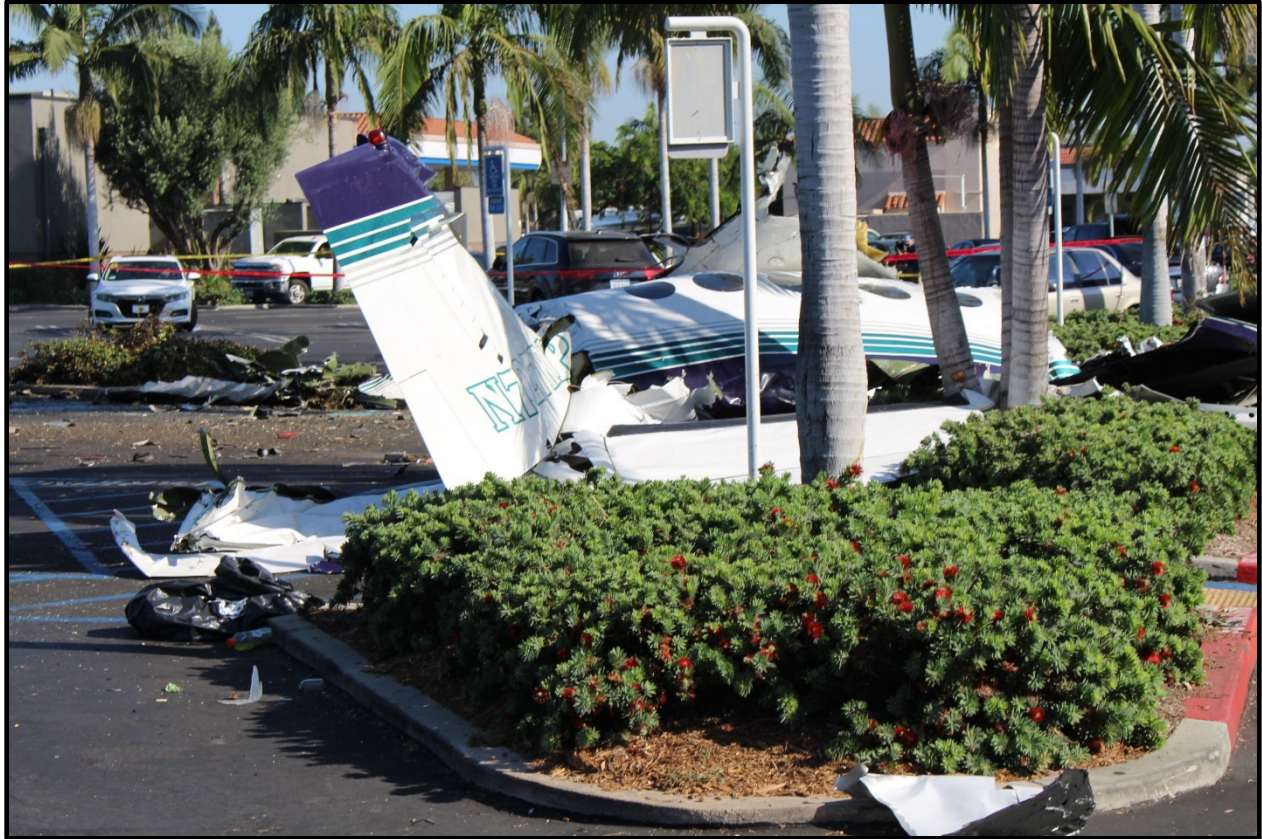
The main wreckage consisted of the fuselage, right engine, right wing, and empennage. The fuselage was slightly canted to the left. The empennage was mostly separated from the fuselage but remained attached by the control cables. The front of the aircraft and cabin area was destroyed during impact. The cabin door remained attached.

Figure 1: Airplane wreckage in parking lot (Right side).

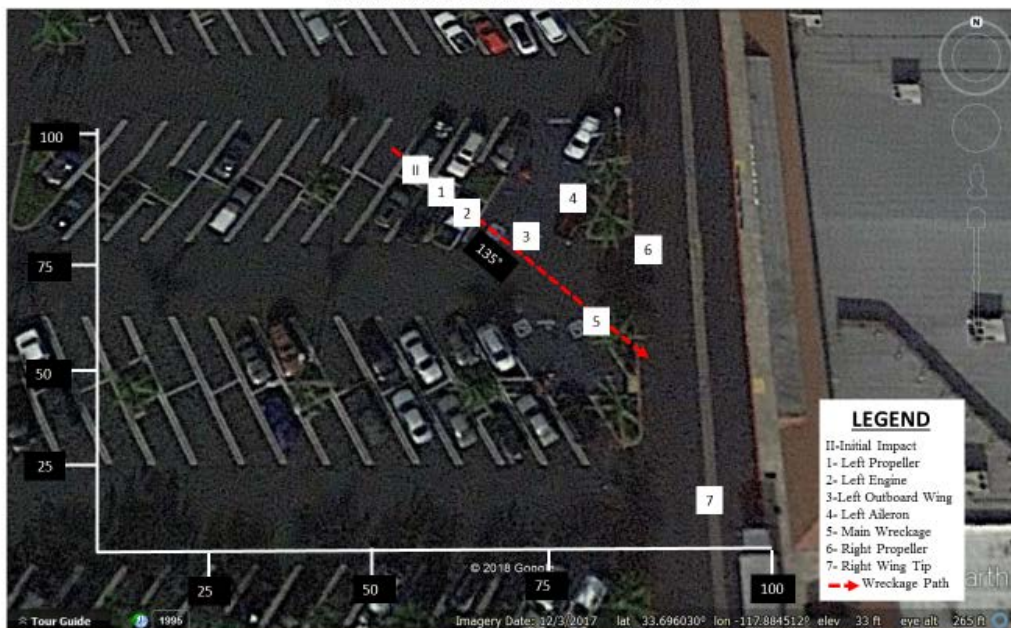
The airplane was examined at the accident site by investigators from the National Transportation Safety Board (NTSB), Continental Motors, and Textron Aviation. The airplane impacted a parking lot about 1.6 miles northwest of the SNA airport. The wreckage was contained within about 150 ft debris trail and the main portion of the wreckage came to rest between the first piece of identified wreckage and the last piece of identified wreckage. The first piece of identified wreckage was the left-wing tip which was located about 90 ft from the main wreckage. The last piece of identified wreckage was the right-wing tip which was located about 60 ft from the main wreckage.

Figure 3: Accident site debris trail.
