**NTSB File No.:** WPR18FA211

**Aircraft:** Cessna 414

**PROPELLER EXAMINATION REPORT**

**Propeller Model(s):** PHC-C3YF-2UF with FC7693DFB blades

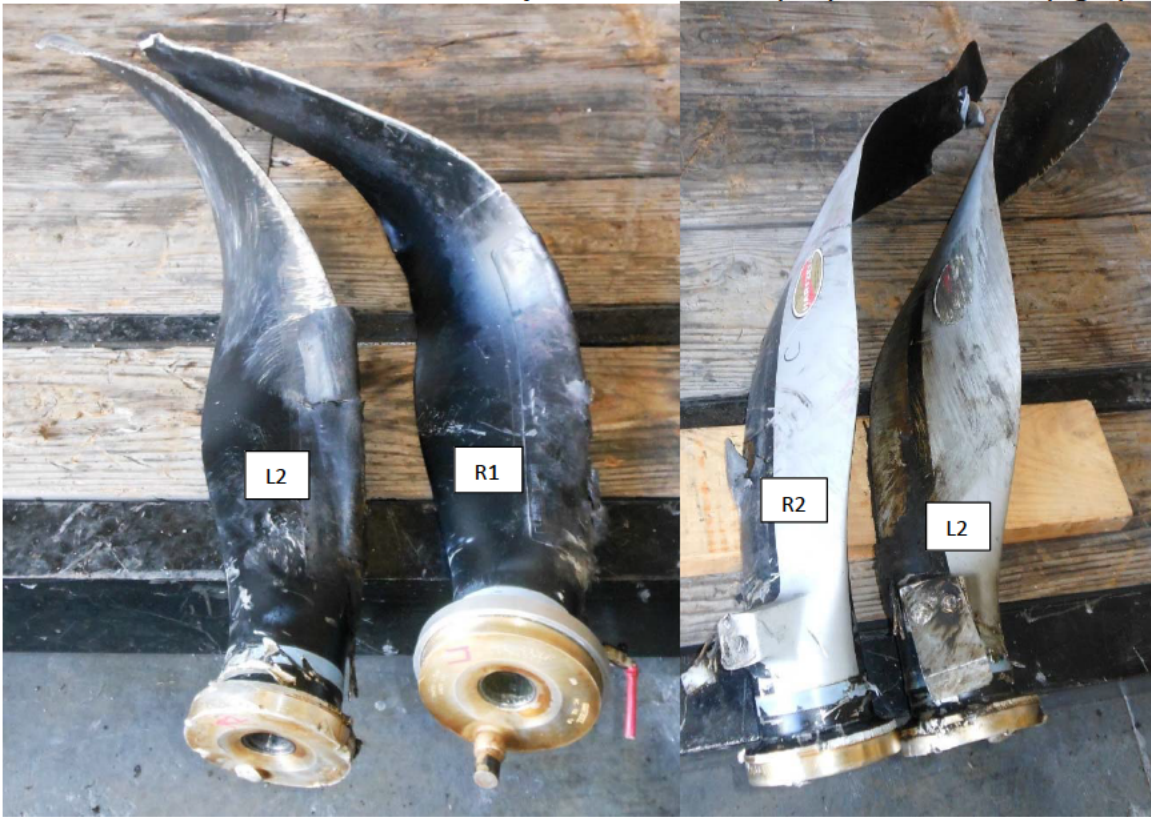
Damage to both left and right propellers was similar. Leading edge gouging and chordwise/rotational scoring indicated rotation. Blade bending and twisting characteristics also suggested rotation at impact. Photo #1 shows the relative bend and twist damage between left and right propeller blades suggesting power symmetry. One blade retention pocket on each propeller (L2 and R2) fractured in a helical direction; aft and opposite rotation (Photo #2).

Overall, the degree of blade bending and twisting was similar between left and right propellers suggesting power symmetry at time impact. Chordwise/rotational scoring, leading edge gouging and blade retention pocket fractures indicated rotation at time of impact. Internal impact marks indicated the propeller blade angle was in the low range of normal operation during the impact sequence. In total, the damage suggested a power ON condition on both propellers at time of impact.

**Photo #1 – Relative bend/twist comparison L2 vs. R1 (left) and R2 vs. L2 (right)**

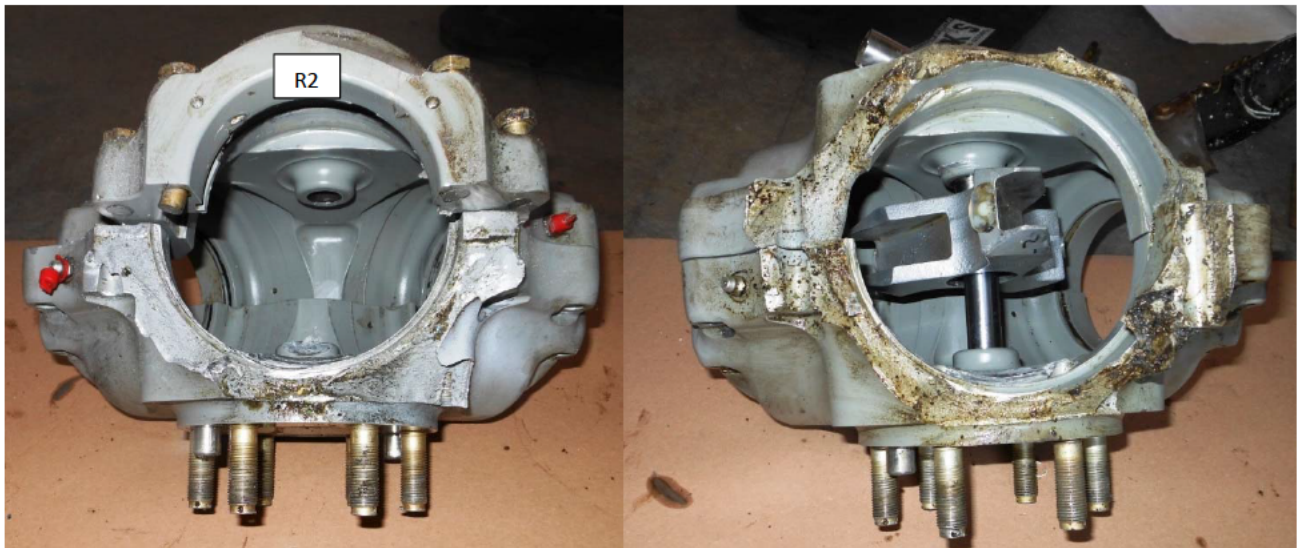
**Photo #2 – Blade retention pocket fracture comparisons  
(R2 pocket on left vs. L2 on right)**

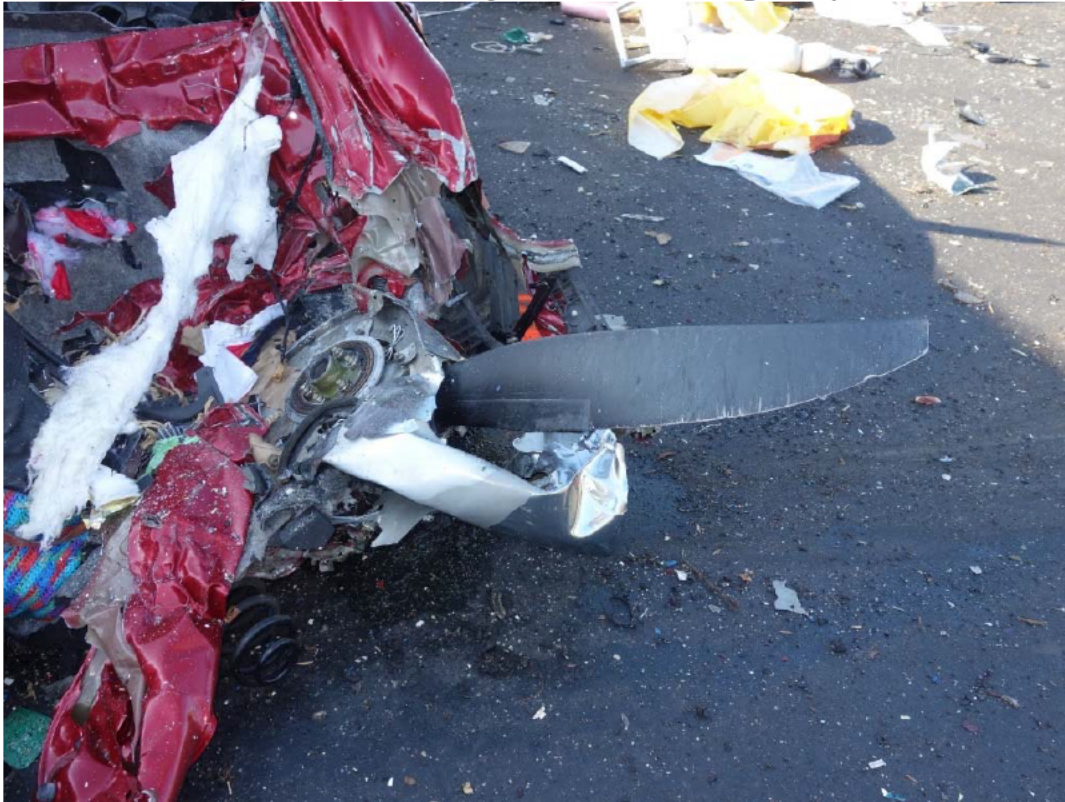
**As Received Condition:** The propeller impacted a red, 2013 Chevy Malibu Eco and fractured from the engine crankshaft during the impact sequence. It lodged in the trunk area of the car at the crash scene as shown in Photo #3. The propeller blades appeared to make multiple cuts through the car sheet metal during the impact sequence. The propeller was recovered to a hangar at Chino Airport for examination as shown in Photo #4. R1 and R2 blades were bent aft, opposite rotation and twisted towards low pitch. Blade R1 had approximately 4-5" of the tip fracture-separated. Blade R2 had a large leading edge gouge. The hydraulic unit fractured from the hub unit (seen in Photo #6) and was not presented for examination. The R2 blade retention pocket was fractured in a helical path direction (aft/opposite rotation direction) as shown in Photos #5 and #6. The R2 counterweight fracture-separated and was not presented for examination. There was distinguishable chordwise/rotational scoring on the camber side of all three blades. Blade R3 also exhibited chordwise/rotational scoring on the face side. There was also leading edge gouging with material deformation towards low and high pitch. One of the three pitch change knobs was fractured.

**Photo #3 – Right propeller in-situ embedded in car  
(Photo provided by on-scene investigators)**

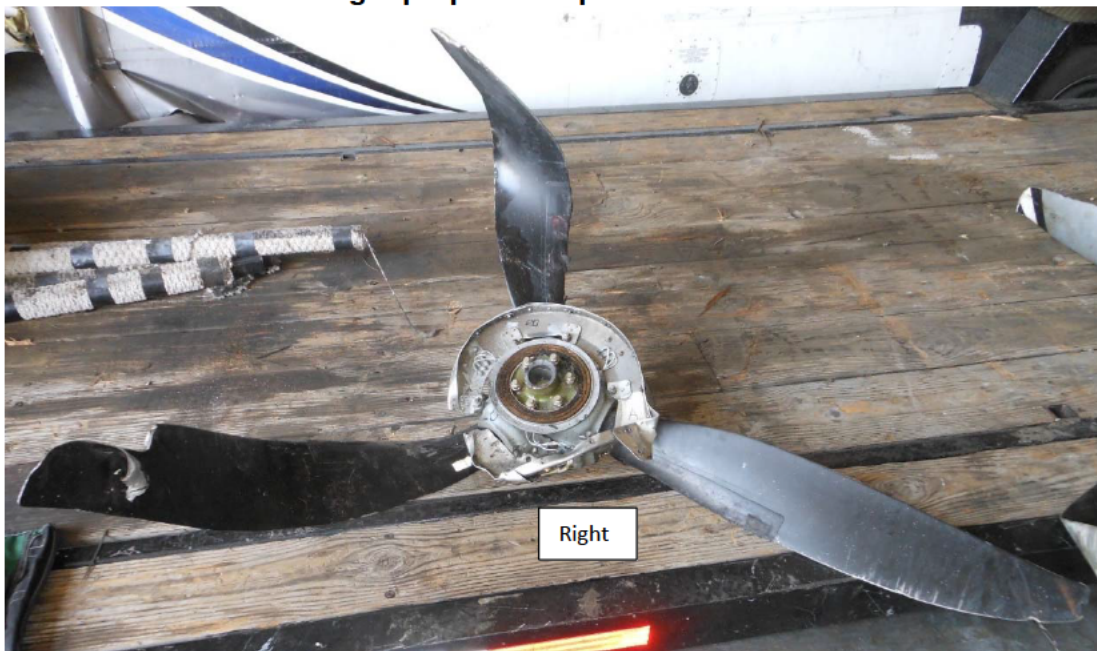
**Photo #4 – Right propeller as-presented for examination**

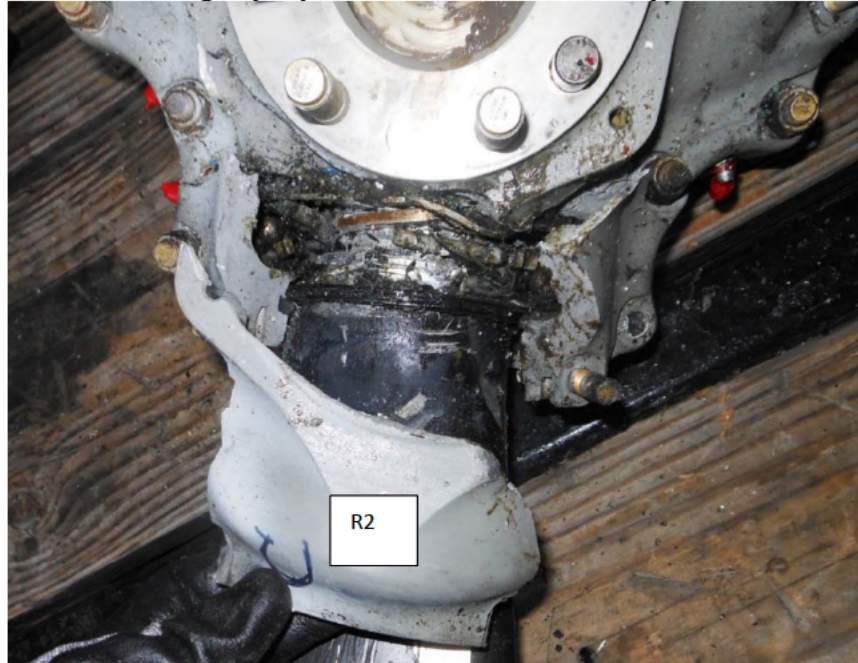
**Photo #5 – Right propeller R2 blade retention pocket fracture**

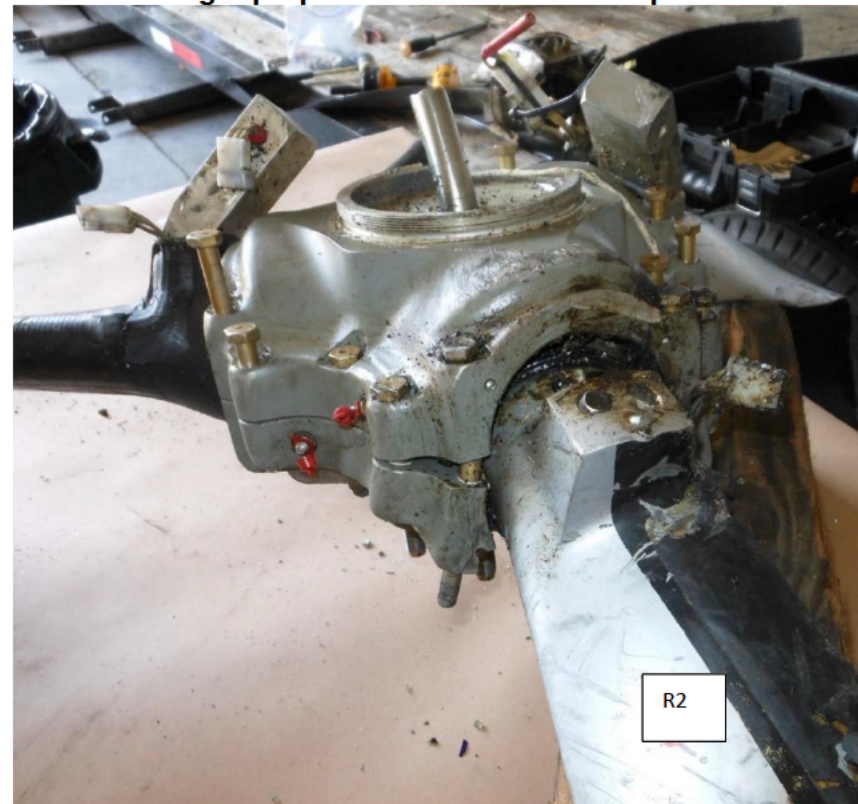
**Photo #6 – Right propeller R2 blade retention pocket fracture**

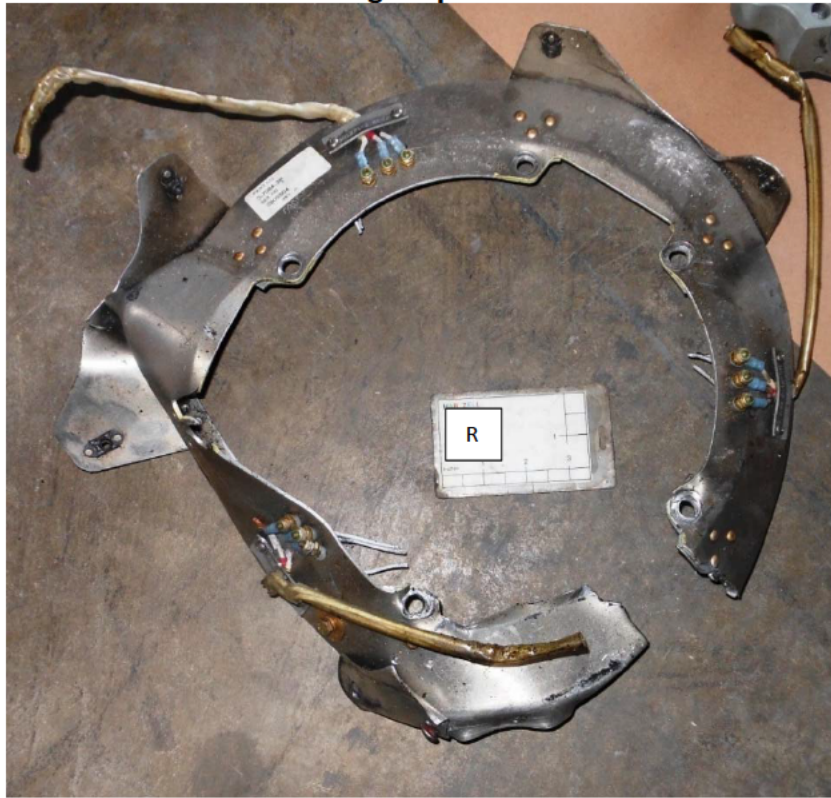
**Spinner Bulkhead:** The spinner bulkhead was bent and torn as shown in Photo #7.

**Photo #7 – Right spinner bulkhead**

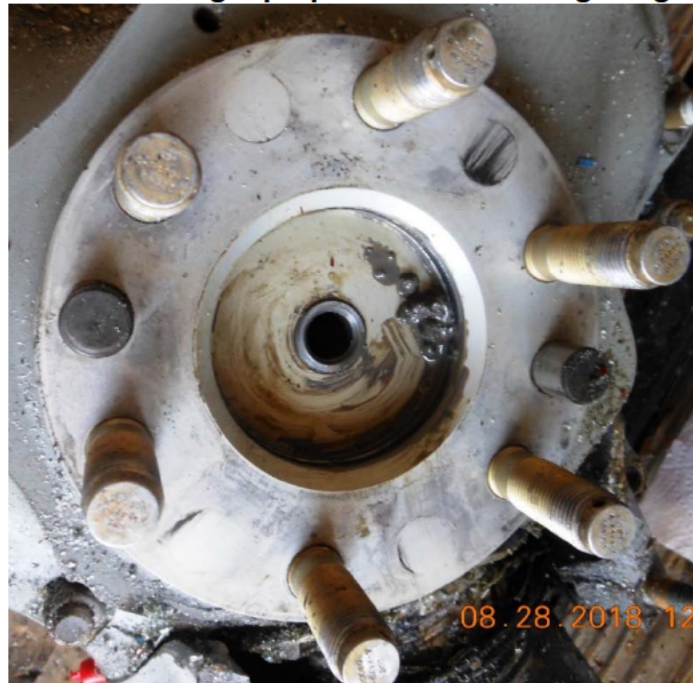
**Engine/Propeller Mounting:** There appeared to be small, hard, cube-like fragments in the propeller hub mounting bore. The fragments were covered in oil/sludge, collected, bagged and left with the other mounting hardware. The crankshaft flange remained attached to the propeller flange and the fasteners were tight. The mounting flange appeared intact and undamaged

**Photo #8 – Right propeller/hub mounting flange**

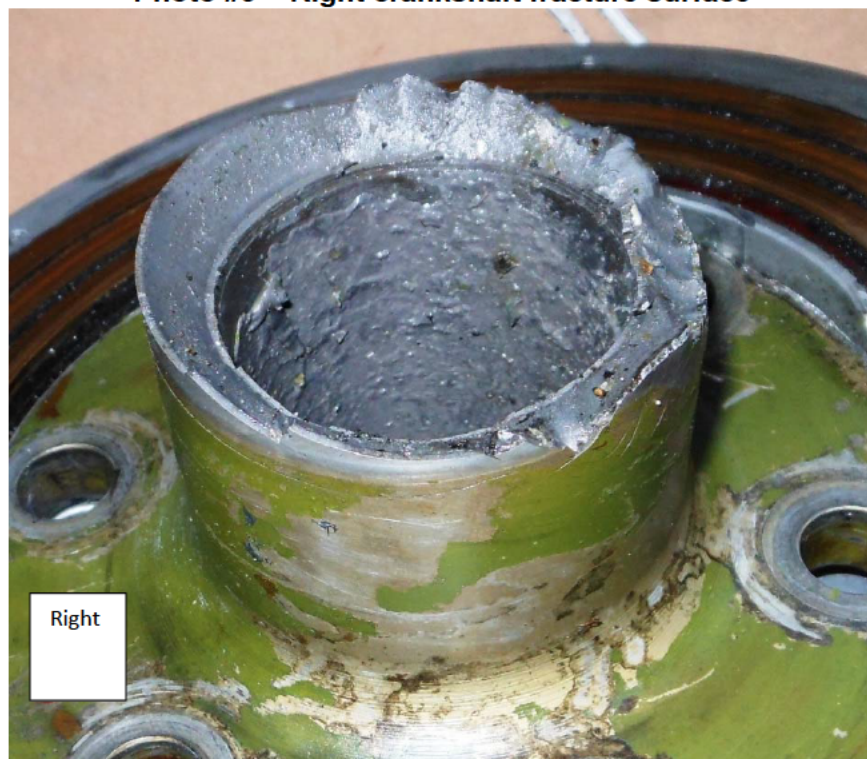
(Photo #8). The crankshaft flange fracture appeared to have some ratchet-like fracture patterns suggesting applied torque at the time of fracture (Photo #9).

**Photo #9 – Right crankshaft fracture surface**

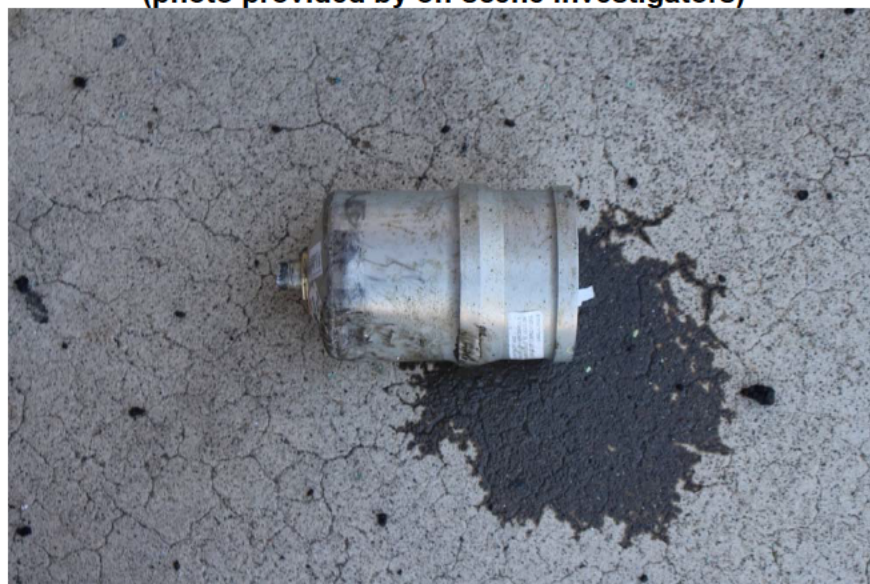
**Hydraulic Unit:** The hydraulic unit consisting of the cylinder, piston, forward pitch change rod, pitch stops (low, feather and start lock), air valve, feathering spring and guides fracture-separated from the propeller assembly during the impact sequence. The hydraulic unit was not presented for examination. Review of the on-scene photos showed the separated hydraulic unit on a sidewalk adjacent to a building in the wreckage path as shown in Photo #10. The cylinder was mostly intact with what appears to be some residual servo oil leaking from it.

**Photo #10 – Right hydraulic unit in-situ  
(photo provided by on-scene investigators)**

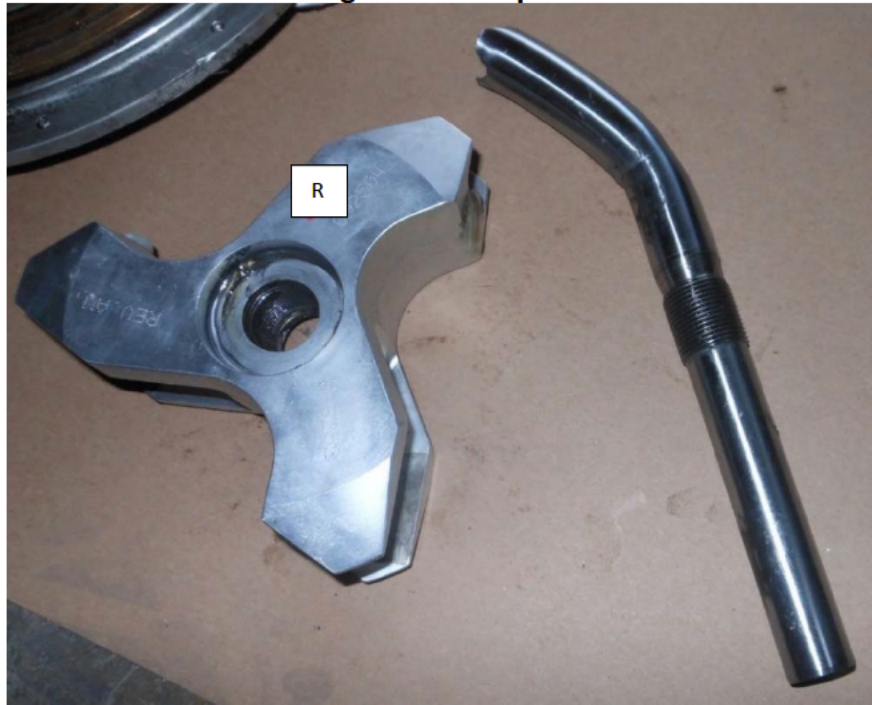
**Pitch Change Rod:** The pitch change rod forward of the hub was fractured and bent as shown in Photo #11. The remaining portion of the rod unthreaded from the fork and was removed without difficulty.

**Fork:** The fork appeared intact with only knob/block impact marks in the slots, otherwise it appeared undamaged (Photo #11).

**Photo #11 – Right fork and pitch change rod**

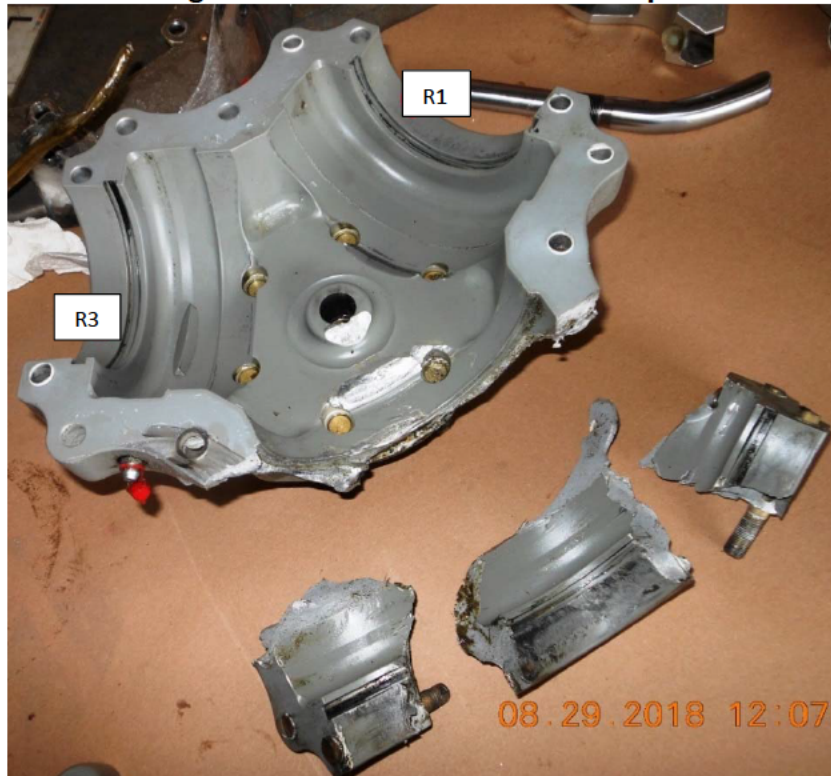
**Hub Assembly:** The hub appeared over-serviced with grease after initially opened. The R2 blade retention pocket was fractured on the aft hub half in the aft/trailing edge direction (Photo #12). The pocket fragmented into three pieces and all remained attached to the assembly. Five hub thru-bolts were bent and had to be cut to separate the hub halves and fragments. The cylinder mounting boss threads were fracture-separated around approximately 30% of the circumference (Photo #13). The internal preload plate pockets of all three blades on both the forward and aft hub halves were damaged (Photos #12 and #14).

**Photo #12 – Right aft hub half and R2 retention pocket fracture**

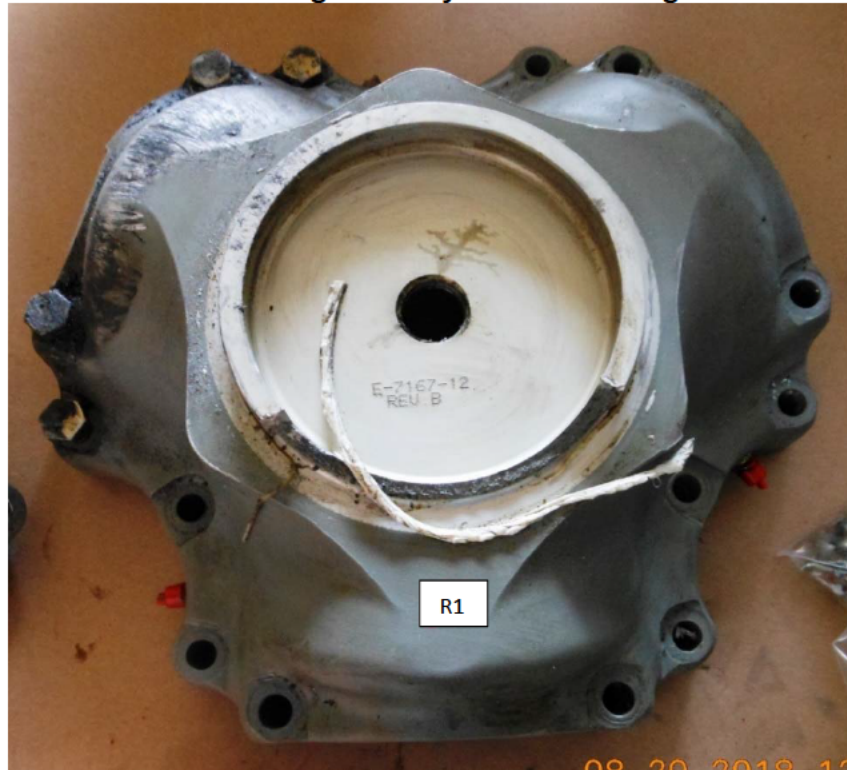
**Photo #13 – Right hub cylinder mounting boss**

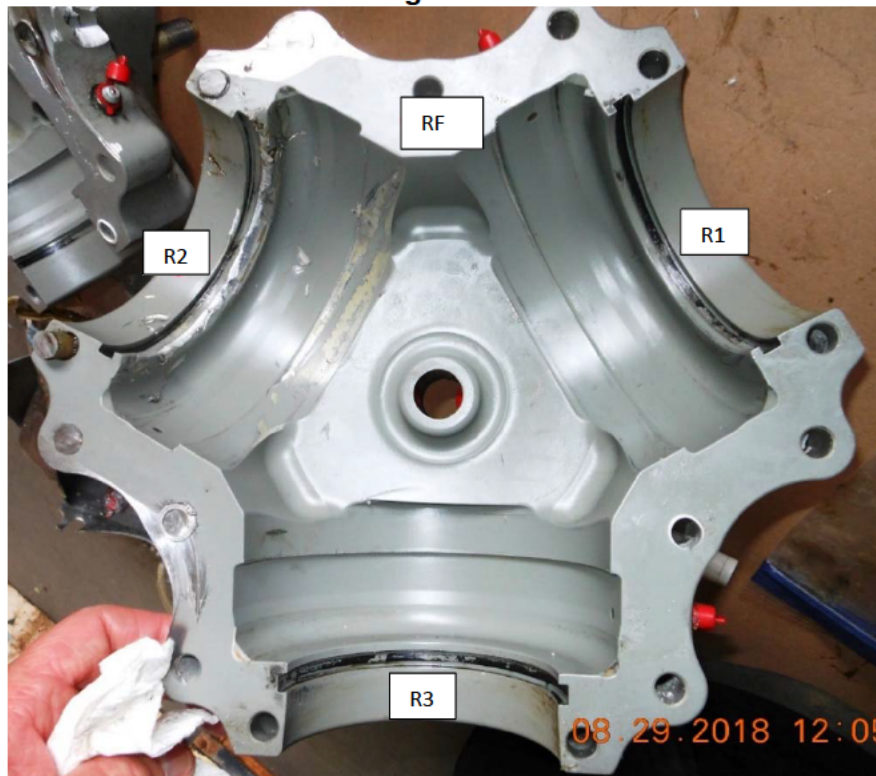
**Photo #14 – Right forward hub half**

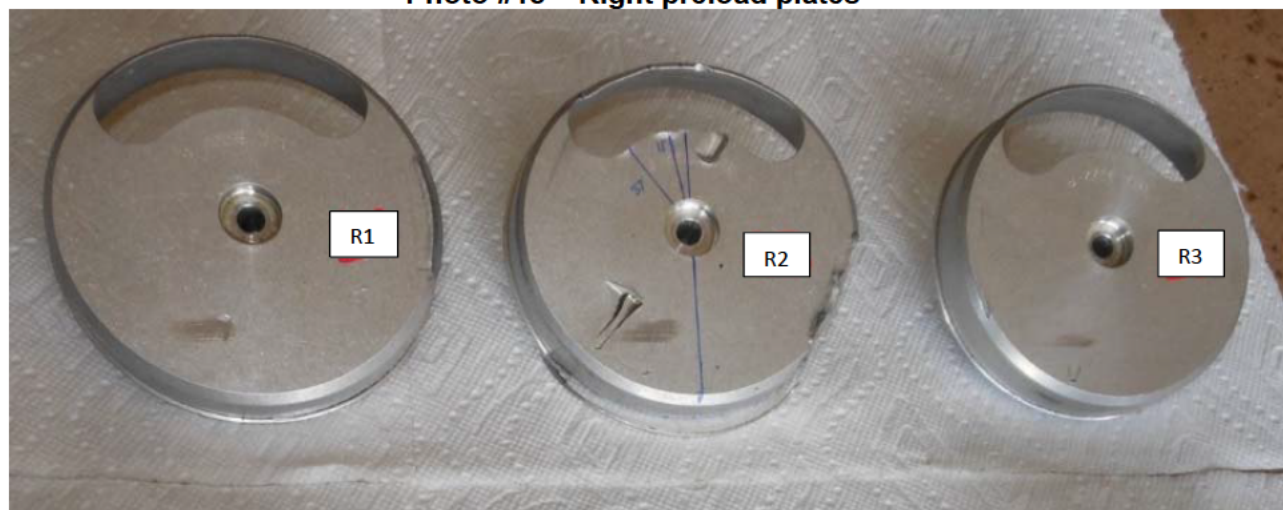
**Preload Plates:** All three preload plate lips were sheared, fractured and/or smashed. R1 and R2 also had impact marks from contact with the aft hub half pocket web.

**Photo #15 – Right preload plates**

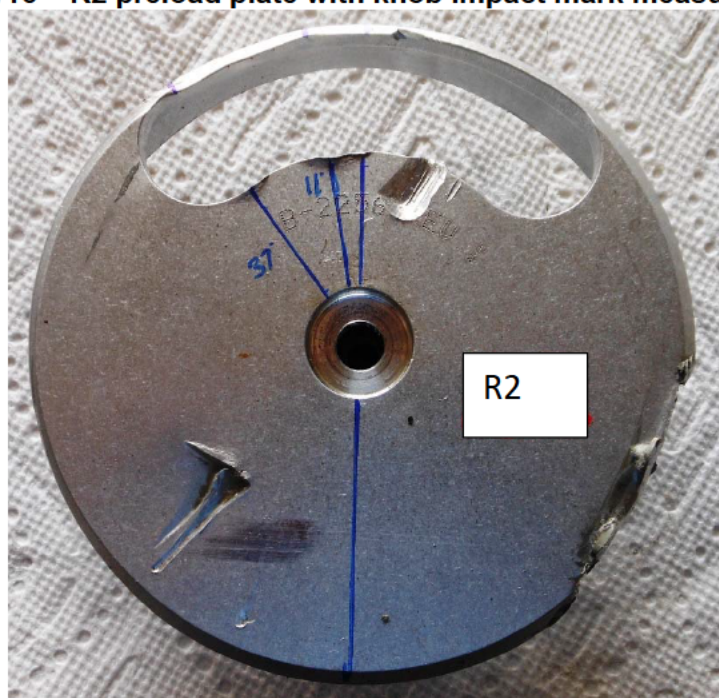
Preload Plate	Condition
R1	Fork contact marks in the low blade angle range.
R2	Fork contact marks in the low blade angle range. Knob impact marks in slot averaging $11^{\circ}$ and $37^{\circ}$ forward of the parting line (Photo #). The aft wall of the plate was fractured and marred by contact with the hub web.
R3	Fork contact mark in the low blade angle range.

**Photo #16 – R2 preload plate with knob impact mark measurements**

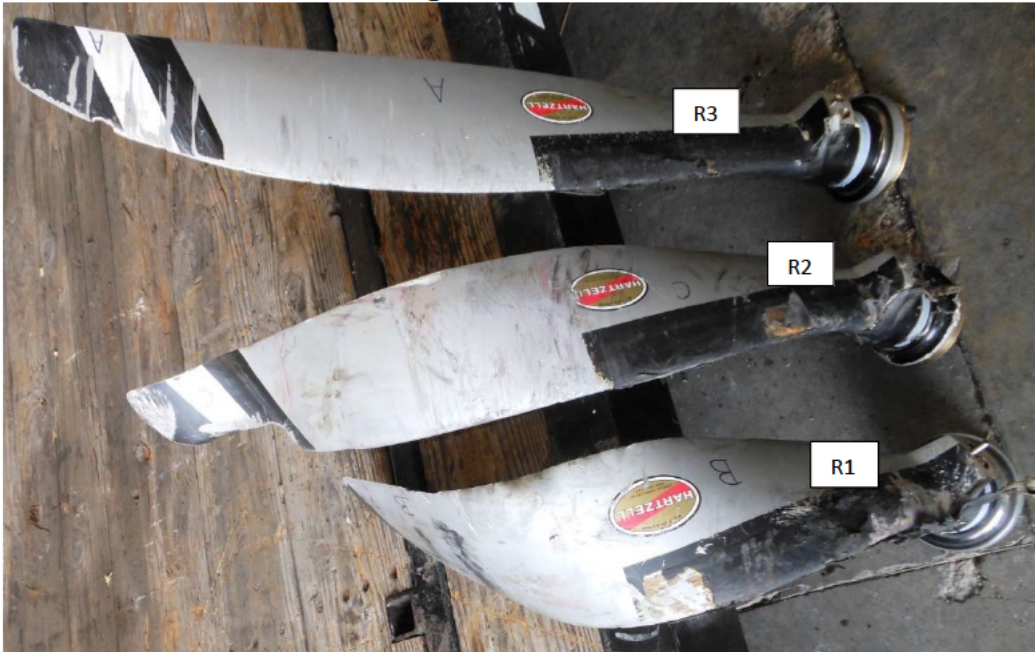
Camber side	Chordwise/rotational scoring
Face side	Chordwise/rotational scoring in mid-blade region, otherwise not remarkable
Bend	Aft and opposite rotation
Twist	Leading edge down, toward low pitch
Lead edge damage	Gouged
Trail edge damage	Wave-type buckling bends, gouged
Knob condition	Intact, bent opposite low pitch.
Counterweight	Intact, removed to facilitate propeller disassembly
Blade bearings	Intact
Butt/shank impact marks	Impact mark from hub aperture in trailing edge quadrant. Impact crescent on butt in the aft/trailing edge quadrant.
De-Ice boot	Torn

**Photo #17 – Right blades camber side view**

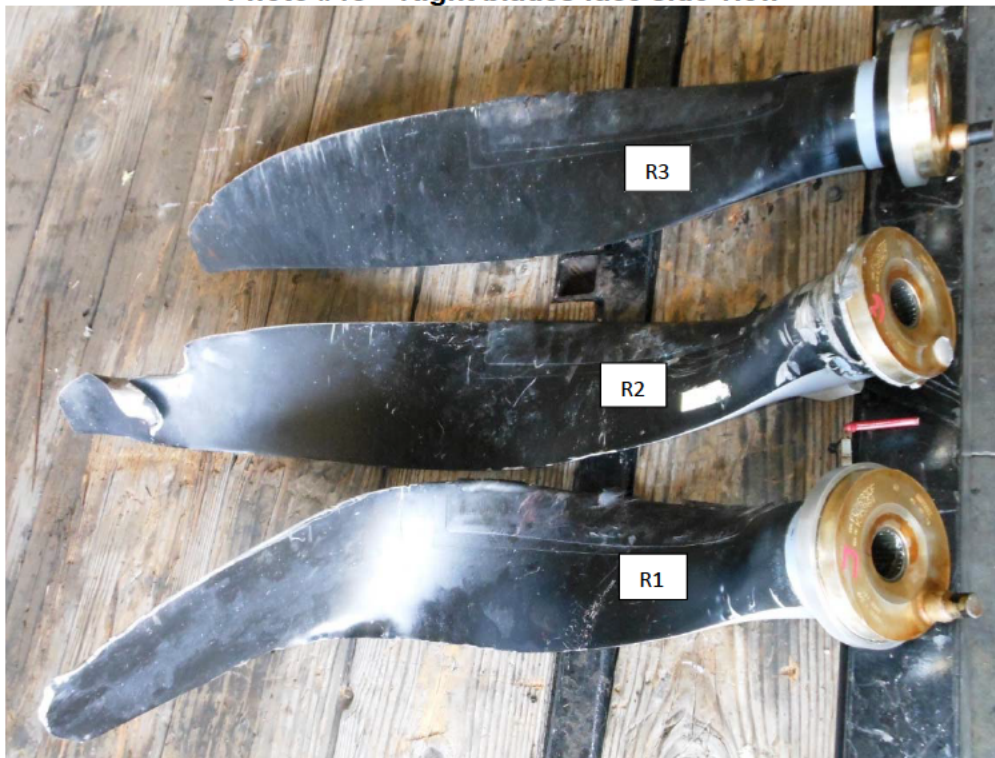
**Photo #18 – Right blades face side view**

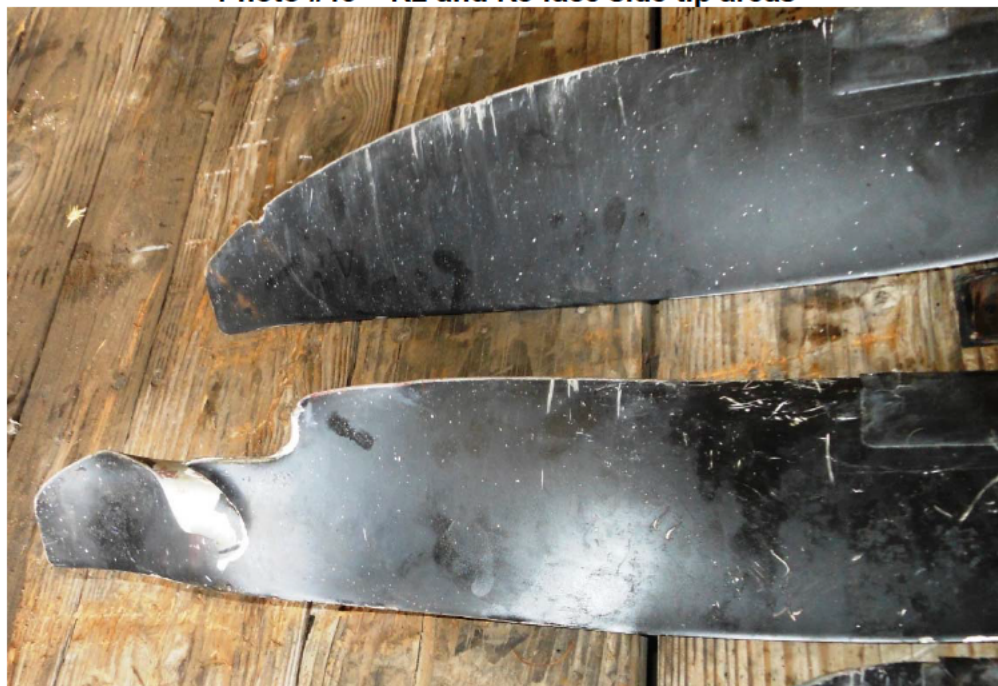
Camber side	Chordwise/rotational scoring characteristic of cutting through sheet metal (Photo #21)
Face side	Chordwise/rotational scoring (Photo #19)
Bend	Slight forward/thrust direction bending near tip
Twist	Not remarkable
Lead edge damage	Gouged
Trail edge damage	Not remarkable
Knob condition	Intact
Counterweight	Intact, removed to facilitate propeller disassembly
Blade bearings	Intact
Butt/shank impact marks	Not remarkable
De-Ice boot	Torn

**Photo #19 – R2 and R3 face side tip areas**

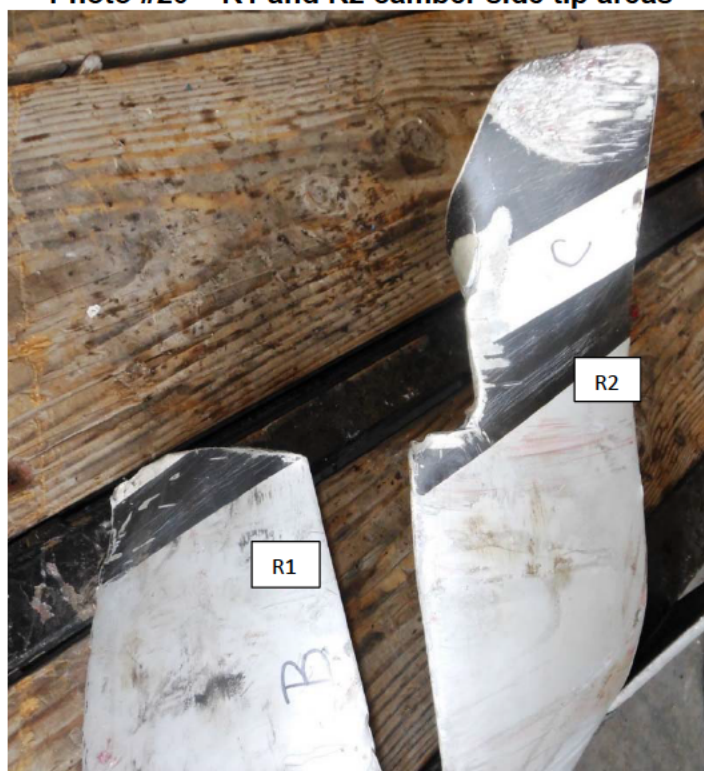
Blade # R1 – Approximately 4-5” of tip fracture-separated, fragment not recovered (Photo #20)

Camber side	Chordwise/rotational scoring with red paint transfer from car
Face side	Chordwise/rotational scoring in mid-blade area
Bend	Aft and opposite rotation with some S-bend characteristics at tip
Twist	Leading edge down, toward low pitch
Lead edge damage	Large, 4” gouge/tear near tip (Photo #20)
Trail edge damage	Random scrapes
Knob condition	Fractured/sheared
Counterweight	Fracture-separated, bolts fractured, not presented for examination. Mounting boss gouged and scored.
Blade bearings	Bearing races were fractured. Bearing retention lip sheared off.
Butt/shank impact marks	Gouges and scoring throughout the aft/face side of the shank and bearing retention lip. Impact crescent in aft/face quadrant.
De-Ice boot	Torn

**Photo #20 – R1 and R2 camber side tip areas**

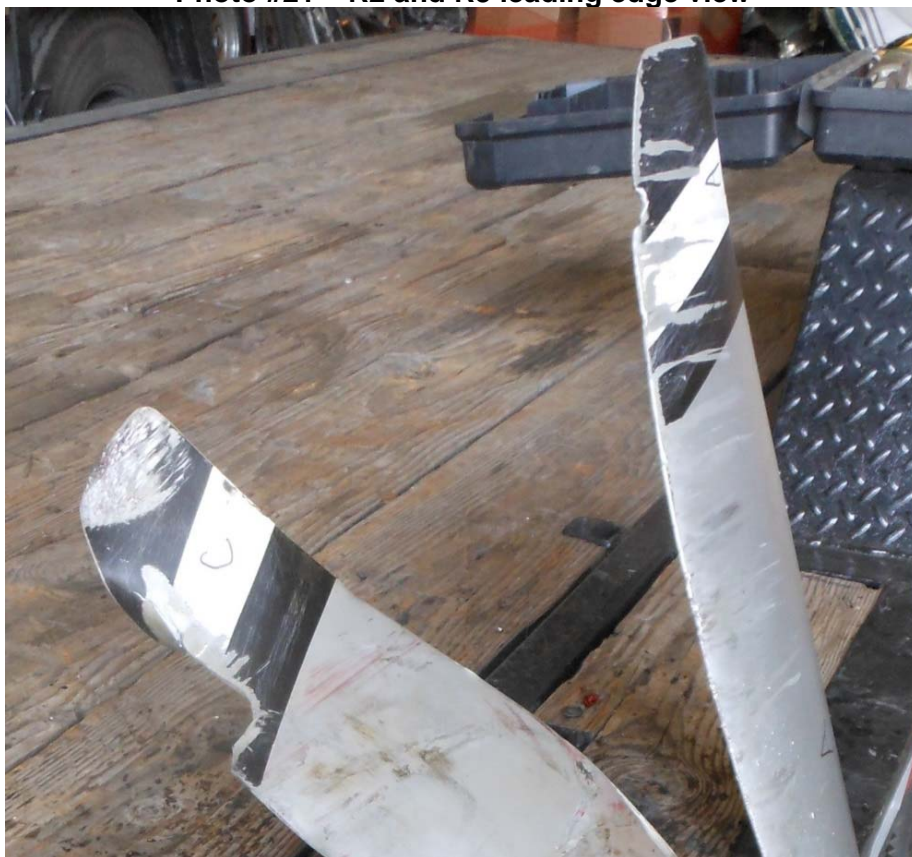
**Photo #21 – R2 and R3 leading edge view**

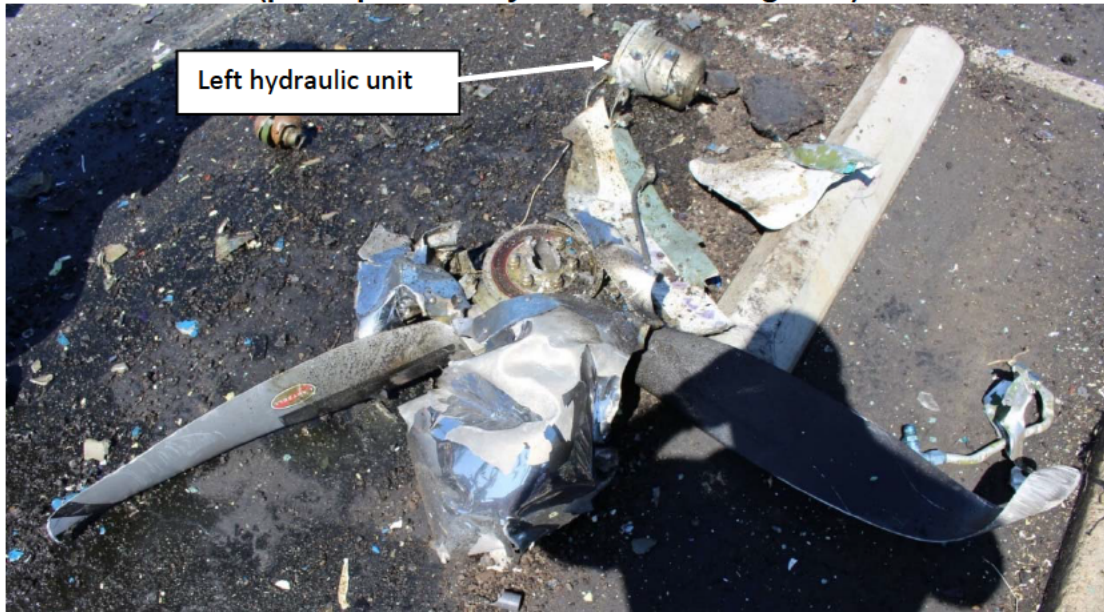
**As Received Condition:** The propeller impacted the shopping center asphalt parking lot and fractured from the engine crankshaft during the impact sequence as shown in Photos #22 and #23. The L2 blade fracture-separated from the assembly and lodged in the impact crater in Photo #23. The propeller blades appeared to have made two distinguishable slash marks in the asphalt as shown in Photo #23 that were estimated from the photo to be 12-15" apart. The propeller was recovered to a hangar at Chino Airport for examination as shown in Photo #24. L1 and L2 blades were bent aft, opposite rotation and twisted towards low pitch. Blade L3 had approximately 4" of the tip fracture-separated and was bent in the forward/thrust direction near the tip. The hydraulic unit fractured from the hub unit but was found nearby as shown in Photo #22. The L2 blade retention pocket was fractured in a helical path direction suggesting rotation and the L2 blade separated from the assembly. There was distinguishable chordwise/rotational scoring consistent with impact into asphalt on the camber side of blades L1 and L2. There was also leading edge gouging with material deformation towards low pitch. Two of the three pitch change knobs were fractured.

**Spinner Dome:** The spinner dome was not presented for examination at Southwest Aircraft. However, review of on-scene photos show the spinner dome was torn and dented (Photo #22). The spinner dome also appeared to have a chrome finish which is not approved by Hartzell Propeller.

**Photo #22 – Left propeller in-situ  
(photo provided by on-scene investigators)**

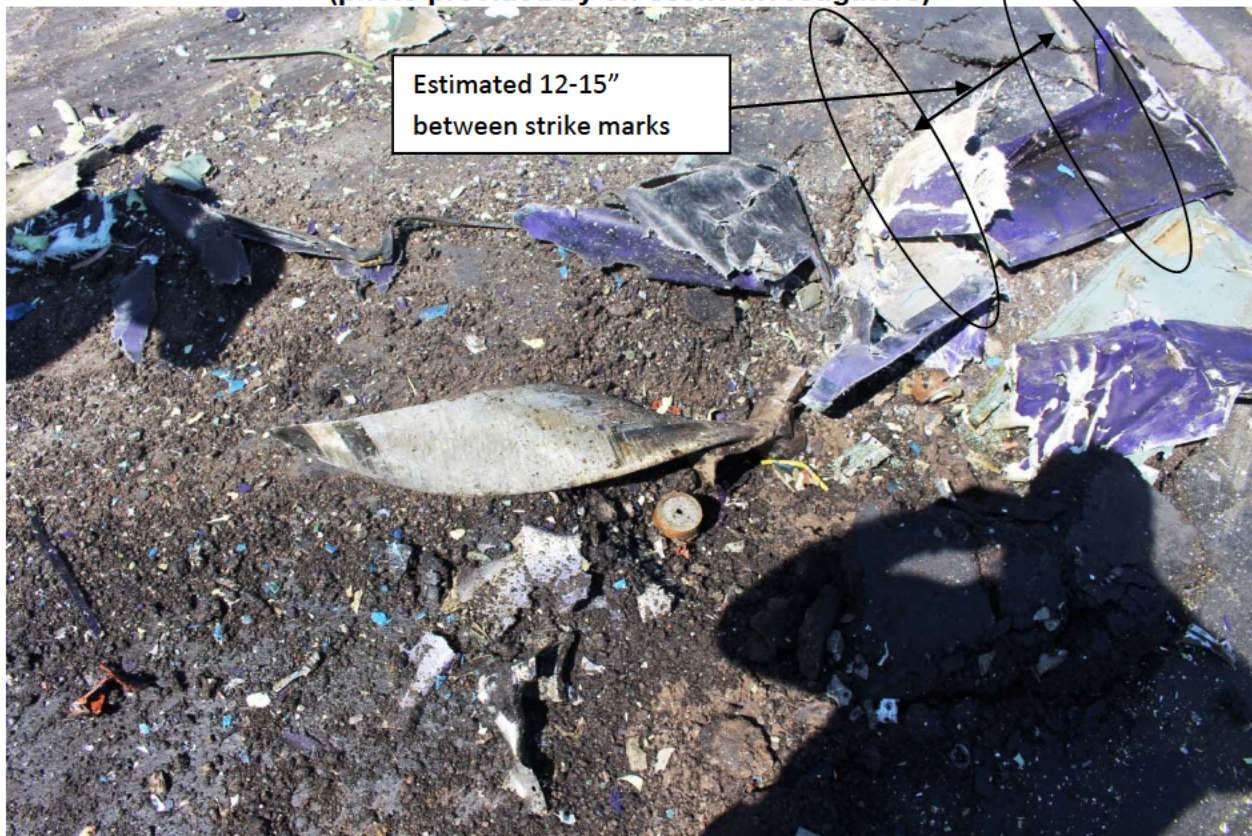
**Photo #23 – L2 blade in impact crater  
(photo provided by on-scene investigators)**

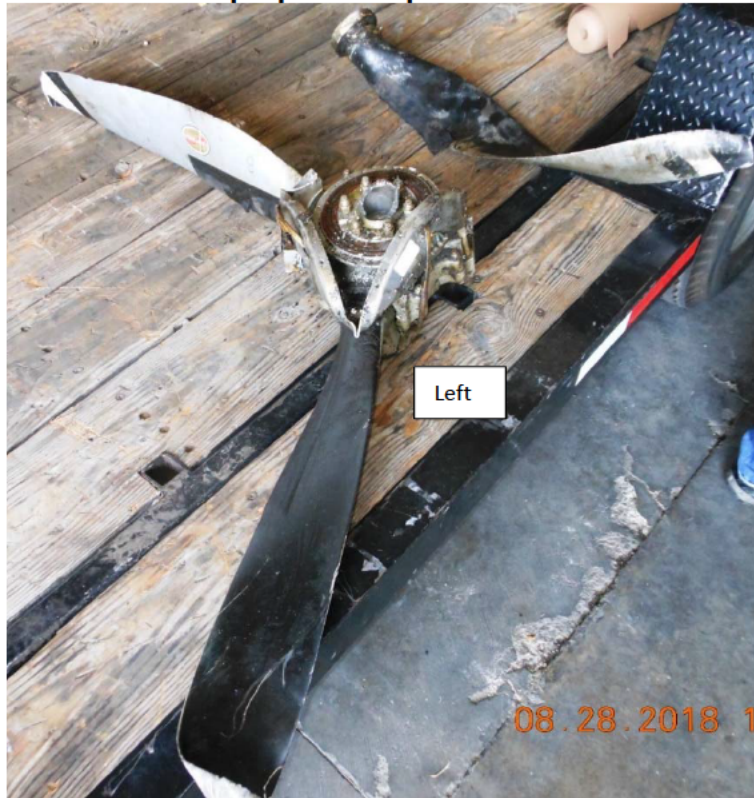
**Photo #24 – Left propeller as-presented for examination**

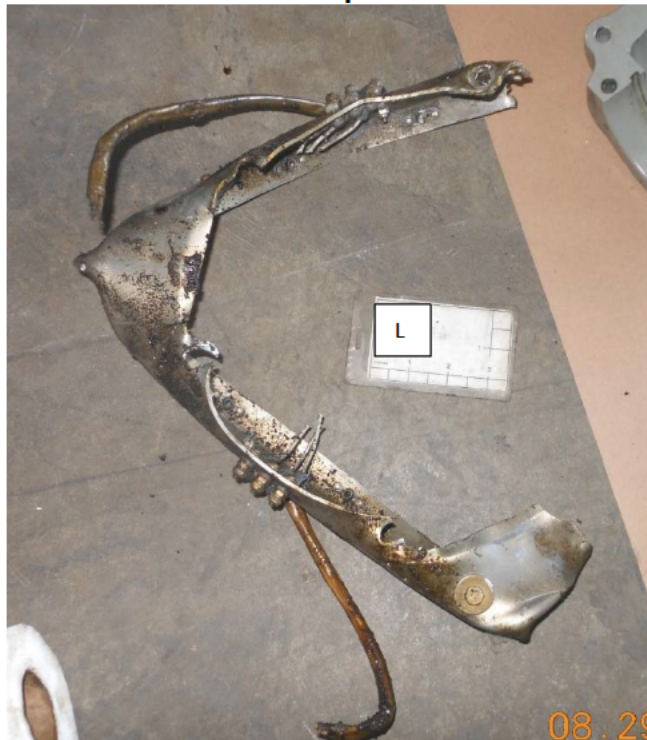
**Spinner Bulkhead:** The spinner bulkhead was bent and torn as shown in Photo #25.

**Photo #25 – Left spinner bulkhead**

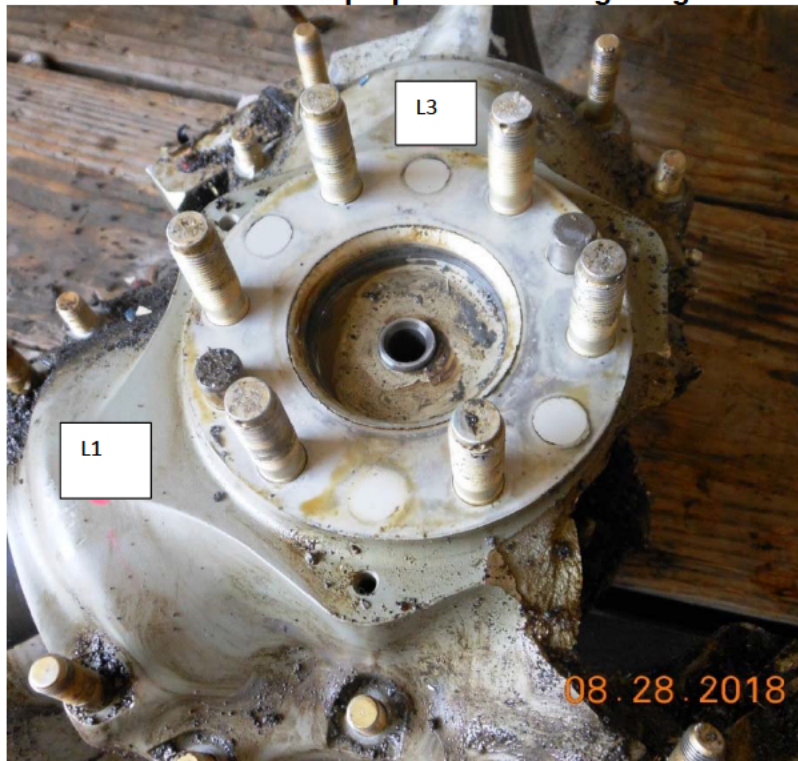
**Engine/Propeller Mounting:** The fractured crankshaft flange remained attached to the propeller mounting flange and the fasteners were tight. The mounting flange appeared intact and undamaged (Photo #26). The crankshaft flange fracture appeared to have some ratchet-like fracture patterns suggesting applied torque at the time of fracture (Photo #27).

**Photo #26 – Left propeller mounting flange**

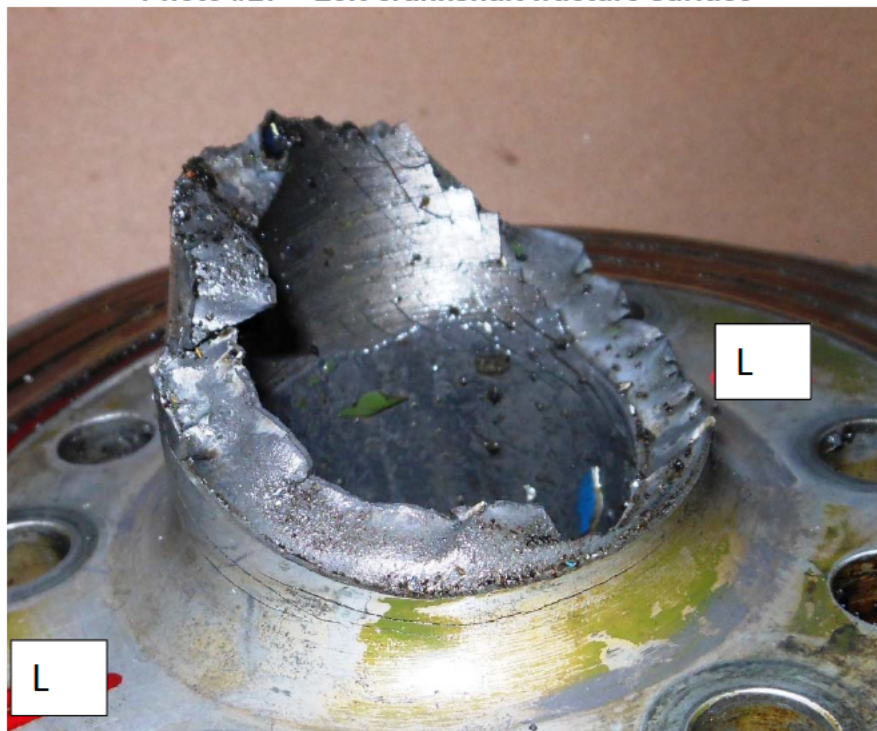
**Photo #27 – Left crankshaft fracture surface**

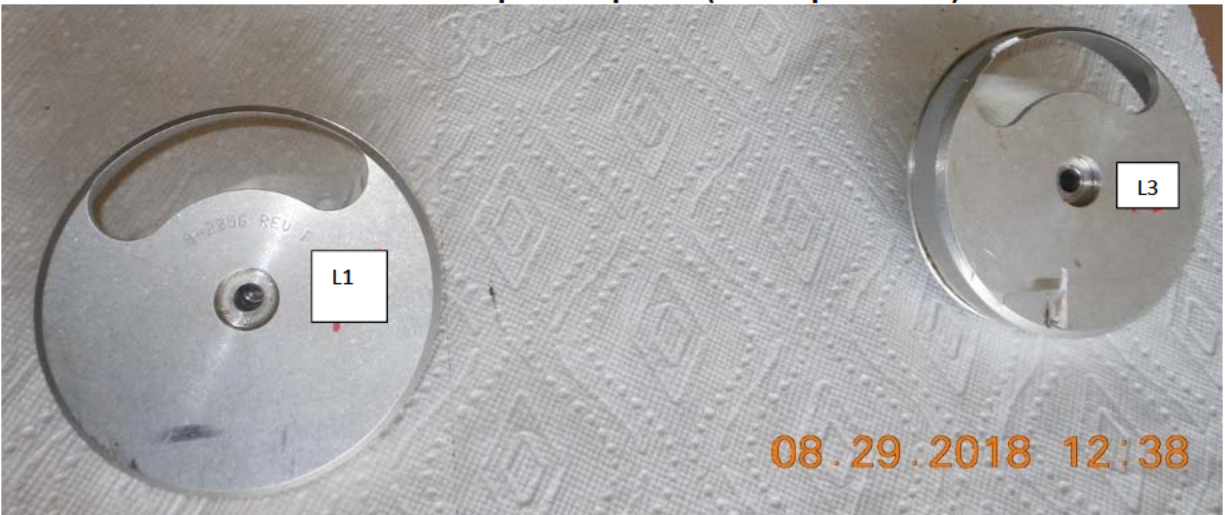
**Preload Plates:** The L2 preload plate was not presented for examination and presumed either destroyed and/or fragmented beyond recognition. The L1 and L3 preload plate lips were sheared, fractured and/or smashed. L1 and L3 also had impact marks from contact with the forward hub half pocket web.

Photo #28 – Left preload plates (L2 not presented)

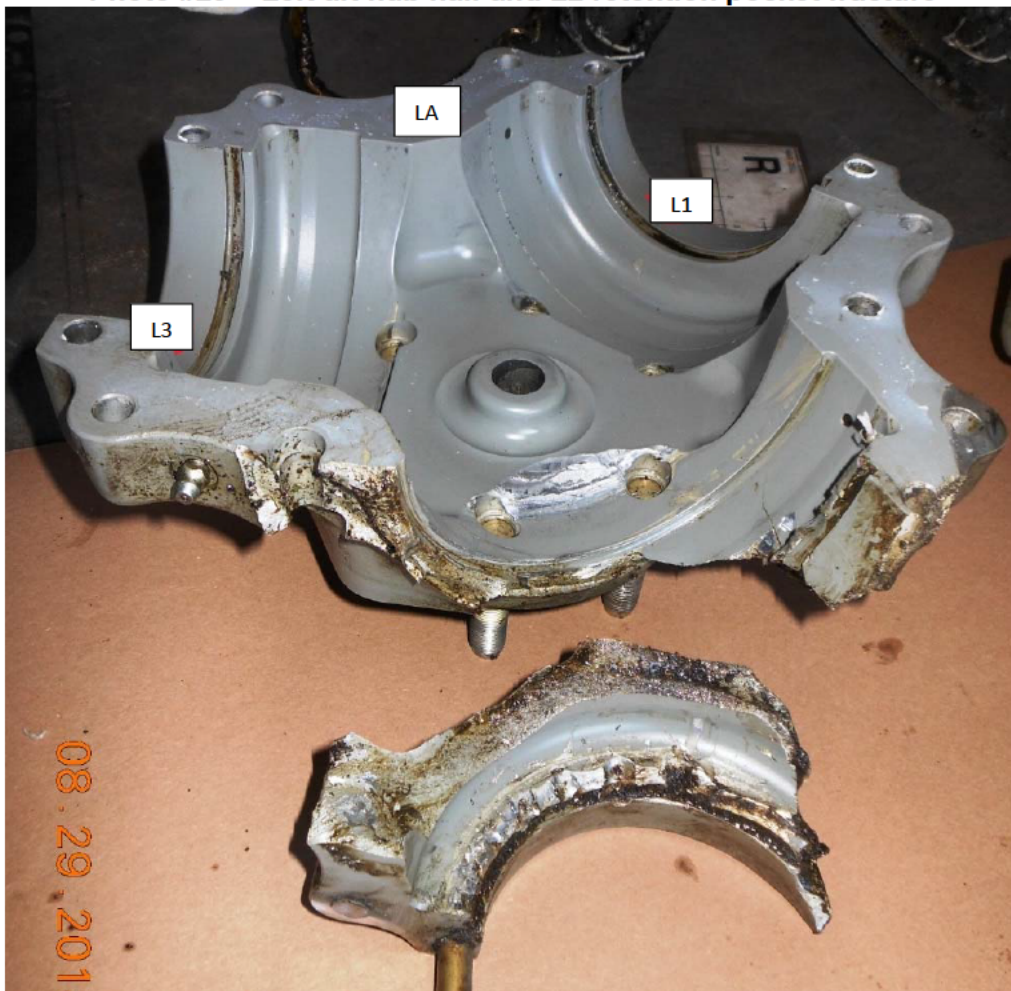
**Hub Assembly:** The L2 blade retention pocket was fractured around both the aft and forward hub half (Photos #29 and #30). A fragment on the lead/camber side of the forward hub half remained attached to the assembly. One hub thru-bolt had to be cut to separate the hub halves and fragment. The cylinder mounting boss threads were fracture-separated around approximately 50% of the circumference (Photo #31). The internal preload plate pockets of all three blades on both the forward and aft hub halves were damaged (Photos #29 and #30). There were ball bearing imprints in the forward hub fragment of the L2 blade retention pocket (Photo #29).

Photo #29 – Left aft hub half and L2 retention pocket fracture
