**NTSB File No.:** WPR18FA211

**Aircraft:** Cessna 414

**PROPELLER EXAMINATION REPORT**

**Propeller Model(s):** PHC-C3YF-2UF with FC7693DFB blades

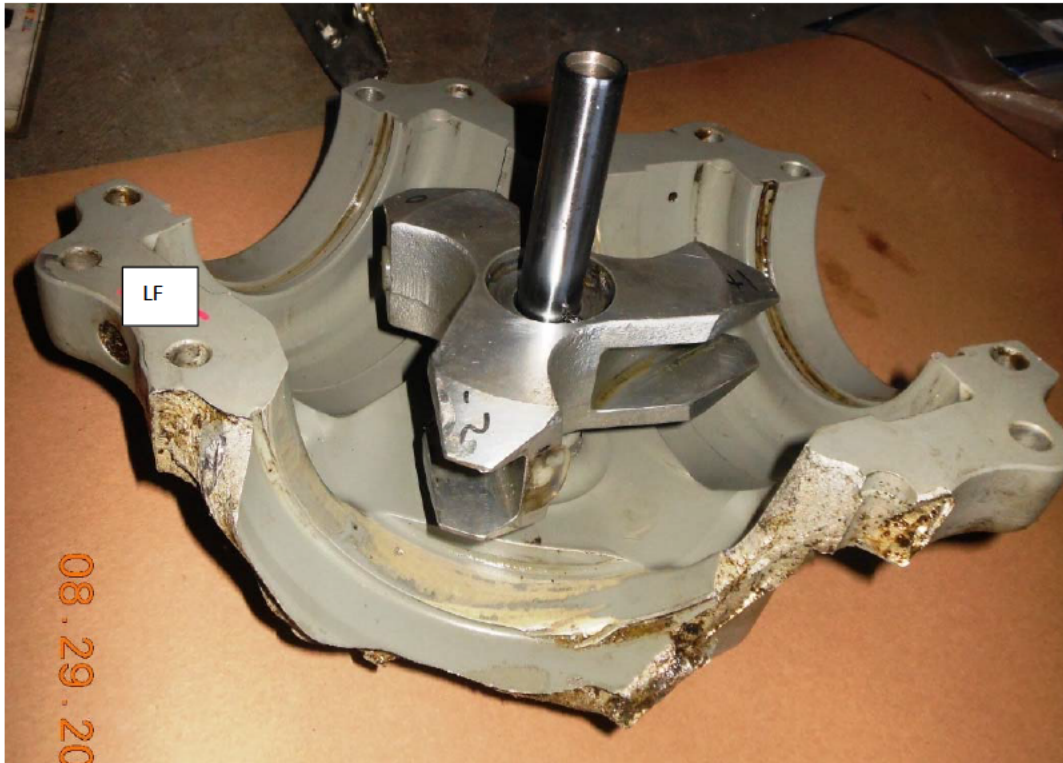
**Fork:** The fork appeared intact with only knob/block impact marks in the slots, otherwise it appeared undamaged (Photo #30). An attempt was made to remove the fork but the remaining portion of the pitch change rod was bent, prohibiting complete removal from the rod threads.

**Hub Assembly:** The L2 blade retention pocket was fractured around both the aft and forward hub half (Photos #29 and #30). A fragment on the lead/camber side of the forward hub half remained attached to the assembly. One hub thru-bolt had to be cut to separate the hub halves and fragment. The cylinder mounting boss threads were fracture-separated around approximately 50% of the circumference (Photo #31). The internal preload plate pockets of all three blades on both the forward and aft hub halves were damaged (Photos #29 and #30). There were ball bearing imprints in the forward hub fragment of the L2 blade retention pocket (Photo #29).

Photo #30 – Left forward hub half

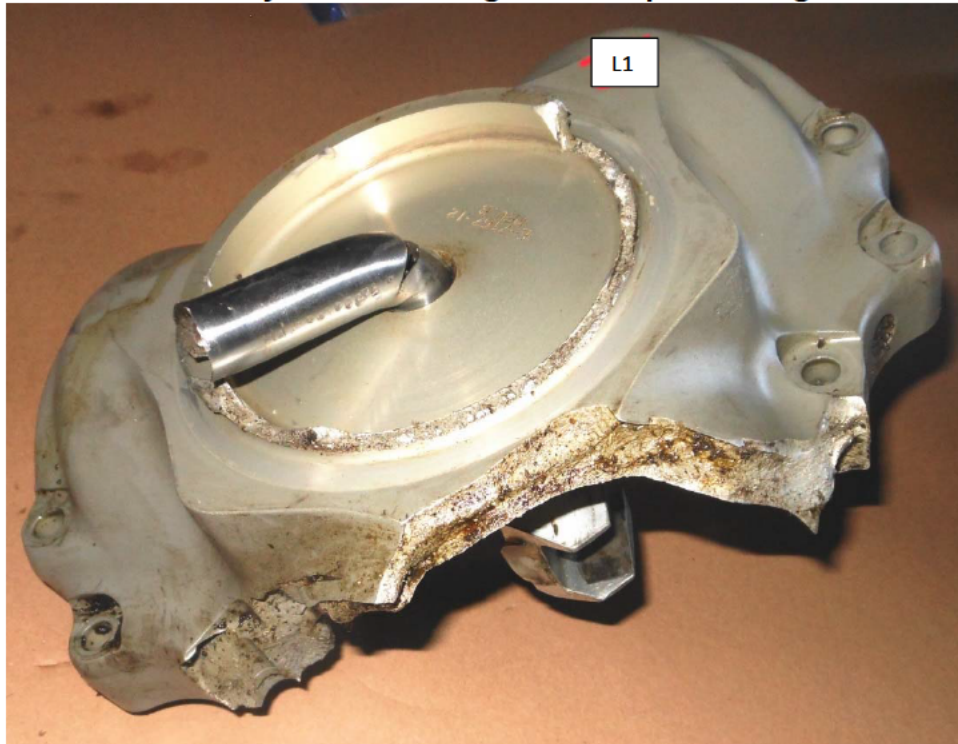
**Pitch Change Rod:** The pitch change rod forward of the hub was fractured and bent as shown in Photo #31 and could not be rotated for removal.

Photo #31 – Left cylinder mounting boss and pitch change rod bend

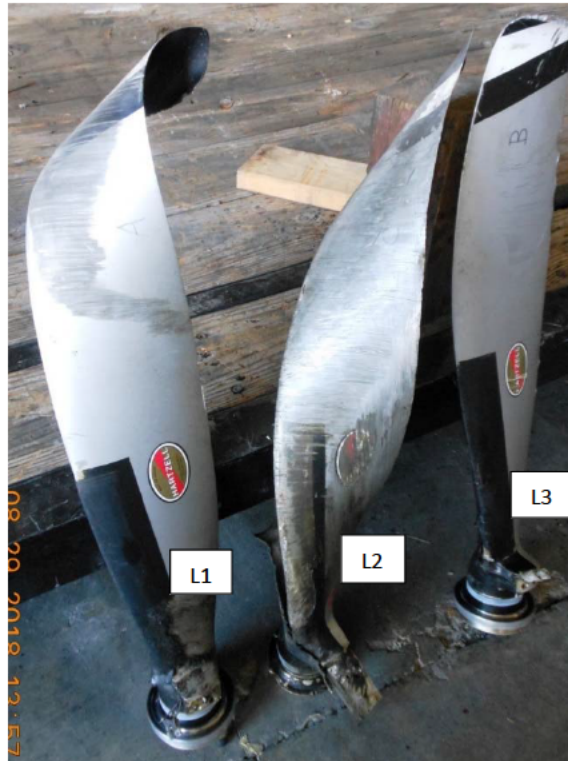
Photo #32 – Left blades camber side view

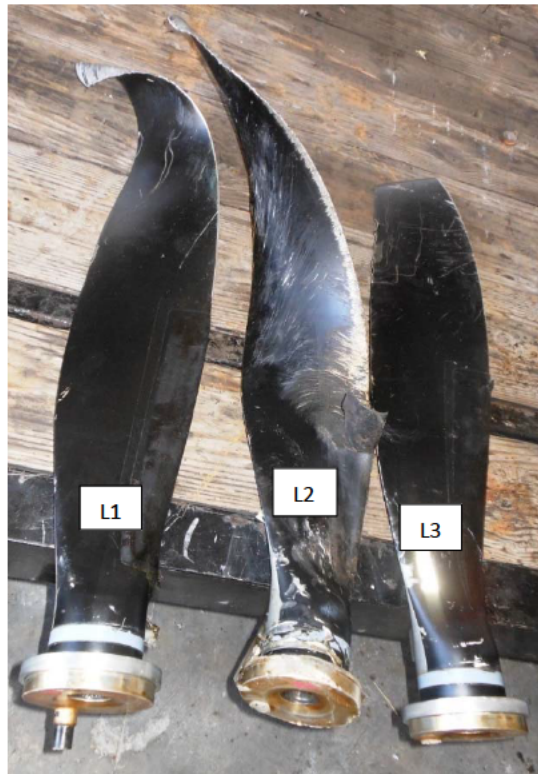
Photo #33 – Left blades face side view

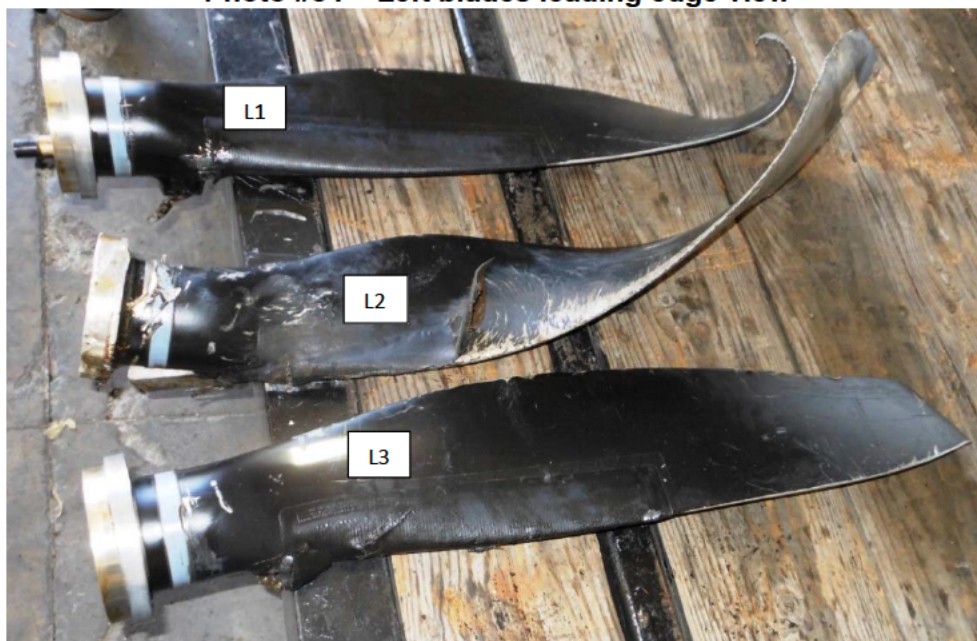
**Photo #34 – Left blades leading edge view**

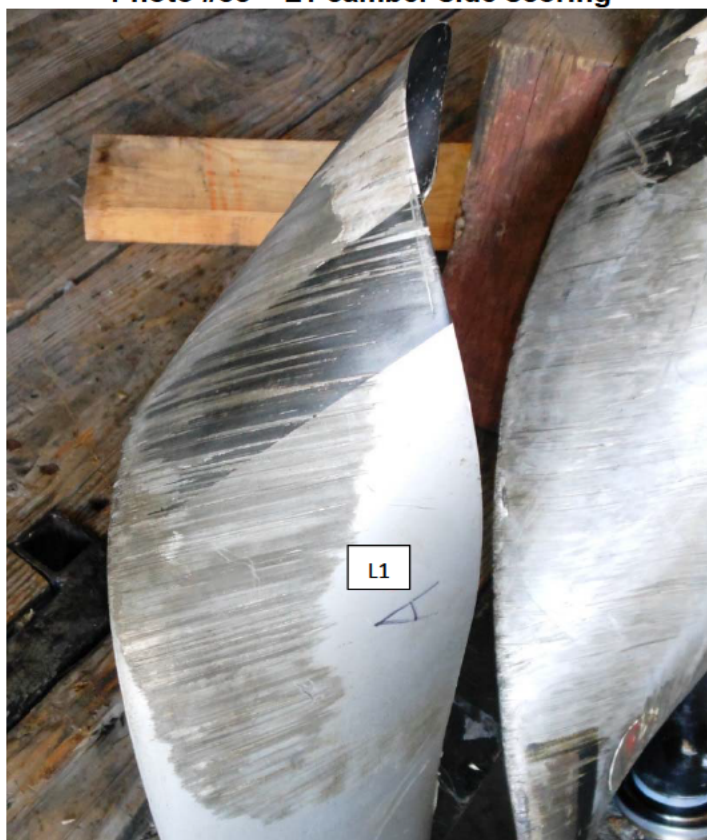
Camber side	Chordwise/rotational scoring (Photo #35)
Face side	Diagonal scoring
Bend	Curled aft, opposite rotation
Twist	Curled leading edge down, toward low pitch
Lead edge damage	Gouged
Trail edge damage	Not remarkable
Knob condition	Intact
Counterweight	Fracture-separated, not presented for examination
Blade bearings	Intact
Butt/shank impact marks	Impact crescents in lead and trail quadrants
De-Ice boot	Mostly intact, abrasion on camber side near counterweight boss

**Photo #35 – L1 camber side scoring**

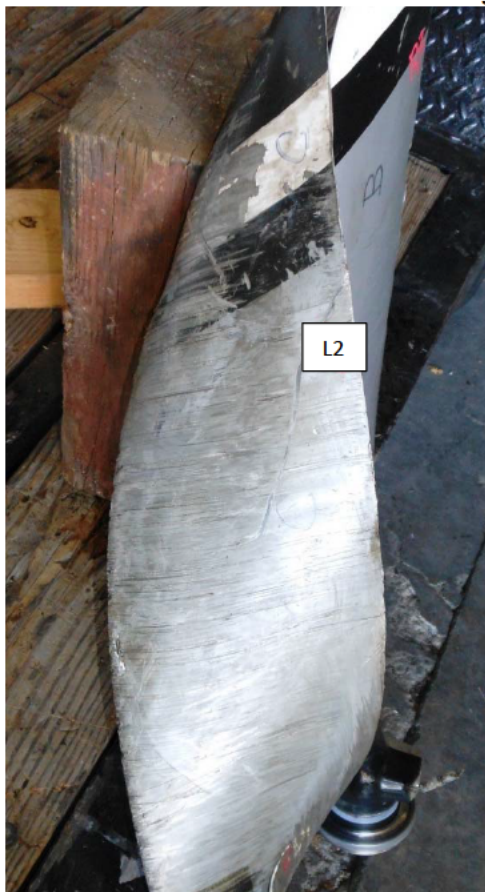
Camber side	Chordwise/rotational scoring (Photo #36)
Face side	Chordwise/rotational scoring near lead edge, diagonal scoring mid-blade
Bend	Curled aft, opposite rotation
Twist	Leading edge down, toward low pitch
Lead edge damage	Nicks and gouges
Trail edge damage	Nicks and gouges
Knob condition	Fracture-separated, not presented for examination
Counterweight	One attach bolt fractured but still attached and displaced from boss. Counterweight boss gouged.
Blade bearings	Not recovered, ball bearing imprints in hub blade retention pocket
Butt/shank impact marks	Gouged, bearing retention lip fracture/sheared. Gouges around aft/face side Teflon rub strip area. Bearing race retention ring missing.
De-Ice boot	Torn

Photo #36 – L2 camber side scoring

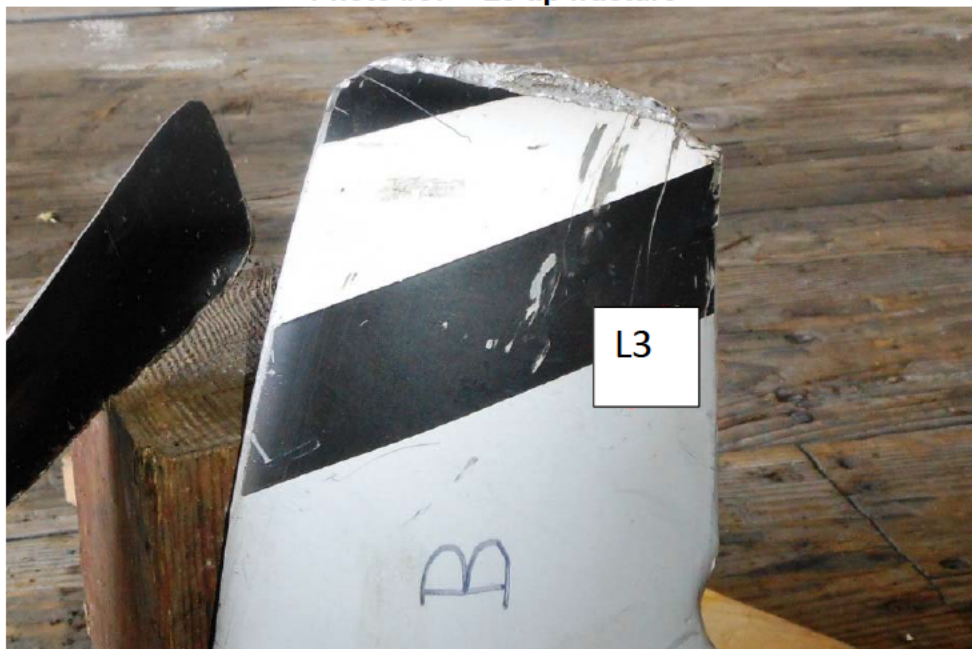
## Blade # L3 – Approximately 4” of tip fracture-separated, fragment not presented (Photo #37)

Camber side	Chordwise/rotational scuffing in mid-blade, trailing edge region
Face side	Chordwise/rotational scoring near tip leading edge
Bend	Forward/thrust direction at tip
Twist	Appears twisted leading edge up, towards high pitch at tip
Lead edge damage	Not remarkable except for tear/fracture at tip
Trail edge damage	Bends, dents and nicks
Knob condition	Fracture-separated, fracture direction suggests towards high pitch
Counterweight	Intact, removed to facilitate propeller disassembly
Blade bearings	Intact
Butt/shank impact marks	Impact crescent in lead quadrant
De-Ice boot	Torn

Photo #37 – L3 tip fracture
