NATIONAL TRANSPORTATION SAFETY BOARD

Group Chairman's Factual Report

WPR19FA079

**Appendix A – Figures
(6 pages)**

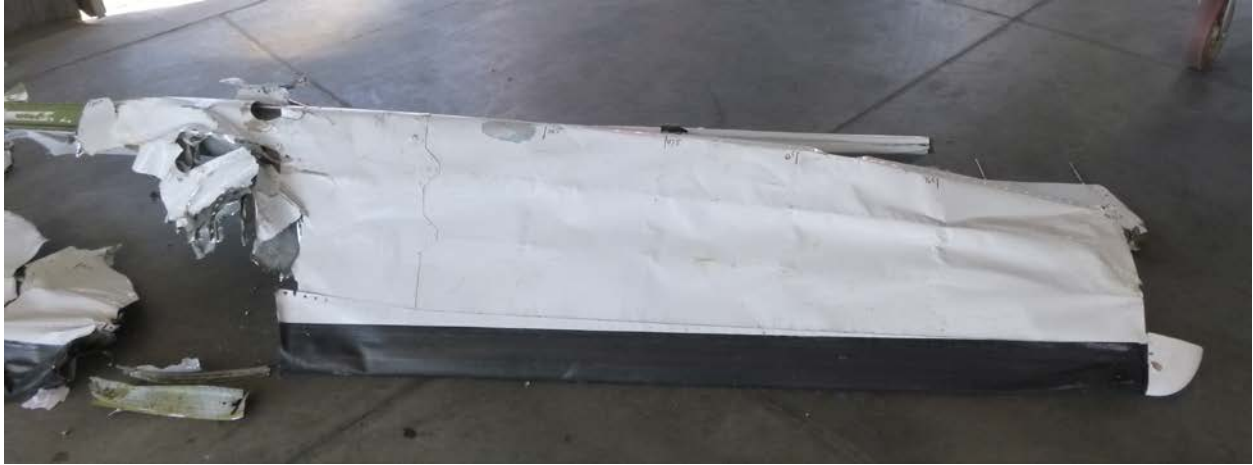
Figure 3 – Left horizontal stabilizer wreckage, viewed looking down at upper surface

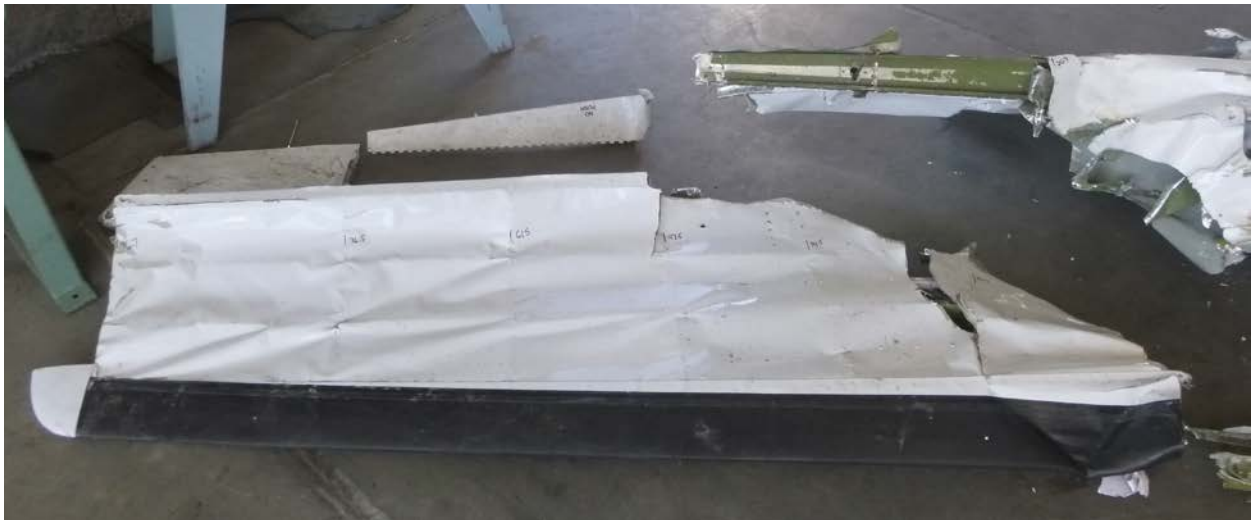
Figure 4 – Right horizontal stabilizer wreckage, viewed looking down at upper surface

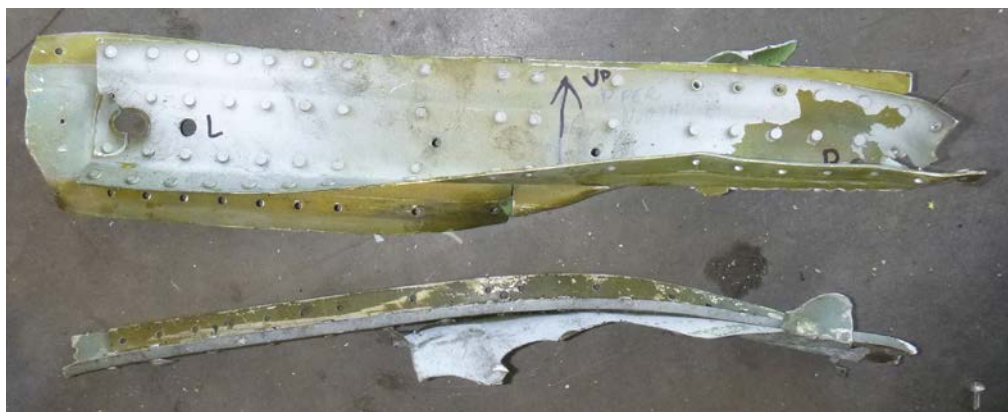
Figure 5 – Horizontal stabilizer forward spar center section, viewed looking aft at forward face

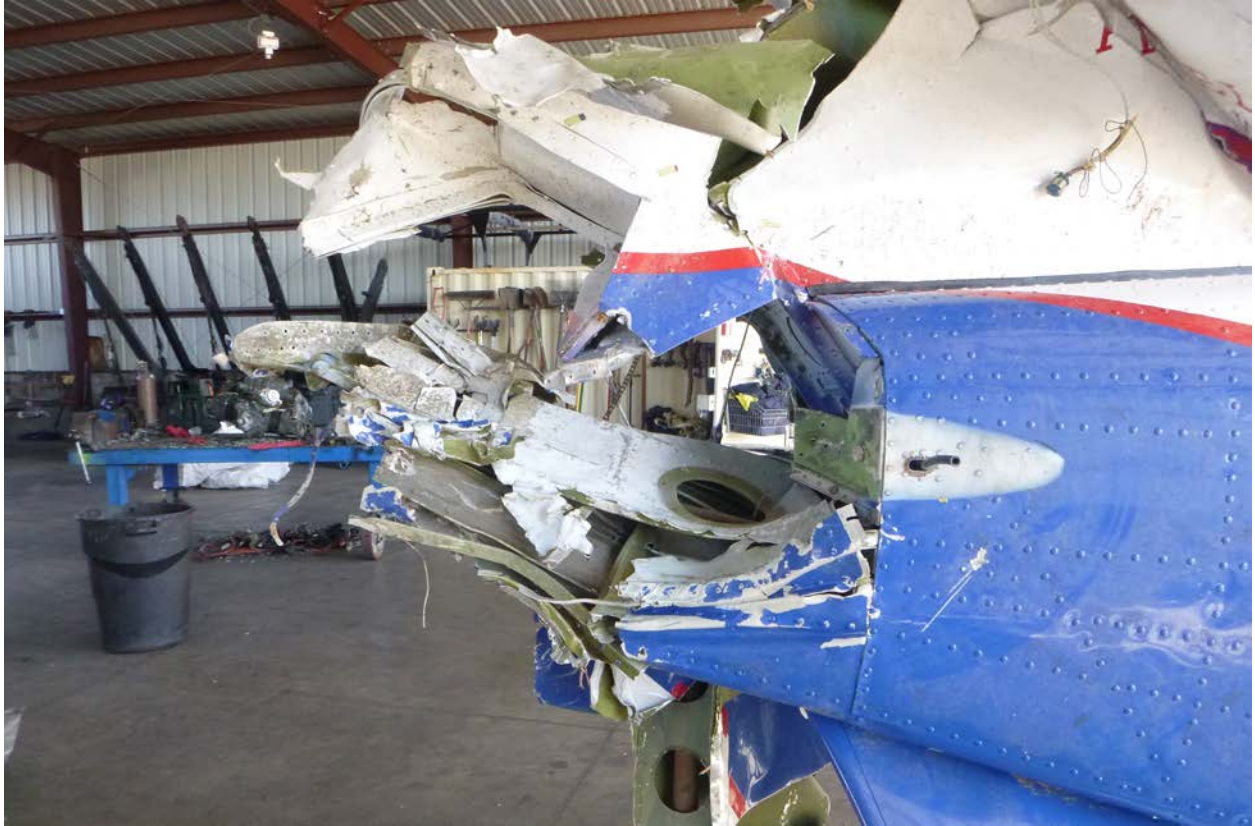
Figure 6 – Right side of empennage

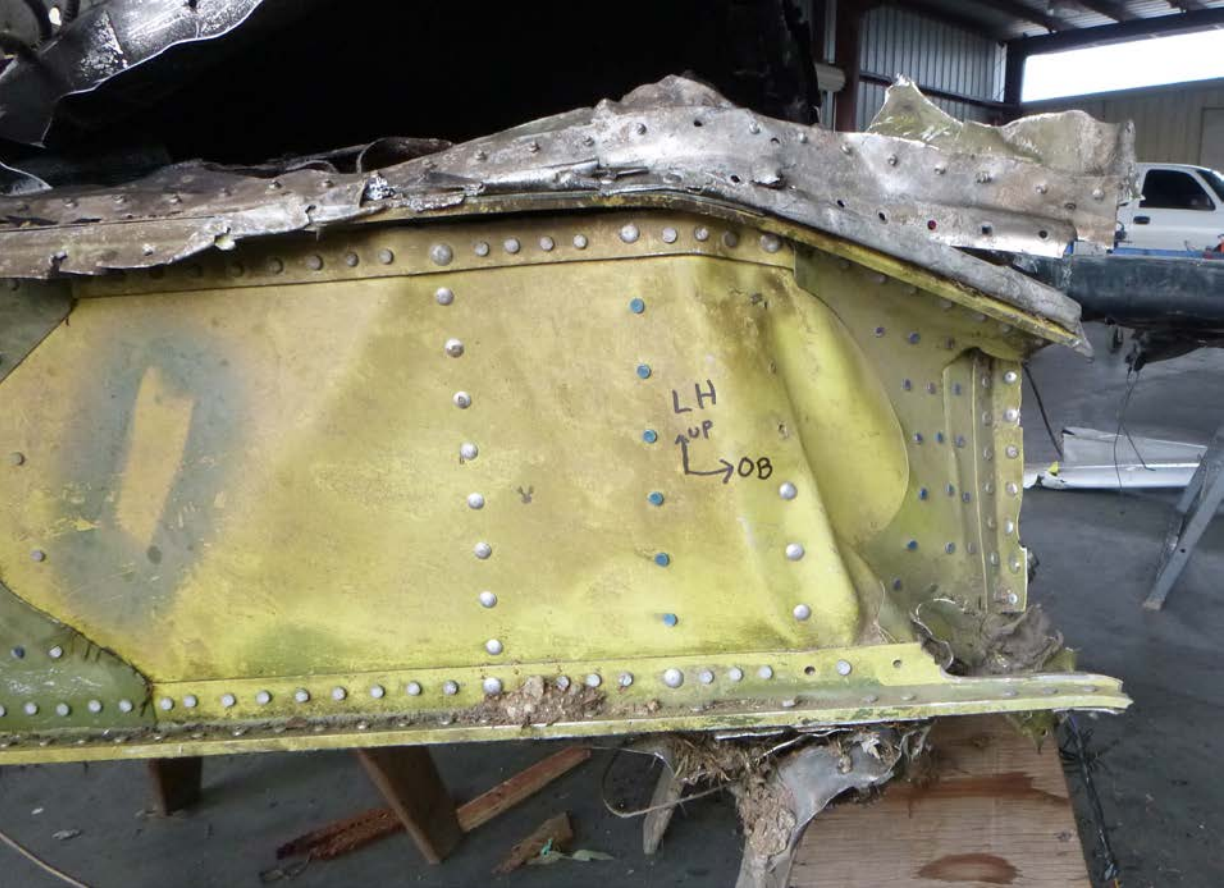
Figure 7 – Left wing fracture location, viewed looking aft

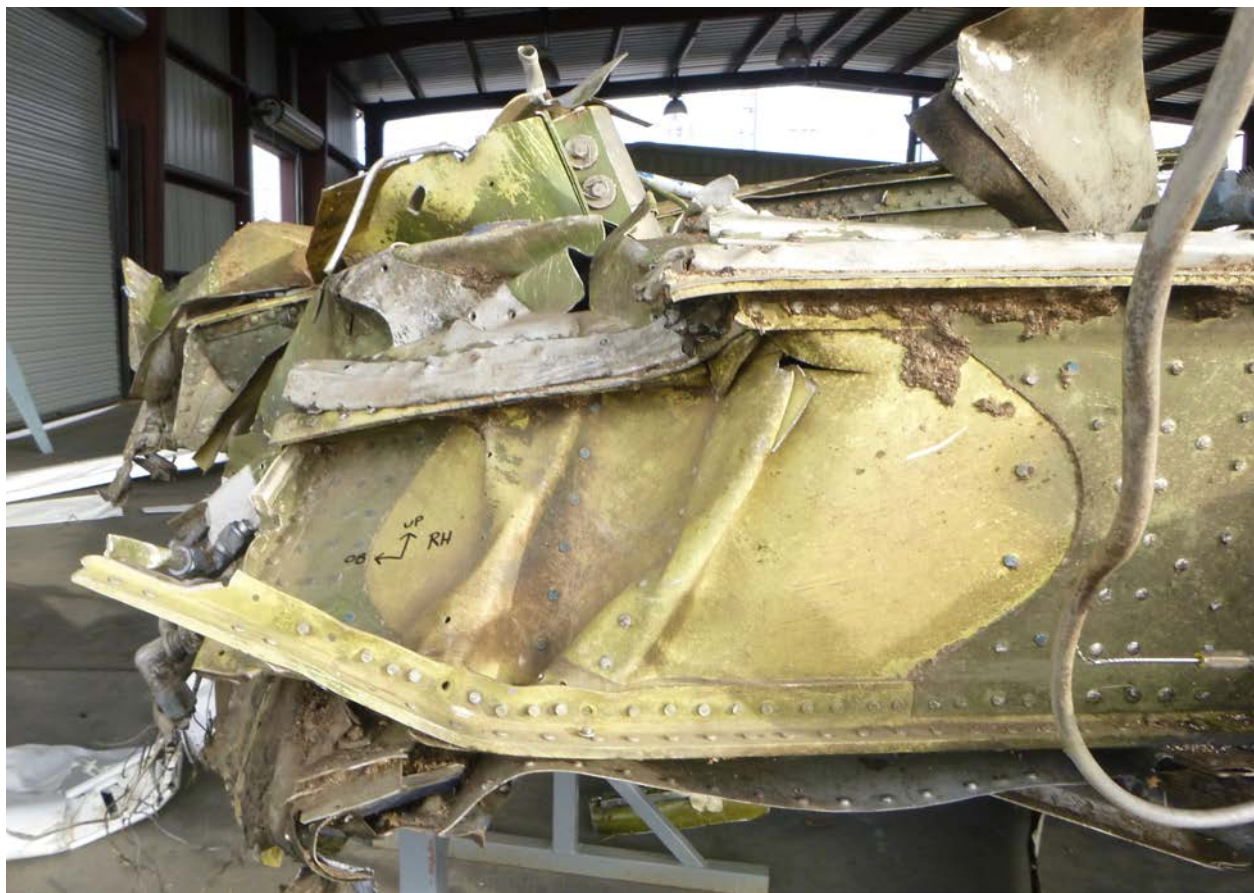
Figure 8 – Right wing fracture location, viewed looking aft
