NATIONAL TRANSPORTATION SAFETY BOARD
Office of Aviation Safety
Washington, D.C. 20594

Unmanned Aircraft System (UAS) Aerial Imagery Report

A. ACCIDENT WPR19FA109

Location: Fort McDowell, Arizona

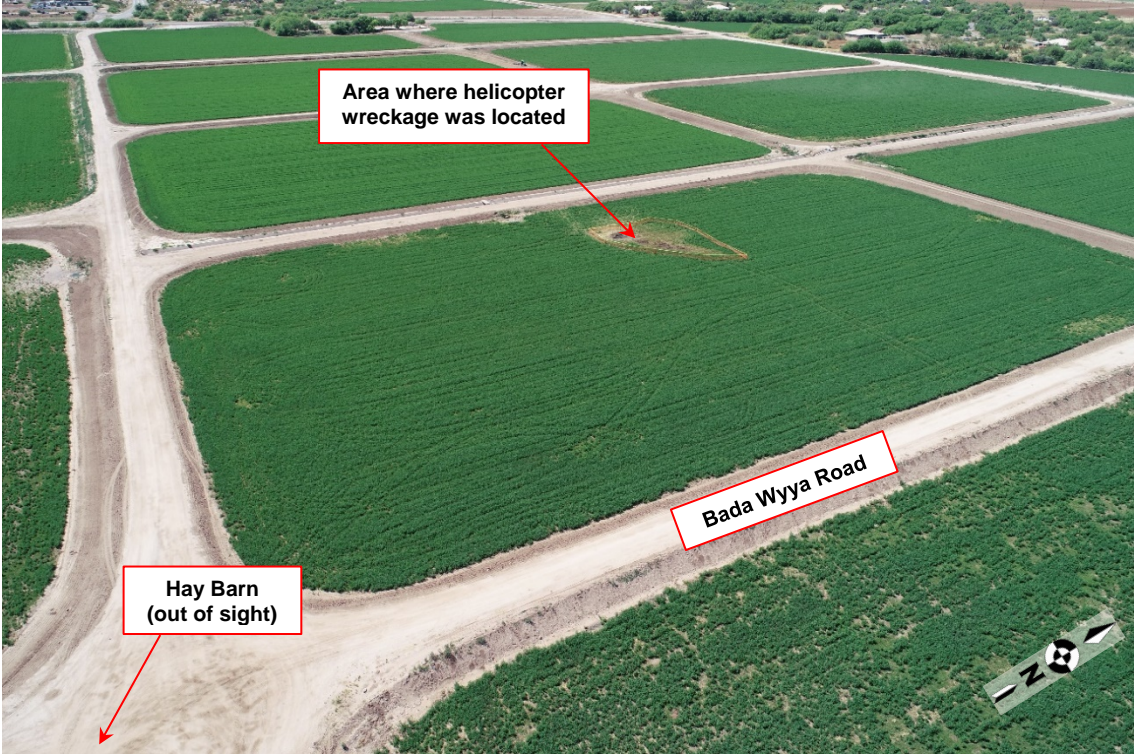
Figure 2 contains a still image taken from north of the hay barn looking toward the accident site in the alfalfa field.

Figure 2 - Accident site (positional arrow approximate)

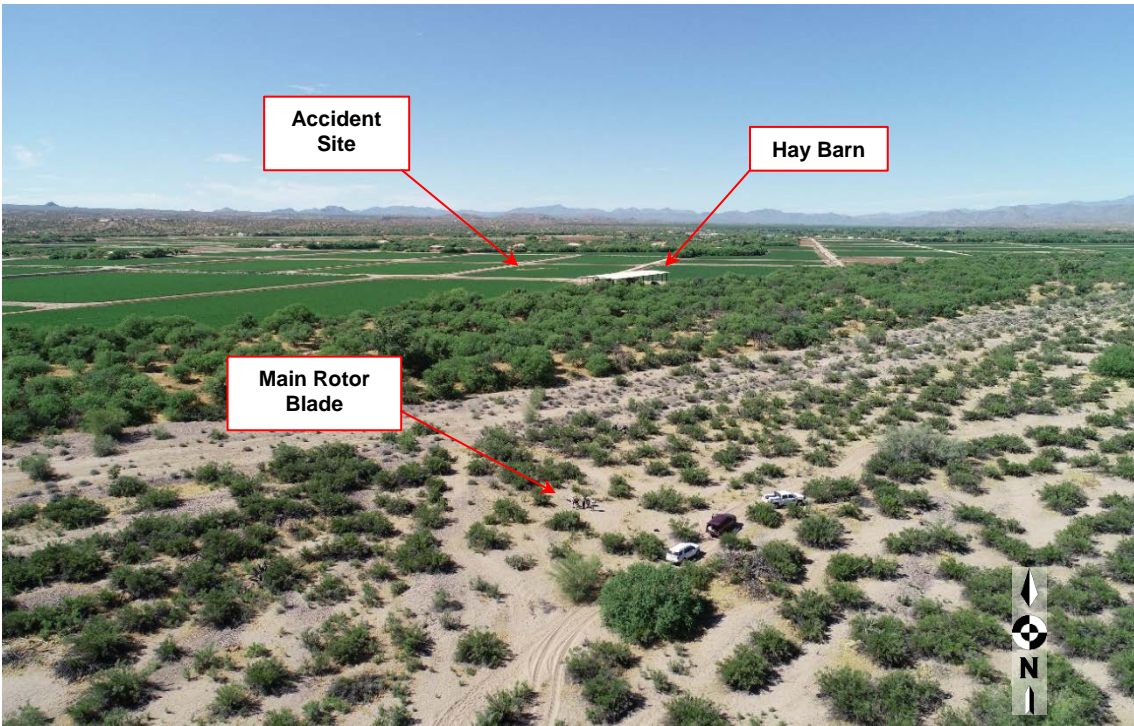
During the review of search grid 2, an object of interest was spotted, and a ground searcher was dispatched to check the object. While enroute to the object, and during the flight of search area 3, the missing rotor blade was found. The missing main rotor blade was located about 1,670 ft south-southeast (160°) from the main wreckage site. Additional sets of still images were taken for additional viewpoints around the accident scene. The remaining search areas were not flown after the rotor blade was identified and recovered. Total flight time was about 1 hour 20 minutes.

Figure 3 contains a still image taken from south looking toward the accident site and including the main rotor blade location.

Figure 3 – View looking at the main rotor blade toward accident site (positional arrow approximate)

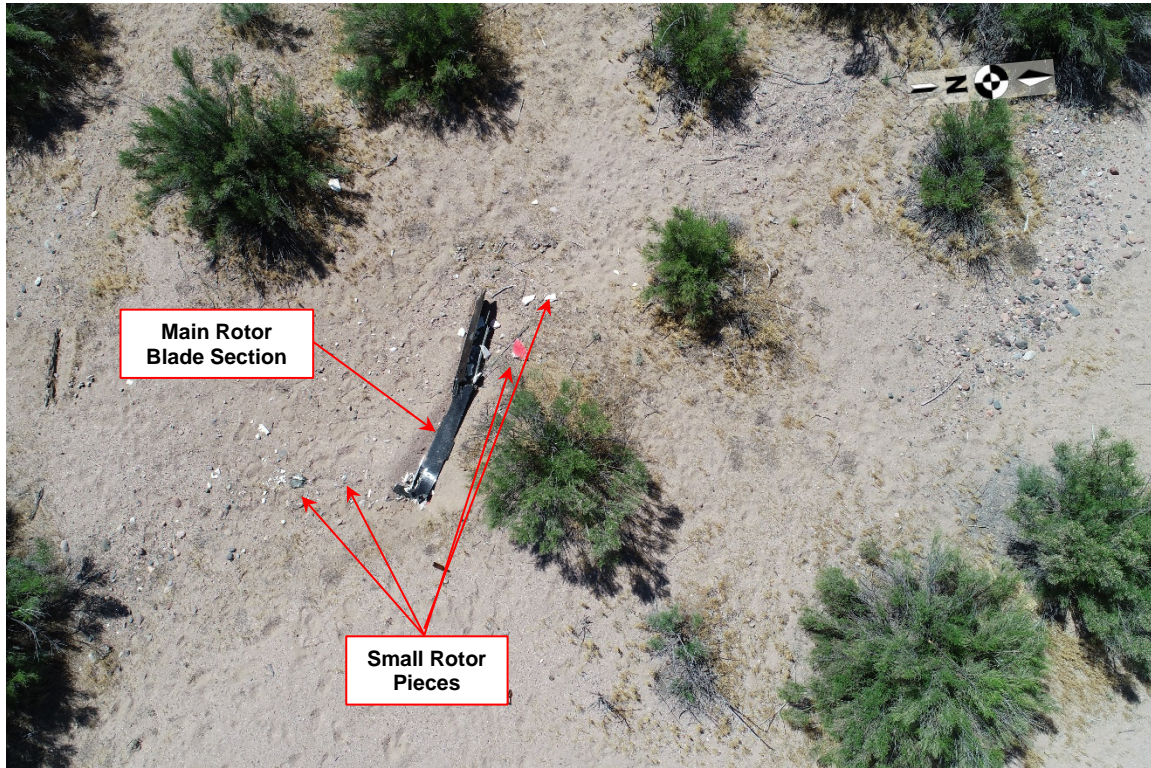
Figure 4 contains a still image taken from overhead of the main rotor blade that was missing. Small pieces of the rotor blade can be seen around the main piece of blade.

Figure 4 – Section of main rotor blade as found (positional arrow approximate)

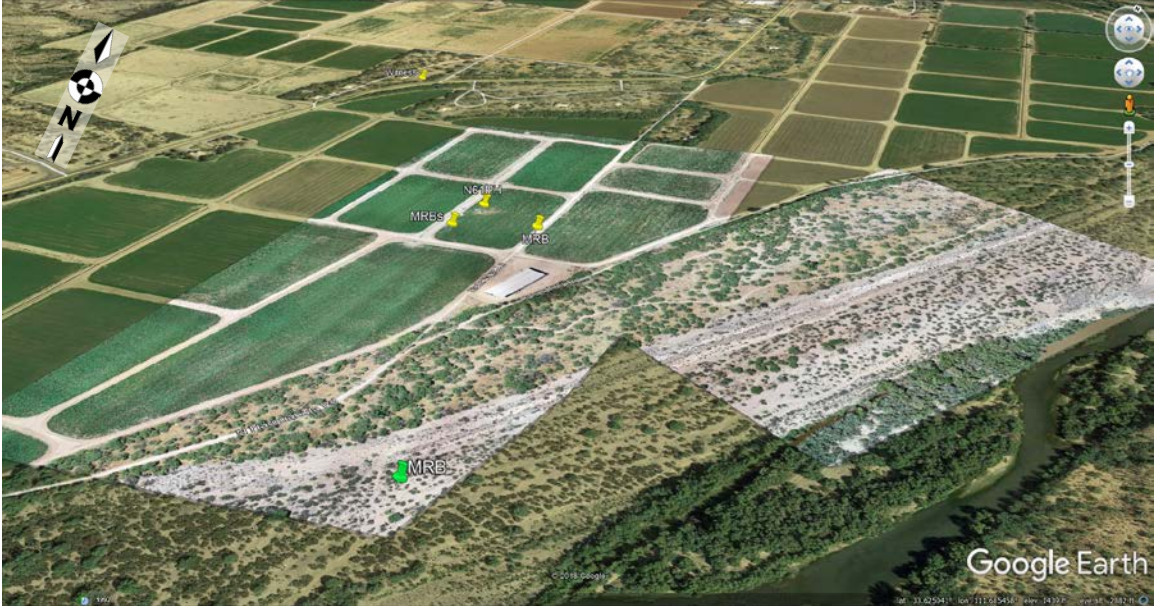
Figure 5 contains multiple orthomosaics generated by Pix4D overlaid on a Google Earth image. A green pushpin indicates the location of the missing main rotor blade, while yellow pushpins indicate the accident site, the witness location, and other recovered main rotor blade sections. Figure 6 contains the search areas extents overlaid on the Google Earth image along with the processed orthomosaics.

Figure 5 - Orthomosaic of searched areas overlaid on Google Earth (green pin indicates location of main rotor blade)
