## RECORD OF EMAIL

**Date: June 5, 2019**  
**Person Contacted: Mr. Sean Payne (NTSB Mechanical Engineer)**  
**NTSB Accident Number: WPR19FA123**

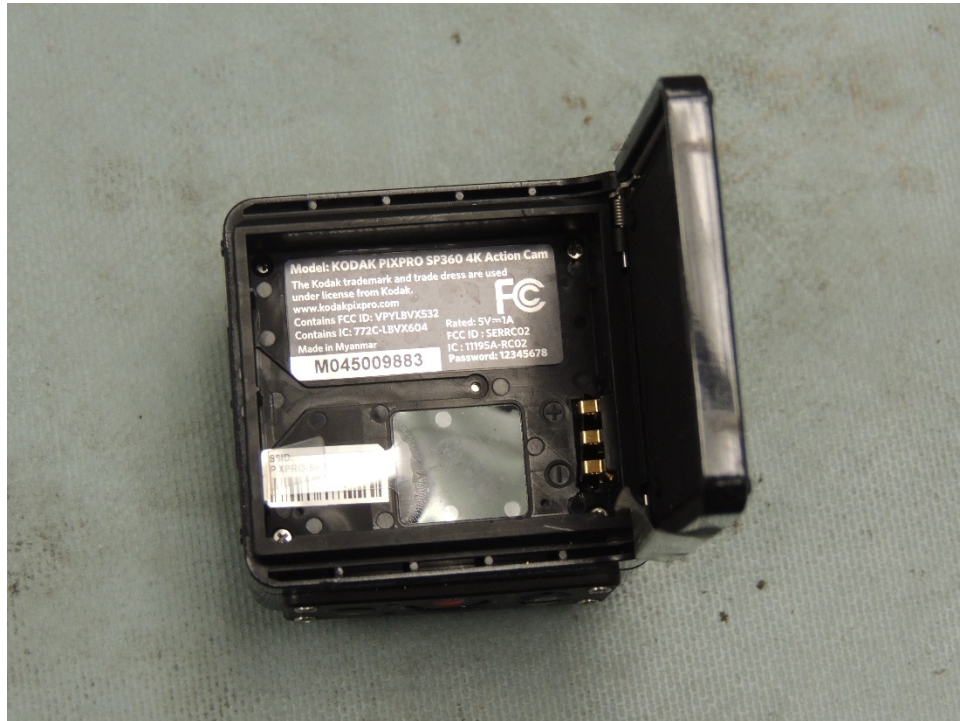
*Figure 1: Camera Information*

The Vehicle Recorder Division received a Kodak PixPro SP360 4K Action Camera (serial number M045009883). The device arrived exhibiting evidence of severe impact damage (kodakcamera.jpg, kodakcamera2.jpg). The memory card was of microSD style and was found seated in the appropriate memory card slot within the camera. The camera was disassembled and the microSD card was extracted. The microSD card was found to be cracked. Approximately one third of the memory card was missing (WPR19FA123\_chip1.jpg). The second half of the card was not present with what was shipped to the laboratory.

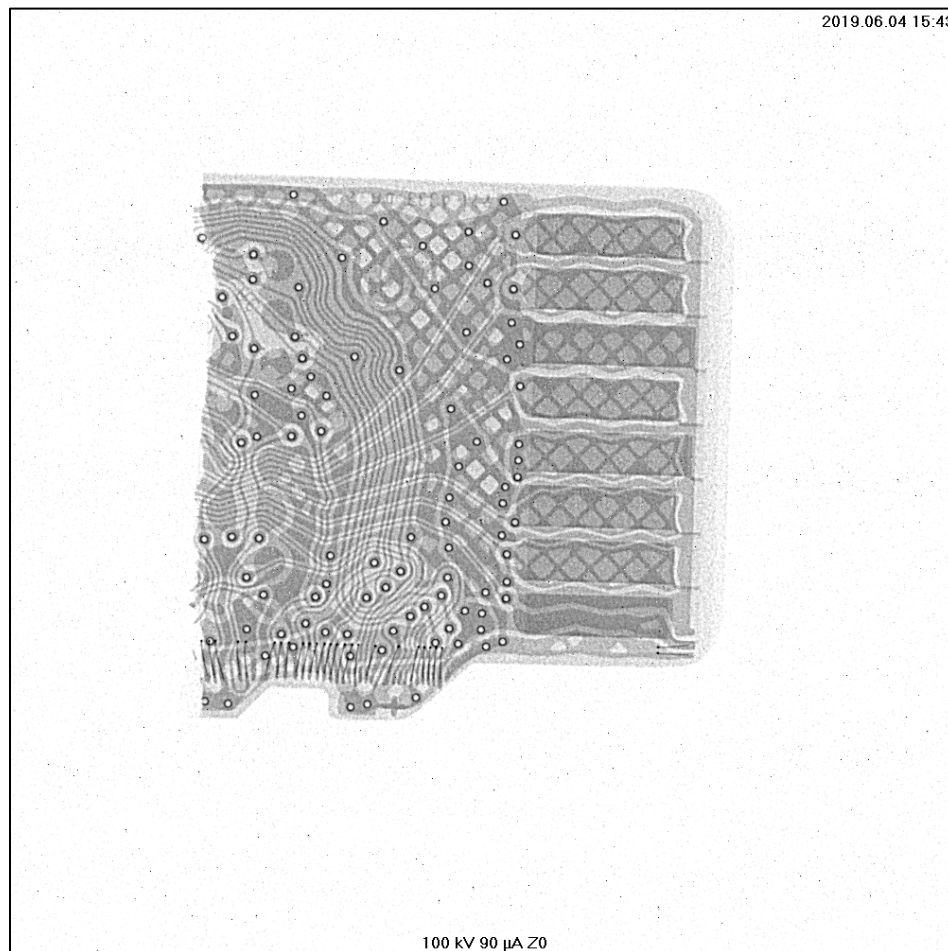
Figure 4: X-ray of Memory Card

The microSD card was examined using an x-ray microscope. The x-ray microscope revealed that the memory card was cracked in such a manner that precluded not only normal recovery, but alternative methods of recovery (WPR19FA123\_chipXray.bmp). The alternative method of recovery involves reading the microSD card through test points found in the memory card. Many of these test points were either severed or missing.

In the event the missing one third of the memory card was located, repair and readout is still not possible.
