Subject: WPR19FA183 - Ephraim, UT Weather Date: Tuesday, July 16, 2019 8:35:55 AM

## Weather conditions over the Ephraim, UT area on July 1, 2019

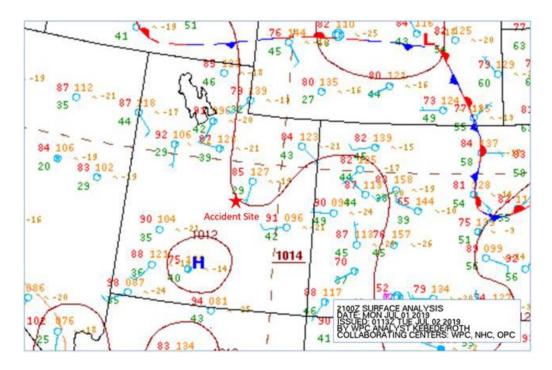
**Synoptic Conditions** – The northwest section of the NWS Surface Analysis Chart centered over Utah for 1500 MDT is included below with the approximate accident site noted by a red star. The chart depicted a dissipating stationary front extending west to east over southern Idaho and Wyoming. A high pressure system at 1014-hectopascals (hPa) was located over southern Utah immediately south of the accident site with a general high pressure ridge extending over the state. The station models surrounding the accident site depicted clear skies, light winds of 5 knots, with temperatures in the upper 80's to low 90's degrees Fahrenheit (F).

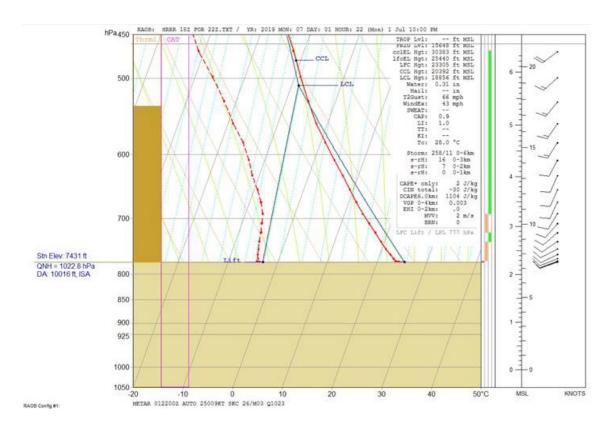
**Sounding** – A High Resolution Rapid Refresh (HRRR) numerical model sounding was obtained from the NOAA Air Resource Laboratory archive data over the approximate accident site at 1600 MDT and was plotted on a Skew T Log P diagram. The numerical model depicted an elevation of 7,431 ft, a surface temperature of 25.5° C (78° F), a dew point temperature of -3.0° C (27° F), a relative humidity of 15%, with a density elevation of approximately 10,016 ft. The sounding indicated support for strong thermal activity from the surface through 17,500 ft. The lifted condensation level (LCL) was identified at 11,425 ft agl (18,856 ft msl) with the convective condensation level above that at 12,961 ft agl. The precipitable water content was 0.31 inches. The sounding was too dry for cloud formation and none were indicated. The lifted index (LI) was 1.0 and indicated a conditional unstable atmosphere.

The wind profile indicated a surface wind from the southwest at 9 knots with winds backing to the south-southwest through 15,000 ft and then slowly veering to the southwest with height. The mean 0 to 6 kilometer or 18,000 ft wind was from 230° at 15 knots, and the maximum wind was identified at 40,000 ft from 220° at 53 knots. The profile did not indicate any significant turbulence, icing, or mountain wave activity over the area.

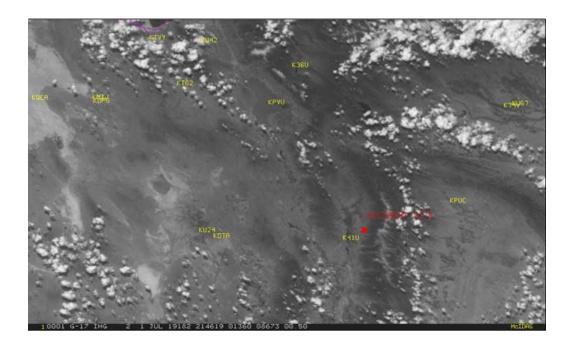
**Satellite** – the GOES-17 visible satellite image for 1546 MDT (2146Z) is included below and depicted clear skies over the accident site, with fair weather cumulus clouds on the eastern slopes of the mountain range immediately east of the accident site.
