## **NATIONAL TRANSPORTATION SAFETY BOARD**

# **AIRFRAME AND ENGINE EXAMINATION**

**WPR19LA006**

Location: Cape Girardeau, MO  
Date: October 9, 2018  
Aircraft: Vans RV-6A, N451JP  
Serial Number 23435  
NTSB IIC: Albert Nixon

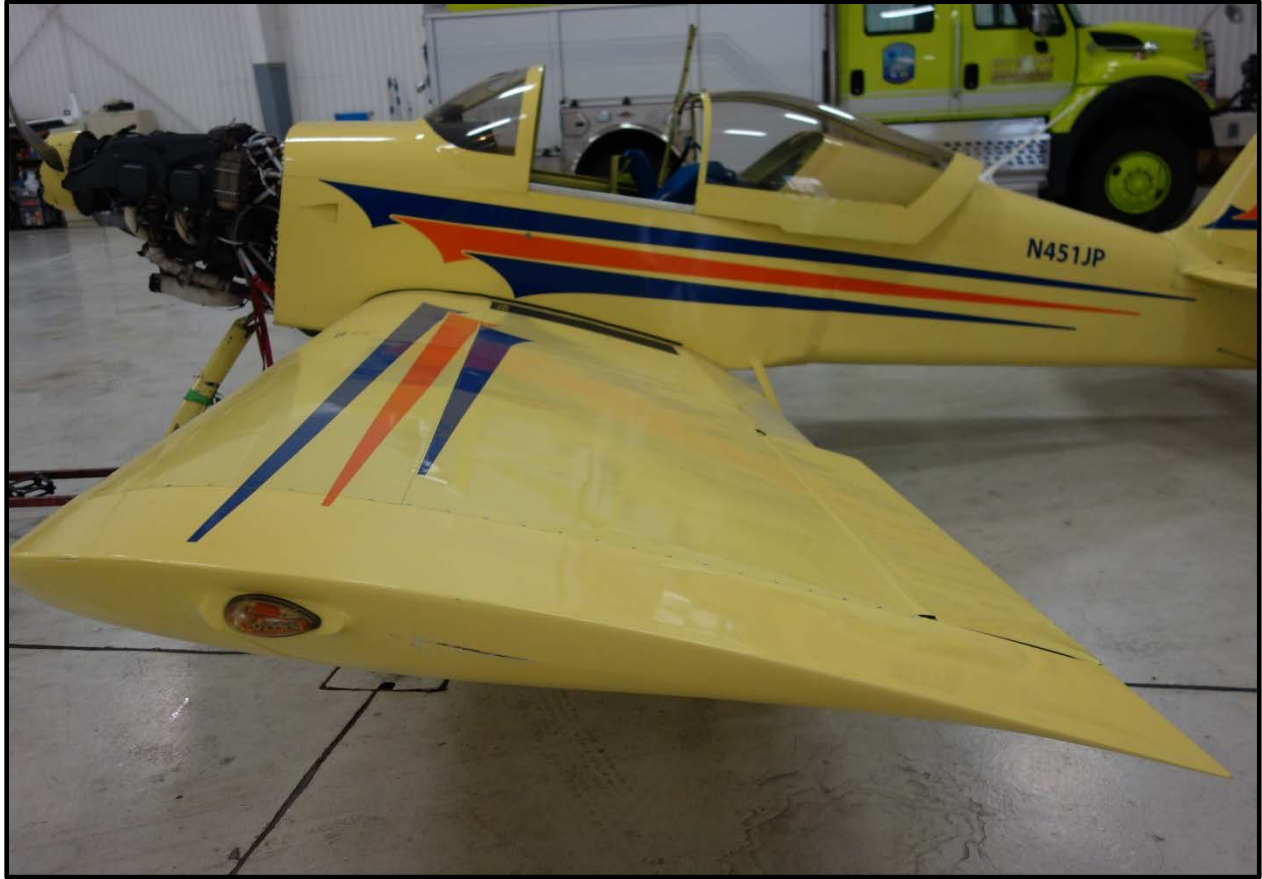
**Figure 1: View of airplane in hanger for examination (left side).**

The left and right wings were attached. The outboard portion of the right wing's leading edge, exhibited a circular crushing impact damage on the outboard 2 ft. Recovered fragments of the windscreen showed no signs of an oil leakage or a bird strike. Throttle control continuity was established. A crease in the fuselage was observed near the cabin compartment. The canopy was scattered on the right side.

The flaps and ailerons were attached at all their respective attachment points. The horizontal stabilizers exhibited wrinkling in the skin and the elevators were attached. The right horizontal stabilizer was bent downwards about 6 inches from the trailing edge from the outer tip. The vertical stabilizer's top portion was crushed. The rudder was attached at all its respective attachment points. Near the middle attachment about mid-span, some impact damage was observed on the rudder. The main gear struts were attached. The nose gear strut was partially attached. All tires and wheels were intact. Brake continuity was established to both wheels. The left elevator's trim tab was observed to be in the neutral position.

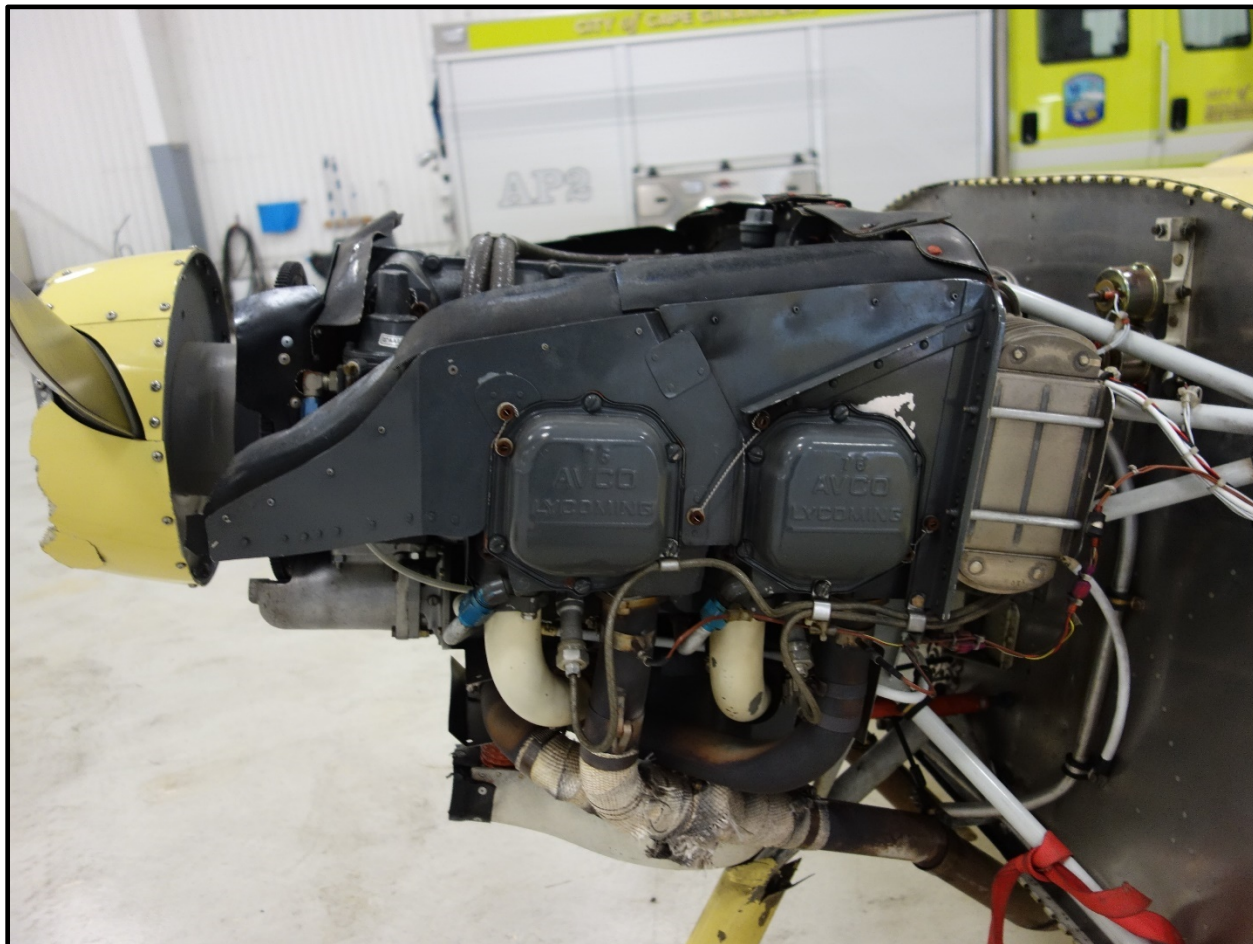
Figure 2: View of engine (left side).

Examination of the Lycoming O-320-H2AD engine, revealed that all engine components and accessories were present, and the engine remained attached to the airframe. The crankshaft was rotated by hand, utilizing the propeller, and rotational continuity was established throughout the engine. Accessory section, and valve train. During crankshaft rotation, thumb compression and suction were attained on all cylinders. A borescope inspection of the cylinders revealed evidence of normal operational conditions.

The two-bladed propeller remained attached to the crankshaft propeller flange with the blades attached. One propeller blade was slightly bent aft about mid-span and the other blade was intact and exhibited a few chord-wide scratches on the outer three inches.

The examination of the engine and the subsequent engine run revealed no evidence of pre-impact mechanical anomalies or malfunctions that would have precluded normal operation.
