# **Analysis of Modules from Accident WPR19MA177**

Prepared for the National Transportation Safety  
Board

October 15, 2019

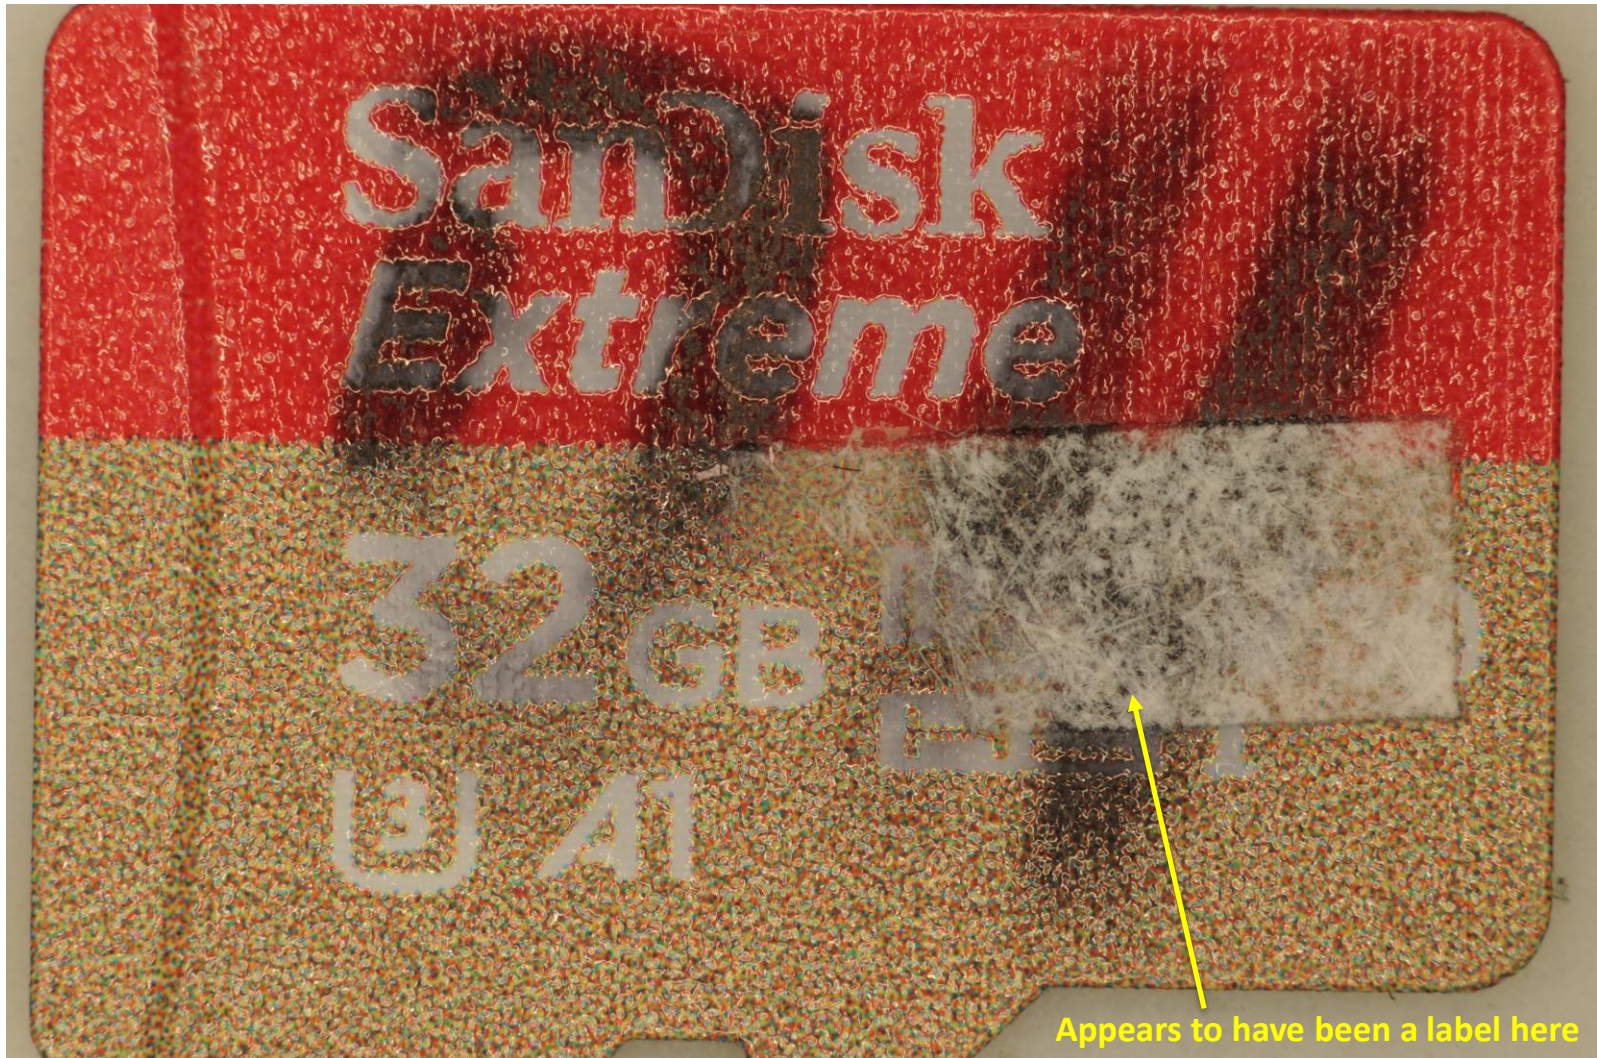
# Optical Image of the Top Side (Dark Field)

No evidence of thermal or mechanical damage

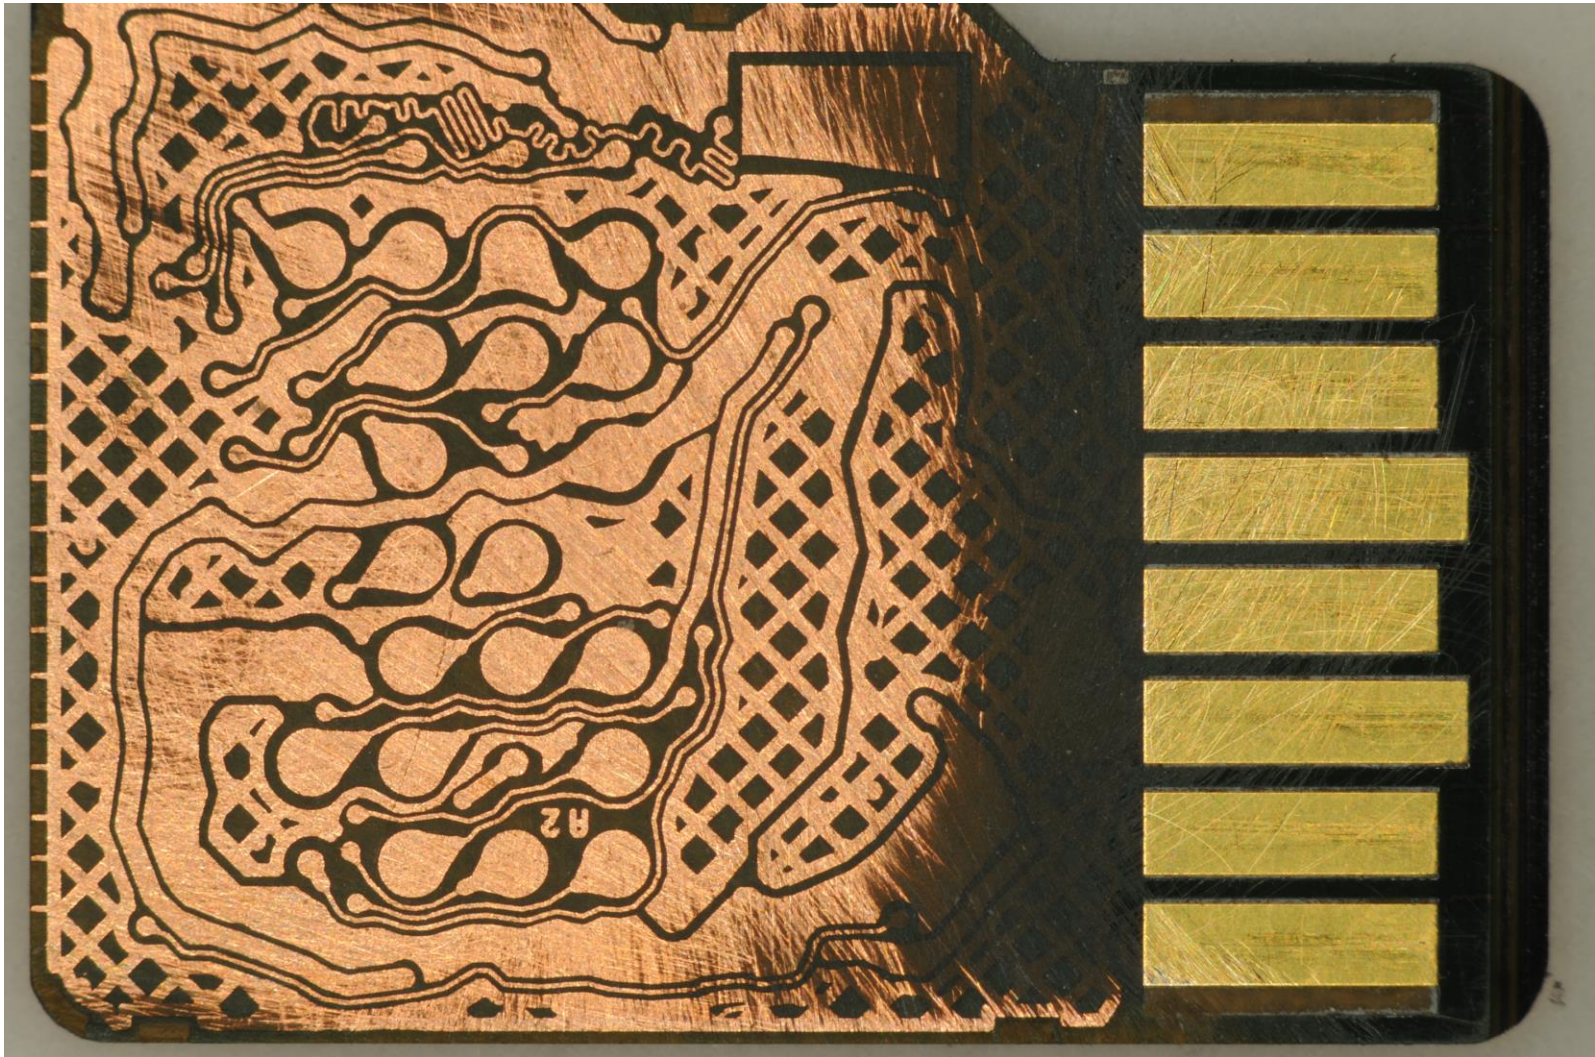
# Optical Image of the Bottom Side (Dark Field)

- No evidence of thermal or mechanical damage (other than the mechanical removal of the bottom dielectric)
- Grinding did not go through multiple planes

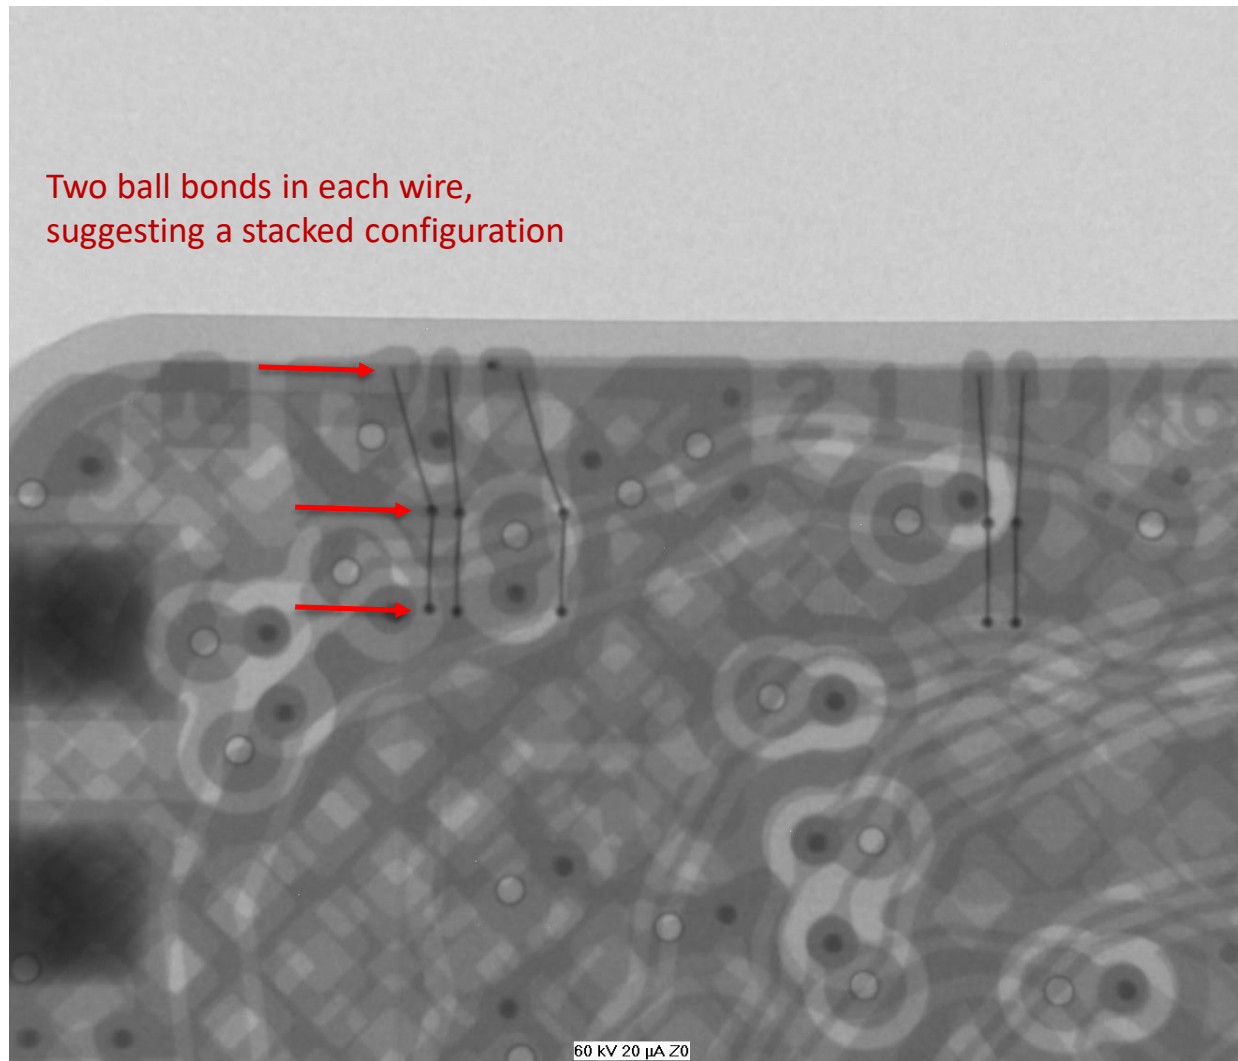
# Top Row of Wire Bonds at Higher Magnification (1)

- No evidence of damage to the wire bonds
- Circuitry of the laminate appears to be intact

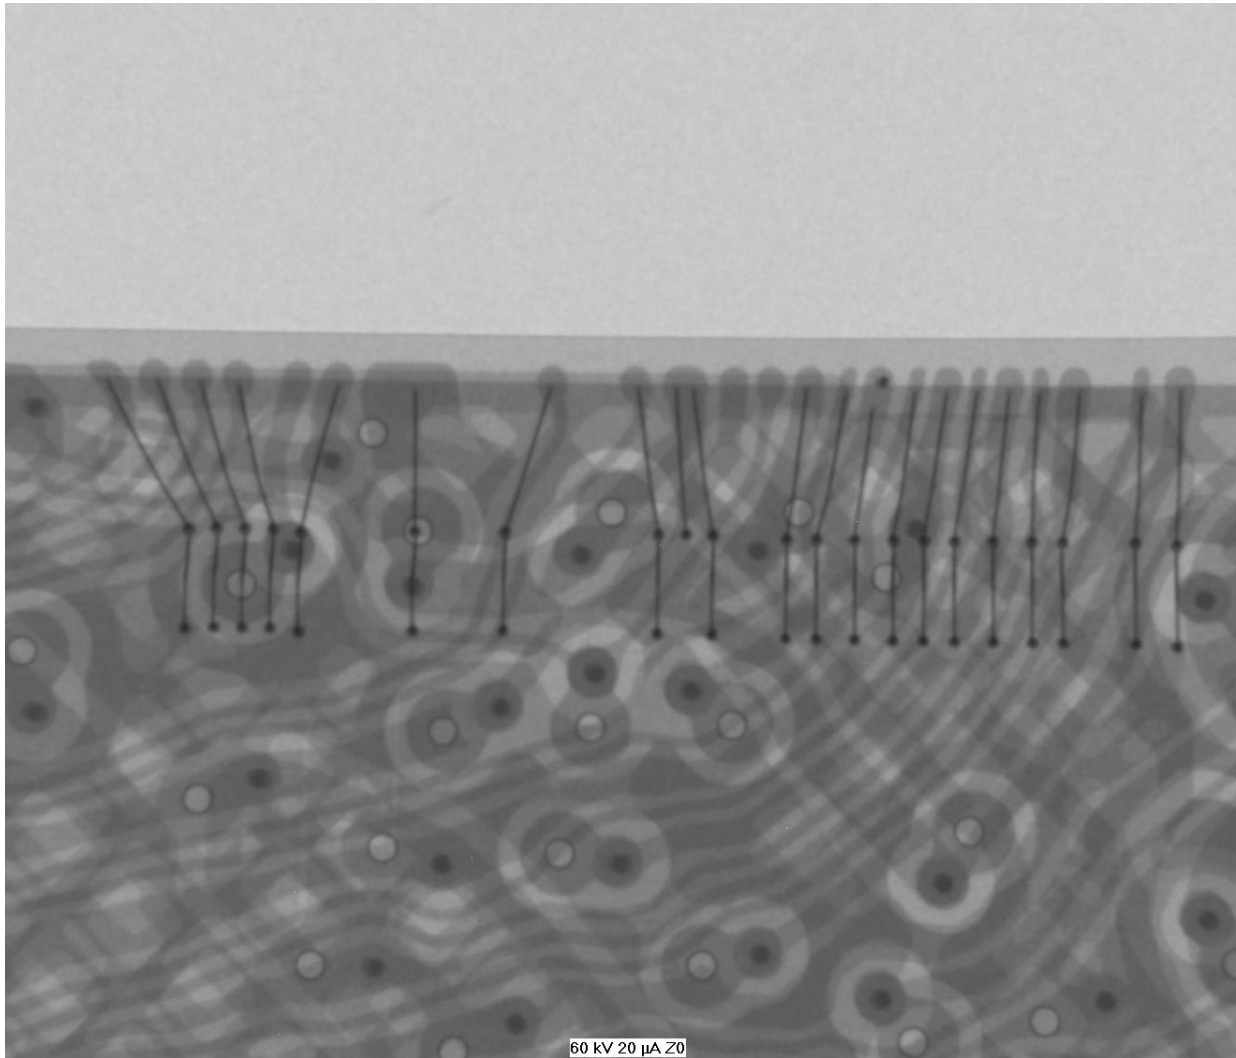
## Top Row of Wire Bonds at Higher Magnification (2)

- No evidence of damage to the wire bonds
- Circuitry of the laminate appears to be intact

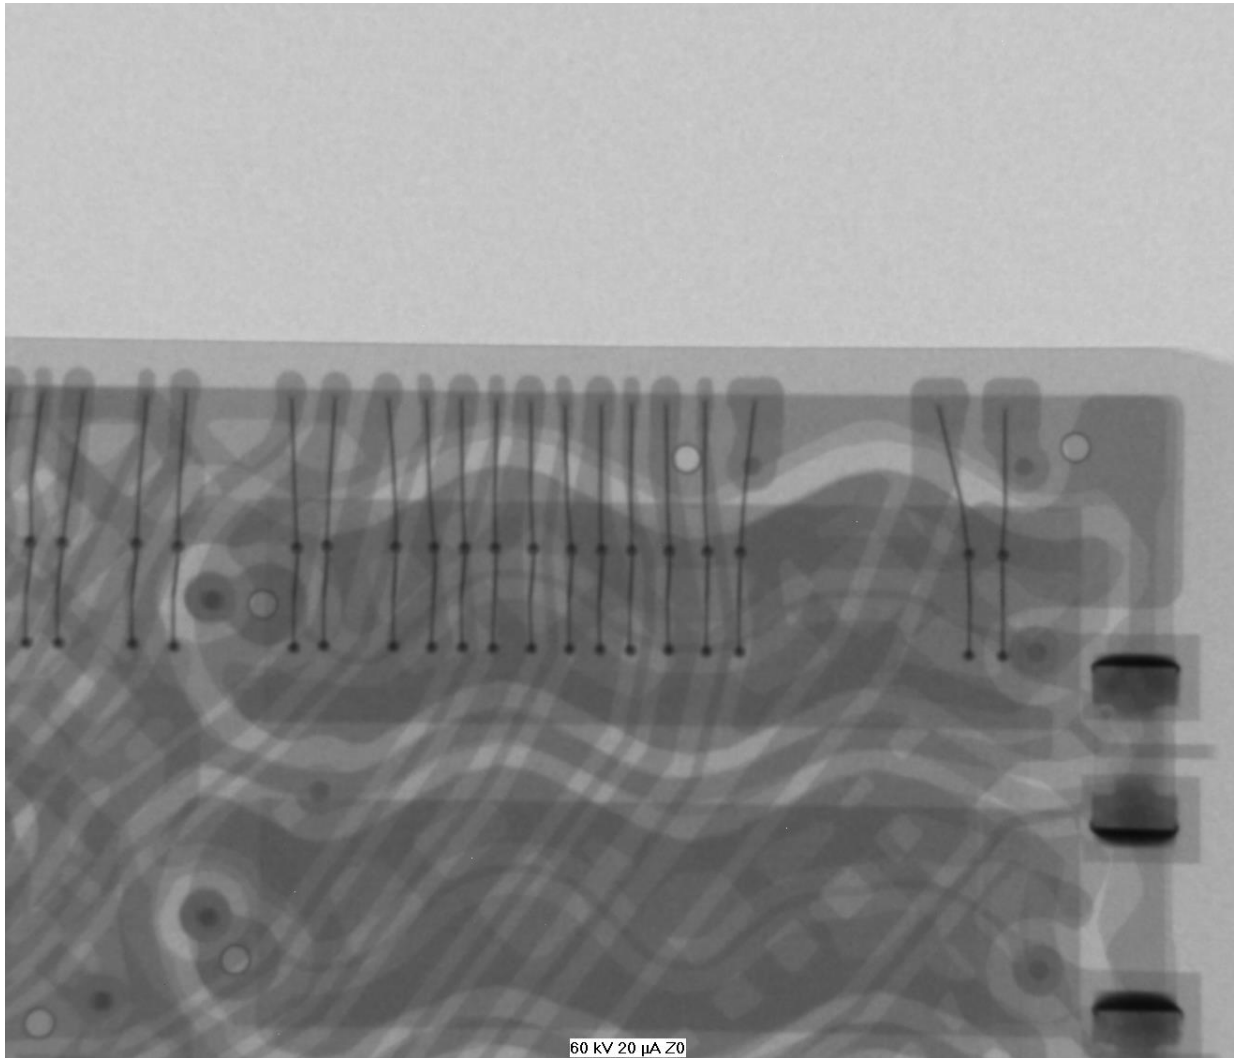
# Top Row of Wire Bonds at Higher Magnification (3)

- No evidence of damage to the wire bonds
- Circuitry of the laminate appears to be intact

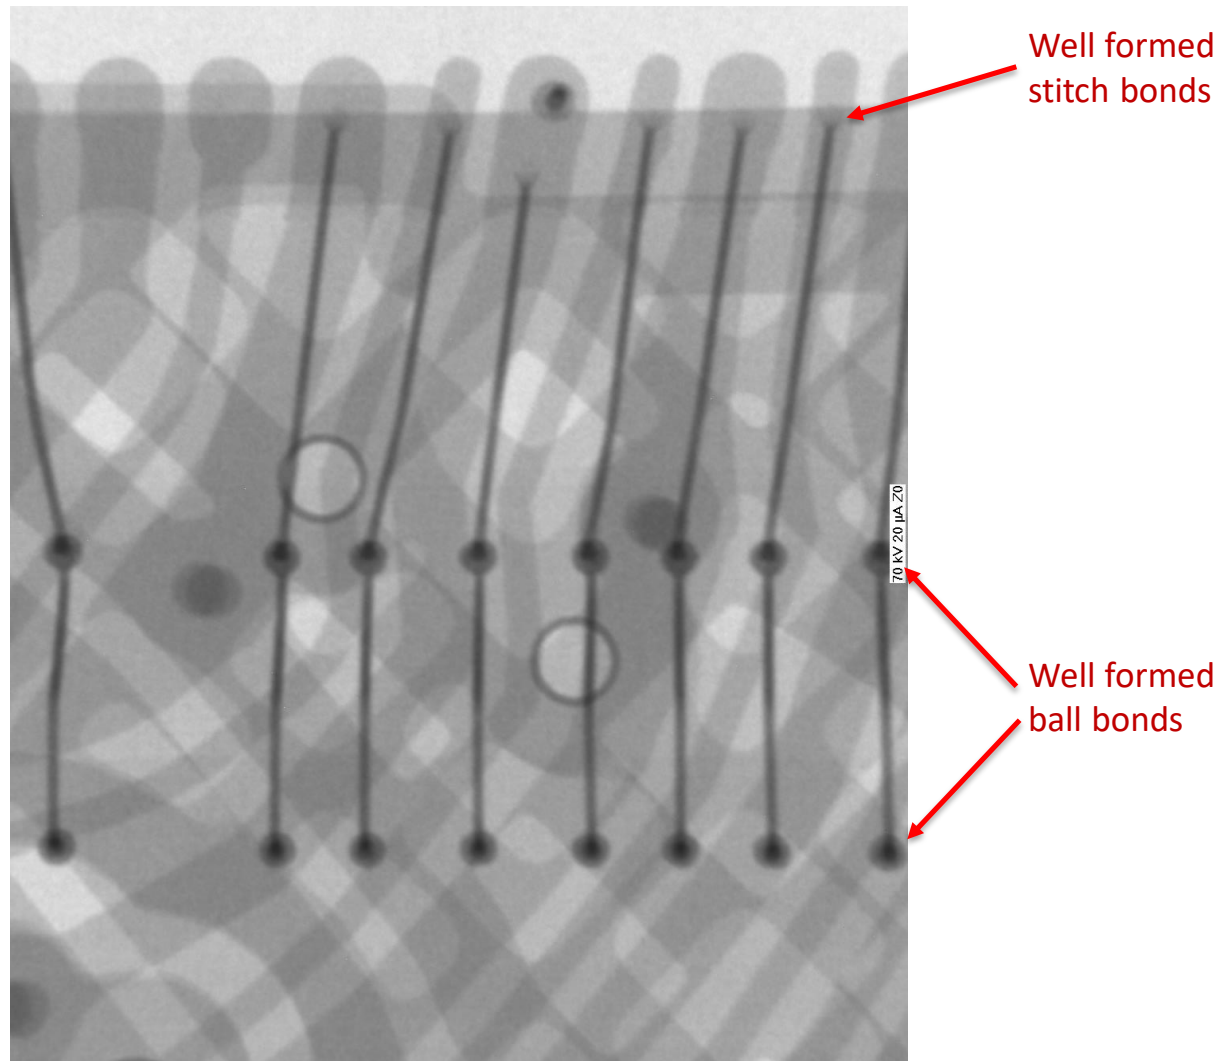
# Top Row of Wire Bonds at High Magnification

- No evidence of damage to the wire bonds
- Circuitry of the laminate appears to be intact

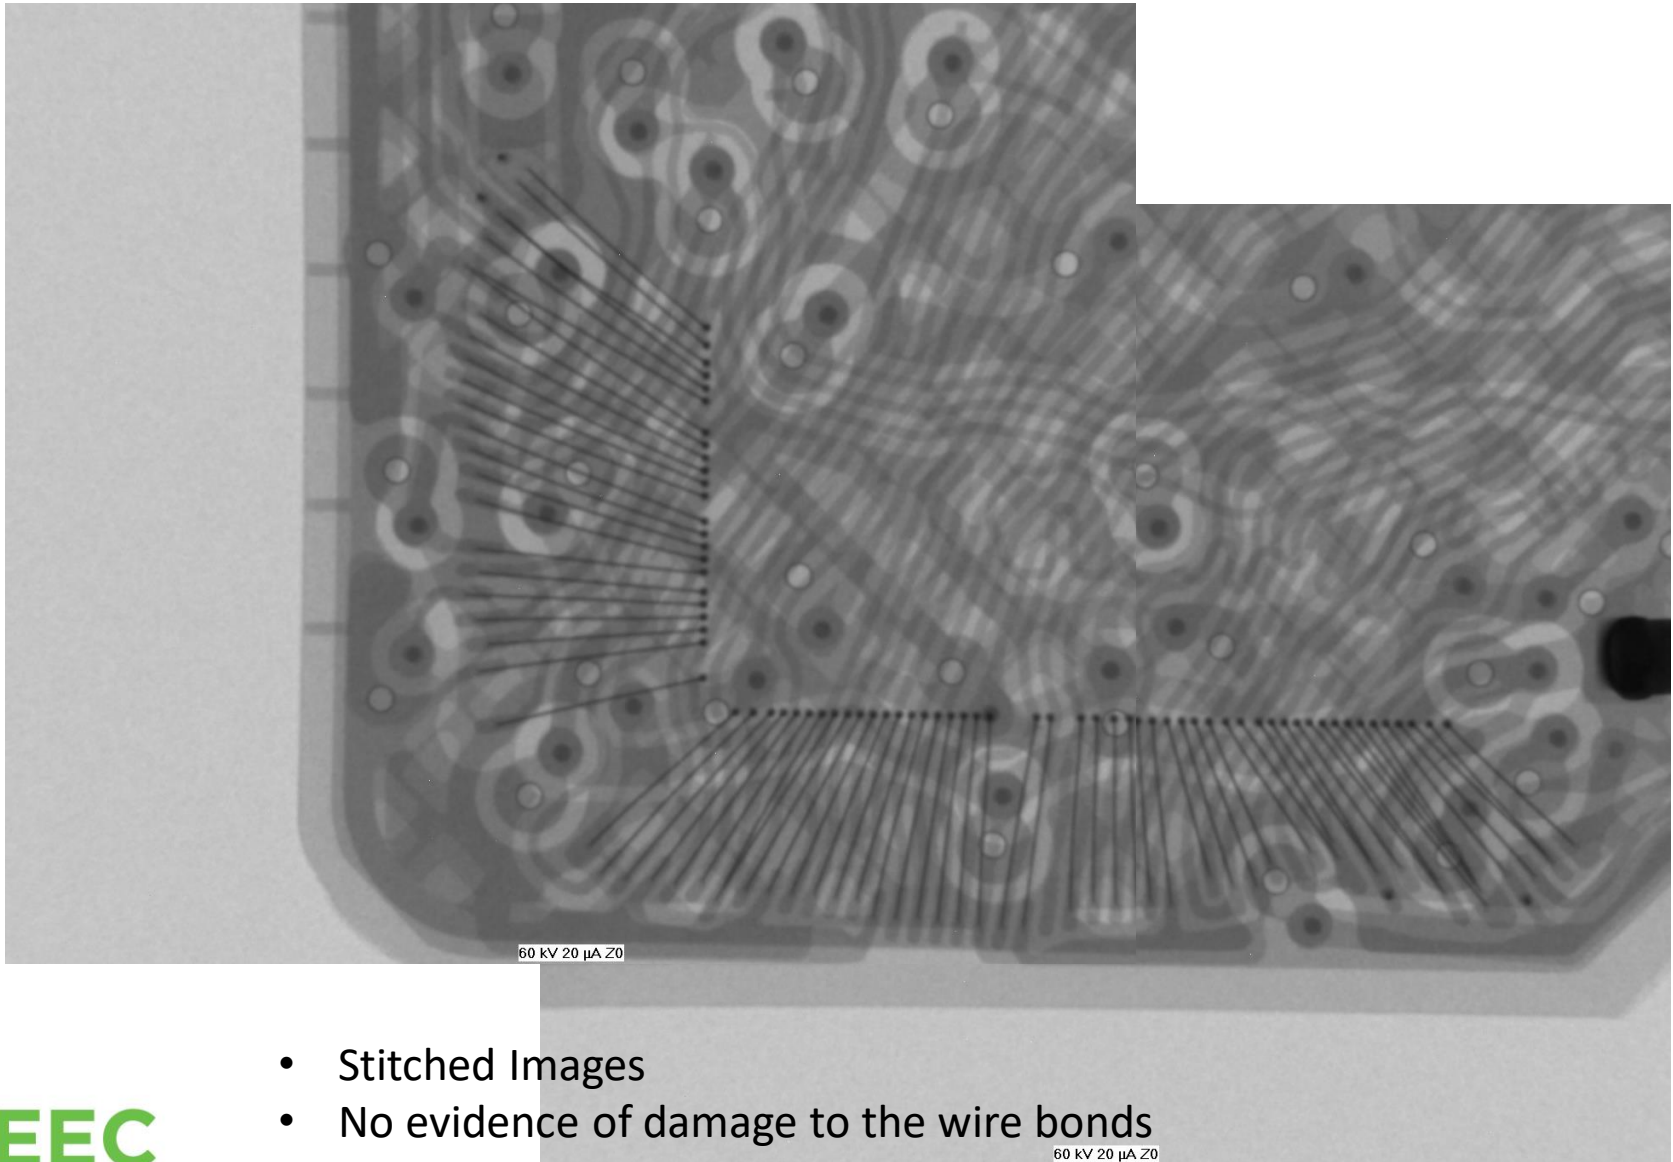
# Bottom Row and Left Column of Wire Bonds

- Stitched Images
- No evidence of damage to the wire bonds
- Circuitry of the laminate appears to be intact

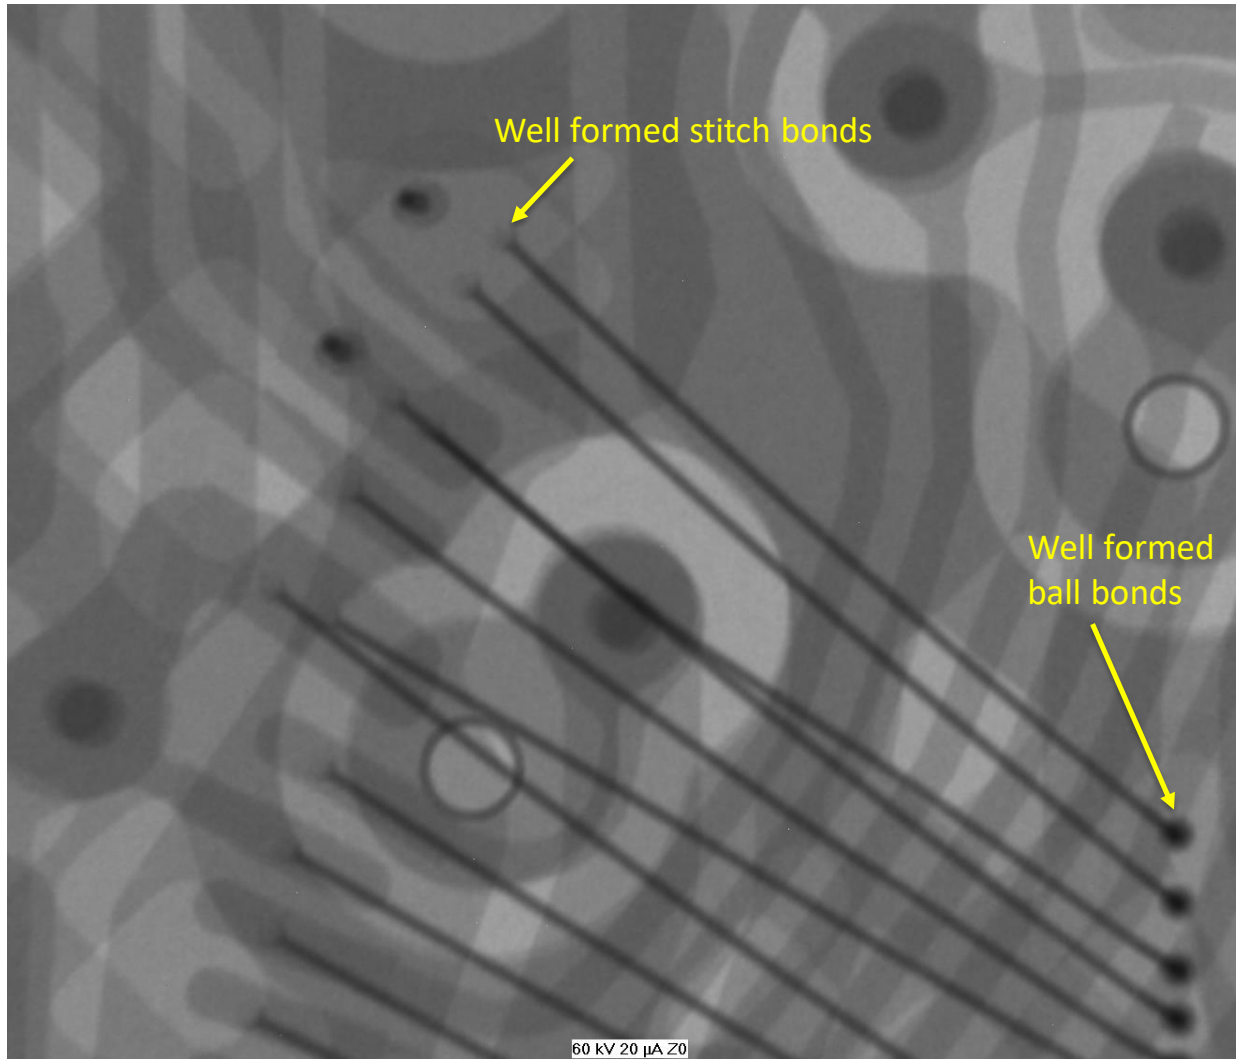
# Left Side Wire Bonds at High Magnification

- No evidence of damage to the wire bonds
- Circuitry of the laminate appears to be intact

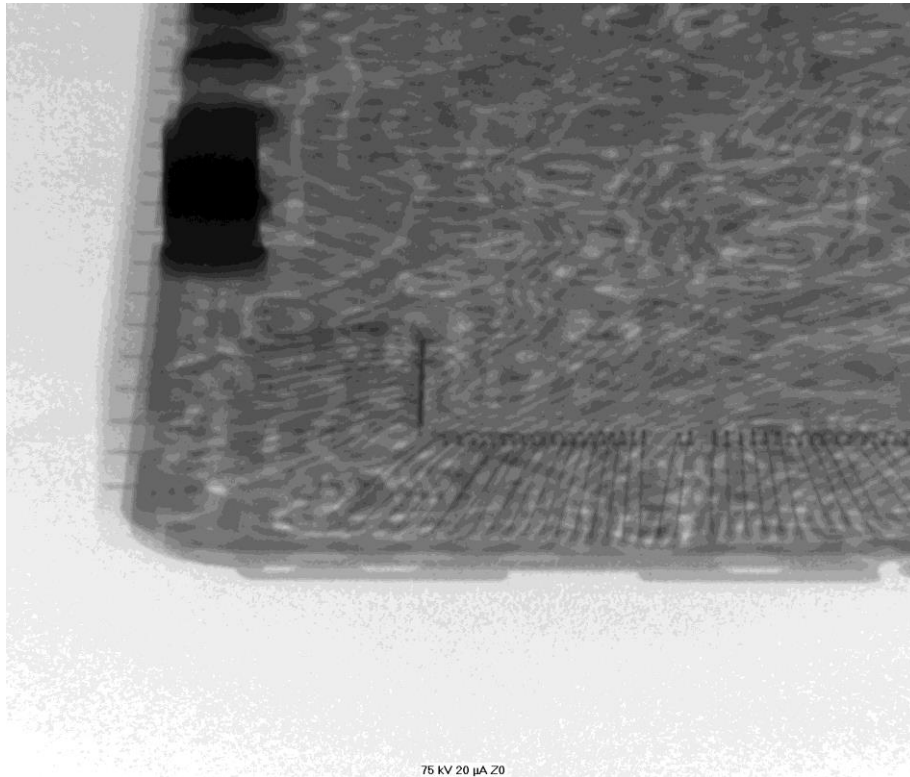
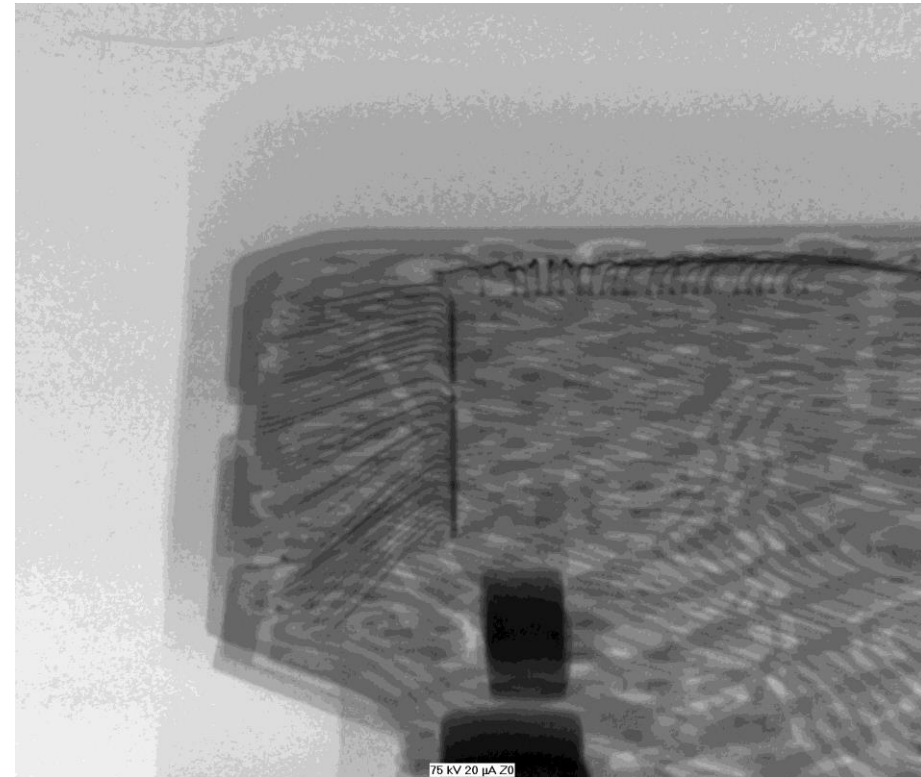
# Tilted View of the Corner Bonds (70° Tilt)

No evidence of out of plane string of bonds (lack of planar string can indicate that the wire bonds were pulled away from the chip)

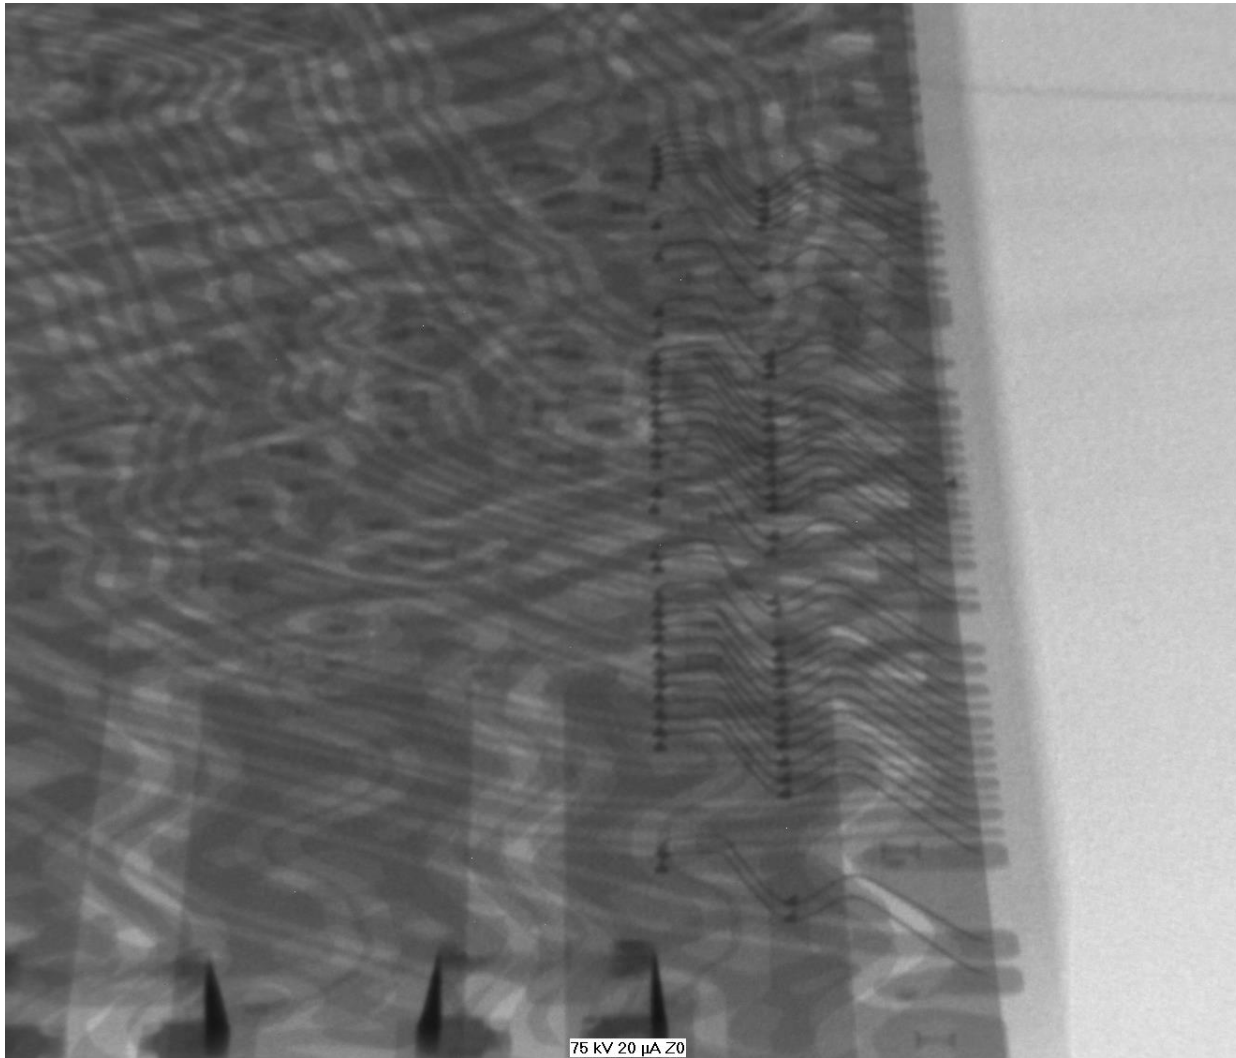
# Tilted View of the Top Row of Wire Bonds

- No evidence of damage to the wire bonds
- Different row height confirms stacked configuration of the chips in this area

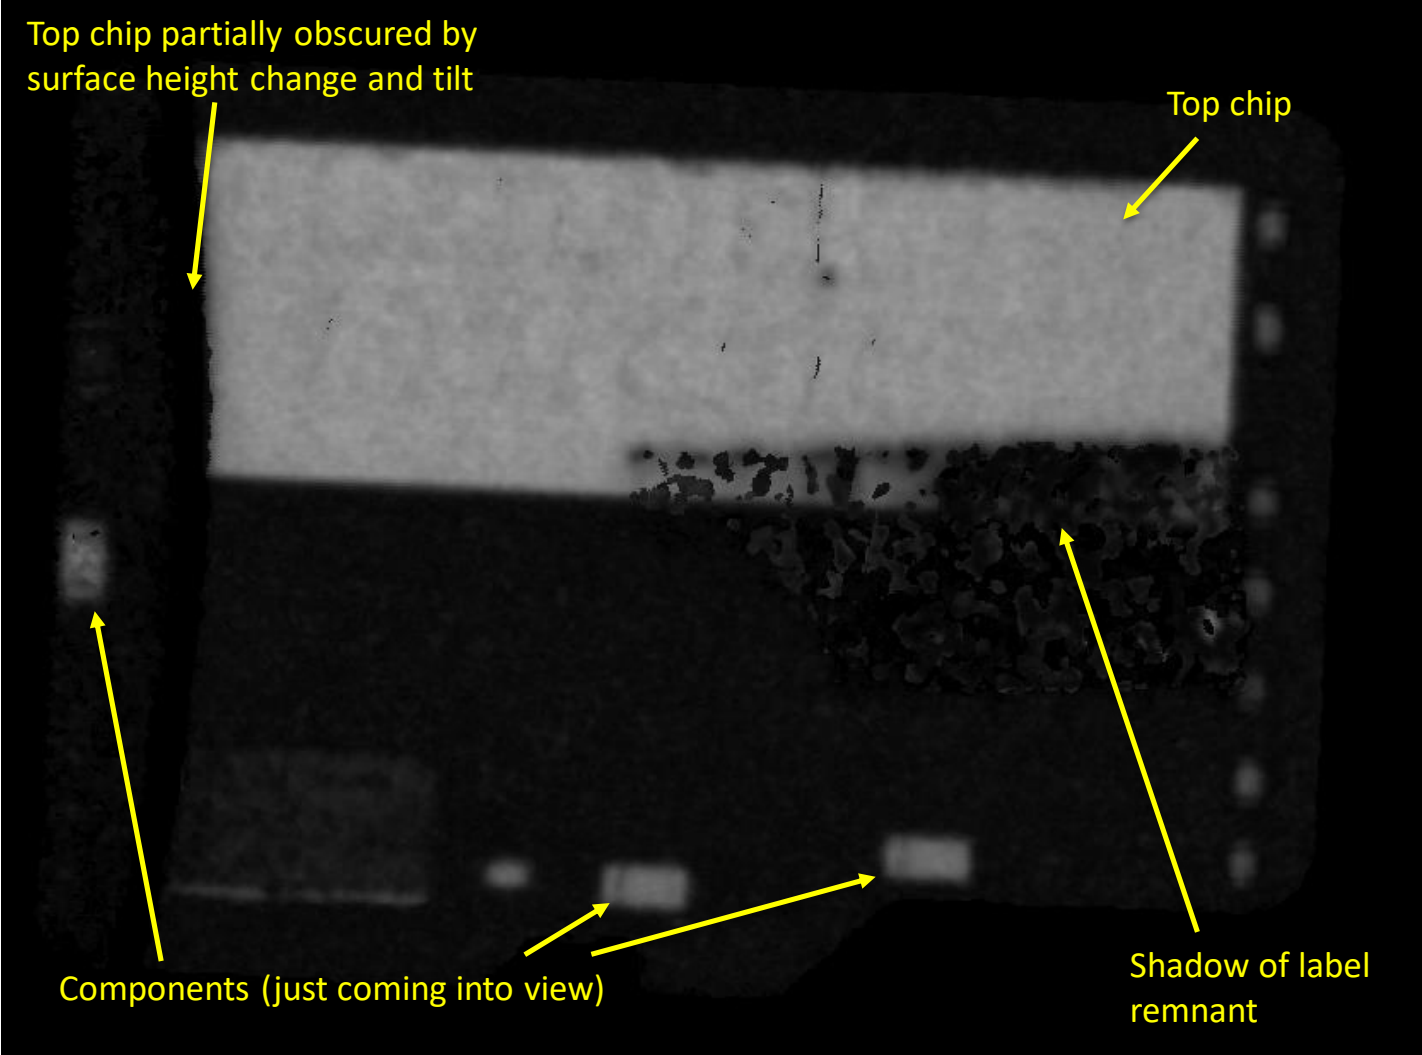
# Image of the Top Chip

No evidence of damage to the chip

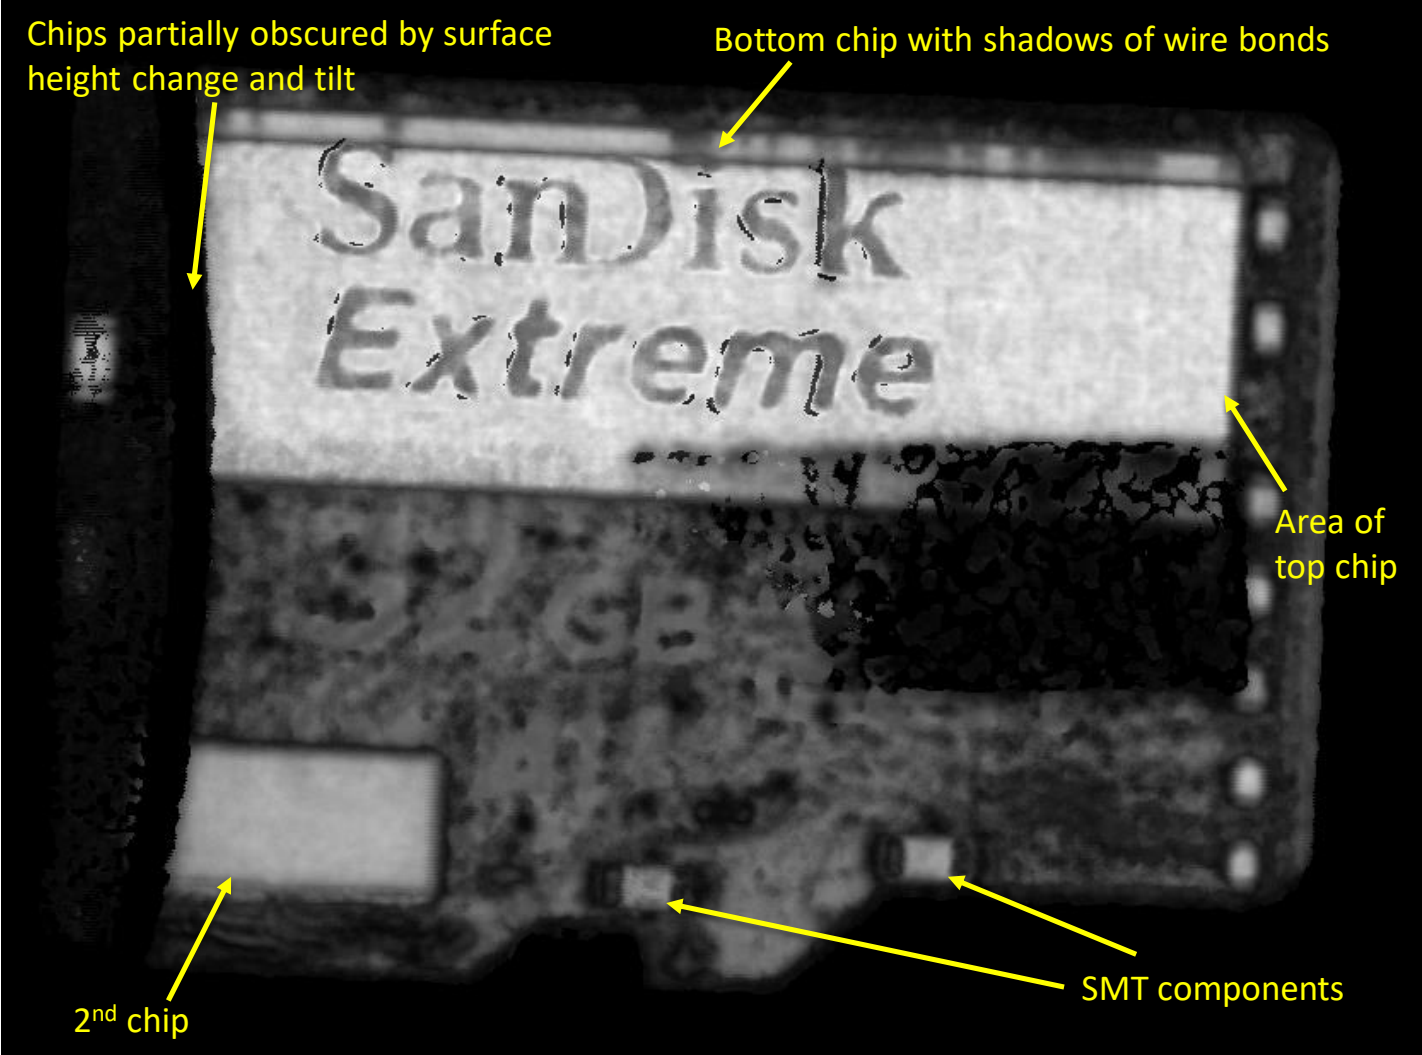
# Image of the Bottom Chip(s)

No evidence of damage to the either chip

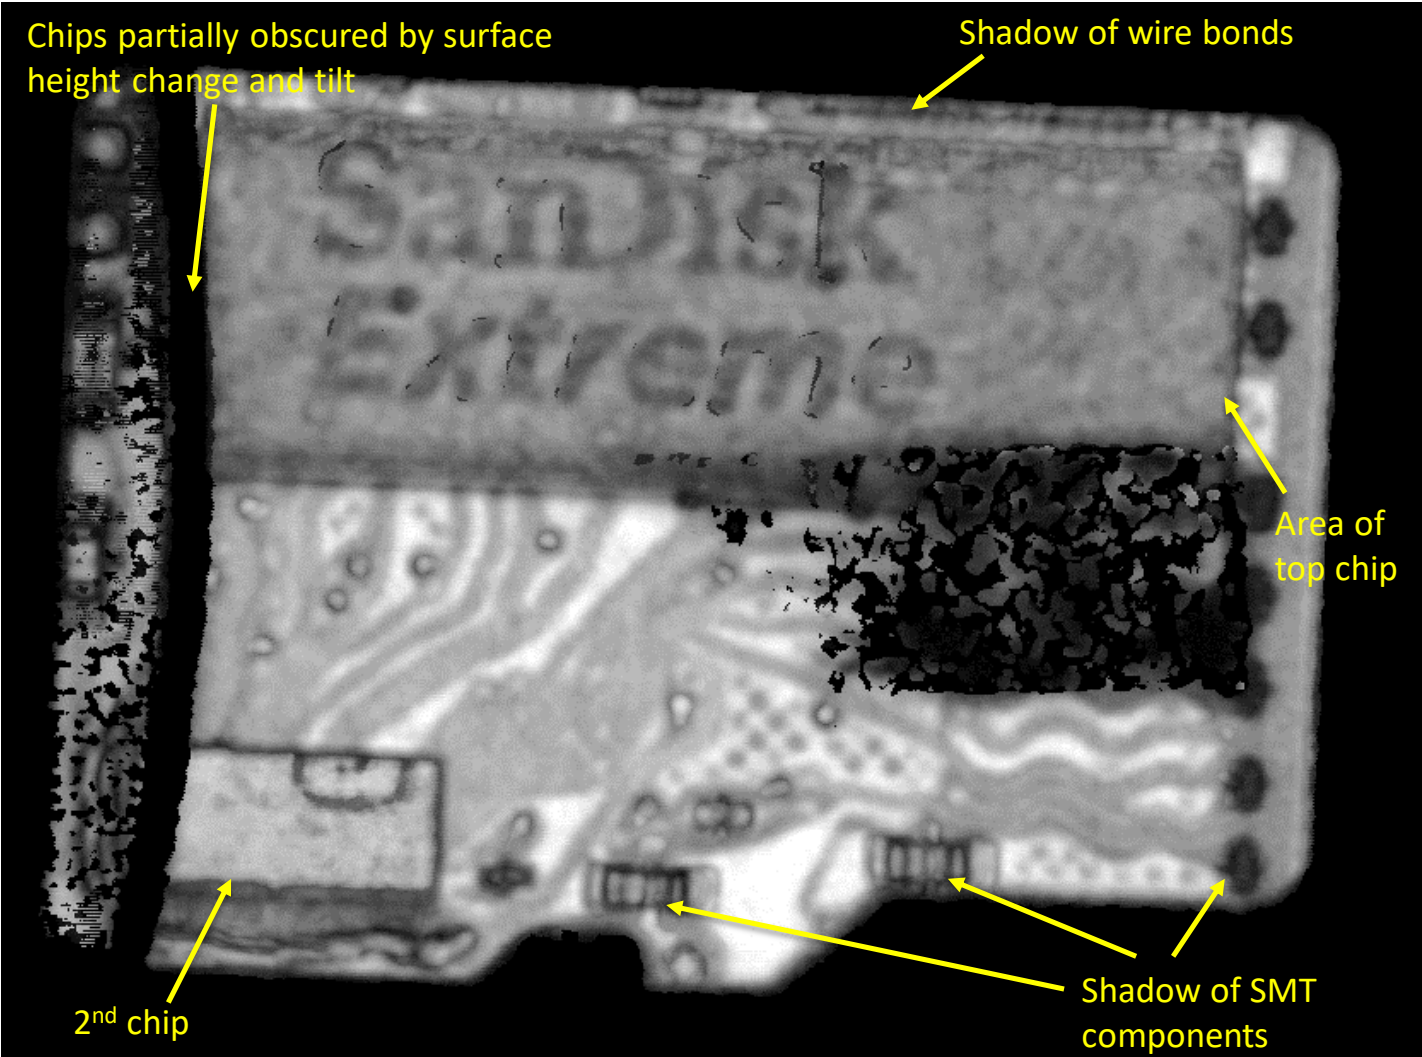
# Image of the Top Layer of Circuitry in the Laminate

No evidence of suspicious delaminations in the package;

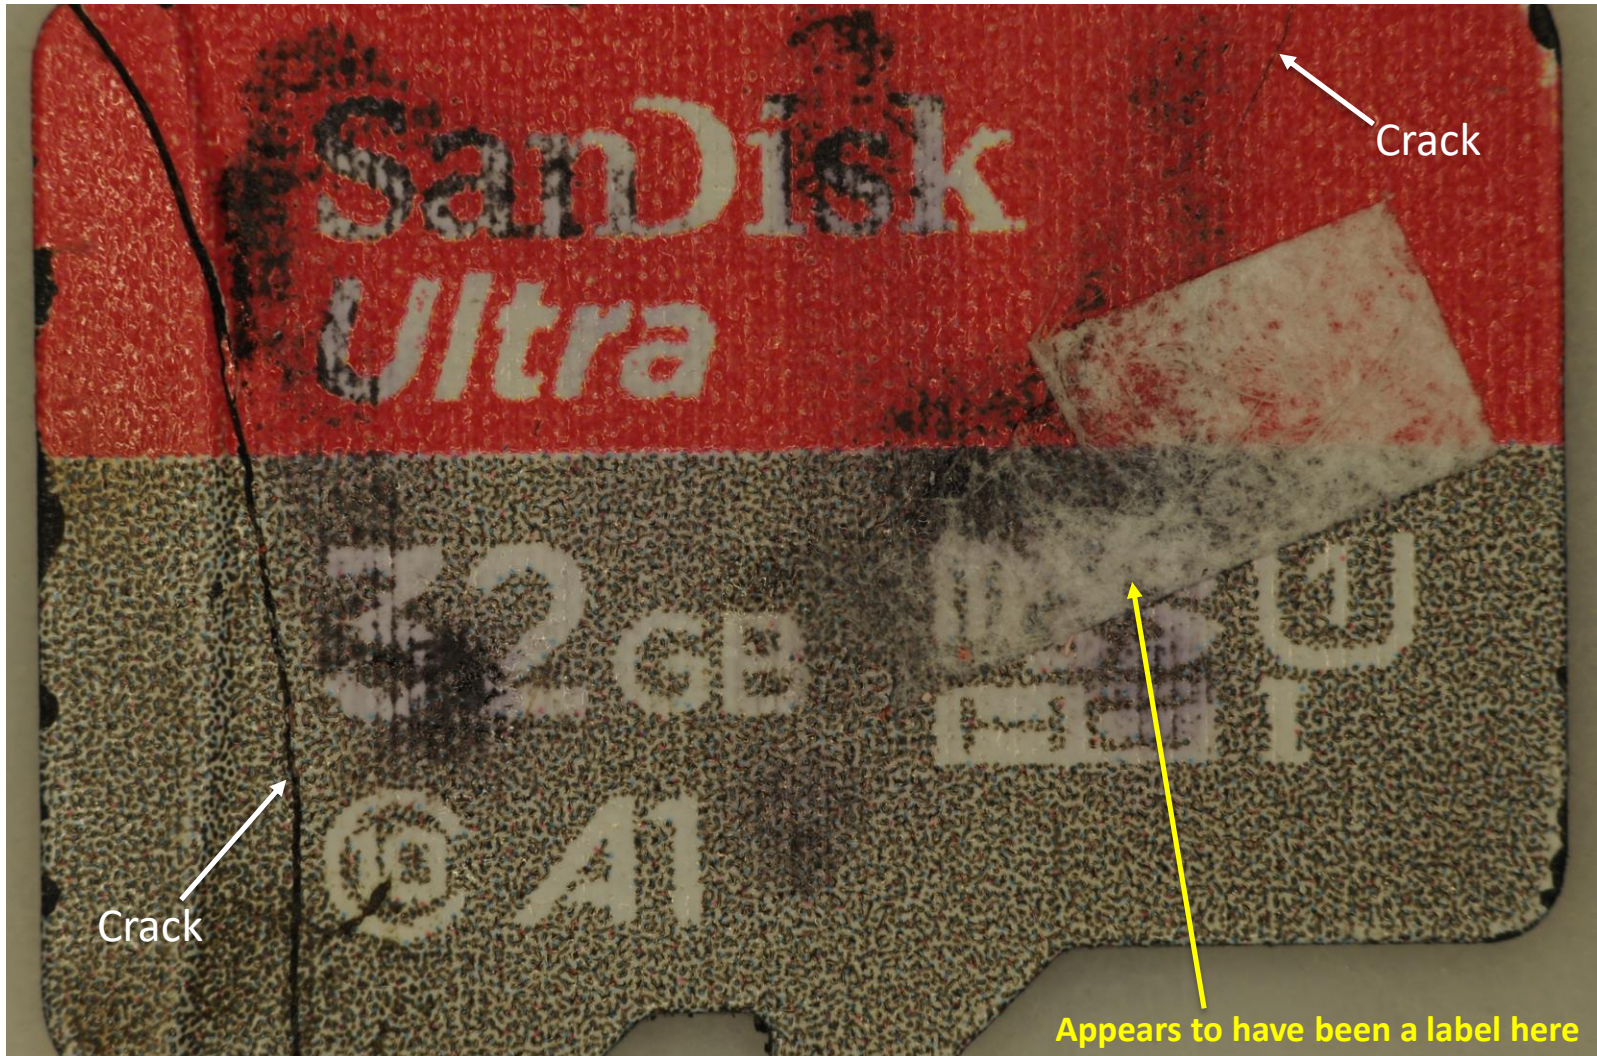
# Optical Image of the Top Side (Dark Field)

- No evidence of thermal
- Two cracks are visible from the surface

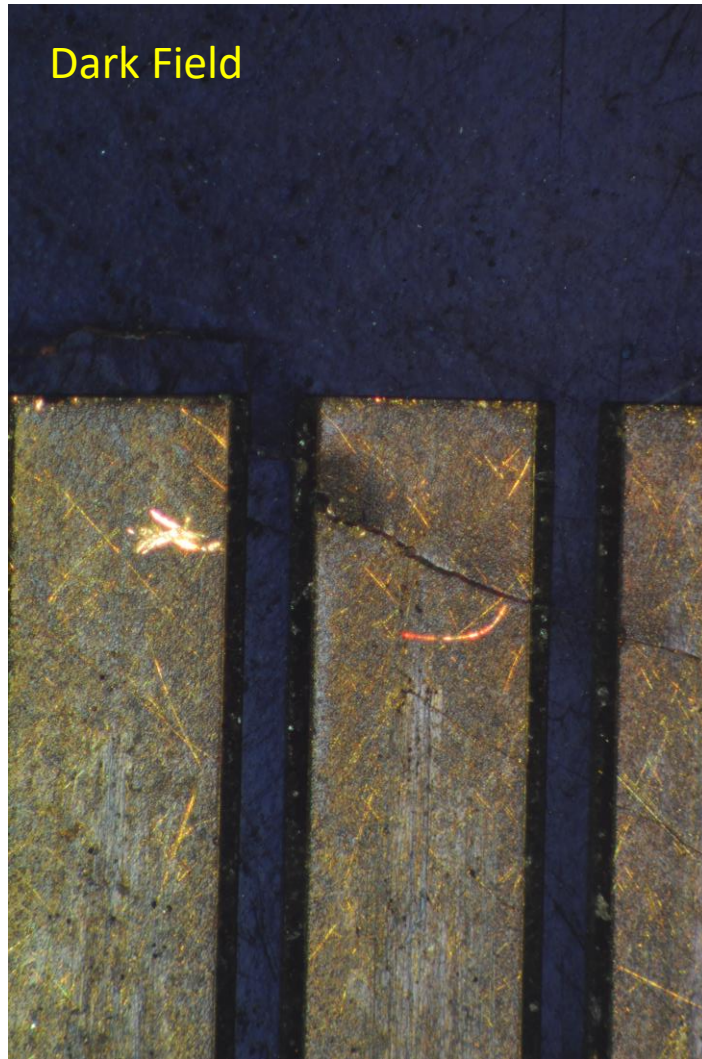
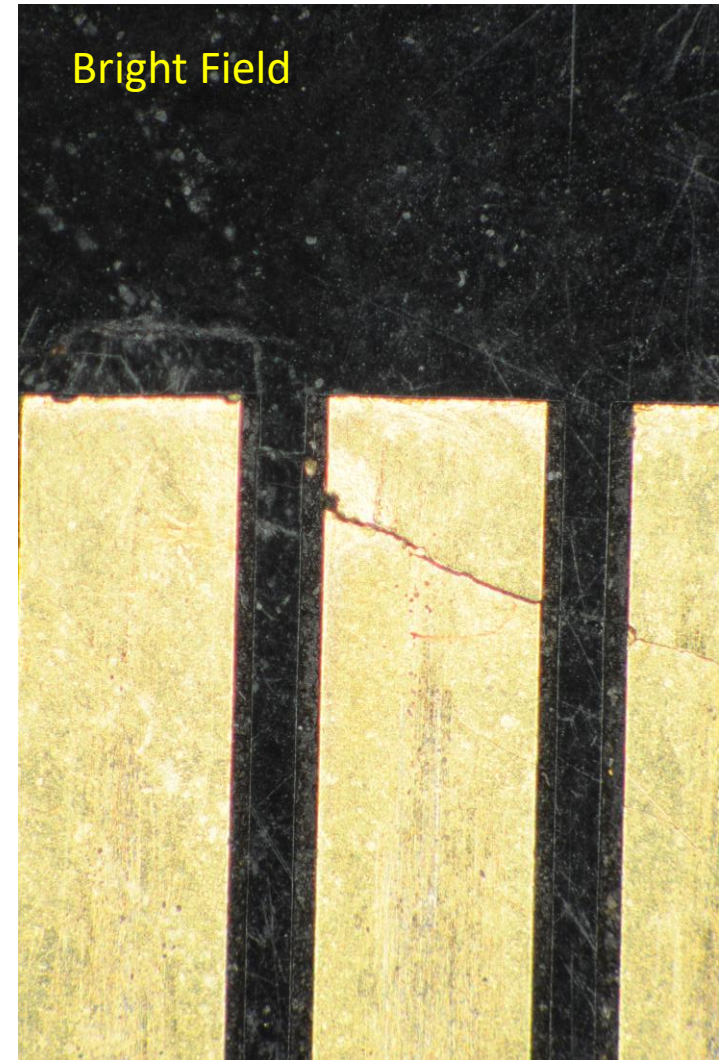
# Back Side View of the Area with the Fine Crack

- Crack has propagated through the module to the back side circuitry
