# **Analysis of Modules from Accident WPR19MA177**

Prepared for the National Transportation Safety  
Board

October 15, 2019

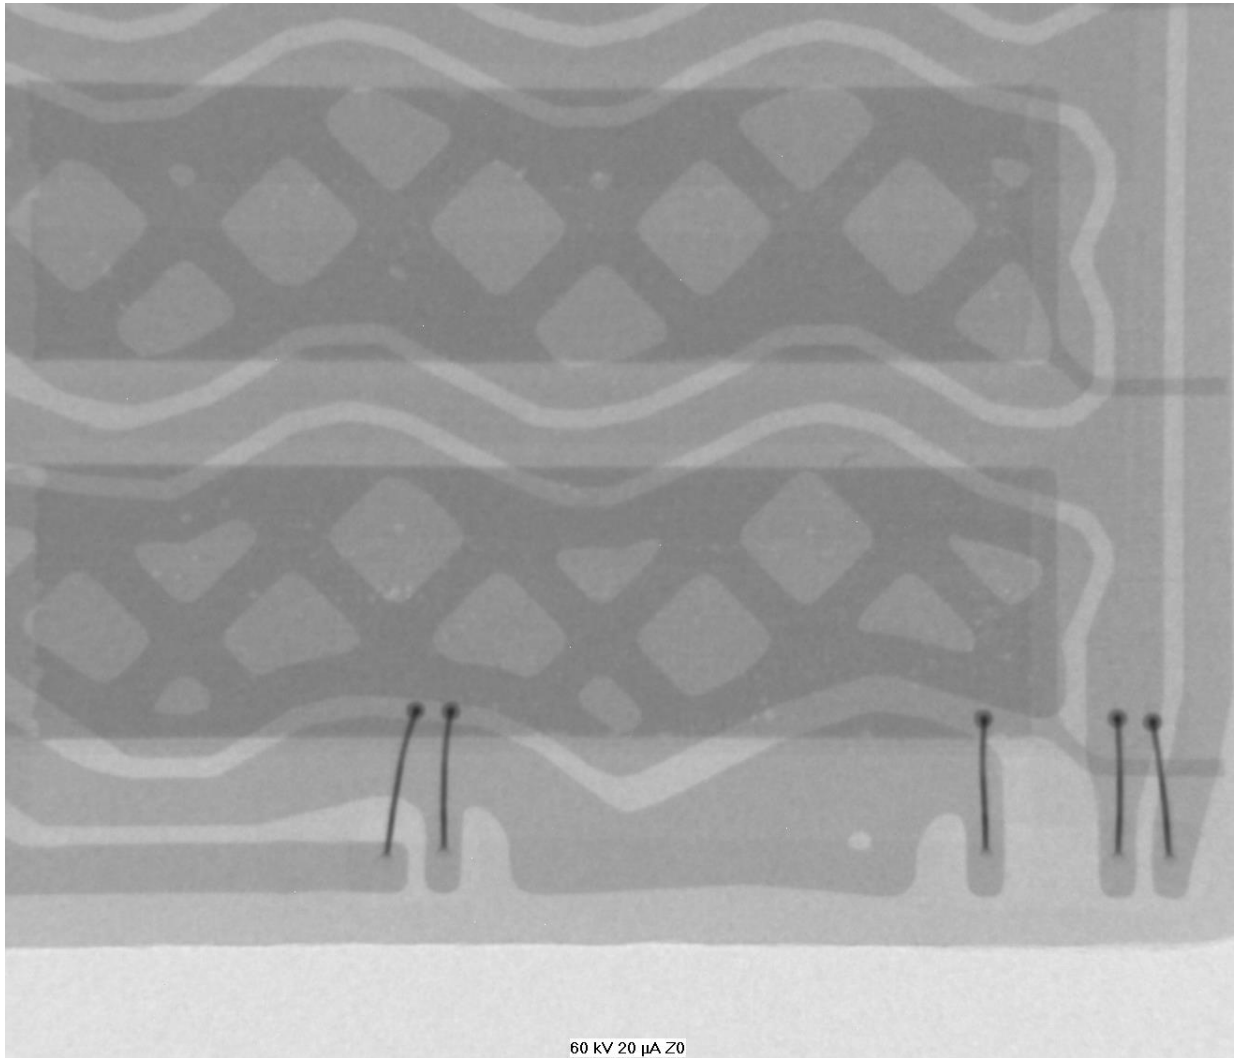
# Bottom Row of Wire Bonds at Higher Magnification (1)

- No evidence of damage to the wire bonds
- Circuitry of the laminate appears to be intact

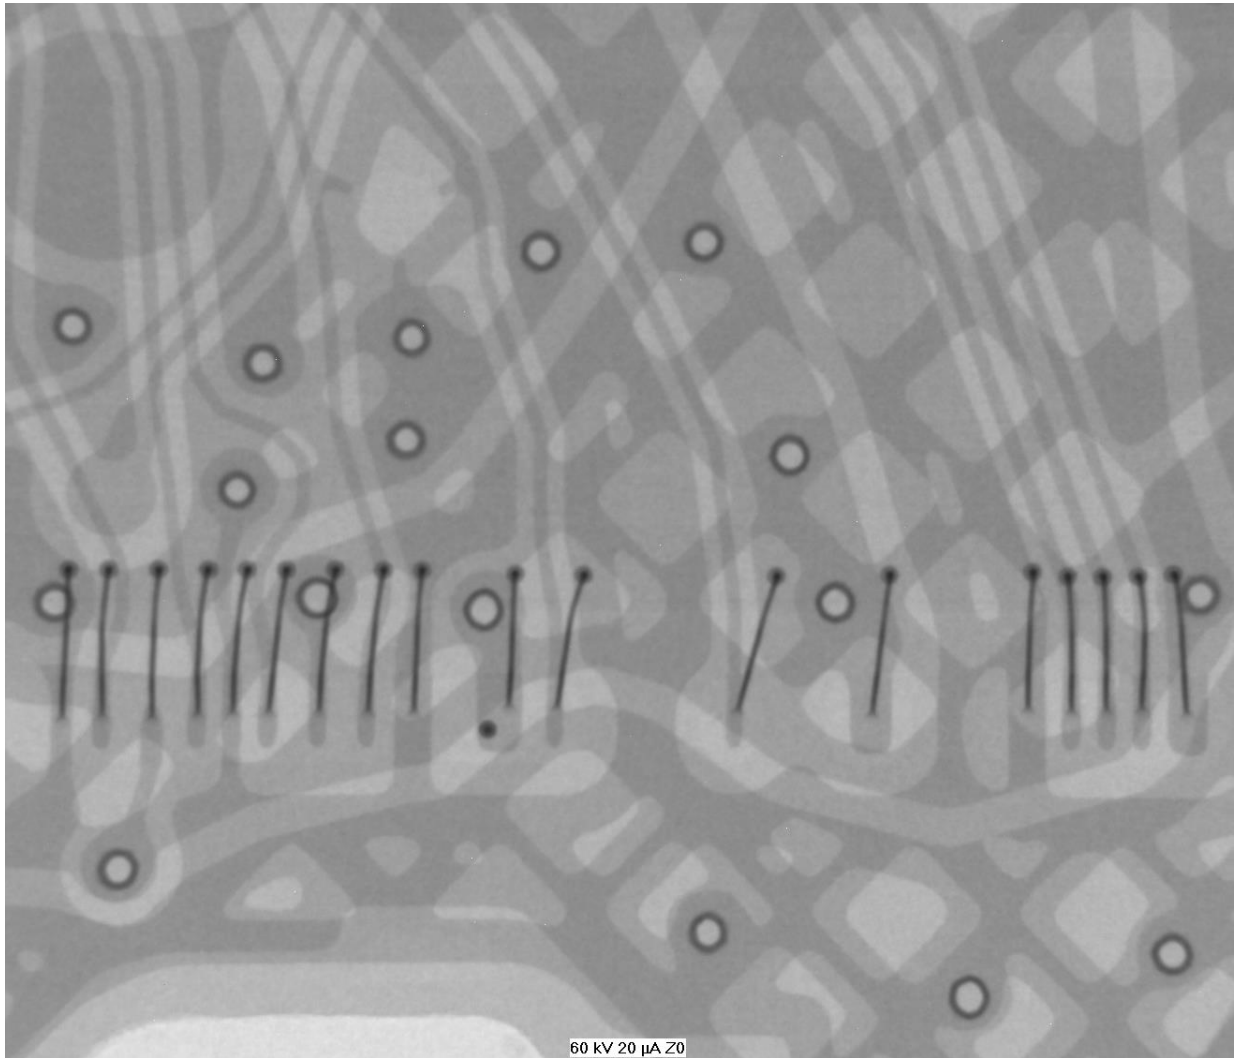
## Bottom Row of Wire Bonds at Higher Magnification (2)

- No evidence of damage to the wire bonds
- Circuitry of the laminate appears to be intact

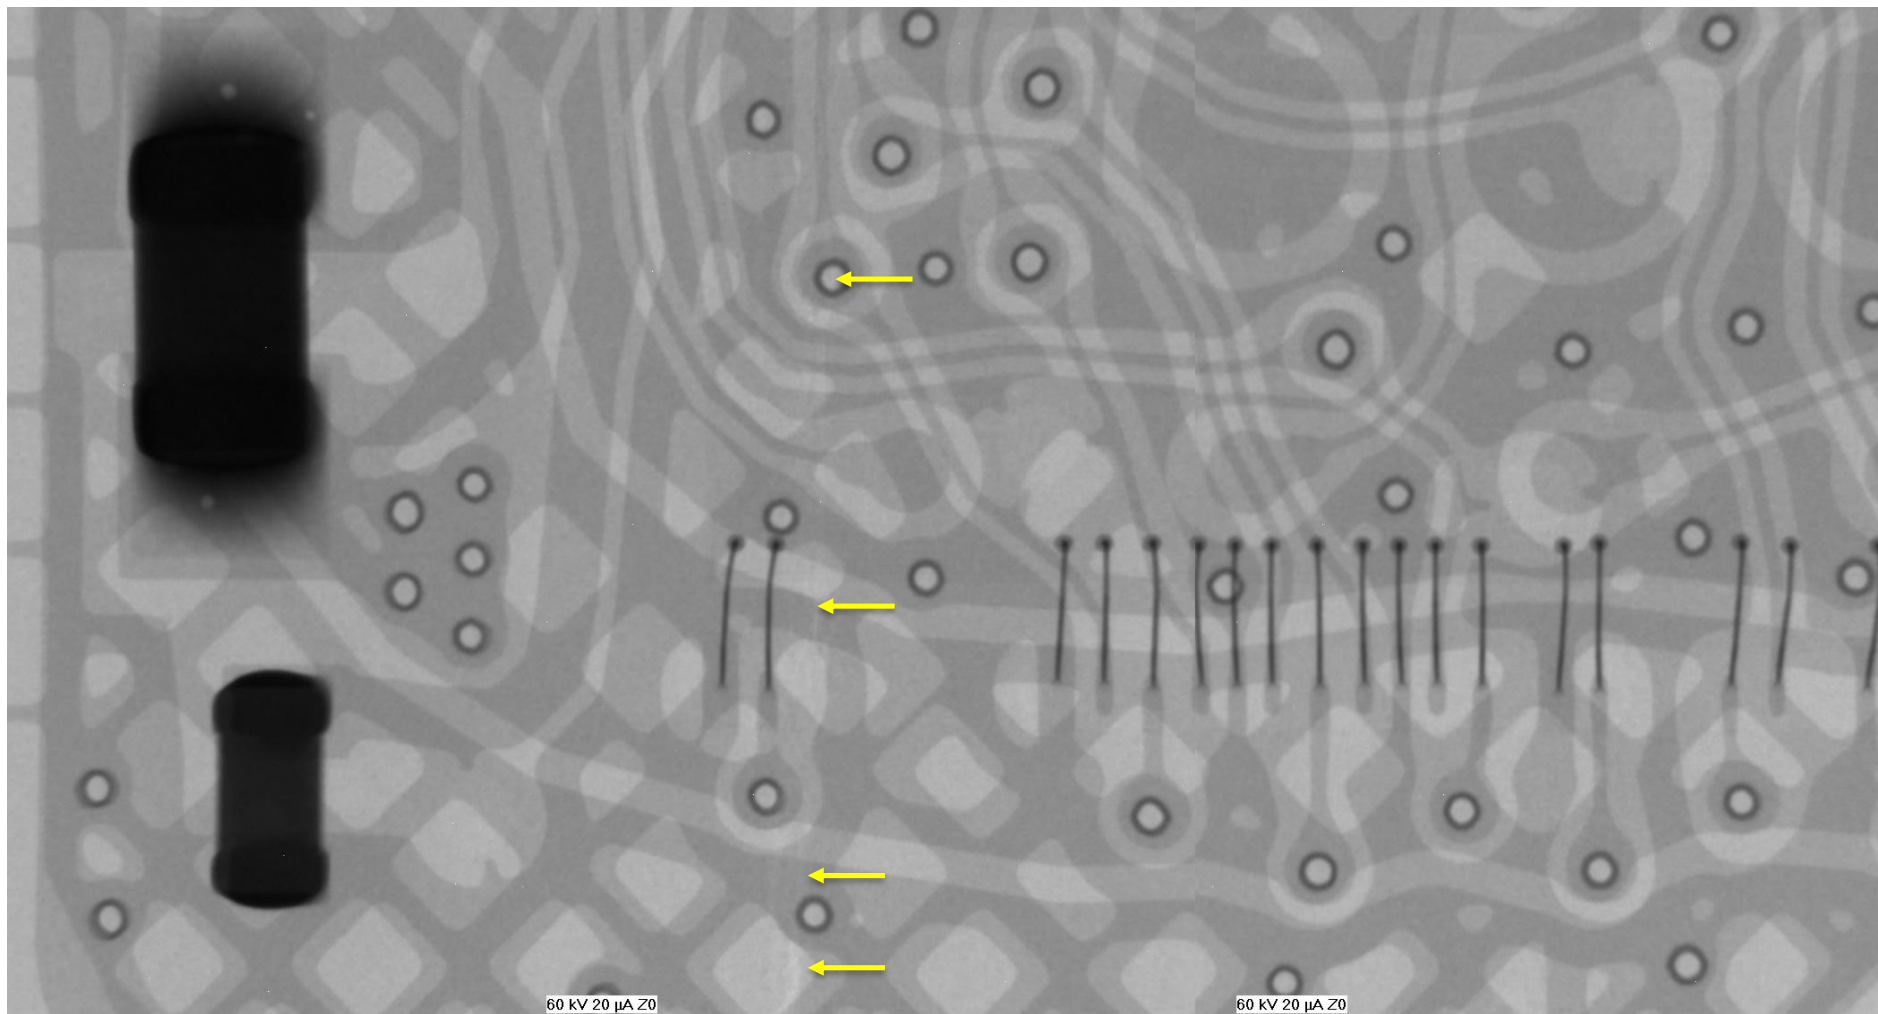
# Bottom Row of Wire Bonds at Higher Magnification (3)

- Stitched image
- No evidence of damage to the wire bonds
- Circuitry of the laminate may be damaged in the area of the crack (arrows)

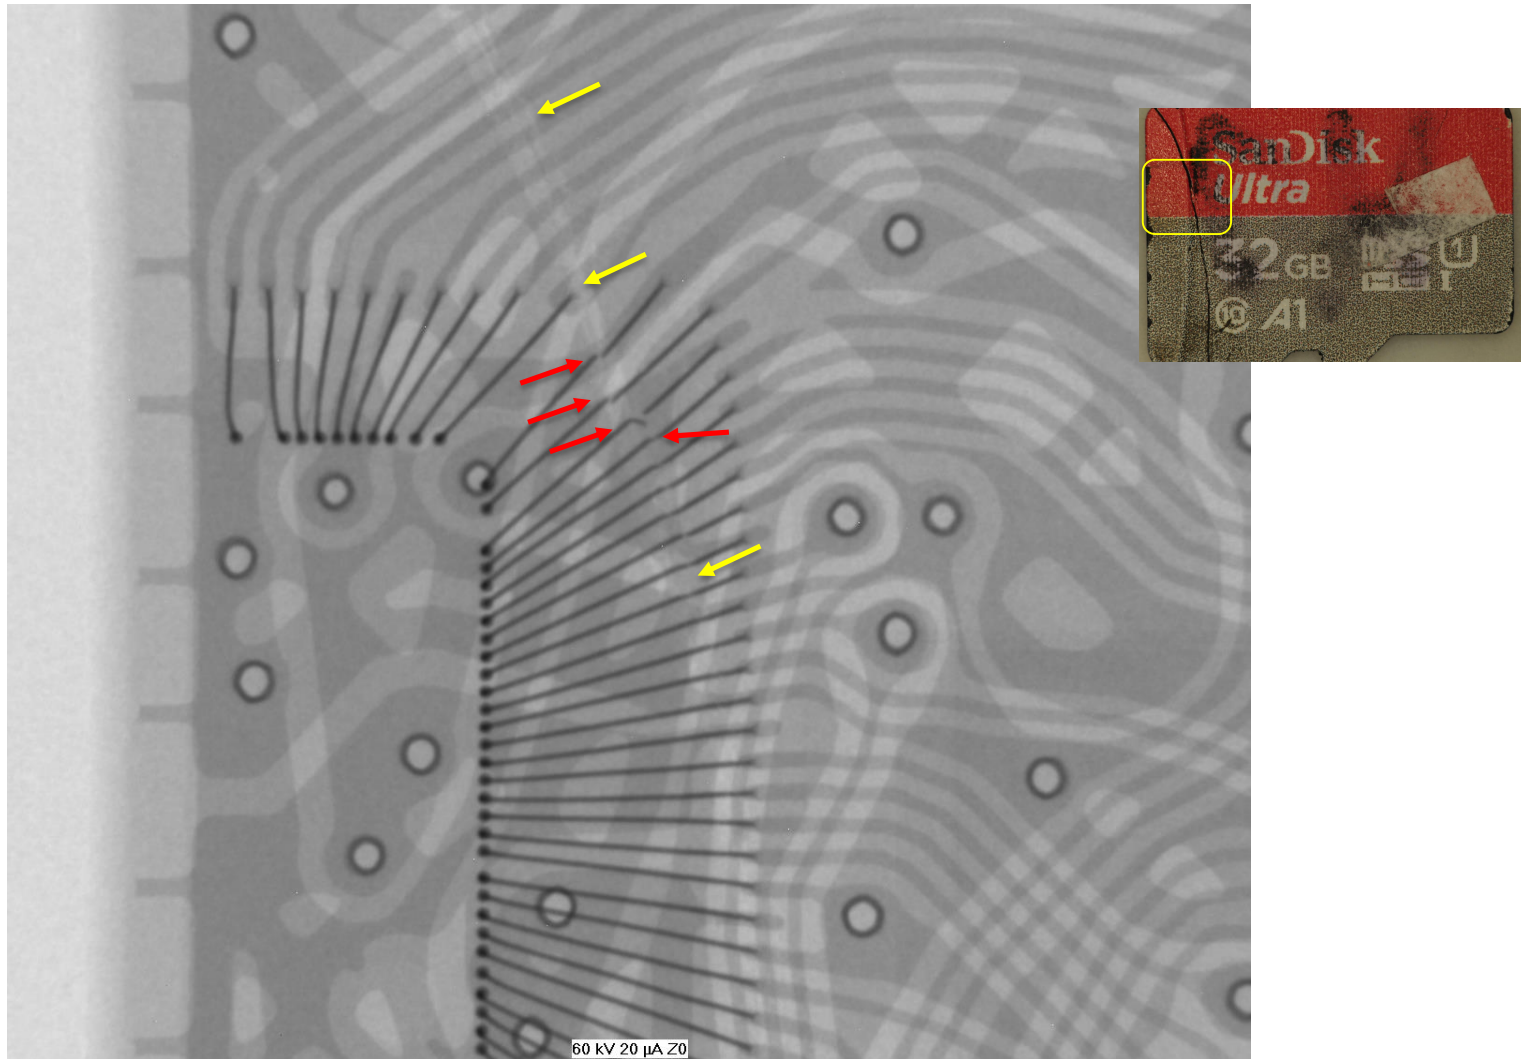
# Crack in the Area of the 2<sup>nd</sup> Chip (Left side of the Package)

- Broken wire bonds (red arrows)
- Circuitry of the laminate may be damaged in the area of the crack (yellow arrows)
- Crack appears to miss the chip in this area (ball bonds are typically on the periphery of the chip)

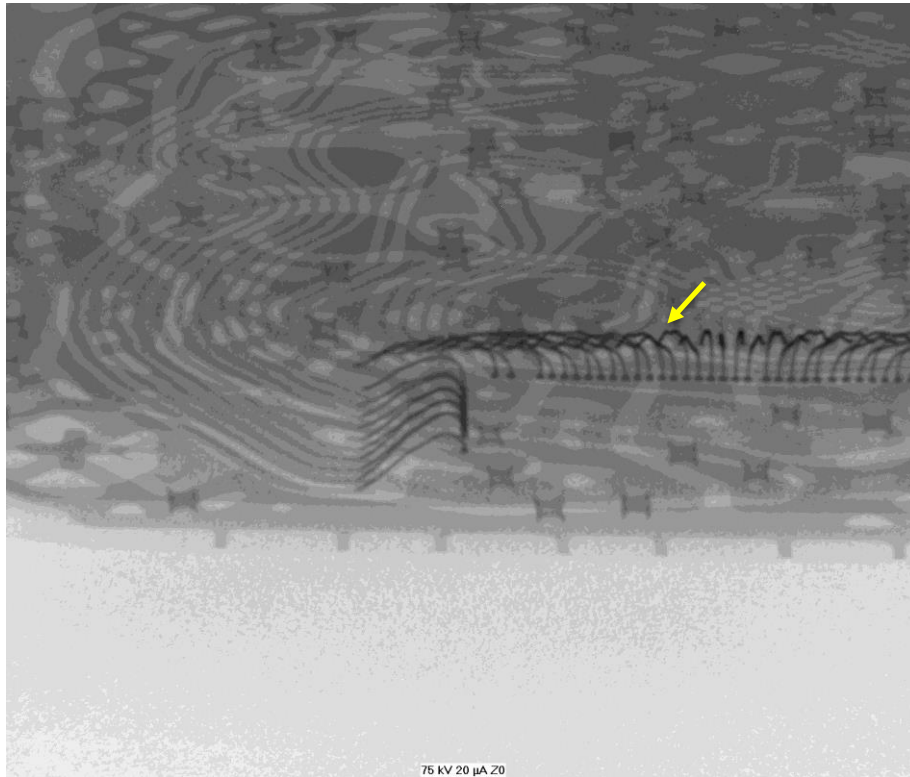
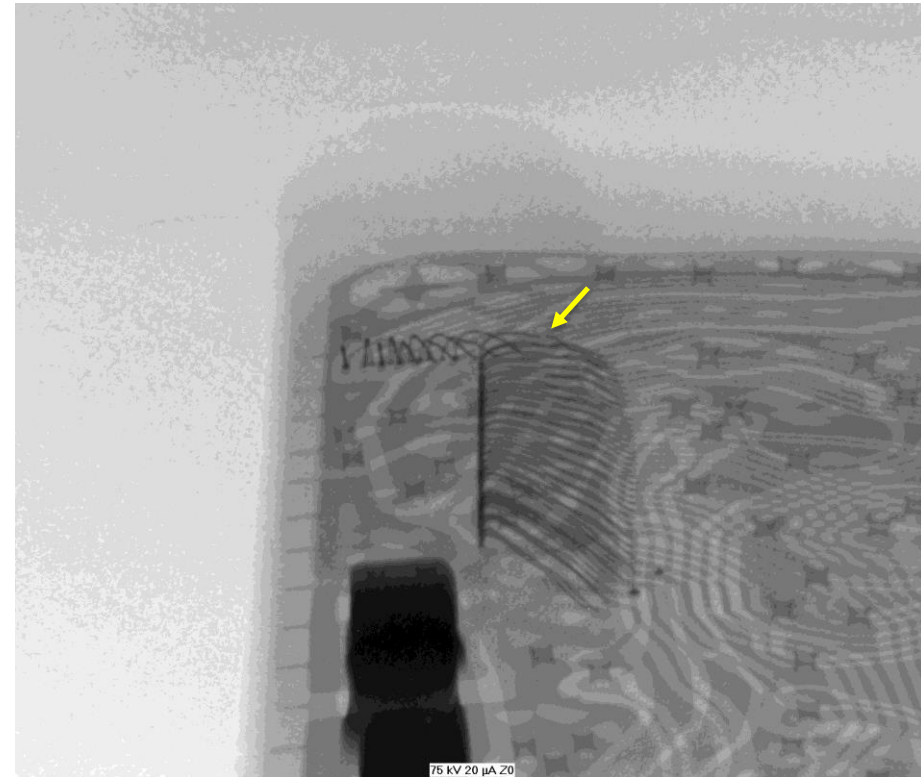
# Tilted View of the Cracked Area (70° Tilt)

- No evidence of out of plane string of bonds (lack of planar string can indicate that the wire bonds were pulled away from the chip)
- Broken and bent wire bonds, nonetheless, are evident (arrows)

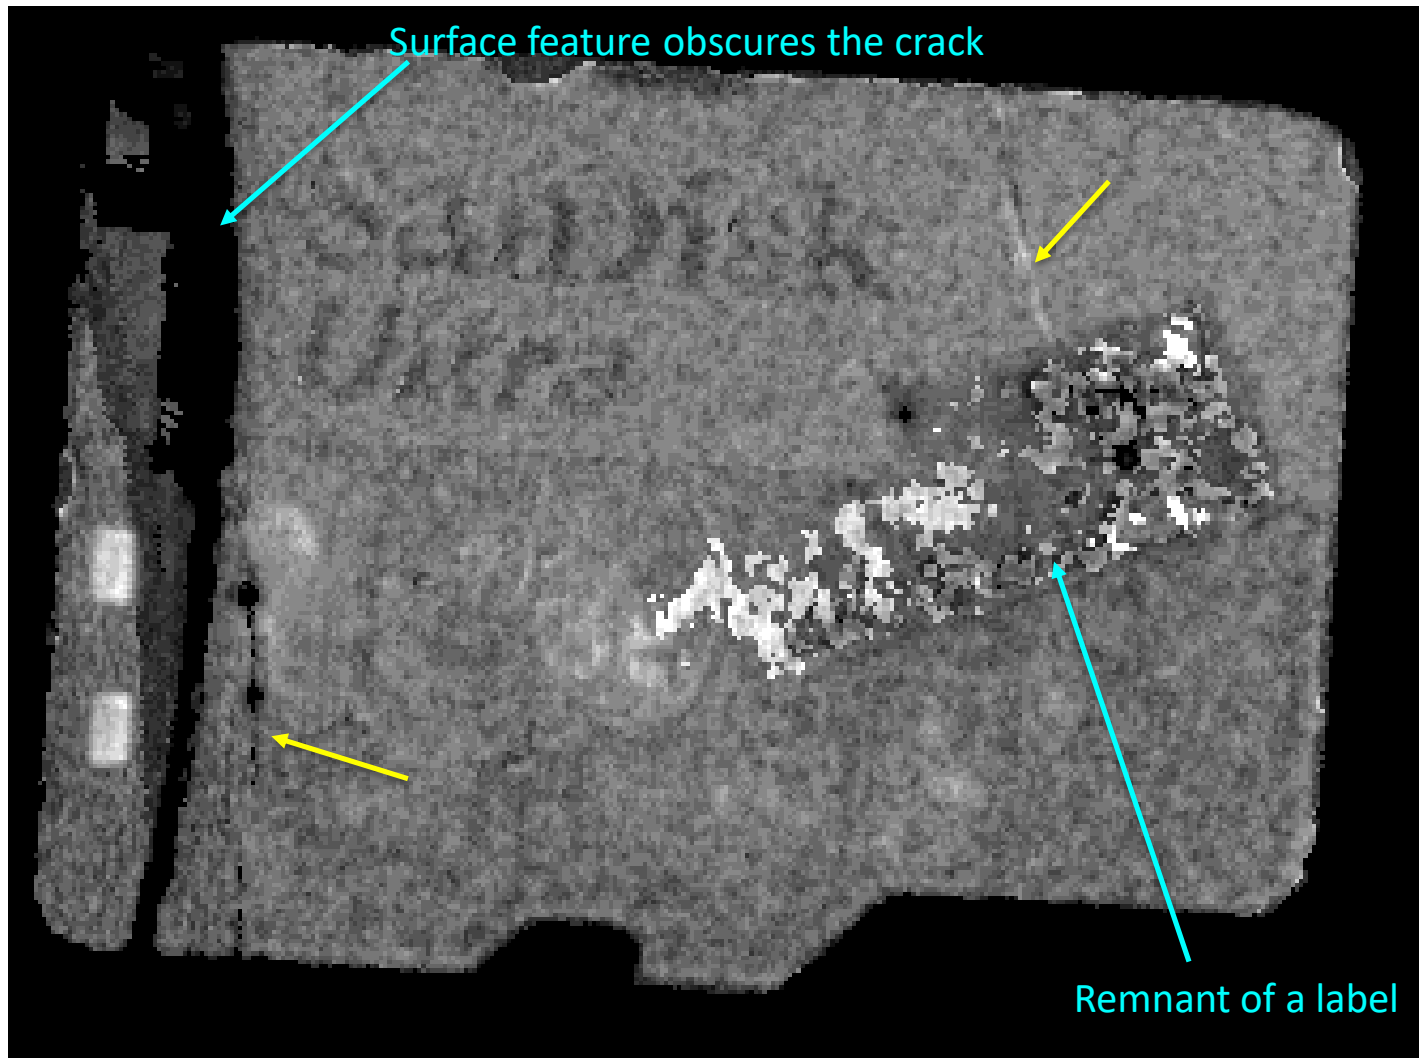
# Cracks Through the Overmold

- Yellow arrows highlight the cracks in the overmold
- The larger crack (left) is partly obscured by the difference in surface height

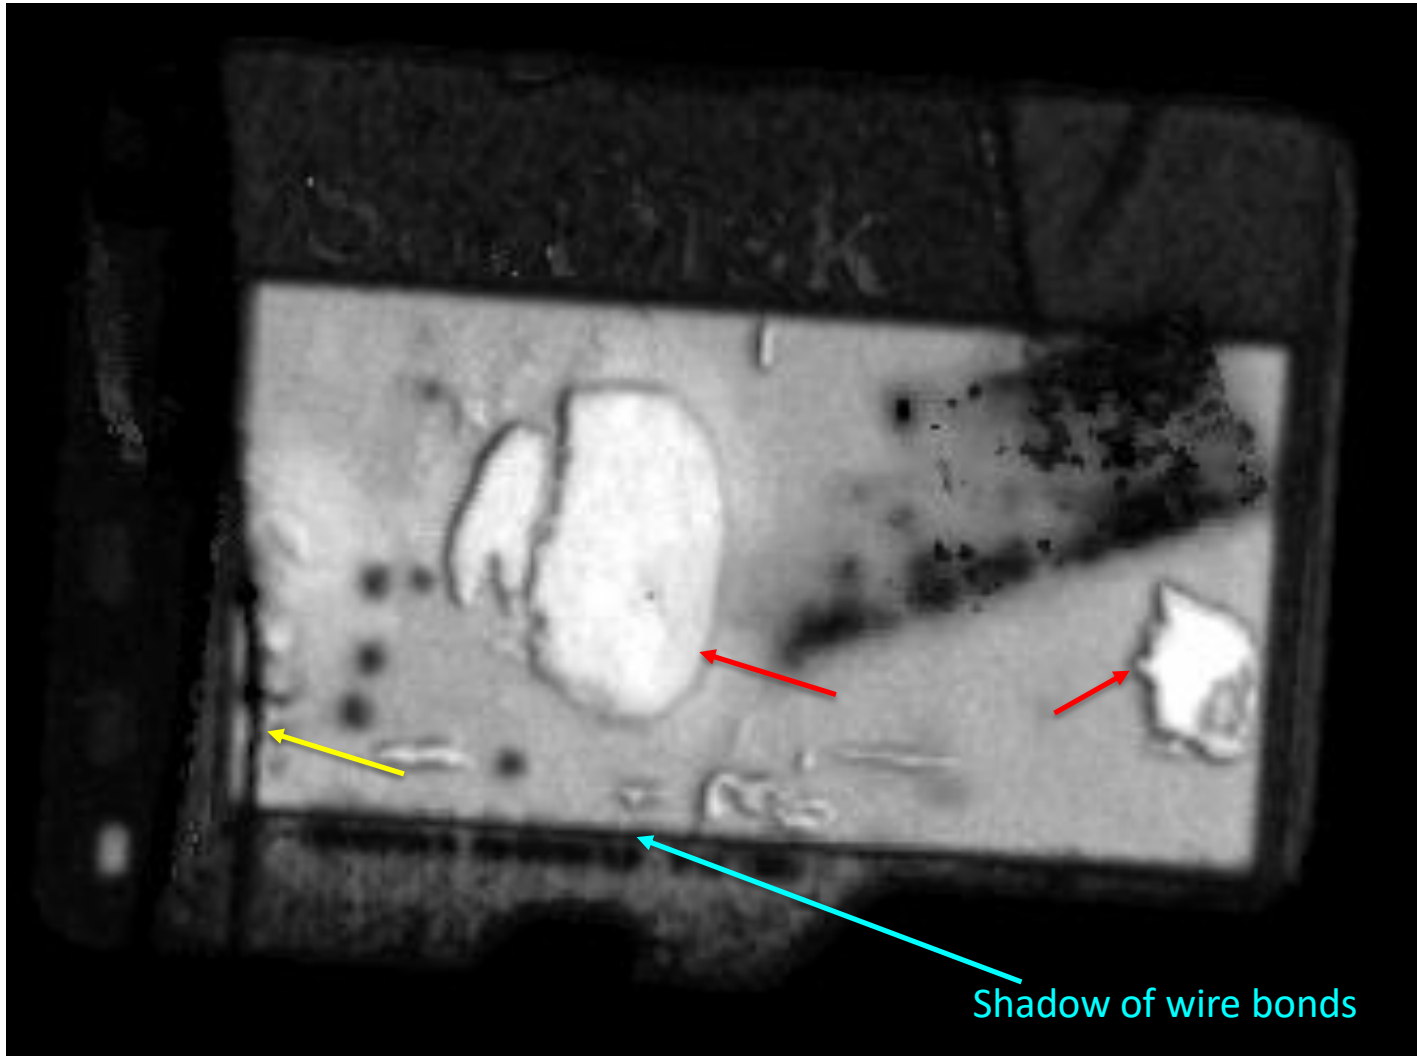
# Anomalies in the Chip

- Yellow arrow highlight the crack (or shadow of the crack) in the chip area
- Suspicious delaminations (bright spots in the chip area, red arrows)
- 2<sup>nd</sup> chip is not visible (obscured by the surface feature)

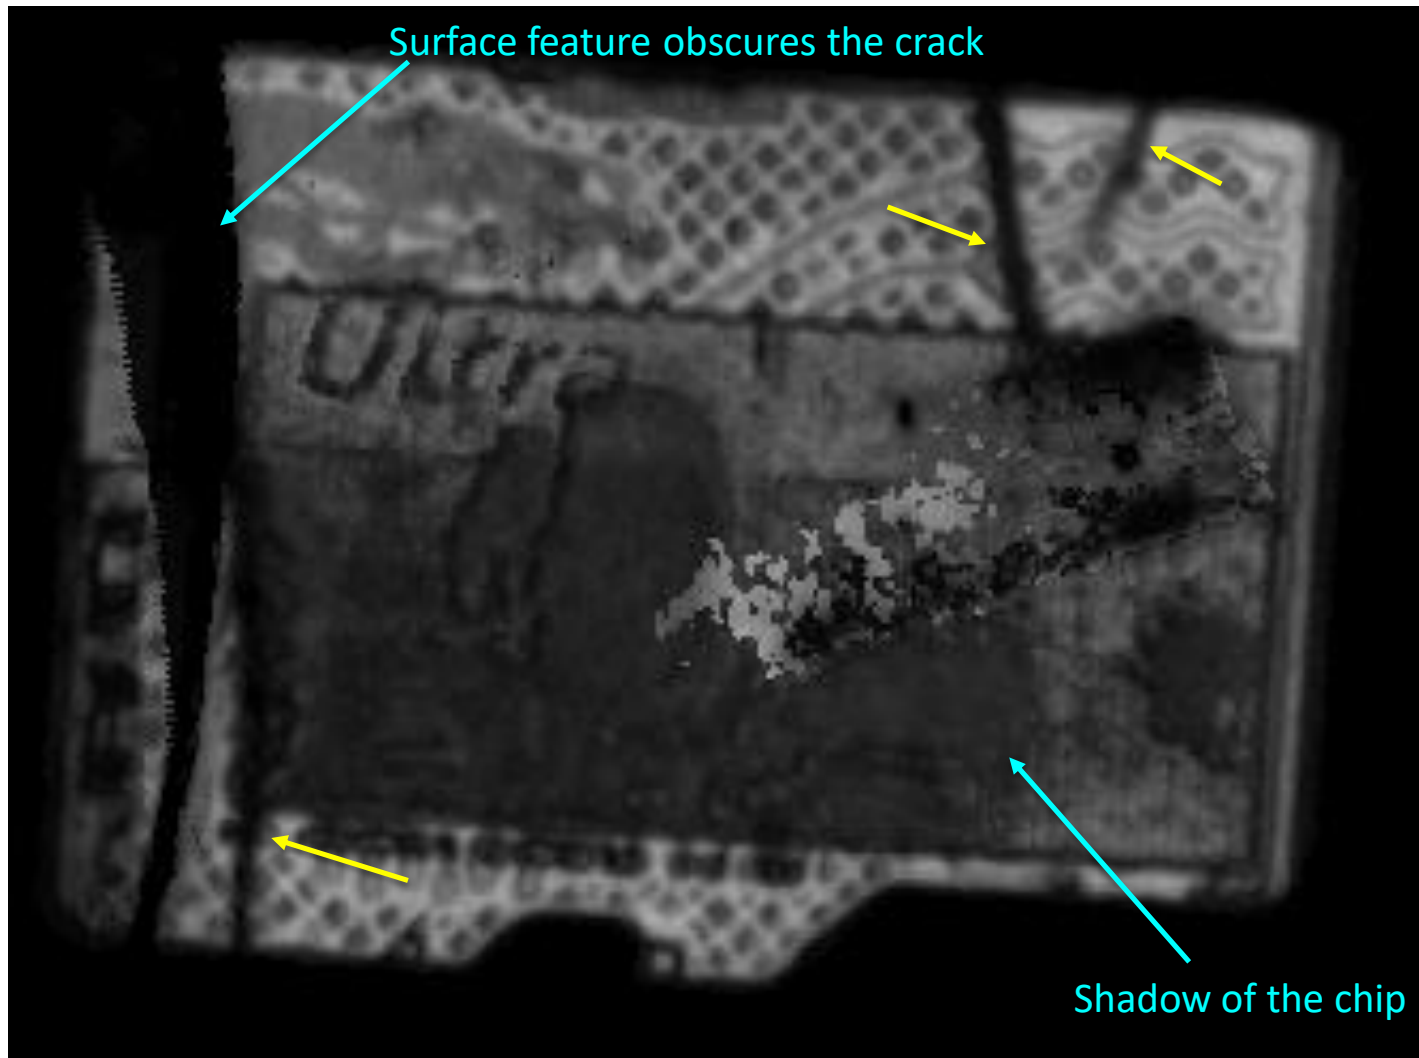
# Cracks (or Shadows of Cracks) on the Laminate

- Yellow arrows highlight the cracks
- Based upon the optical images of the back side of the laminate, these cracks are not mere shadows, but indeed penetrate to the laminate
