National Transportation Safety Board
Office of Research and Engineering
Washington, D.C. 20594

Airplane Performance Study

Specialist Report Timothy Burtch

Location: Mokuleia, Hawaii
Date: June 21, 2019
Time: 0422 GMT (1822 HST)
Airplane: Beechcraft 65-A90, King Air, N256TA
NTSB Number: WPR19MA177

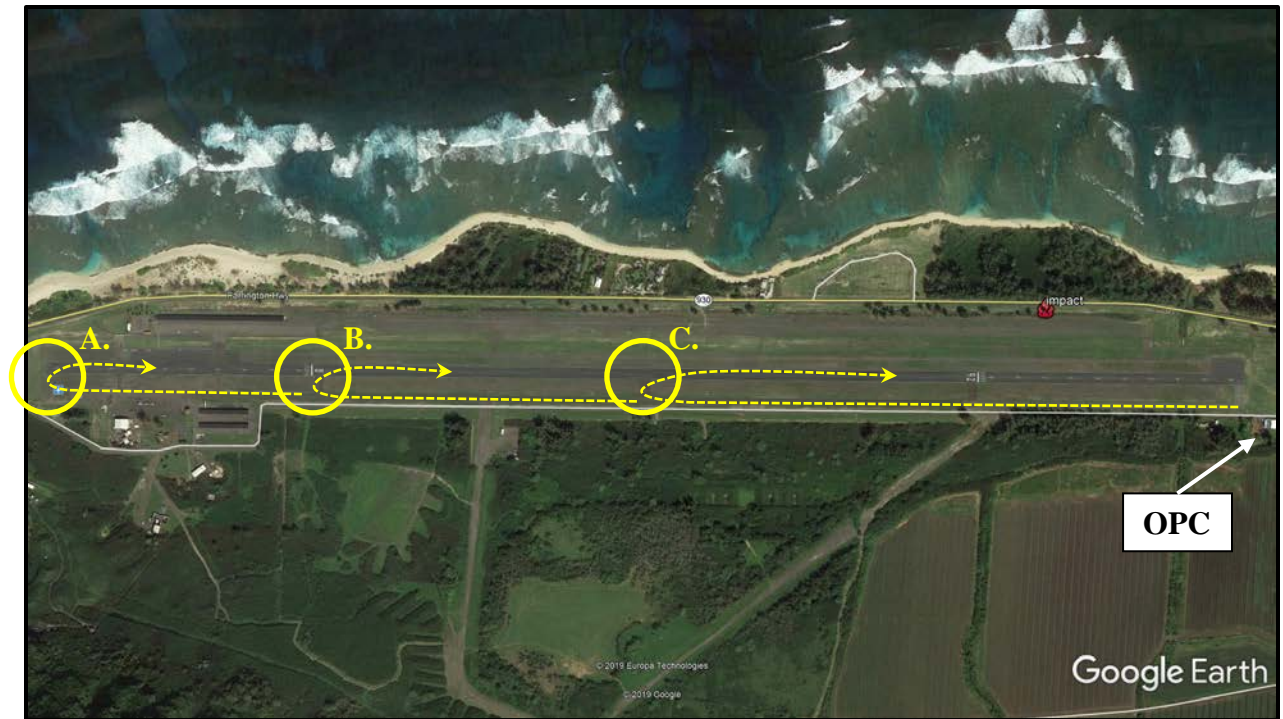
HDH runway 8 has 9,007 ft of runway available for take-off, including a 2,000 ft displaced threshold on both ends. However, it is unknown where N256TA initiated its take-off preceding the accident. Figure 3 highlights three locations where N256TA may have initiated the take-off roll: location A provides the full 9,007 ft available, location B provides 7,007 ft of runway, and location C provides approximately 4,500 ft for take-off. Based on video analysis of the previous flight documented in the video study, it is believed that N256TA initiated the accident take-off from location C. Locations A, B and C are at positions where the taxiway south of the runway connects to the runway. As indicated by the dotted lines in Figure 3, the airplane would have taxied from the OPC location at the east end of the runway, and then turned right onto the runway to take off to the east.

The accident flight lasted less than a minute and occurred approximately 3,030 ft from the likely starting point of N256TA's take-off roll from runway 8 (the connection with the taxiway at point C in Figure 3). The wreckage was found about 460 ft to the left of the runway centerline.

The estimated take-off distance from both flight test and POH data put the airplane at approximately 100 ft agl over the displaced threshold for the opposite runway 26. While a take-off from point C in Figure 3 at the connection with the taxiway may or may not have been standard practice for the accident pilot, it left approximately half the available runway, or 4,507 ft, unused.

Figure 3: Possible Take-off Initiation Points for Runway 8

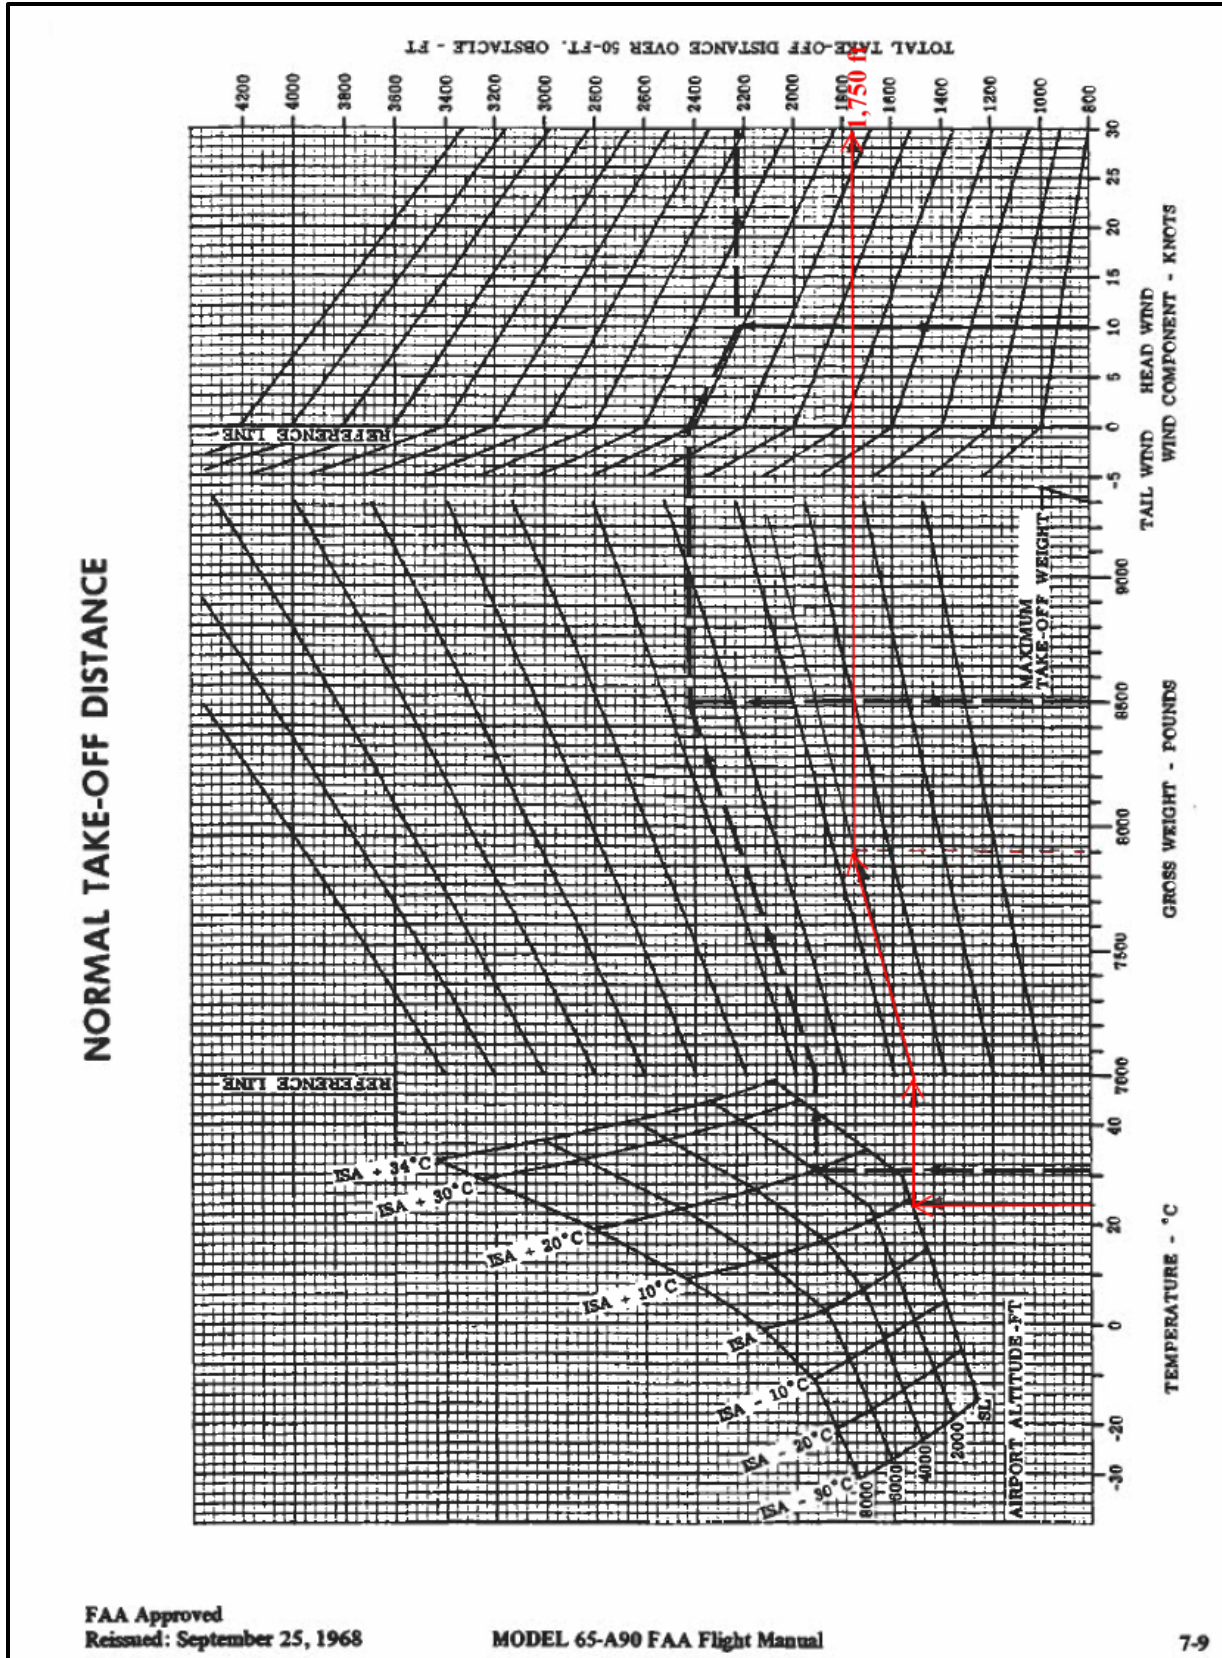
Beechcraft’s estimated take-off distance over a 50 ft obstacle at conditions similar to the accident is shown in Figures 4 and 5. The normal take-off distance chart in the A90 Pilot’s Operating Handbook (POH) indicates that approximately 1,750 ft are necessary to clear a 50 ft obstacle. This assumes light winds, sea level airport altitude, and a take-off gross weight of approximately 7,900 lb.

Figure 4: Estimated Take-off Distance over 50 ft Obstacle from POH: 1,750 ft

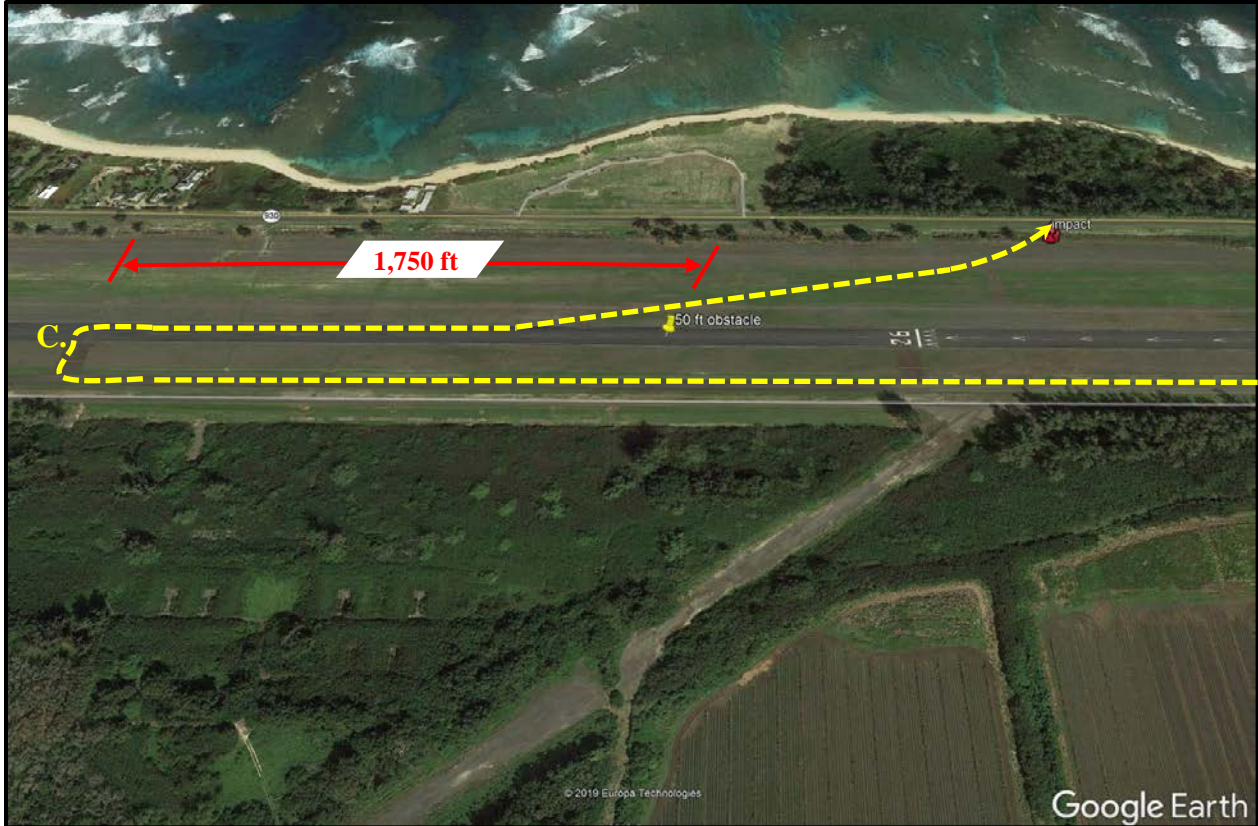
The wreckage was located approximately 3,030 ft upwind of location C and 460 ft to the left of the runway centerline. In addition to the impact location shown in Figures 5 and 6, Figures 7 and 8 show security video stills just before and after impact. The impact location is consistent with the take-off distance calculations from point C.

Figure 5: Estimated Take-off Distance Over 50 ft Obstacle from POH: 1,750 ft

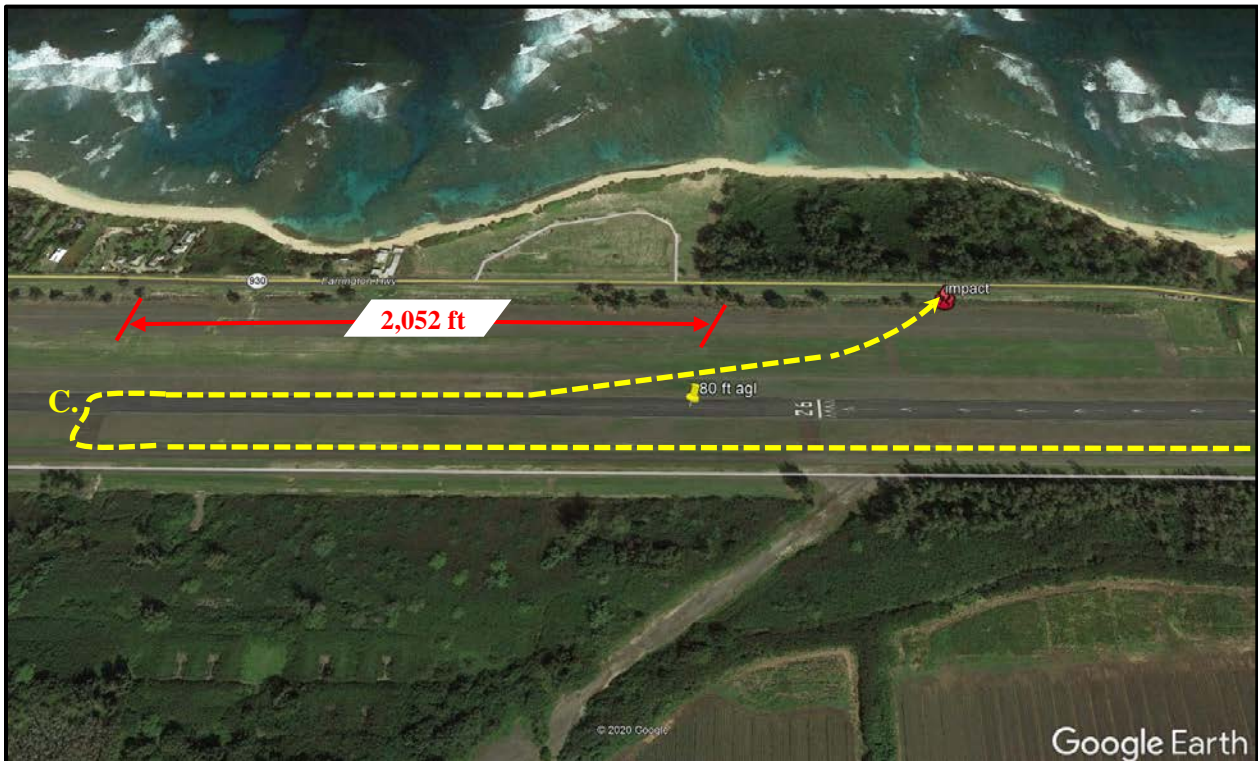
distance of approximately 2,052 ft over a 45 sec time period³. The climb to 80 ft is shown in the context of runway 8 in Figure 6. The flight test and POH data produce similar take-off results.

Figure 6: Estimated Take-off Distance to 80 ft from Flight Test Data: 2,052 ft

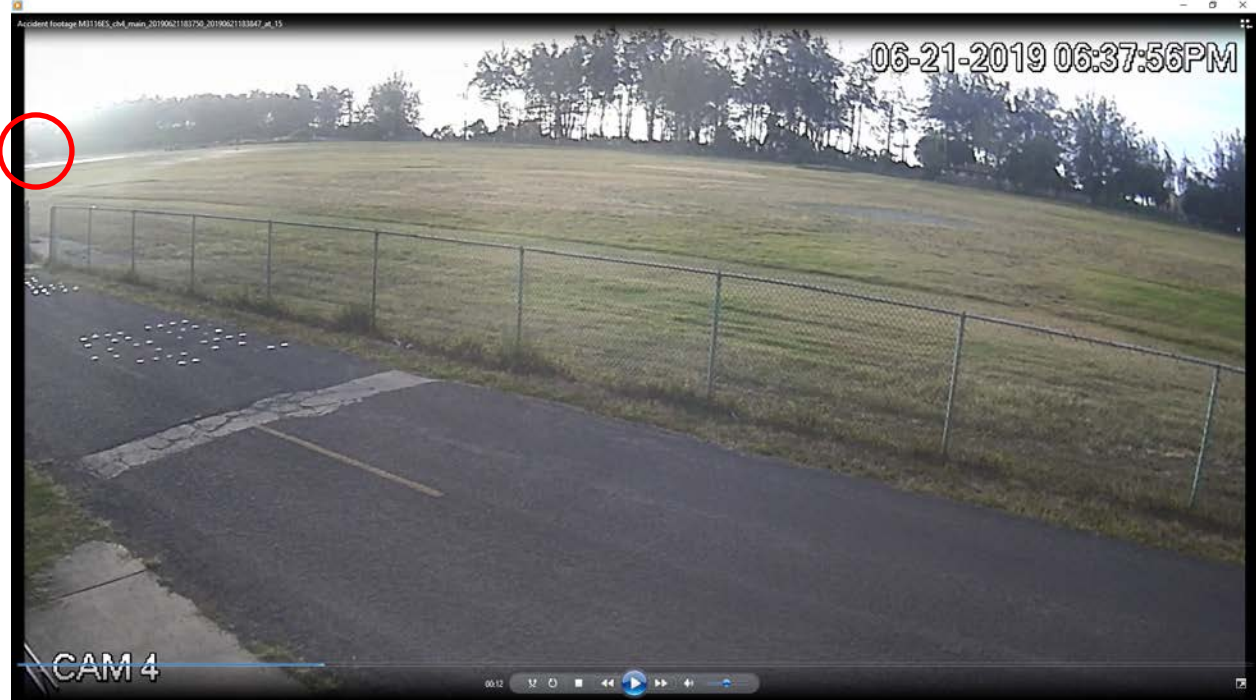
An aft CG reduces the static longitudinal stability of the airplane⁴. Static longitudinal stability is a measure of the airplane's tendency to return to its equilibrium or "trim" point once disturbed. For example, static longitudinal stability affects how the airplane responds to an atmospheric disturbance. In addition, an aft CG results in lighter pilot stick forces. In the extreme case, an aft CG can lead to the pilot overcontrolling the airplane and loss of control. The CG of the accident airplane was of particular interest because the video shows the airplane impacting the ground in an unusual pitch attitude consistent with a loss of control.

Figure 7: Security Footage Just Before Impact

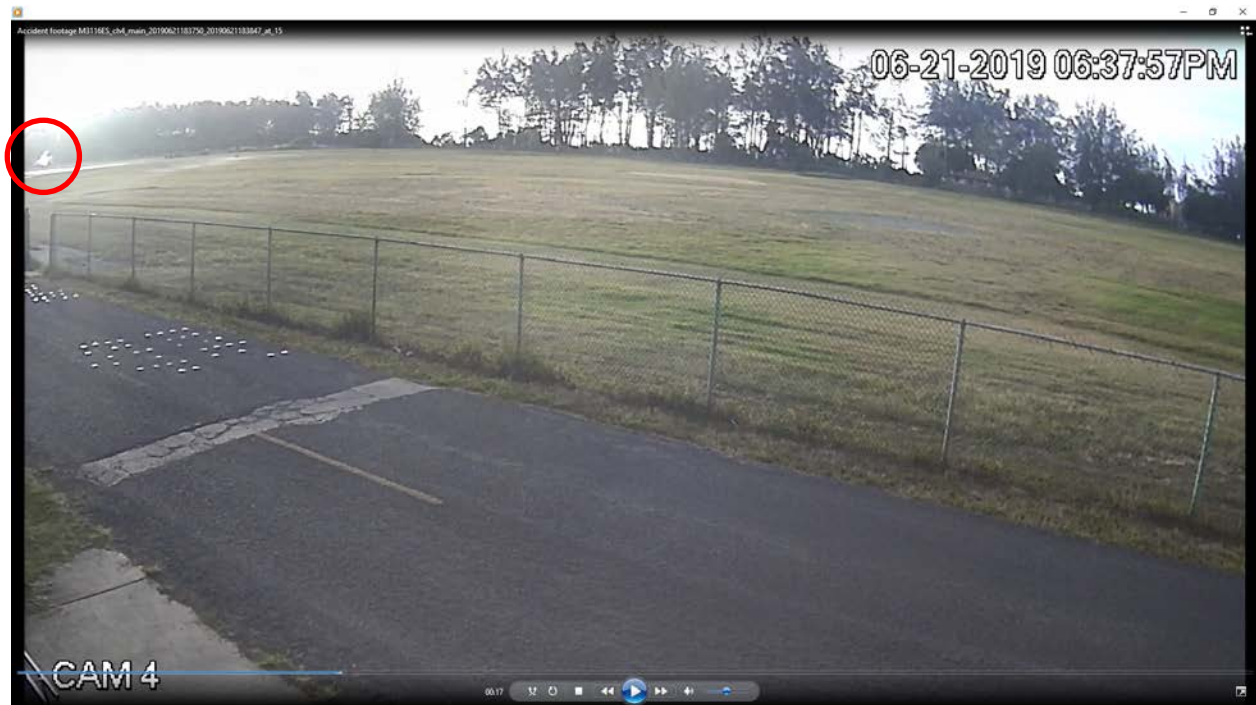
Figure 8: Security Footage Just After Impact

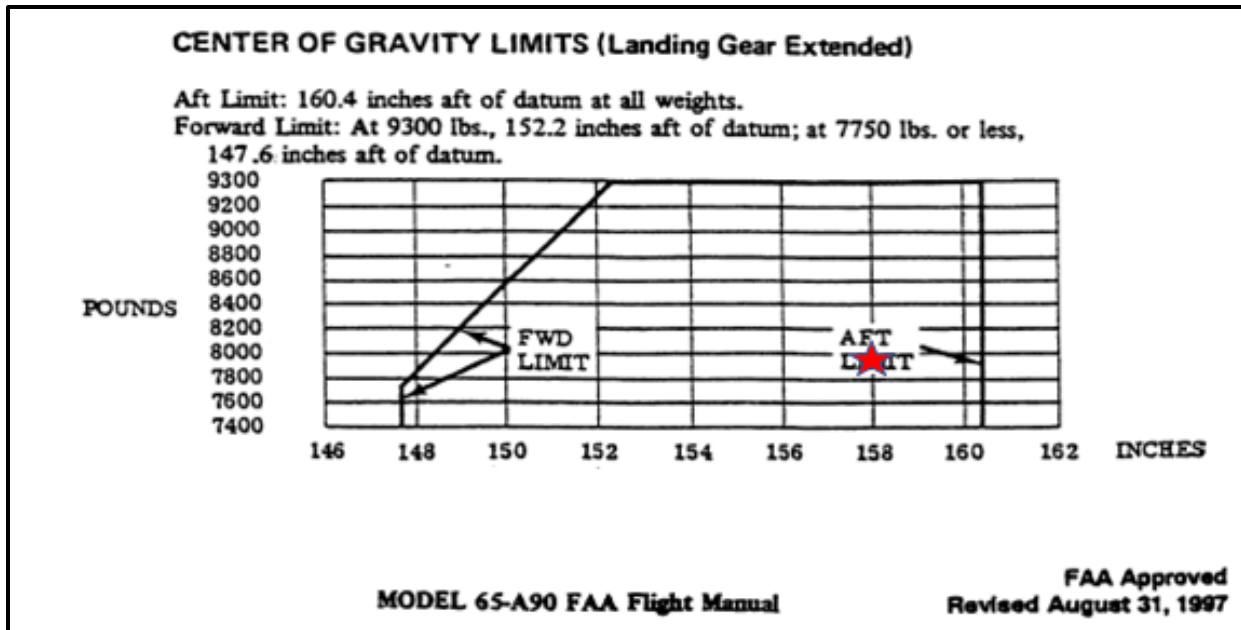
The accident airplane was operating close to the aft center of gravity (CG) limit of 160.4" (aft of the weight and balance datum). The exact location of all passengers and their gear are unknown. However, the likely loading scenarios that were considered all put the accident CG either slightly forward or just aft of the aft CG limit. See Figures 9-11.

Figure 9: Center of Gravity (★) Assuming Last Two Passengers on Floor in Back

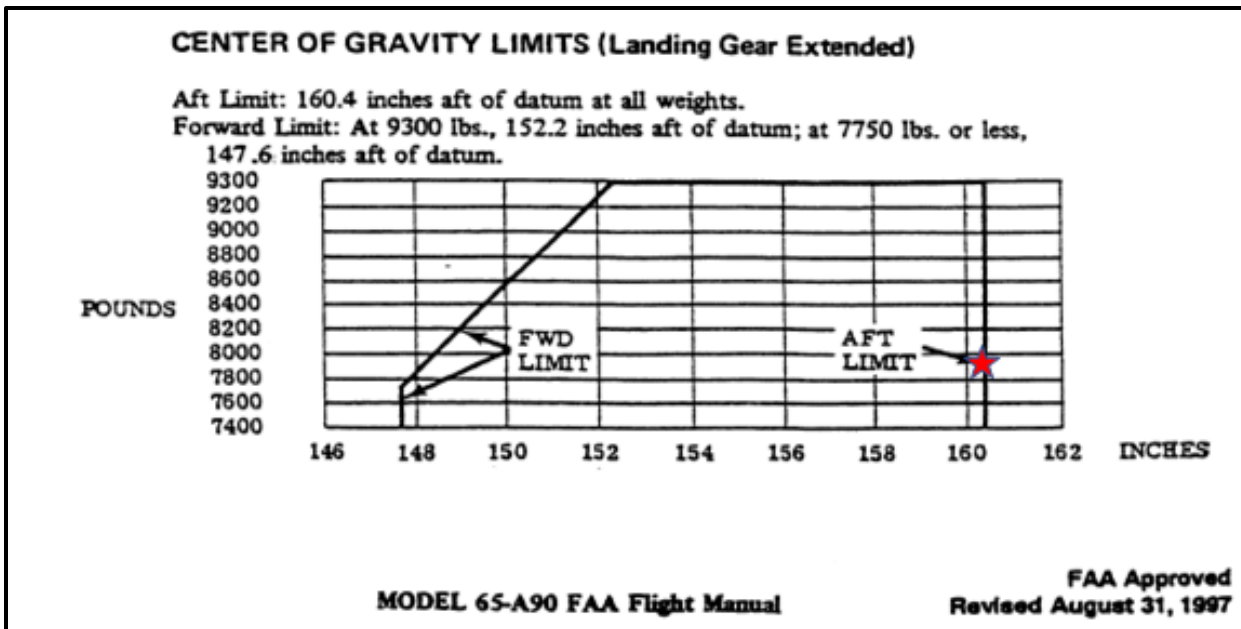
Figure 10: Center of Gravity (★) Assuming Last Two Passengers at Aft Pressure Bulkhead

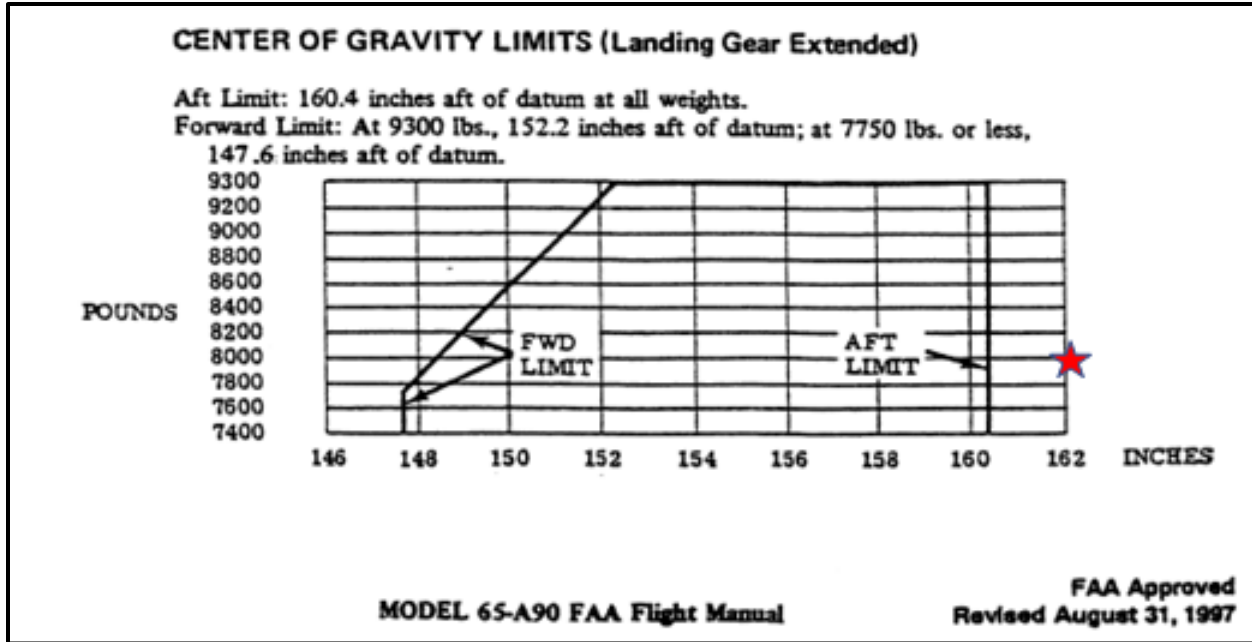
The airplane was operating at an aft CG where pilot column forces are lighter. Light column forces can lead to the pilot overcontrolling the airplane and loss of control. It could not be determined if the aft CG was a factor in the accident.

Figure 11: Center of Gravity (★) Assuming Last Three Passengers at Aft Pressure Bulkhead

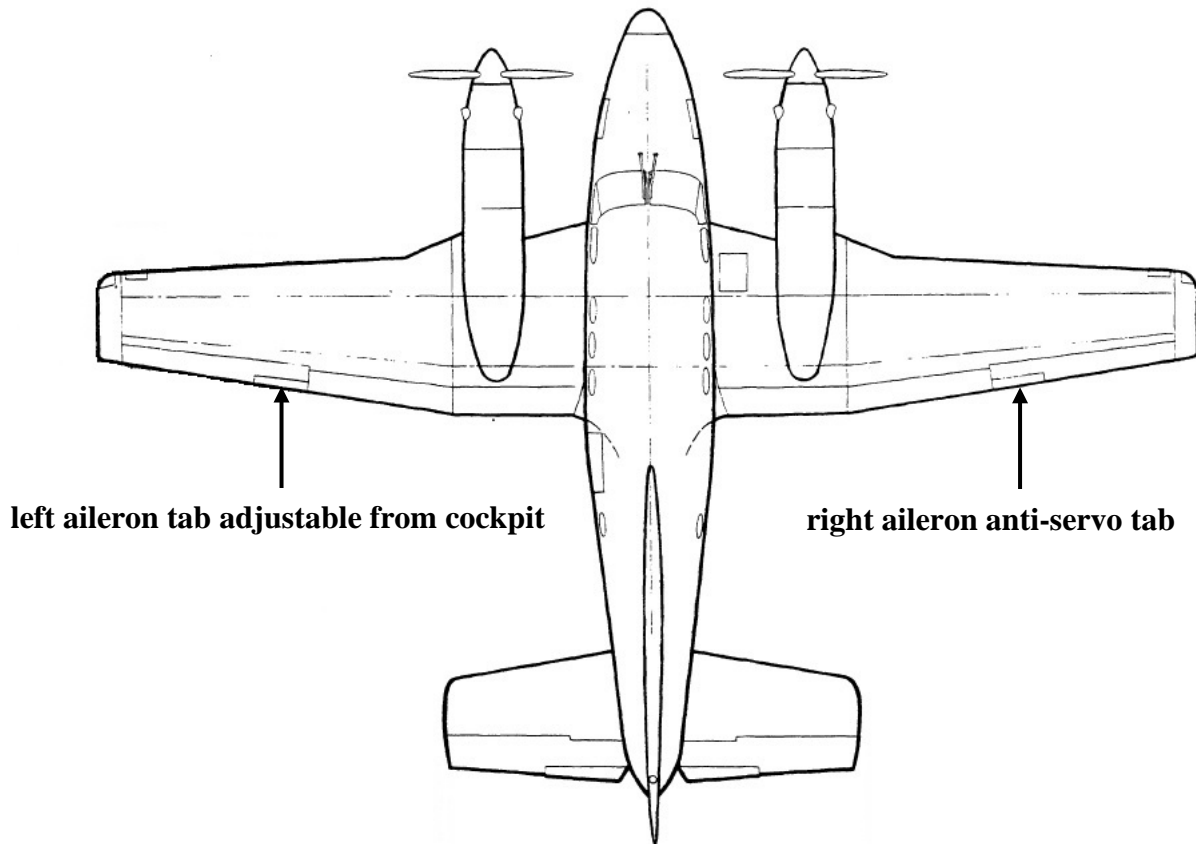
The aileron trim⁷ was found in the full left-wing-down (LWD) position in the wreckage. Prior photographs confirmed that this was required for take-off in N256TA, possibly due to an earlier accident in which the airplane was substantially damaged⁸.

⁷ Only the left aileron tab on the Beechcraft 65-A90 is adjustable from the cockpit. The right aileron has an anti-servo tab that is driven by aileron movement. The role of the anti-servo tab is to increase the control wheel force. See Figure 12.

Figure 12: Plan View of Beechcraft 65-A90, King Air

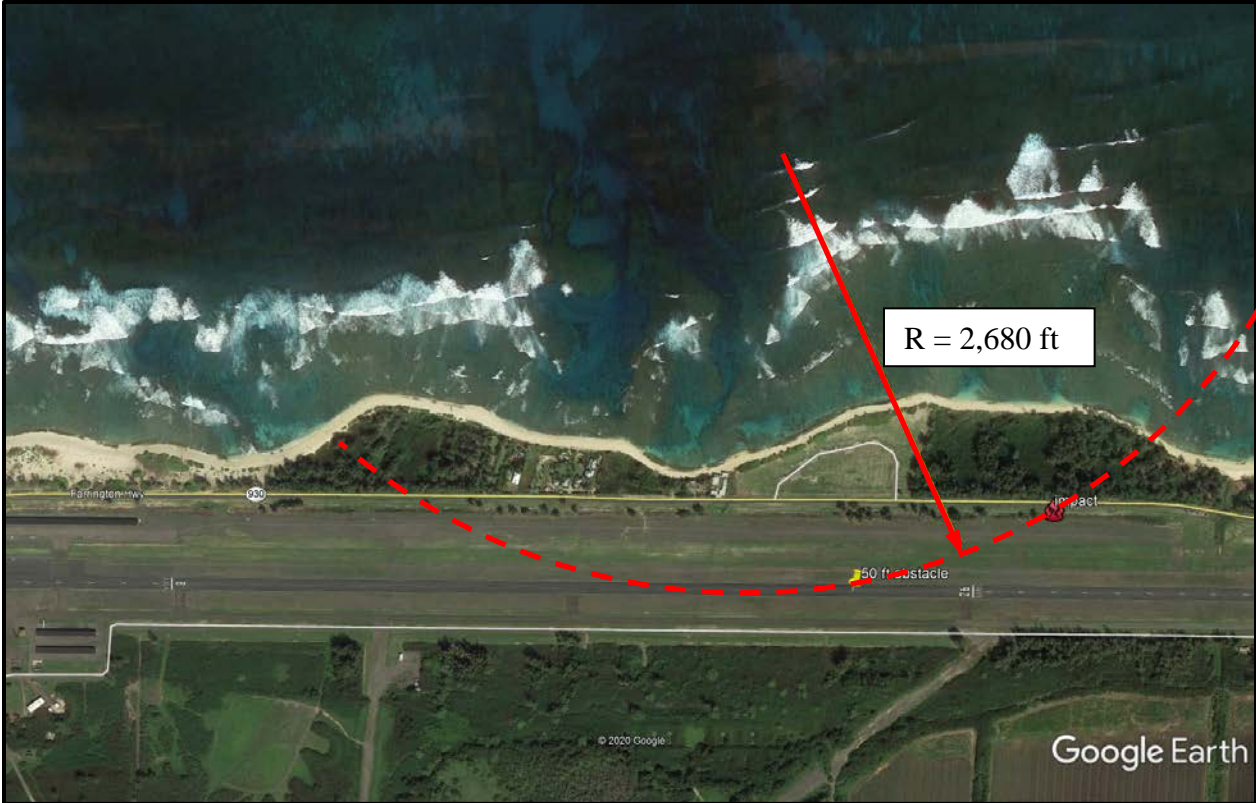
Note: A 20° left-banked turn was found to provide the appropriate radius to the crash site. The turn radius of 2,680 ft that results from calculations from the 50 ft obstacle point to the crash site is depicted in Figure 14. This suggests that little bank angle, i.e., 20°, was required to reach the accident site and does not indicate a turning/accelerated stall. However, if the turn is initiated at the end of runway 8 (as marked by the two trees in Figure 15 and discussed in the video study), a tighter turn is necessary. With a left-banked turn of approximately 66°, an accelerated stall would result. The calculation is shown below.

Figure 14: Steady, Coordinated Turn Shortly after Lift-off until Final Impact

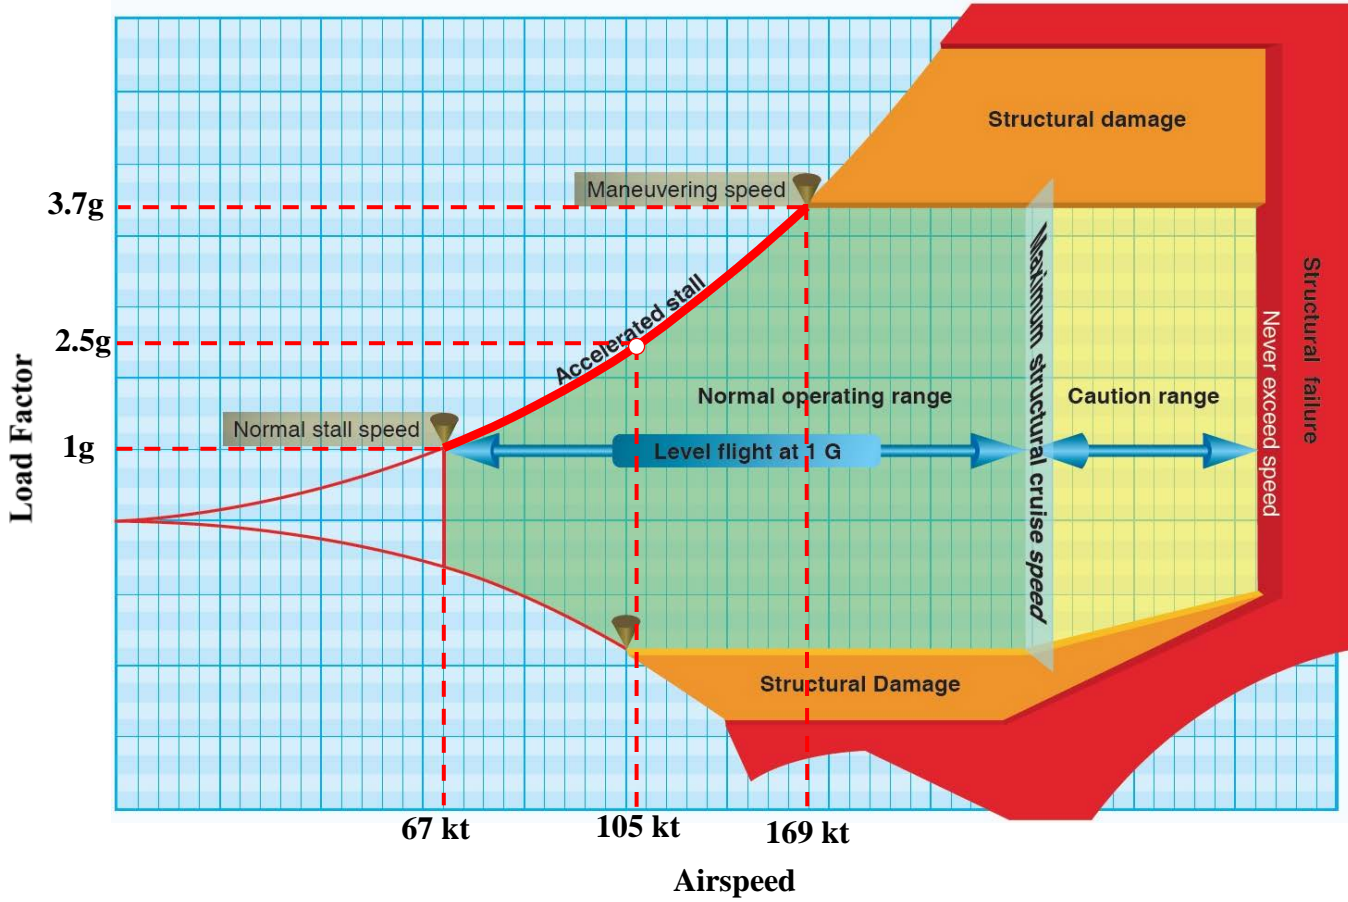
The V-G diagram¹⁰ shows the load factor that an airplane can sustain at various speeds. A generic diagram with select Beechcraft 65-A90 airspeeds is shown in Figure 15. Note that the curved line of maximum positive lift capability is highlighted by the solid red line. Any load factor above this line is unavailable aerodynamically because the airplane will stall. Stalls at load factors above “1g” are called accelerated stalls and occur at speeds greater than the 1g stall speed. The power on, 1g, stall speed for the Beechcraft 65-A90 at the accident conditions is approximately 67 kt.

Figure 15: Typical V-G Diagram
(Source: FAA Pilot's Handbook of Aeronautical Knowledge)

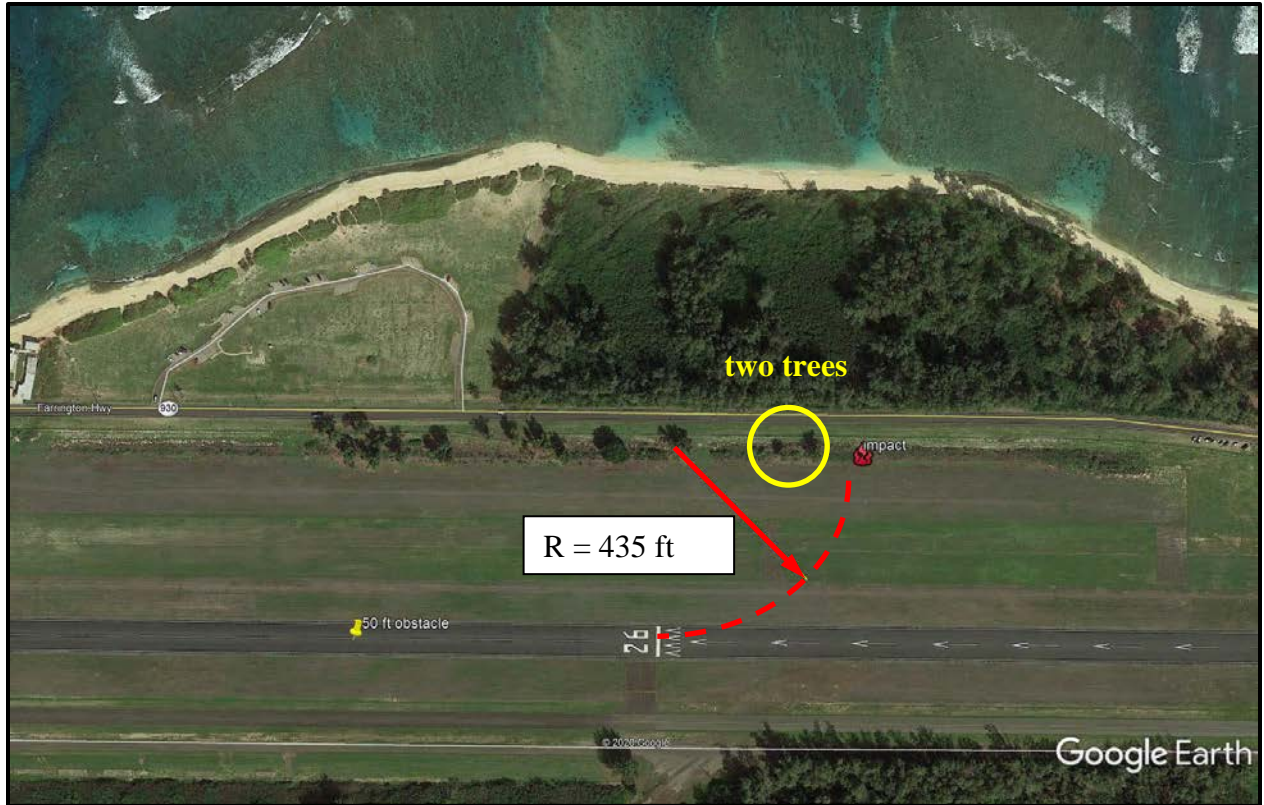
The turn radius of 435 ft that results from calculations from the end of the runway to the crash site is depicted in Figure 16.

**Figure 16: Steady, Coordinated Turn from End of Runway (two trees) until Final Impact
(Note: this is the turn radius and not necessarily the actual ground track.)**
