NATIONAL TRANSPORTATION SAFETY BOARD

ACCIDENT SITE EXAMINATION

WPR20FA057

Location: Santa Clarita, CA
Date: January 4, 2020
Aircraft: N151WR Amateur-built
experimental TM-1
Thunder Mustang
NTSB IIC: Albert Nixon

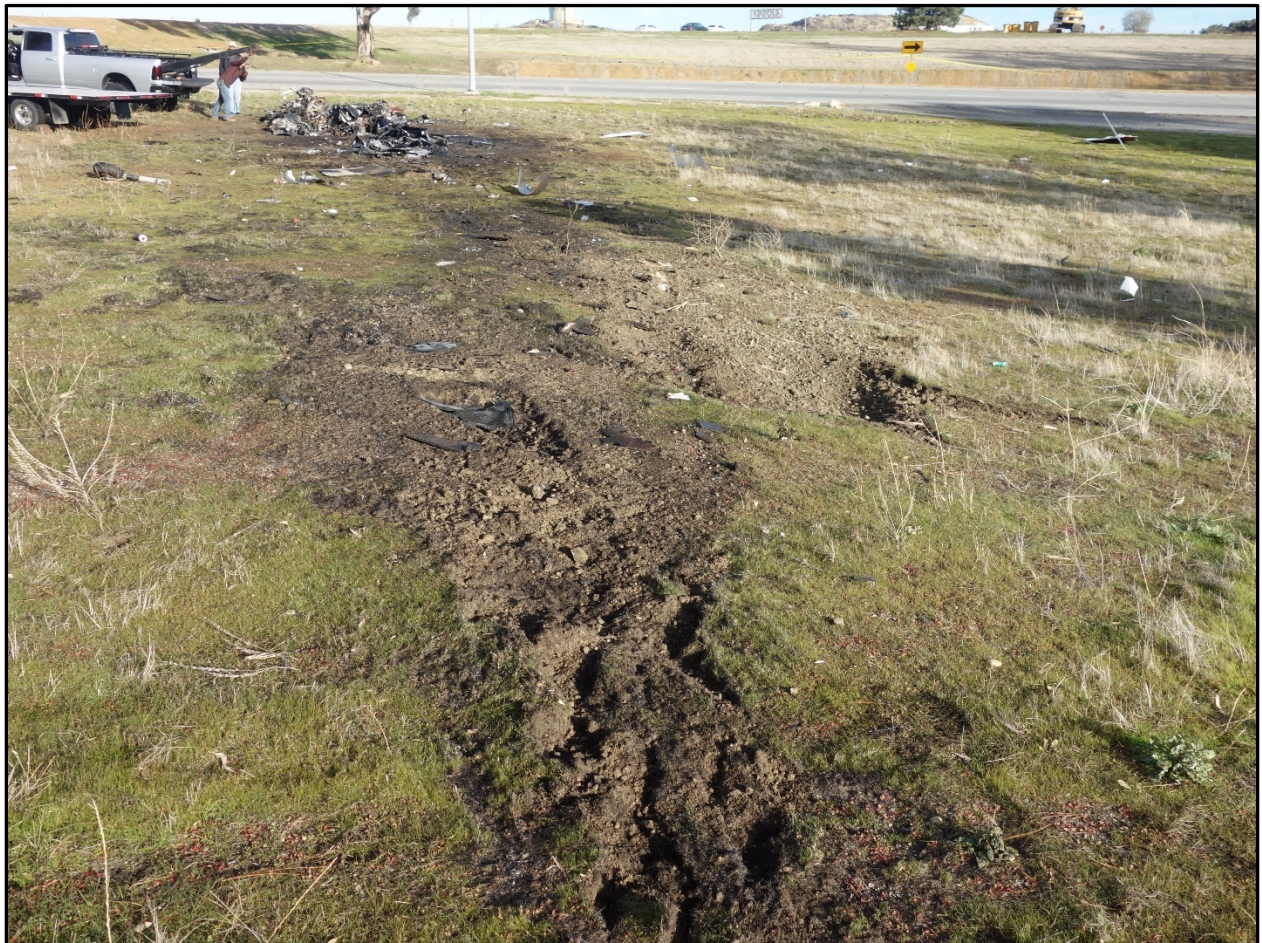
About 75 ft past the reservoir, the airplane wreckage came to rest upright on about a 140° magnetic heading. The wreckage site was at an elevation of about 1,429 ft msl. A ground disturbance was observed about 60 ft northeast from the wreckage that measures about 10 ft by 30 ft. All major components of the airplane necessary for flight were contained within the main wreckage site. Flight control continuity was unable to be established due to the extensive thermal damage sustained by the airplane. Most of the wreckage debris, consisted of small fragments of

the canopy and of the landing gear that had sheared off. The canopy fragments were clear of contamination. There was a postimpact fire that thermally damaged and consumed most of the airplane and the engine.

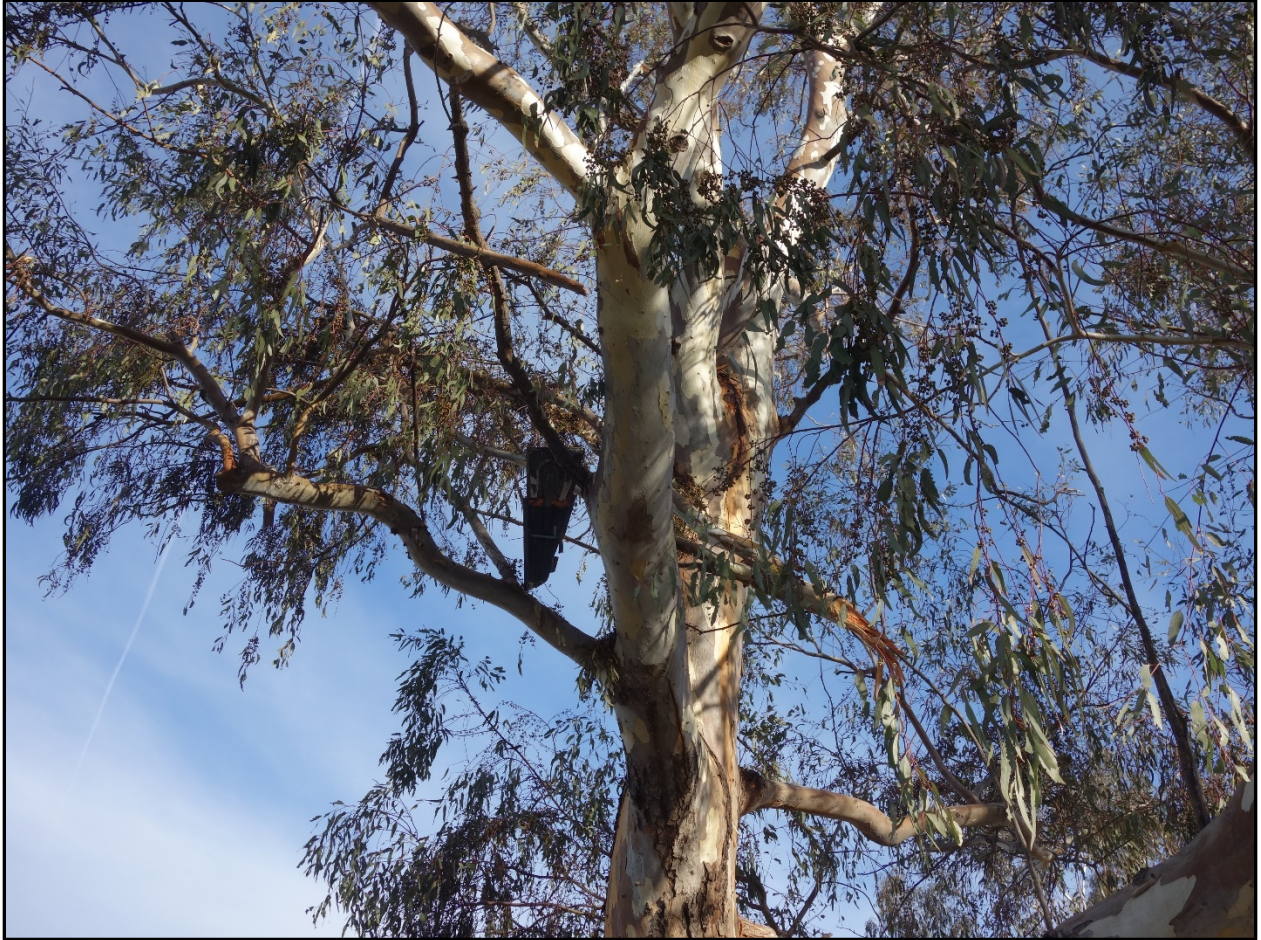
Examination of the accident site revealed that the airplane impacted level terrain in a median located in the center of an interstate freeway exit ramp. The terrain consisted of grass and dirt. On the east side of the median several tall trees were present. The first point of impact was near the top of about a 60 ft tall tree. Several branches were observed broken with fresh breaks and a section of the airplane was observed embedded in the tree along with two smaller pieces. Additionally, parts of the propeller blades and numerous broken branches with fresh breaks were located at the bottom of the tree.

Figure 2: Tree that airplane struck with section of the airplane visible on left side.
