## **NATIONAL TRANSPORTATION SAFETY BOARD**

# **ENGINE EXAMINATION**

**WPR20FA057**

Location: Santa Clarita, CA  
Date: January 4, 2020  
Aircraft: N151WR Amateur built  
experimental TM-1  
Thunder Mustang  
NTSB IIC: Albert Nixon

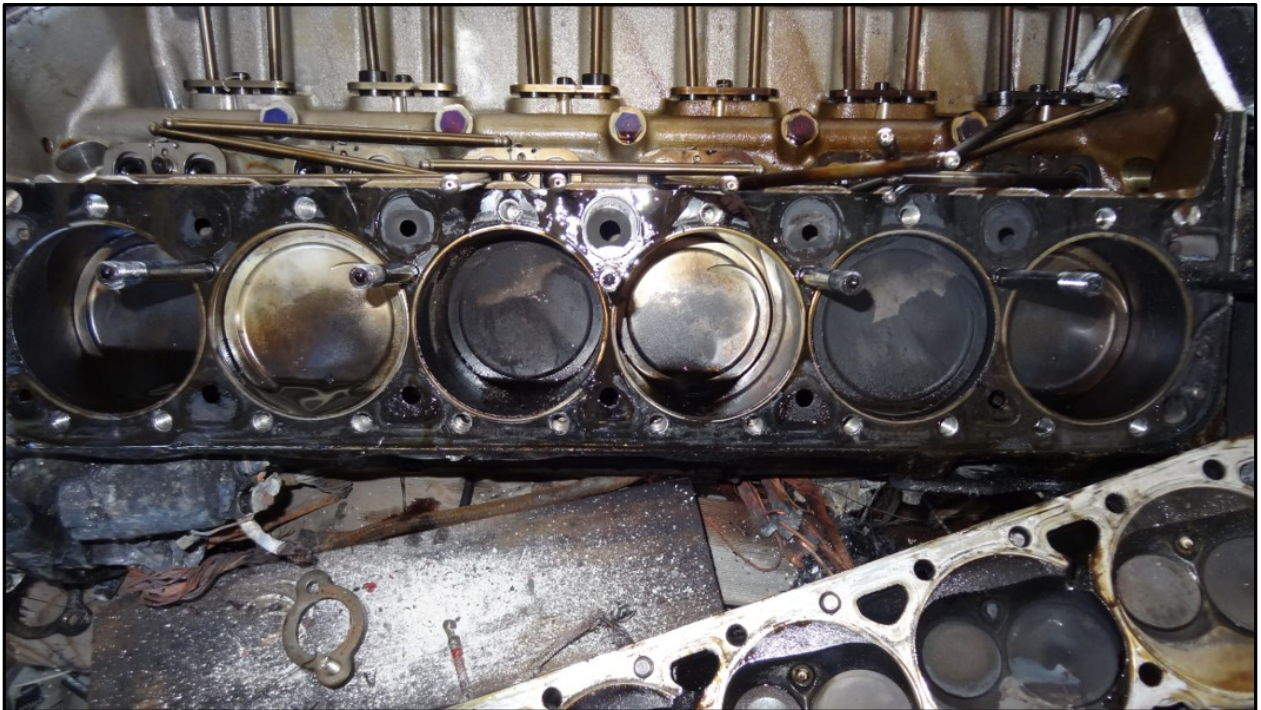
Examination revealed that the Falconer V-12 engine had separated from the fuselage. All the engine components and accessories were present and remained attached to the airframe. The engine appeared intact, with impact damage noted on the engine mount support tubes on the right side of the engine. No rotation of the crankshaft was able to be accomplished due to the impact and thermal damage sustained by the engine. A borescope inspection of the cylinders revealed evidence of that the 6 right side cylinders had relatively normal operating conditions, however, on the left side of the engine, The Nos. 1, 3, and 5 cylinders were nearly black in color.

**Figure 1: Engine cylinders as observed from the left side.**

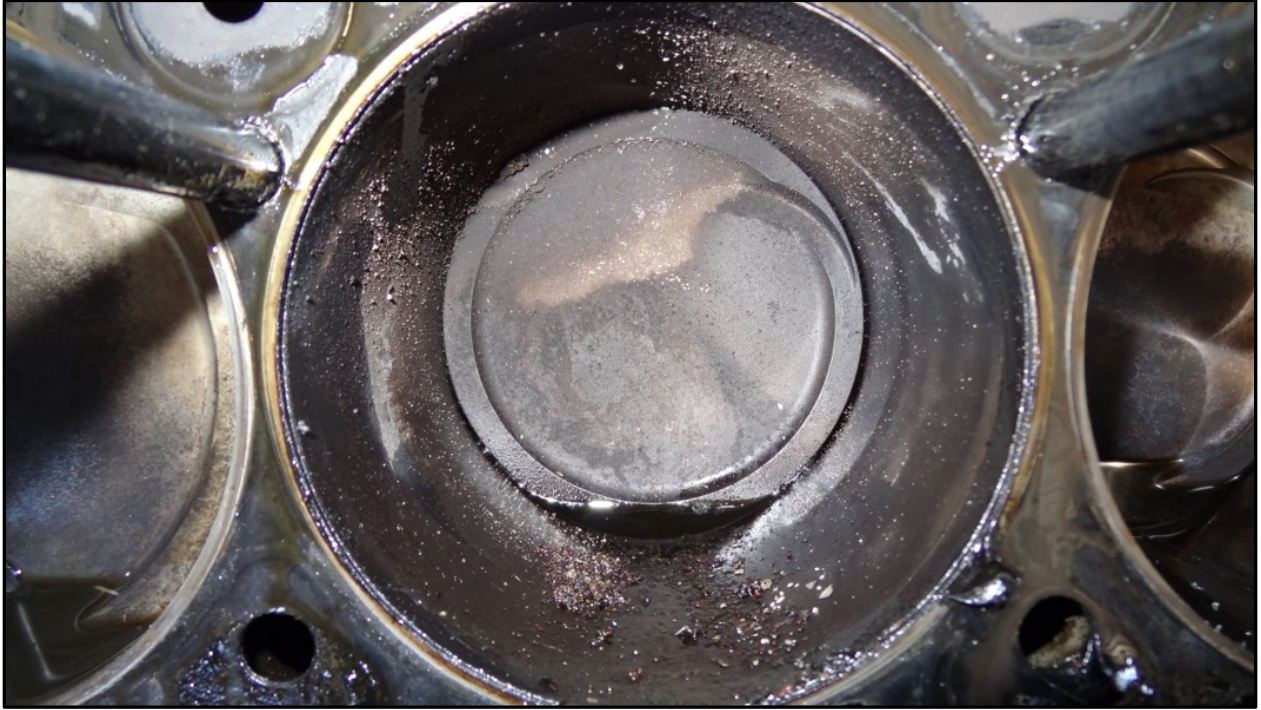
The engine was disassembled and revealed cylinder damage consistent with detonation. The cylinders piston top and cylinder heads were absent of any carbon build up and exhibited a sandblasted appearance consistent with detonation. Further, the cylinders exhibited damage consistent with detonation at the cylinder head and piston face edges. Traces of oil were present in engine and no coolant was observed in the engine. The electronic engine control from the left side was not found in the wreckage.

**Figure 2: No. 2 cylinder internal damage.**

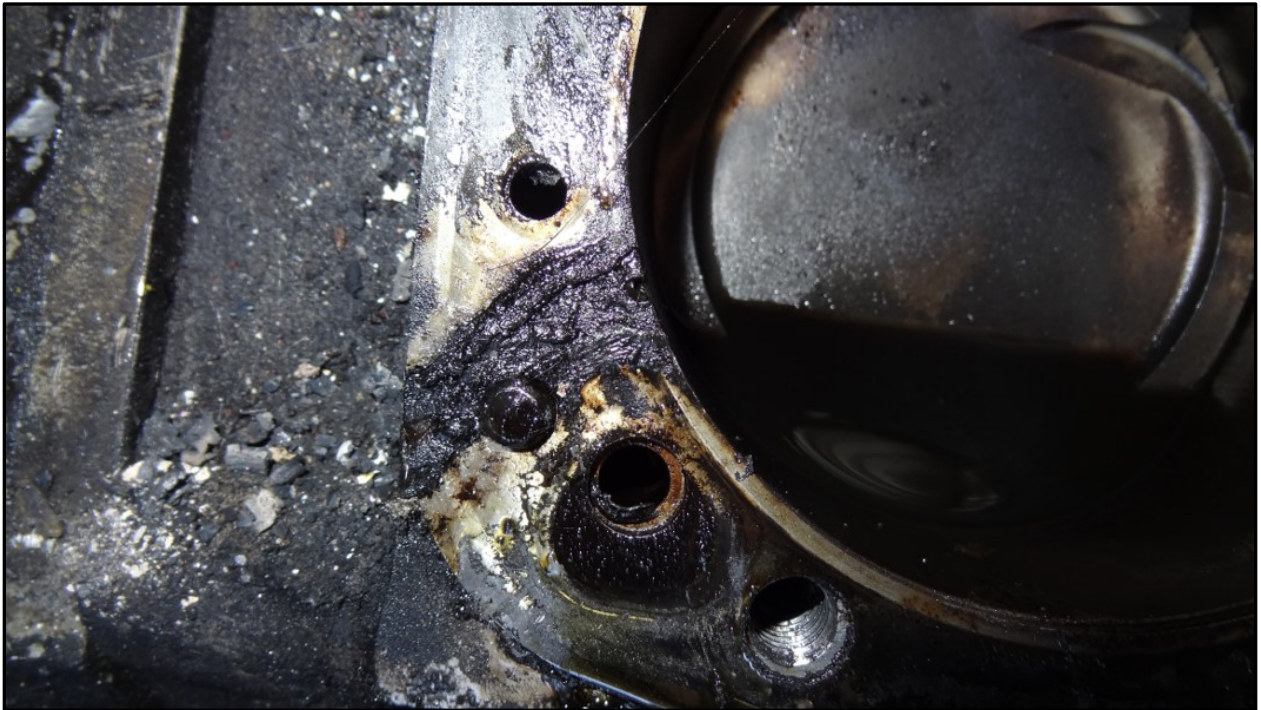
The intake manifold, valve cover, and intake plenum were removed from the engine. The exhaust valve push rod for the No. 5 cylinder was not secured and observed lying inside the engine consistent with improper installation. The left side head assembly was removed and revealed that the Nos. 1, 3, and 5 cylinders head attachment areas each had metal deformation consistent with an internal combustion gas leak. The No. 1 cylinder had metal deformation

through a coolant passageway and the crankcase, and about a 1 cm wide by 3 ml deep hole was observed. Additionally, discoloration and metal deformation near the hole was consistent with extreme hot gasses. On the Nos. 3 and 5 cylinders, the hot combustion gasses had only penetrated into the coolant passageway and had not yet burnt through the crankcase.

**Figure 3: No. 1 cylinder metal deformation.**
