NATIONAL TRANSPORTATION SAFETY BOARD

AIRFRAME EXAMINATION

WPR20LA315

Location: Emmett, Idaho
Date: September 22, 2020
Aircraft: Air Tractor, AT-802A, N836MM
NTSB Investigator-in-Charge: Eric M. Gutierrez

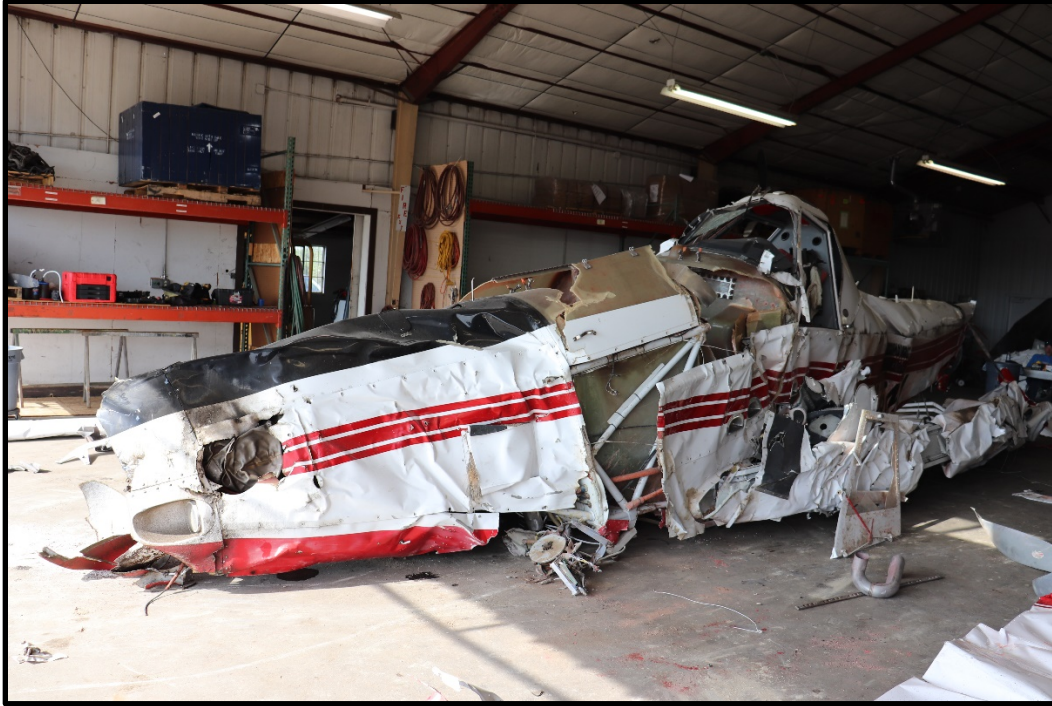
The fuselage was mostly intact. The engine, cowling, and forward portion of the fuselage was impact damaged. The forward section of the cockpit was impact damaged and was displaced to the right. The left side of the fuselage, forward of the cockpit was impact damaged, with multiple separations found in the tubular fuselage structure. The left side of the fuselage, aft of the cockpit was impact damaged, bent, and twisted throughout. The right side of the fuselage, forward of the cockpit was impact damaged, with multiple separations found in the tubular fuselage structure.

Figure 1: View of left side of airplane.

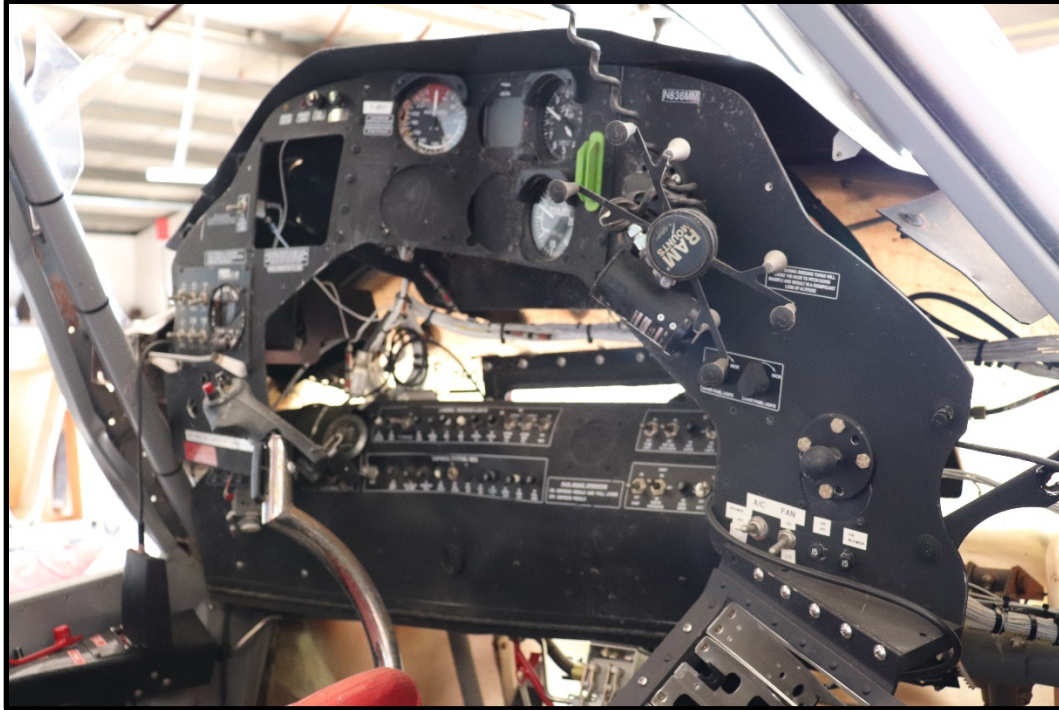
The instrument panel was impact damaged with multiple instruments displaced.

Figure 2: View of instrument panel.

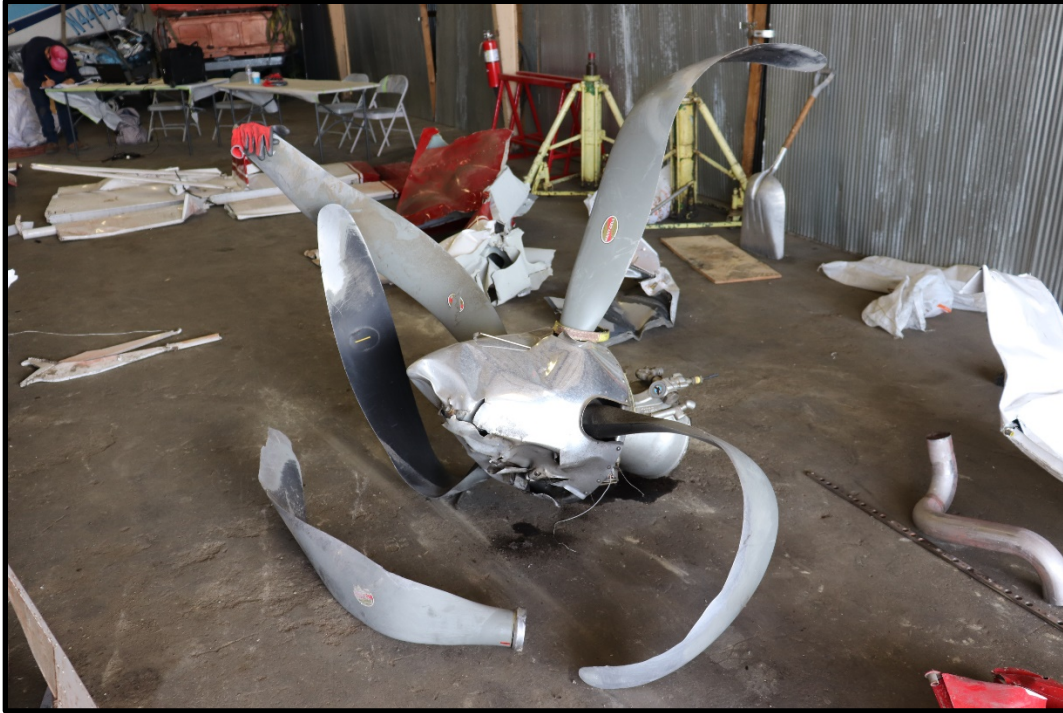
Four of the five propeller blades remained attached to the propeller hub. One propeller blade exhibited bending aft about mid span, with polishing and unidirectional striations on the cambered side of the blade. A propeller blade exhibited bending forward about mid span, with polishing and unidirectional striations on the cambered side of the blade. A propeller blade exhibited bending aft near the hub, with polishing and unidirectional striations on the cambered side of the blade. A propeller blade exhibited bending aft about mid span, with polishing and unidirectional striations on the cambered side of the blade. The separated propeller blade exhibited bending aft about mid span, with polishing and unidirectional striations on the cambered side of the blade.

Figure 3: View of Propeller.

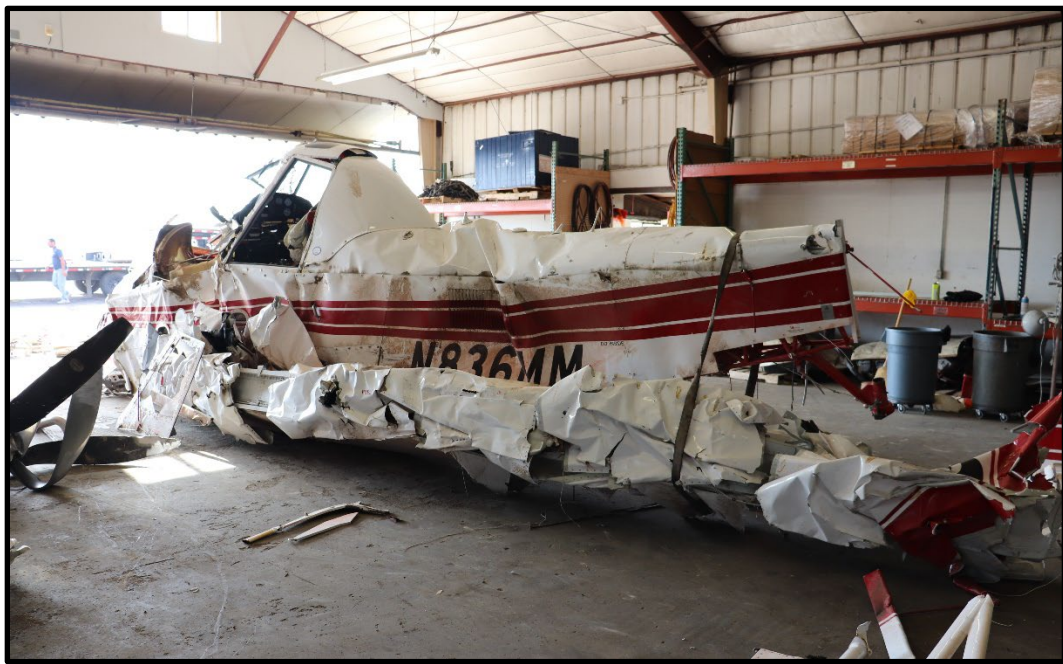
The left wing remained attached to the fuselage and was bent aft about 90°. The leading edge of the wing exhibited aft crushing throughout its span. The upper and lower wing was torn from mid span to wing tip. The outboard portion of the left flap was separated from the wing. The outboard portion was crushed between the wing and the fuselage. The aileron separated from the attachment points and exhibited crushing and bending throughout.

Figure 4: View of left wing damage.

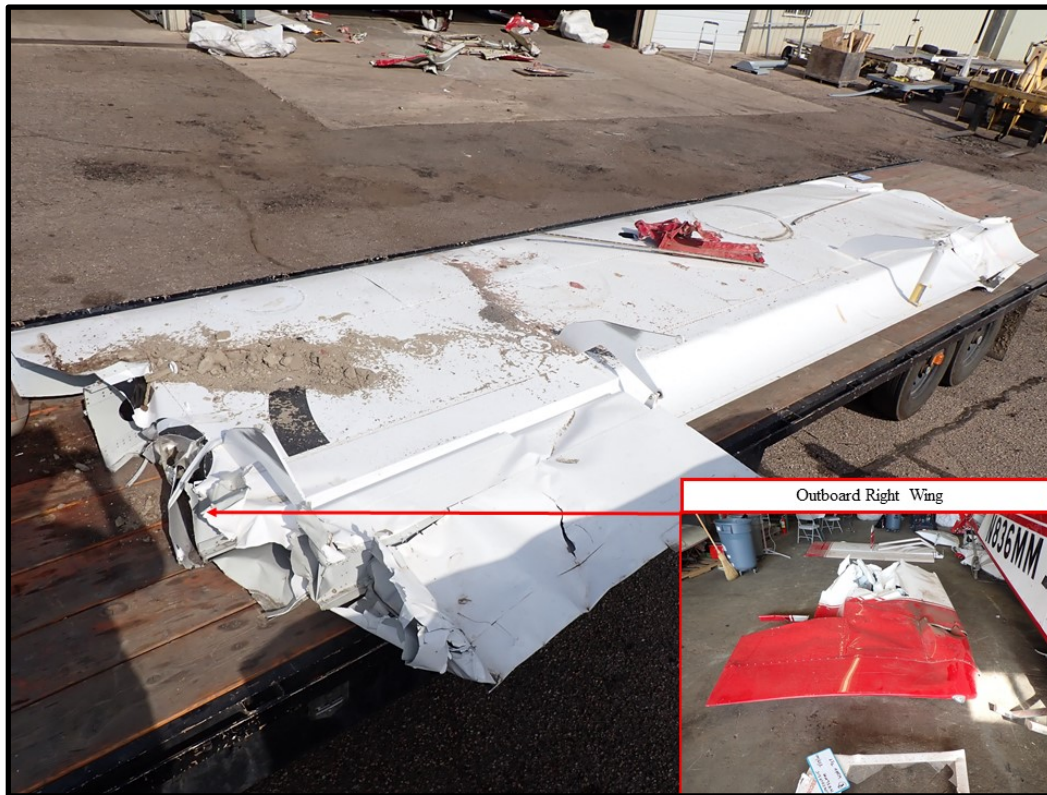
The right wing was separated by recovery personal at the wing root. About 6 ft of the outboard portion of the right wing exhibited impact damage was removed to facilitate recovery. The right flap was separated from the attachment points and exhibited crushing and bending throughout. About 5ft of inboard section of aileron remained attached to the wing, the remaining outboard portion of the aileron was separated and exhibited crushing and bending throughout.

Figure 5: View of ring wing damage.

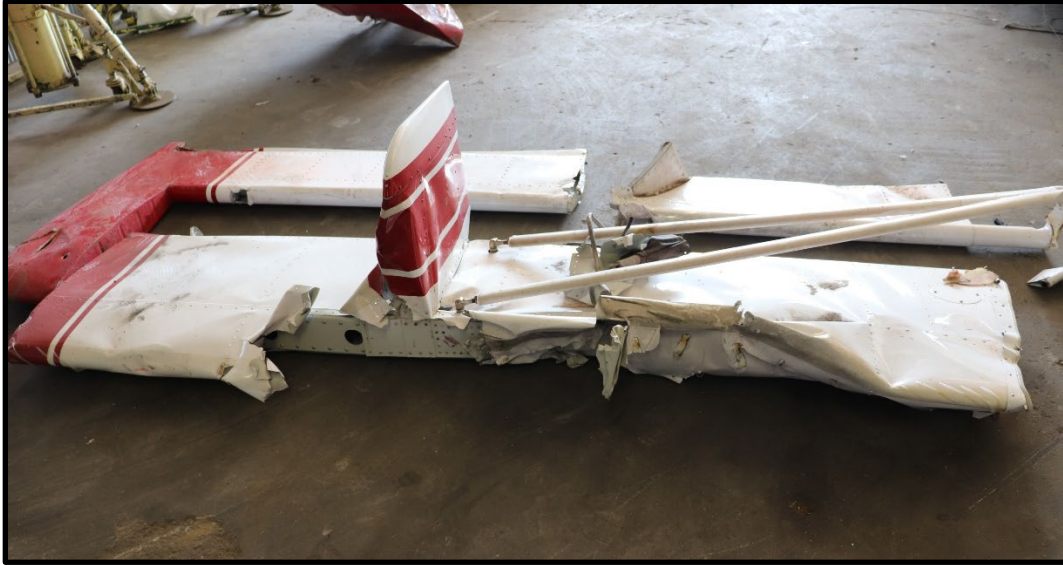
The left horizontal stabilizer was separated at the root. The leading edge exhibited crushing throughout its span, the middle portion of it was torn open, and either not located, or displaced. The left auxiliary vertical fin leading edge exhibited aft crushing. The v strut remained attached to the horizontal stabilizer via their mounts. The v strut fuselage attachment point was cut by recovery personal. The left elevator was separated from the horizontal stabilizer and was separated about mid span.

Figure 6: View of left horizontal stabilizer.

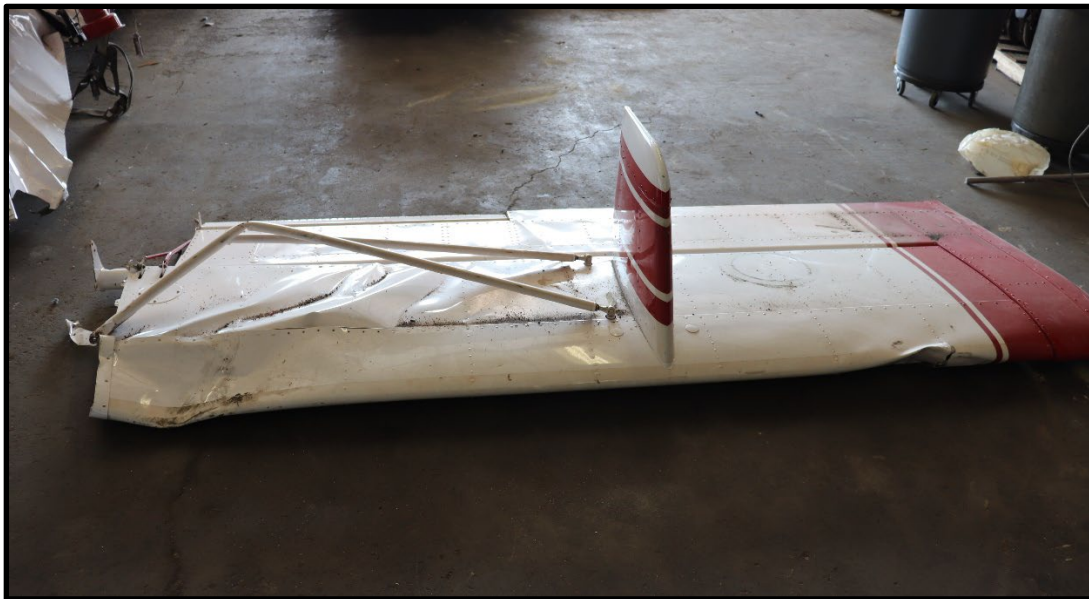
The right horizontal stabilizer was separated at the root. The v strut remained attached to the horizontal stabilizer via their mounts and bending about 2 ft from the fuselage attachment point. The leading edge exhibited upward crushing of the skin near the root, with 45° buckling. Downward crushing of the leading edge about 18 inches from the tip of the horizontal. The right elevator remained attached to the horizontal stabilizer via their mounts.

Figure 7: View of right horizontal stabilizer.

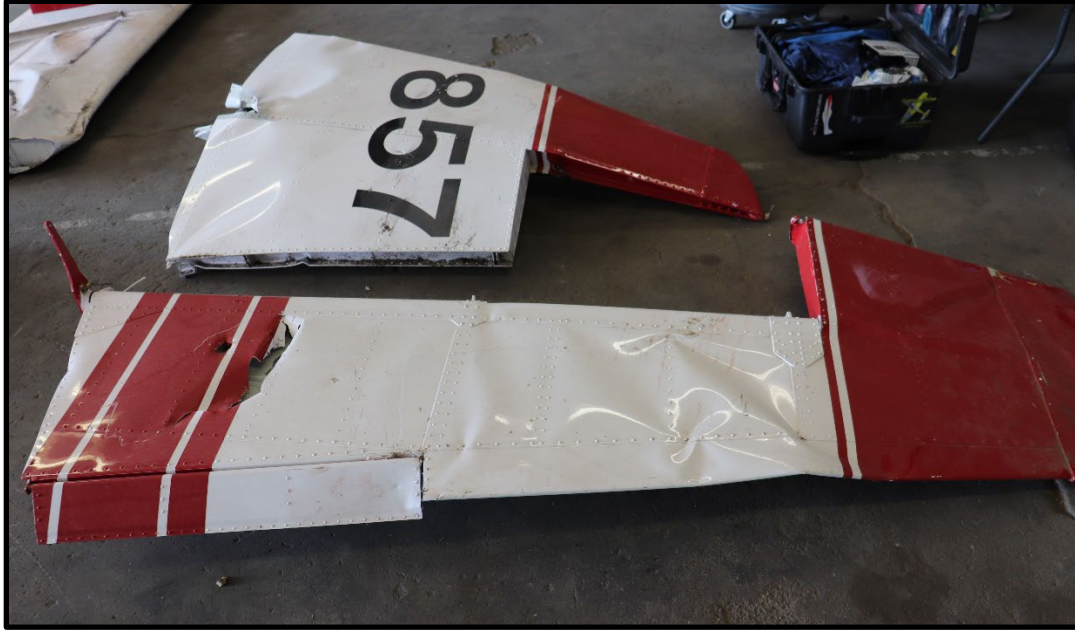
The vertical stabilizer and rudder were separated by recovery personal. The vertical stabilizer was slightly left about mid height. The rudder was buckled throughout from about mid height to the top of the rudder. Punctures of the skin on the left side of the rudder were observed about 15 inches from the bottom of the rudder.

Figure 8: View of vertical stabilizer and rudder.

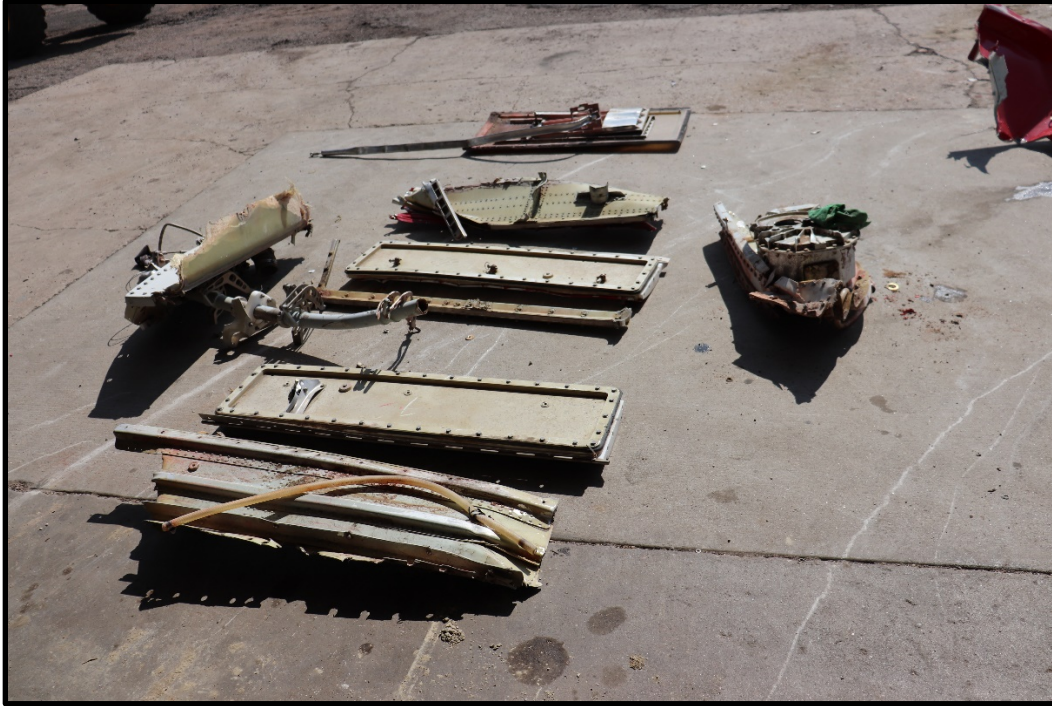
The fire retardant dispersal system was separated from the fuselage with significant impact damage. The forward fire gate bulkhead separated from the fuselage. The fire gate gearbox remained attached to the forward fire gate bulkhead. The gearbox was tested using a hand tool and the gearbox rotated from stop to stop. The electric motor was separated from the gear box and was impact damaged. The fire gate torque tube was separated from the gearbox and exhibited upward bending about mid span. Four of the six door pull arms remained attached to the torque tube but were separated from the doors. One of the door pull arms was separated, heavily damaged and the remaining pull arm was not recovered. The aft fire gate bulkhead separated from the fuselage. The emergency dump linkage was heavily damaged but remained attached to the aft fire gate bulkhead.

Figure 9: View of fire retardant dispersal system.

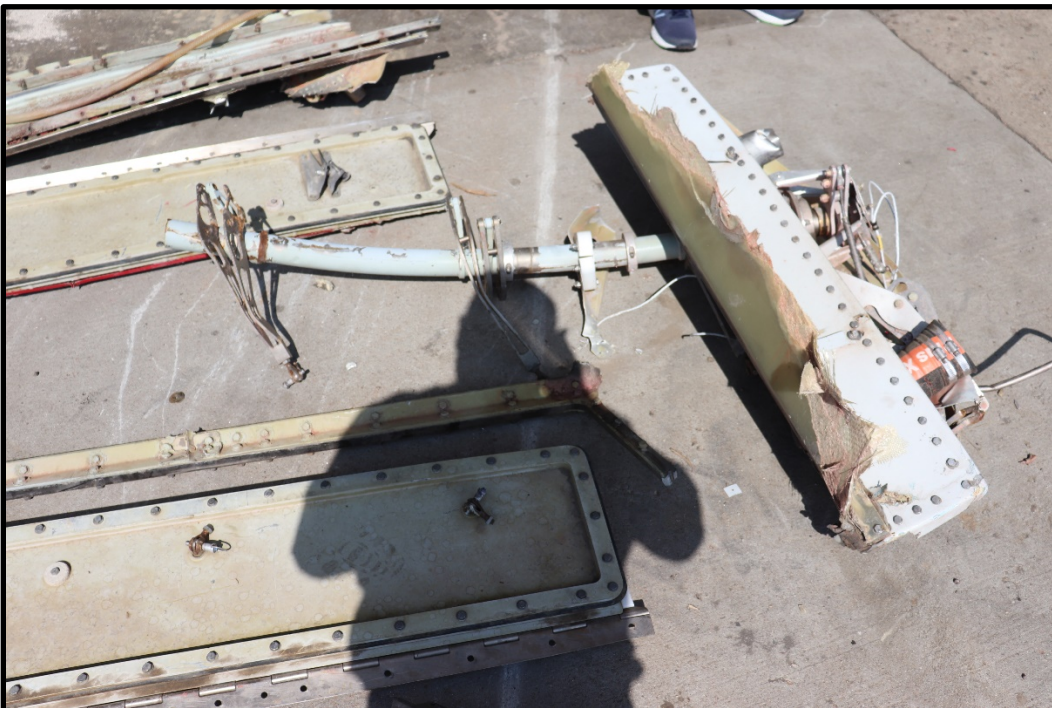
Mechanical continuity of emergency dump handle was established from the cockpit to the gate, with two fractures in the linkage tubes consistent with impact damage. The linkage position at the fire gate was consistent with the fire gate in the closed position.

Figure 10: View of aft fire gate bulkhead.

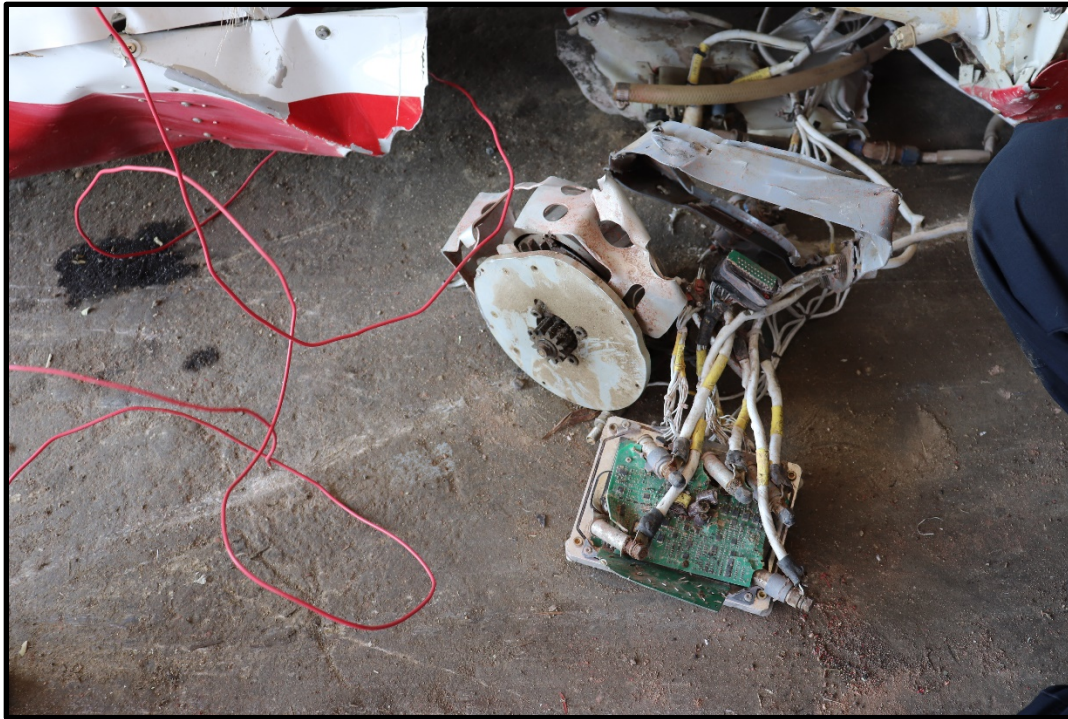
Electrical continuity from the battery buss and main breaker was established to the motor drive. The motor drive was heavily damaged as was the electric motor. Electrical continuity from the motor contactor and EDUMP limit switches was established. The limit switches were tested to work properly.

Figure 11: View of electric motor damage.

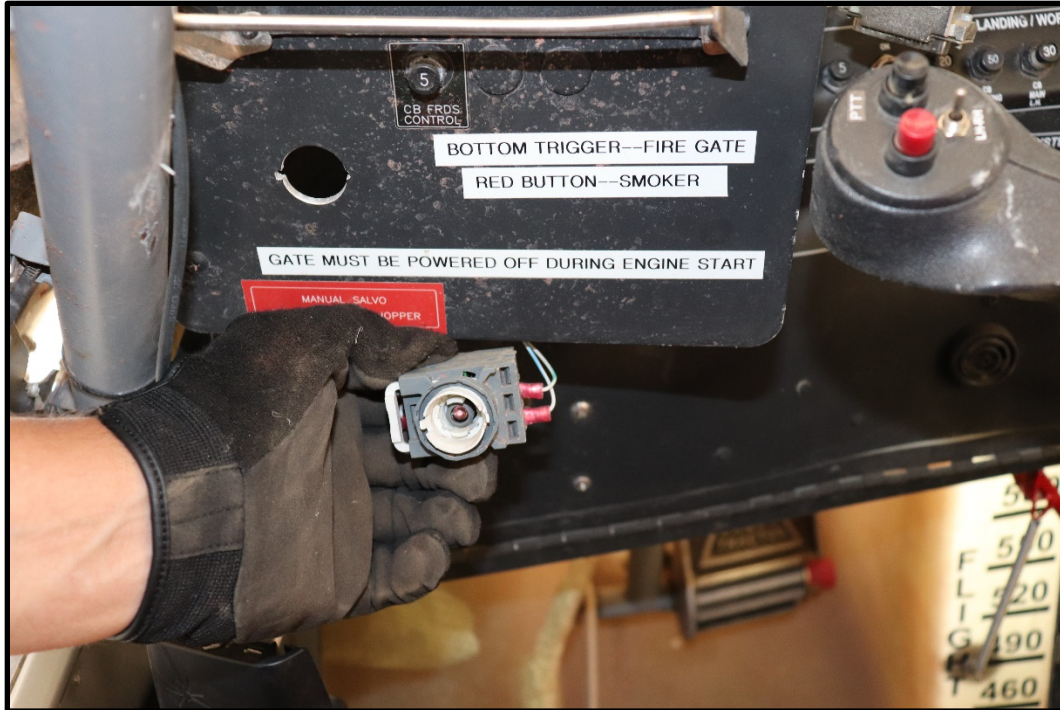
Electrical continuity was established from the +28V buss to the manual salvo button to the electric motor cover bulkhead. The manual salvo button was separated and not recovered. The salvo housing was separated from the instrument panel.

Figure 12: View of manual salvo button.

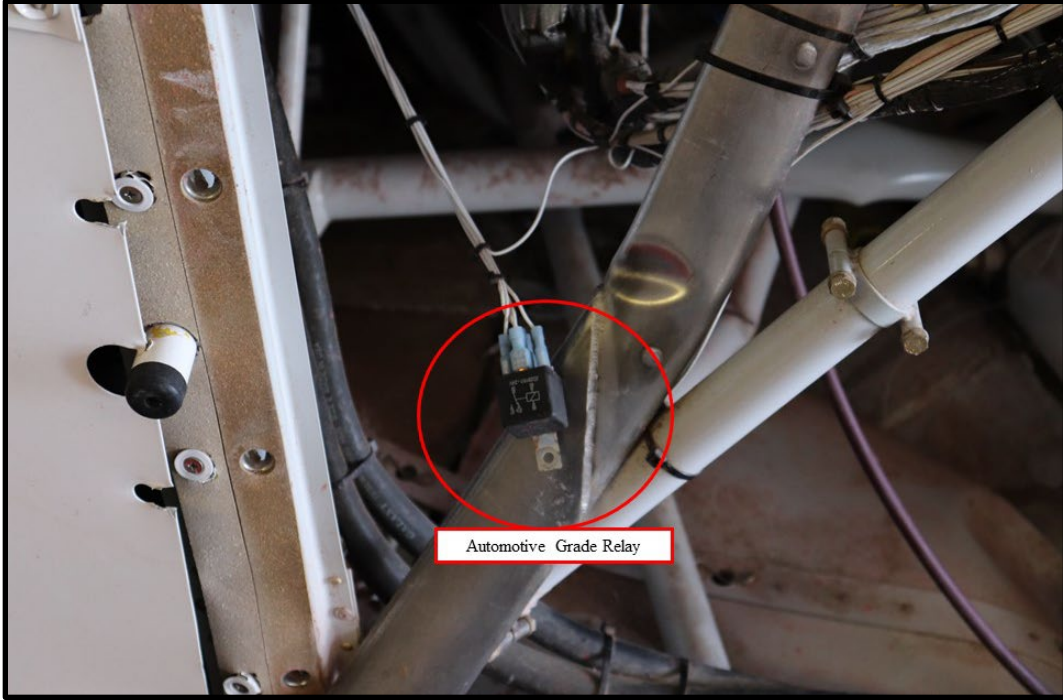
The drop switch wiring had been modified from the factory configuration to move the position of the switch from the top of the flight control stick to the lower “trigger” position. The trigger switch utilized was a single pole switch, a 24Vdc relay had been wired in to create the second (normal closed) contact needed to operate the system. The wires used for the relay were MS-22759 or similar with push on type terminals that remained intact and installed on an automotive grade +24V, single pole relay. Labels were not applied to the wiring.

The switch would only affect the AUTO/MANUAL modes of operation and would have no effect on the MANUAL SALVO operation.

The manufacturer wiring configuration utilizes a 2 channel NO/NC, that prevents short circuits from causing an inadvertent dump.

Figure 13: View of automotive grade relay.
