# National Transportation Safety Board

## Performance Study

### Specialist Report

Location: Emmett, Idaho  
Date: September 22, 2020  
Time: 18:45 mountain daylight time (MDT)  
Airplane: Air Tractor AT-802A, N836MM  
NTSB Number: WPR20LA315

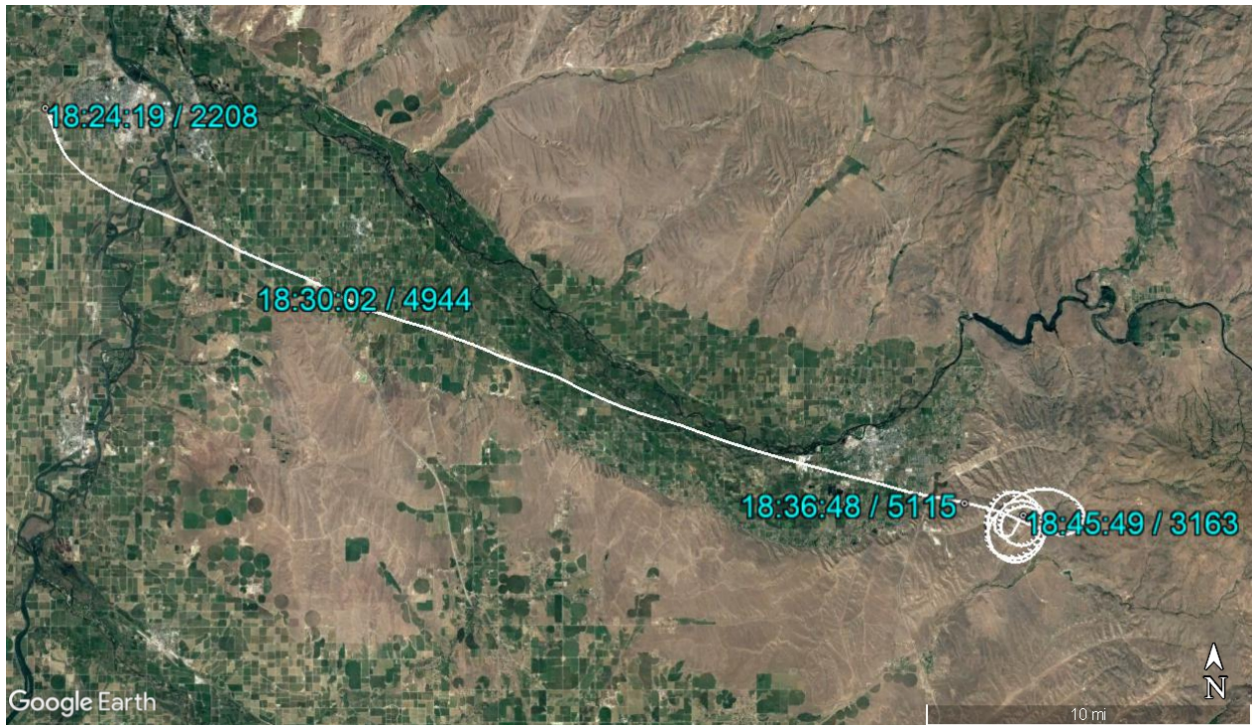
The airplane took off from Ontario Municipal Airport in Ontario, Oregon at 18:24 MDT (Figure 1) to conduct firefighting operations in an area south-east of Emmett, Idaho. It climbed to an altitude between 5,000 and 5,500 ft msl while en route to the fire location (Figure 2). The airplane reached the area of the accident at about 18:37 and began a series of left-hand circles over the area. The airplane descended below 5,000 ft at 18:43 and slowed from about 140 kts of calibrated airspeed to 120 kts. Air Tractor, Inc. lists the AT-802A's typical working speed to be between 113 and 139 kts [1].

**Figure 1.** Accident flight in white with select times and altitudes (msl) annotated in blue.

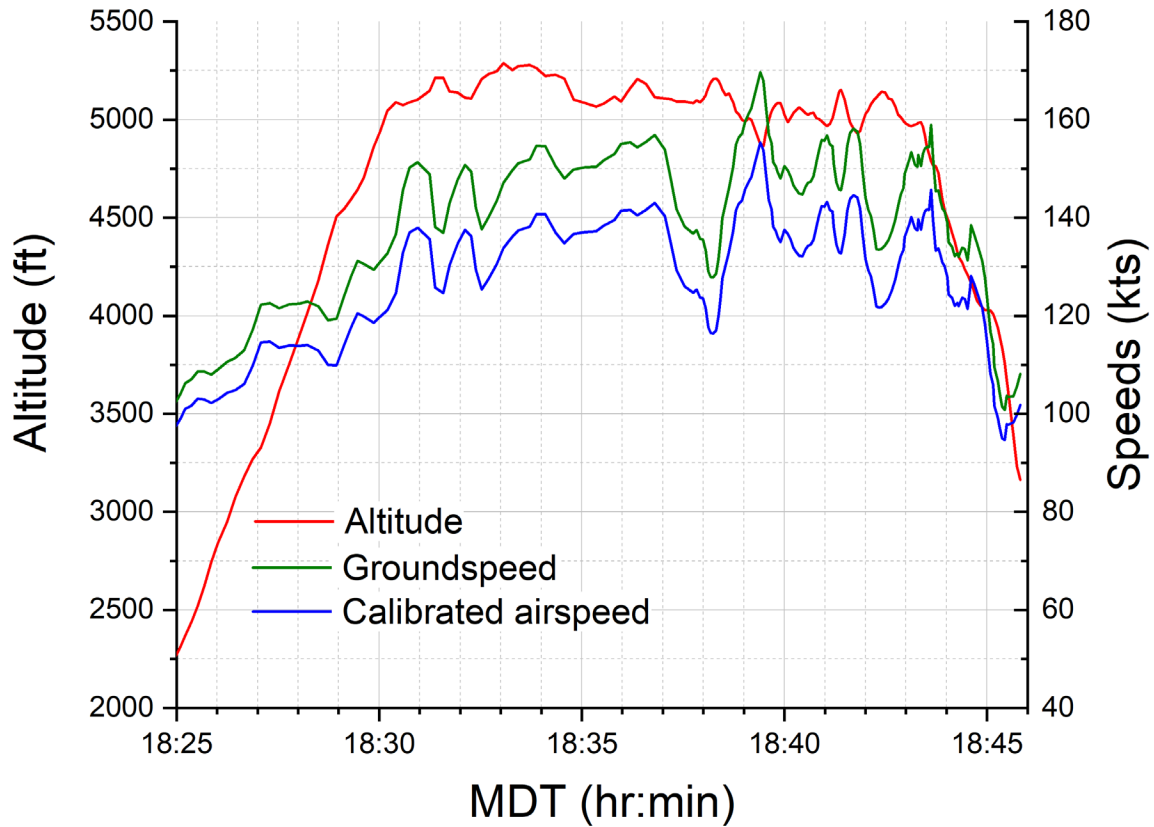
**Figure 2.** Recorded altitude (msl) and calculated groundspeed and calibrated airspeed.

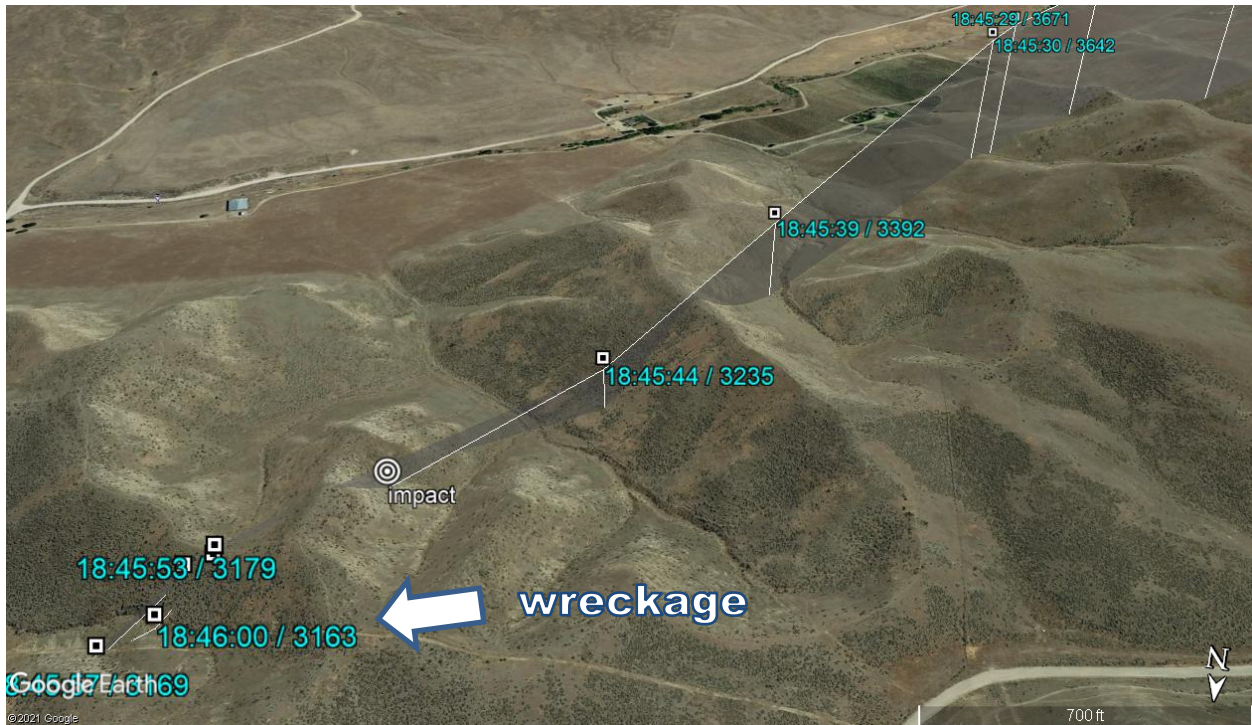
The end of the GPS data is shown in Figure 3. The airplane had descended into a small valley and was climbing when it impacted terrain. The wreckage then continued over the top of ridge and down the other side, which is reflected by the GPS data points post-18:45:52 in Figure 4. The elevation of the impact point was approximately 3,220 ft. The elevation of the top of the ridge was about 40 ft above the impact point at approximately 3,260 ft.

**Figure 3.** End of accident flight. Points after "impact" are from the airplane wreckage as it moved down the far side of the hill.

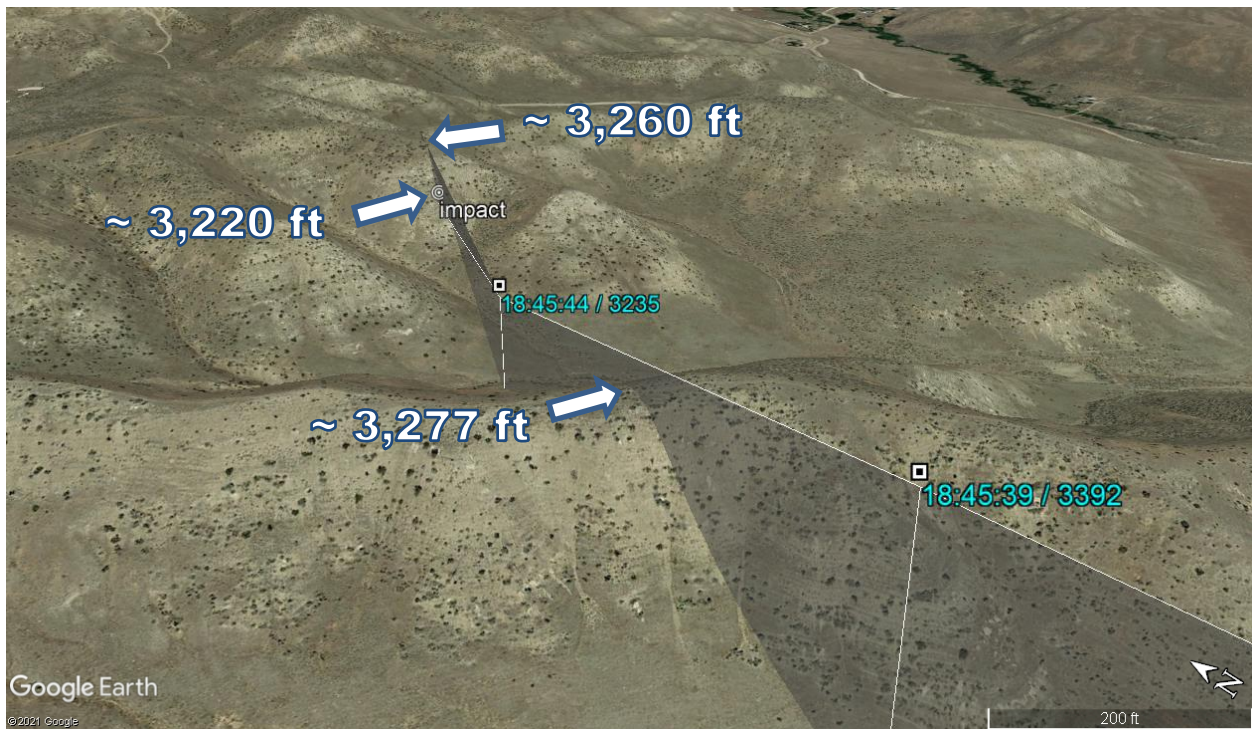
**Figure 4.** End of GPS flight data with the approximate elevations noted.

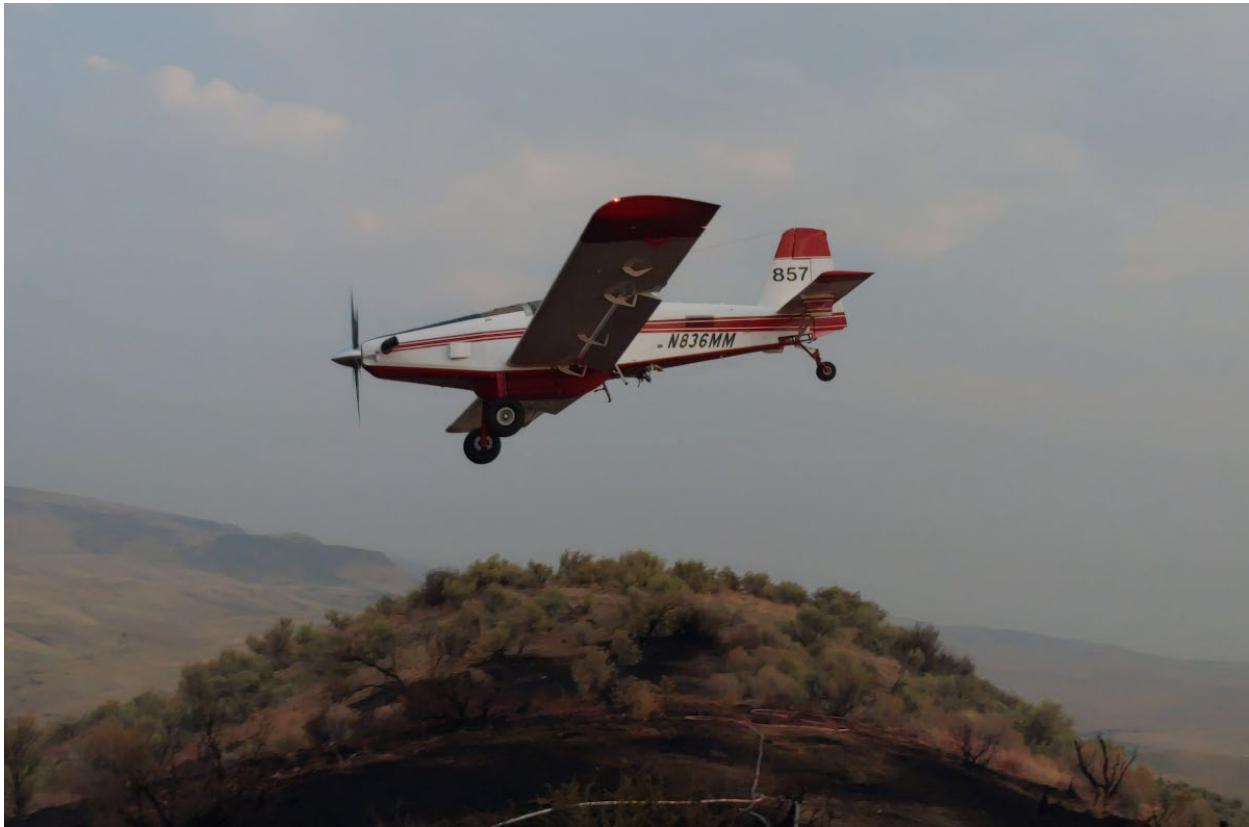
The last flying GPS data point was at 18:45:44, when the airplane was at a recorded altitude of 3,235 ft. The path between 18:45:39 and the final flying GPS point is consistent with the accident video which showed the airplane descending and passing low over the 3,277 ft ridgeline shown in Figure 5. This is the only GPS data point in the valley of the accident.

**Figure 5.** Accident airplane passing low over prior hillside.

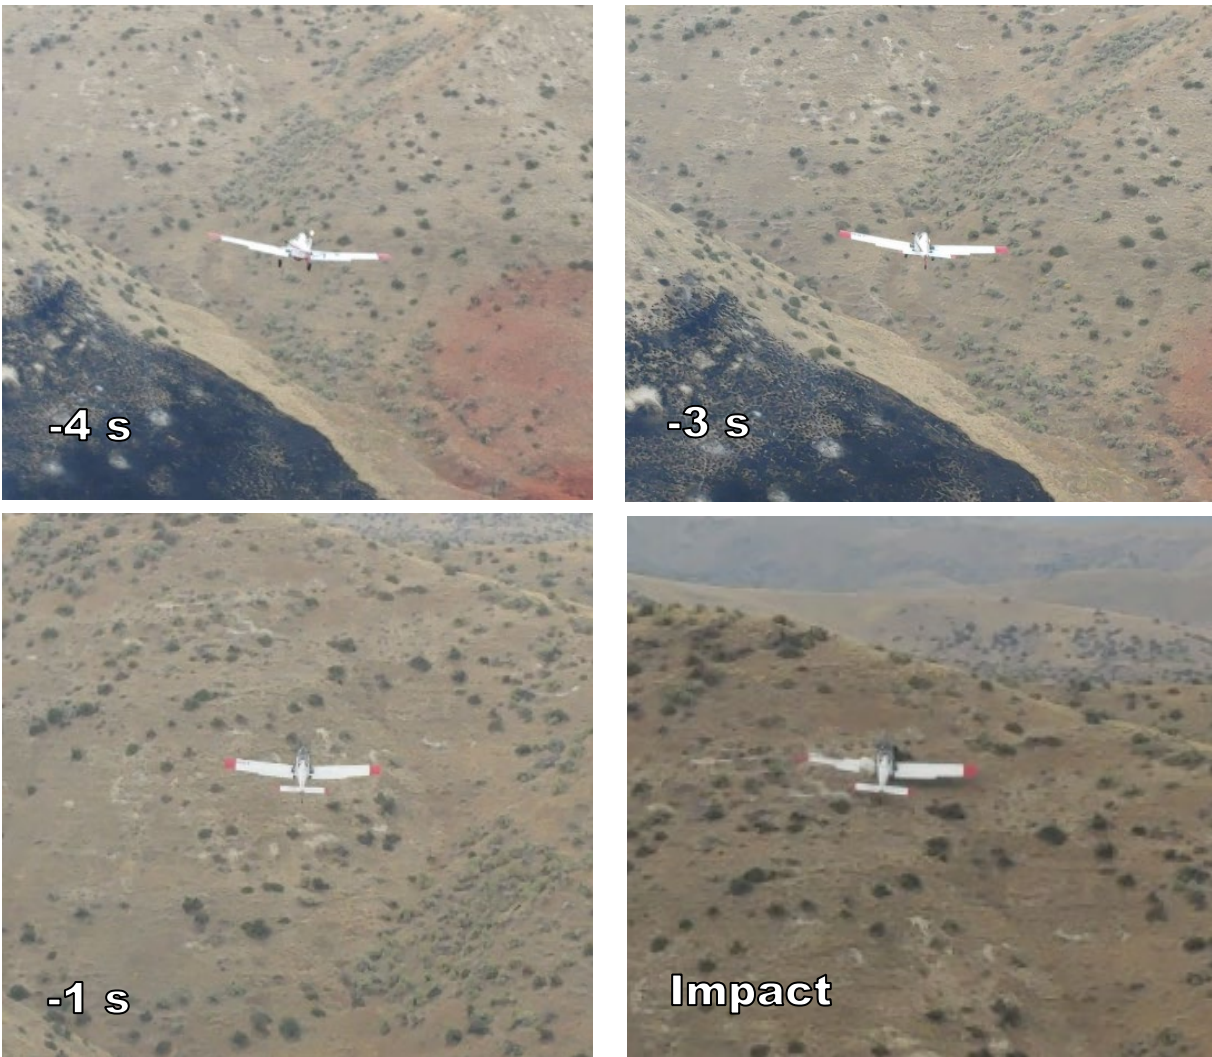
Figure 6 shows four frames from the video that captured the accident impact. In the first, about 4 seconds before impact, the airplane was still descending. In the second, about 3 seconds before impact, the airplane has begun to climb. The frame one second before impact shows the airplane in a steeper climb as more of the top side of the airplane can be seen from the witness location.

**Figure 6.** Frames from accident video showing transition from descending ( - 4s to impact) to climbing ( - 3s to impact) to impact with terrain.

The final GPS point was about 900 ft from the approaching terrain (Figure 8). At 105 kts, the last calculated groundspeed, it would take about 4.5 seconds to reach the impact location. The video indicates that the airplane did not begin climbing until about 3 seconds before impact. This is consistent with the elevation of impact location (3,220 ft) being lower than the final GPS point as the airplane was still descending.

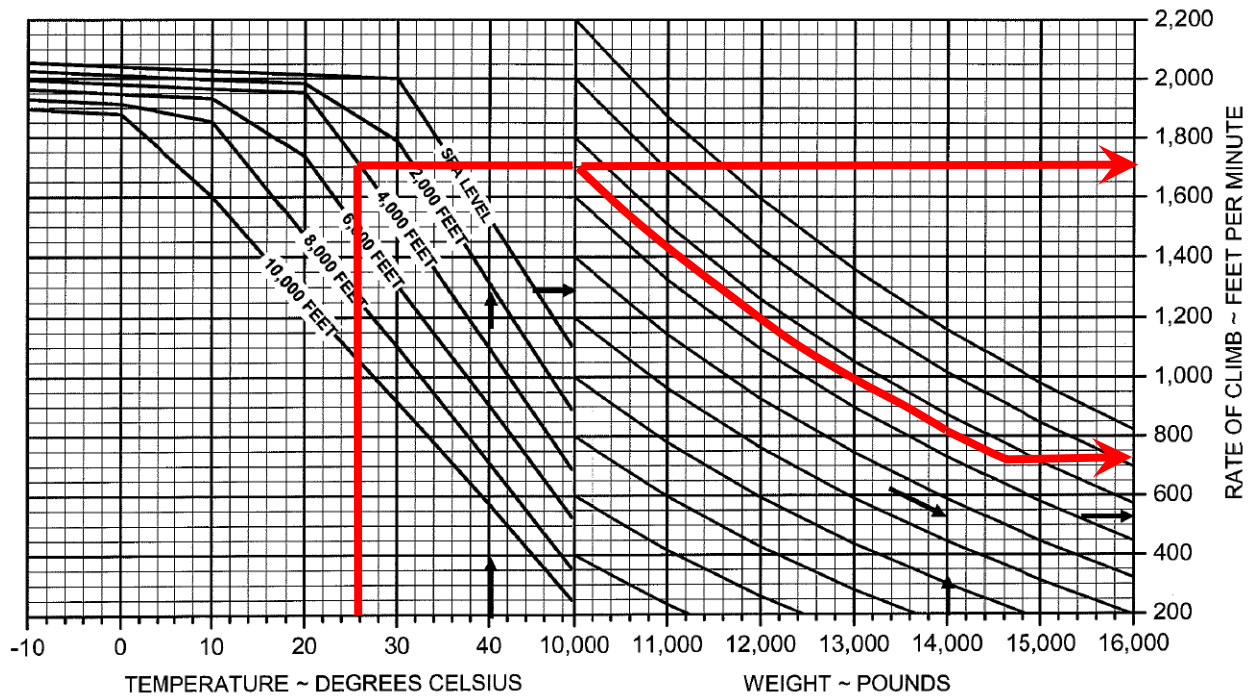
Figure 7 shows the climb performance for an AT-802A with fire fighting equipment. On take-off, the airplane was estimated to have a gross weight of 15,890 lbs; 1,685 lbs of fuel and 6,992 lbs of fire fighting payload. The airplane at the time of the accident was likely between 14,000 and 15,000 lbs at the time of the accident and its rate of climb can be estimated to be about 700 ft/min or roughly 12 ft/s.

**Figure 7.** Climb performance for AT-802A with fire fighting equipment. Conditions for climb performance include maximum continuous power and flaps 10°.

At 700 ft/min, the airplane could have gained 36 ft in altitude in the three second the video shows it's climbing. To impact the hillside at 3,220 ft of elevation, the airplane's minimum altitude in the valley could have been no more than approximately 3,184 ft. This is 50 ft lower than the last reported GPS point and 75 ft lower than the oncoming terrain (Figure 8). This also indicates that the airplane was still descending at the last GPS point.

Without the firefighting payload, the airplane would have been nearly 7,000 lbs lighter. Climb performance data is not provided below 10,000 lbs gross weight, but at the recorded temperature and altitude, its climb rate could improve to greater than 1,700 ft/min or 28 ft/s, more than twice the performance of the loaded airplane. If climbing for three seconds from the same point, the airplane could have gained an extra 48 ft of altitude compared to the heavier weight climb. The airplane impacted terrain 40 ft below the top of the ridgeline.

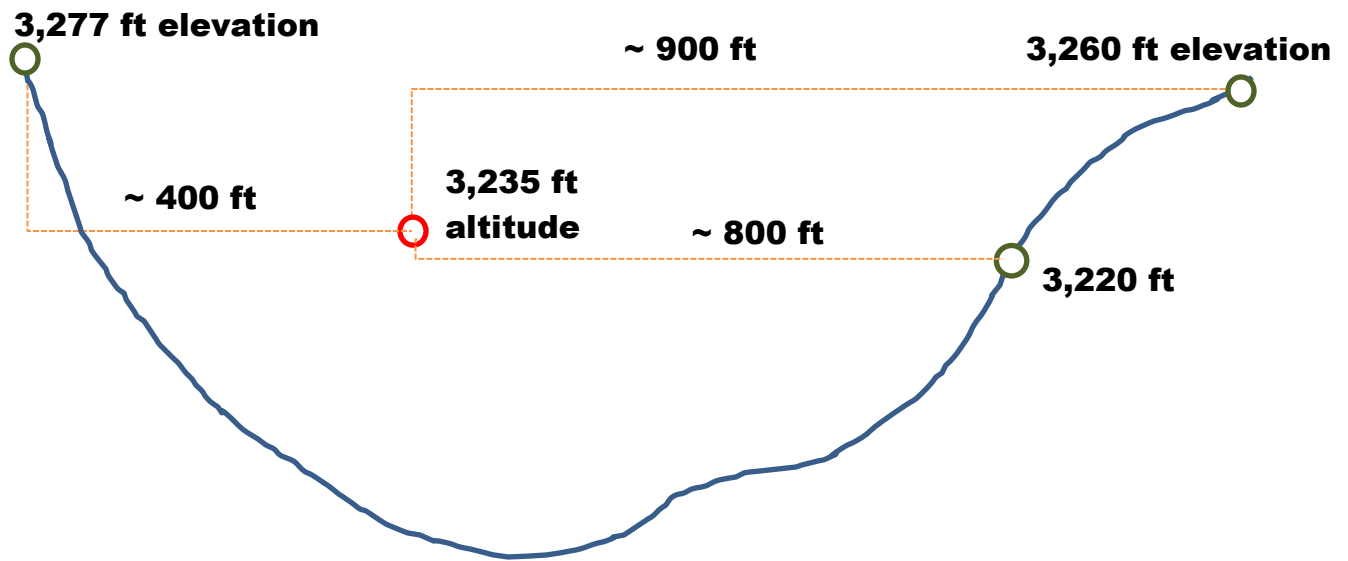
**Figure 8.** Accident airplane is represented by red circle 400 ft past the prior hillside (3,277 ft high) and 900 ft from the approaching hillside (3,260 ft high).
