## **NATIONAL TRANSPORTATION SAFETY BOARD**

### **Specialist's Factual Report**

# **METEOROLOGY**

WPR21FA143

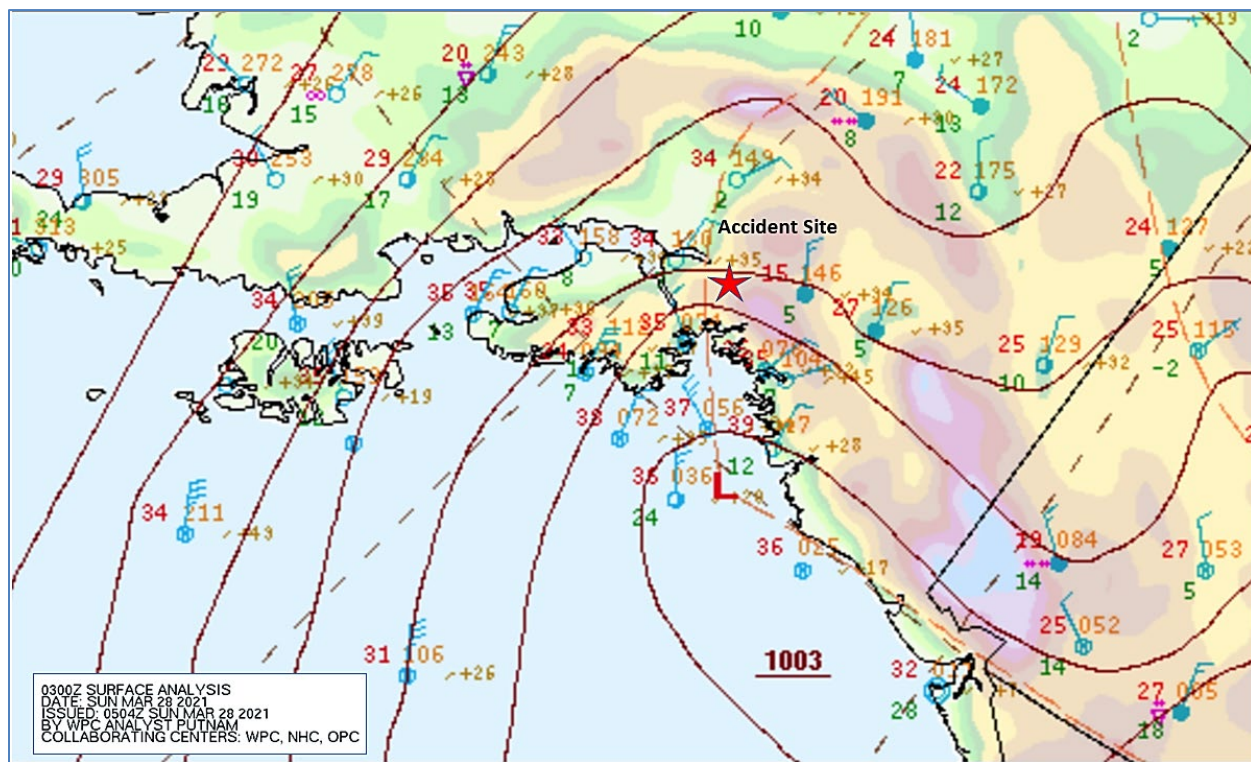
Figure 1 - NWS Surface Analysis Chart centered over southcentral Alaska for 1900 AKDT with the approximate accident site marked by a red star.

The closest depicted station models on the chart to the west of the accident site<sup>2</sup> depicted northerly winds of 10 knots, clear skies, a temperature of 34° F and a dew point temperature of 11° F. The station model to the east-northeast of the accident site at Eureka (PAZK) depicted northerly winds at 15 knots, overcast clouds, a temperature of 15° F, with a dew point temperature of 5° F, and a sea-level pressure of 1014.6-hPa.

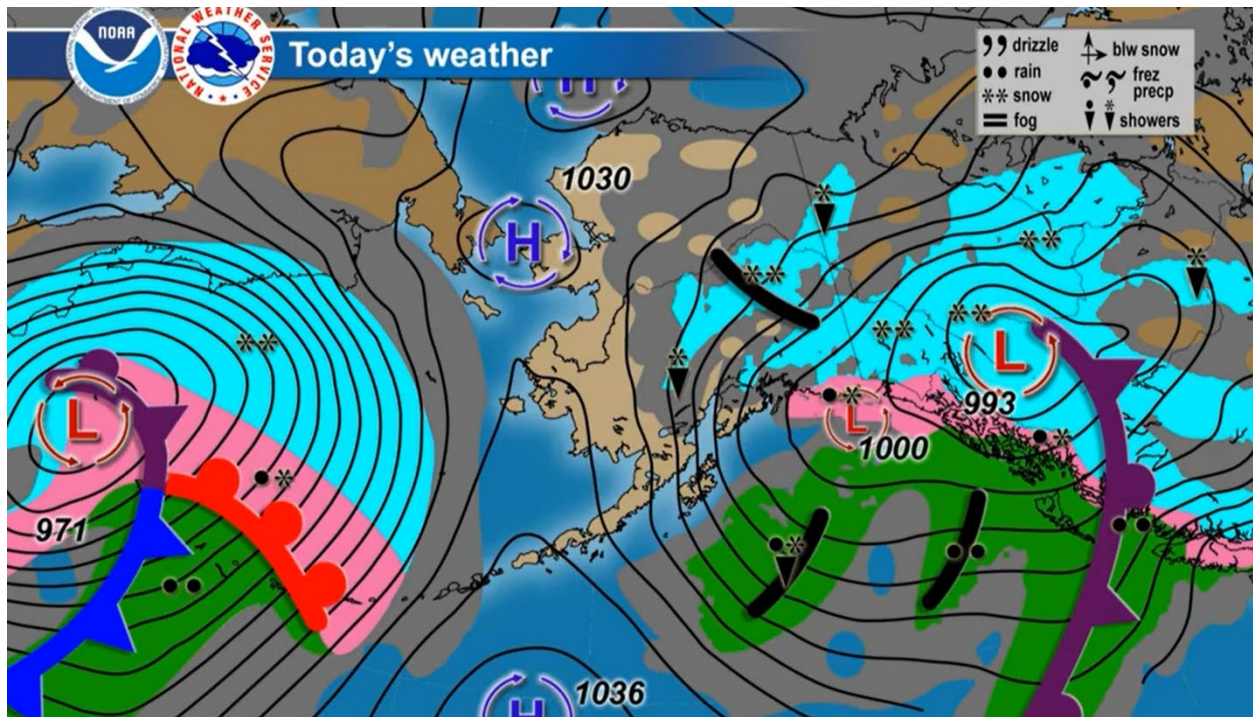
The NWS Anchorage Weather Forecast Office (WFO) Forecast Weather Chart issued for the period is included as figure 2. The chart depicted the low-pressure system in the northern Gulf of Mexico at 1000-hPa and moving eastward along the Alaska coast, with another low at 993-hPa over the Yukon Territory of Canada associated with an occluded frontal system. The chart depicted an area of mixed freezing precipitation along the southcentral Alaska coastal section, with light continuous snow inland over the Chugach Mountains in southcentral Alaska in the vicinity of the accident site.

Figure 2 - Forecast Weather Chart issued for the period.

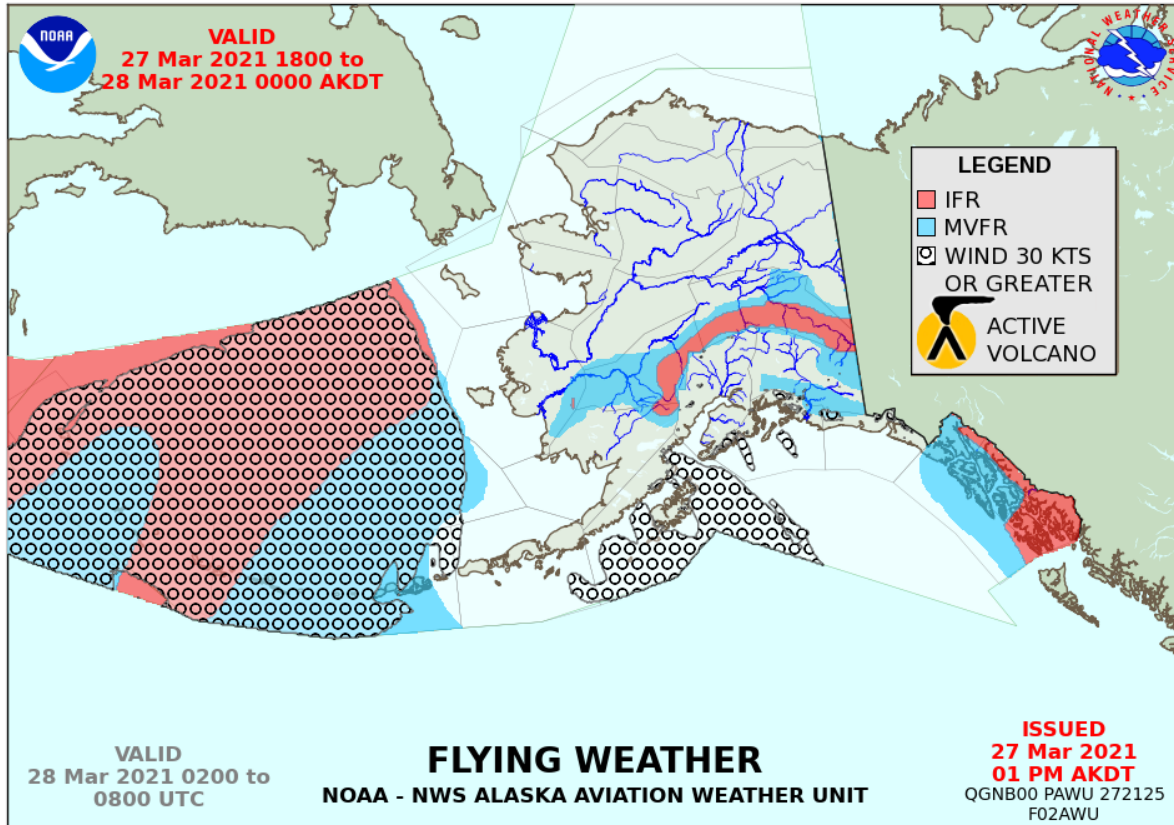
expected during the period is included as figure 3. The chart depicted general VFR conditions prevailing over the Palmer and Knik Glacier areas with MVFR conditions to the east over the Chugach Mountain range. Further to the north, over the Alaska Range, MVFR to IFR conditions were depicted. An area of winds greater than 30 knots were also depicted south of Prince William Sound between Montague and Hinchinbrook Islands in the Gulf of Alaska and generally south of the accident site.

Figure 3 - NWS AAWU Flying Weather Chart depicting the general flight categories expected during the period between 1800 through 2400 AKDT.

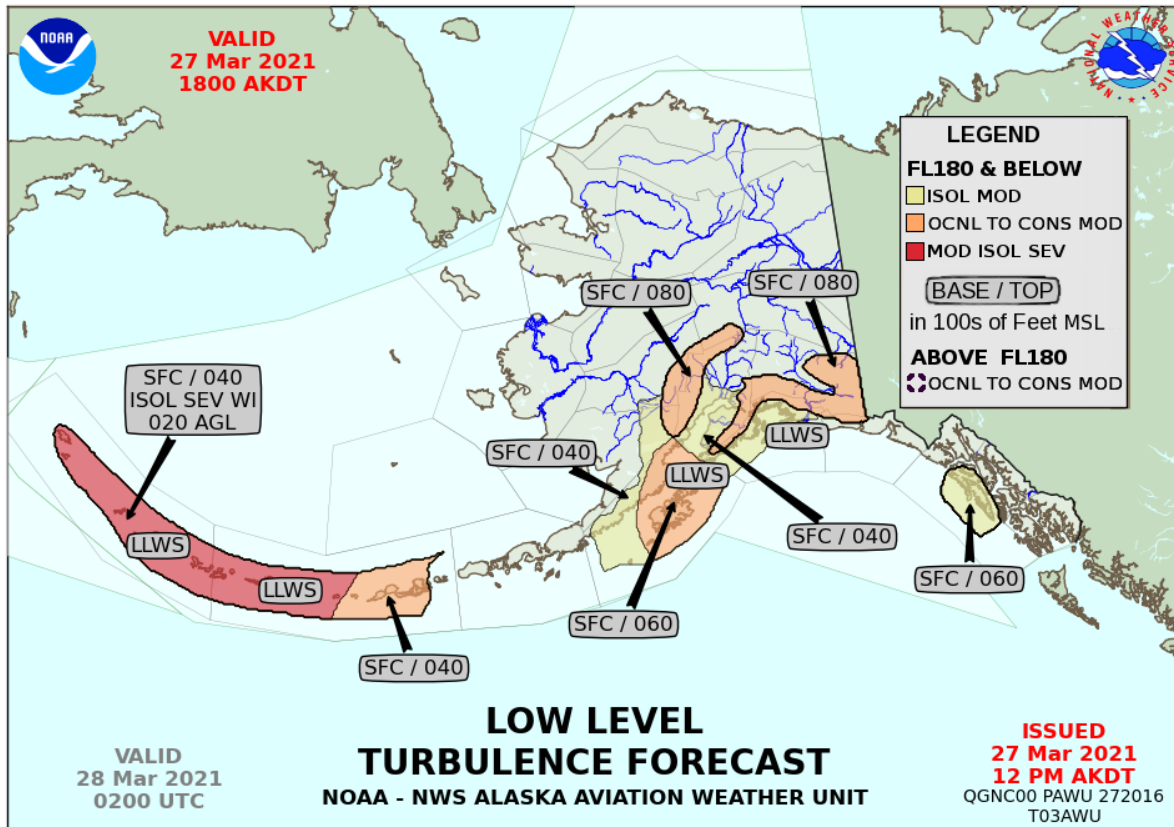
chart depicted occasional to continuous moderate turbulence from the surface to 8,000 ft and a threat of low-level wind shear over the area.

Figure 4 - NWS AAWU Low-Level Turbulence Forecast depicting the potential for turbulence and low-level wind shear over the area during the period between 1800 through 0200 AKDT.

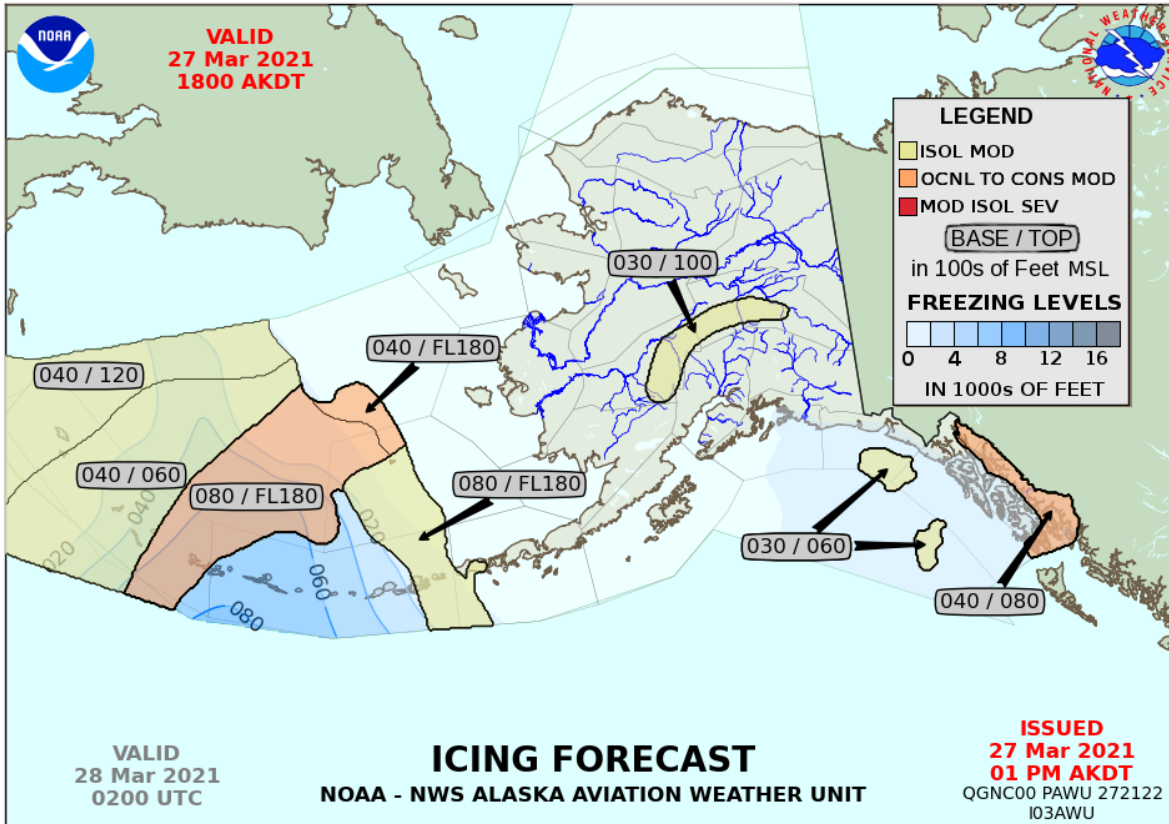
The NWS AAWU Icing Forecast Chart issued at approximately 1300 AKDT and valid for the period from 1800 through 0200 AKDT is included as figure 5. The chart depicted no significant icing expected over southcentral Alaska in the vicinity of the accident site.

Figure 5 - NWS AAWU Icing Forecast valid for the period from 1800 through 0200 AKDT.

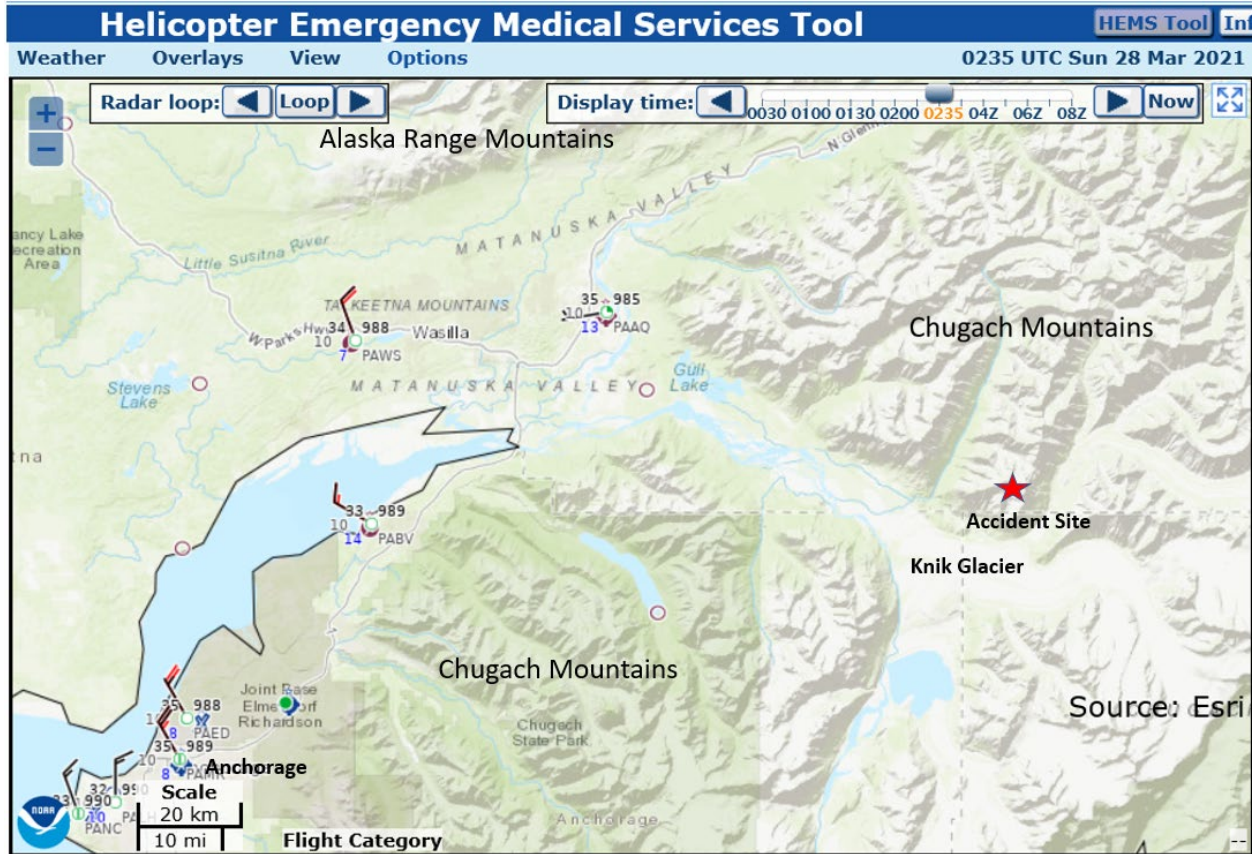
included as figure 6, with the general topography of the area and the approximate accident site marked by a red star. The highest peak in the vicinity of the accident site was 6,608 ft.

Figure 6 - NWS HEMS Weather Tool depiction of conditions at 1835 AKDT with the accident site marked.

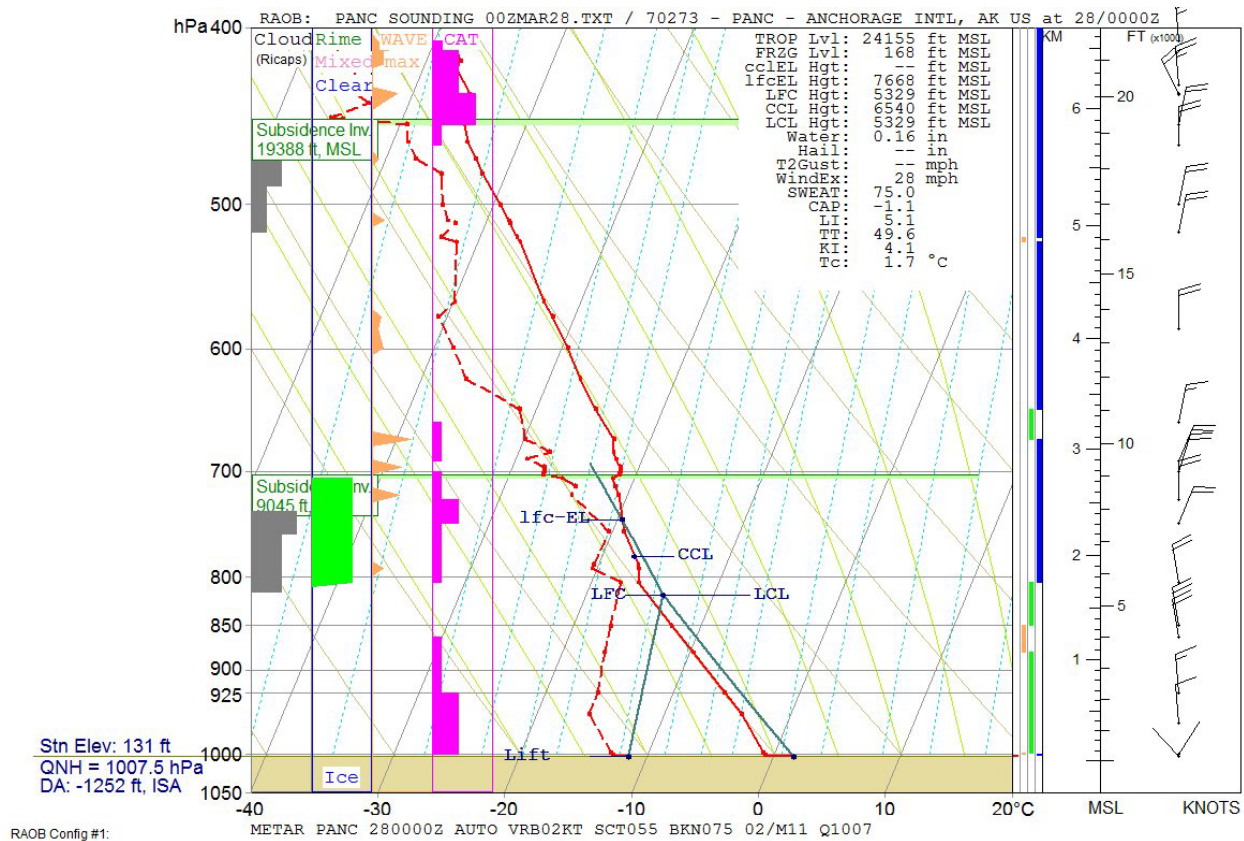
Figure 7 - NWS Anchorage 1600 AKDT sounding

The PANC sounding listed an elevation of 131 ft, and reported a surface temperature of 2° C, and a dew point temperature of -11° C at the time of the observation. The freezing level was identified immediately above the surface at 168 ft msl, with the lifted condensation level (LCL)<sup>10</sup> and level of free convection (LFC)<sup>11</sup> at 5,198 ft agl (5,329 ft msl), with the RAOB analysis program indicated supported for a scattered to broken layer of clouds with tops near 8,000 ft. A shallow temperature inversion was noted at 9,000 ft. The RAOB software indicated the potential for light to moderate icing in clouds between approximately 5,000 ft through 8,000 ft.

The PANC 1600 AKDT sounding wind profile indicated light surface wind, with wind from the north above the surface with little directional variation with height and with increasing wind speeds. At approximately 6,000 ft the wind was from 350° at 21 knots with a temperature of -17° C. The sounding was characterized as conditionally unstable below 6,000 ft and stable above that level. The RAOB analysis program sounding supported light turbulence below 8,000 ft and mountain wave activity. Based on the accident location south of the ridge line, the northerly winds would have resulted in general downslope wind flow south of the mountain ridges and in the vicinity of the accident site.

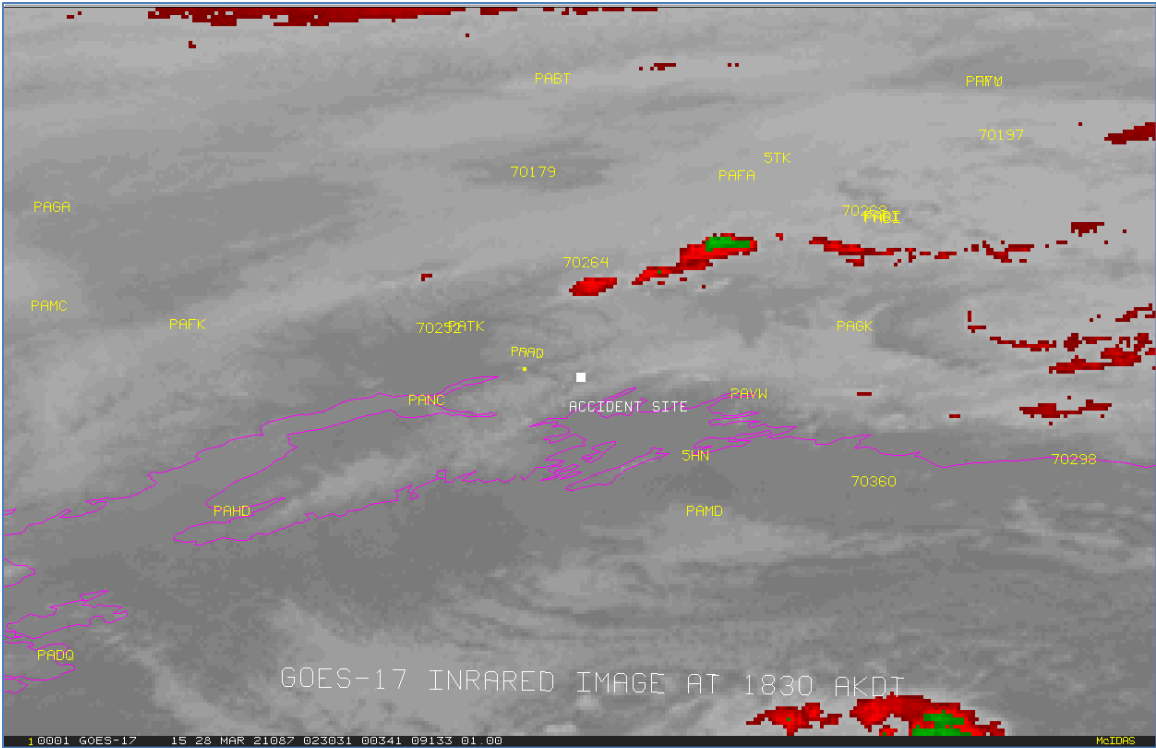
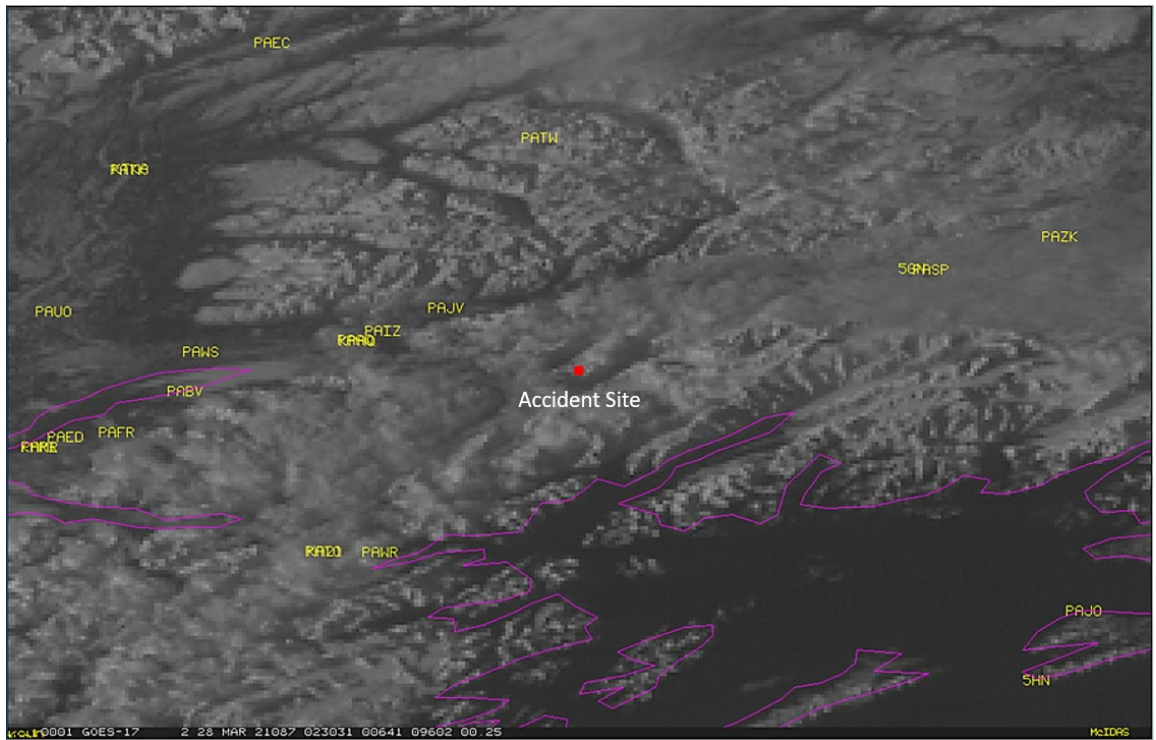
Figures 9 and 10 are the GOES-17 infrared and visible images at 1830 AKDT at 4X magnification respectively. The infrared image depicted a radiative cloud top temperature of 258 Kelvin or -15° C over the approximate accident site, which corresponded to near surface temperatures. The ground was covered by snow over the area, making it the imagery difficult to differentiate any clouds from the snow-covered surface.

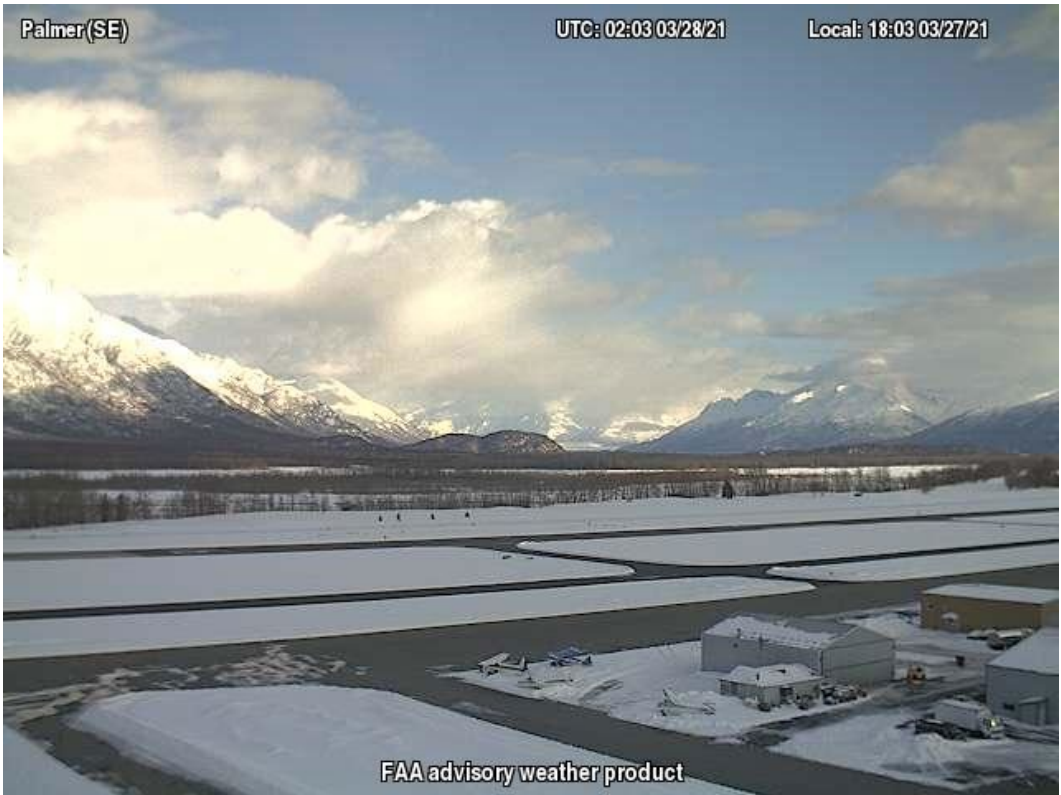
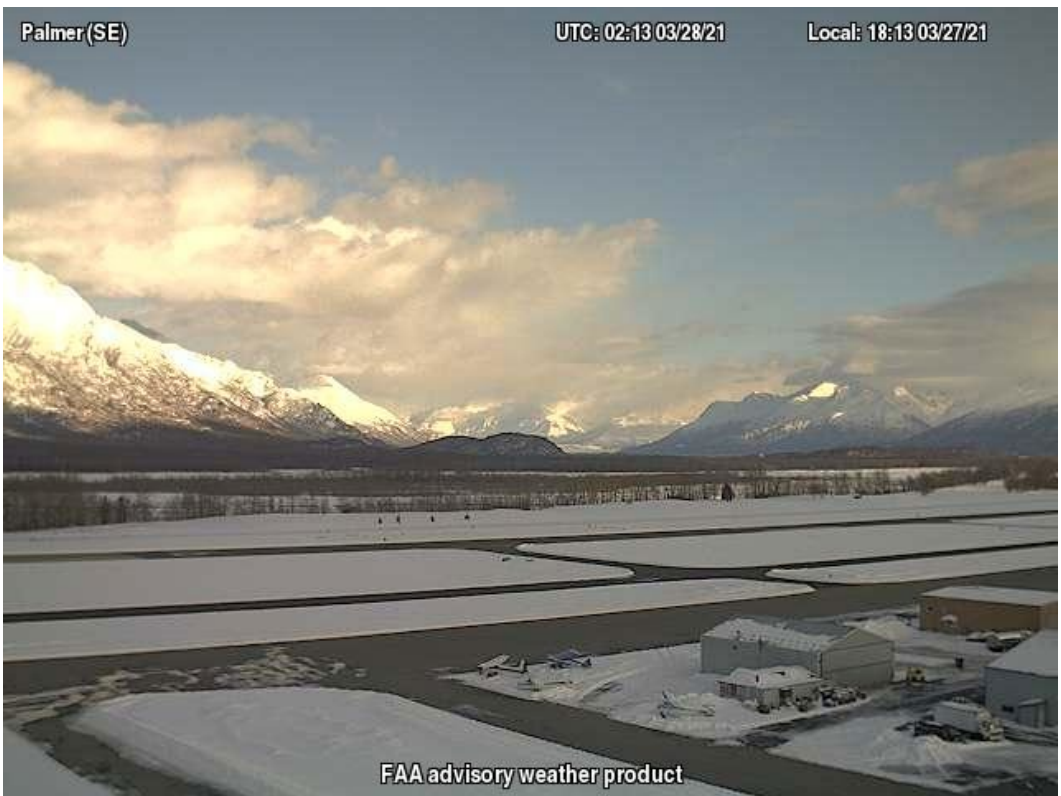
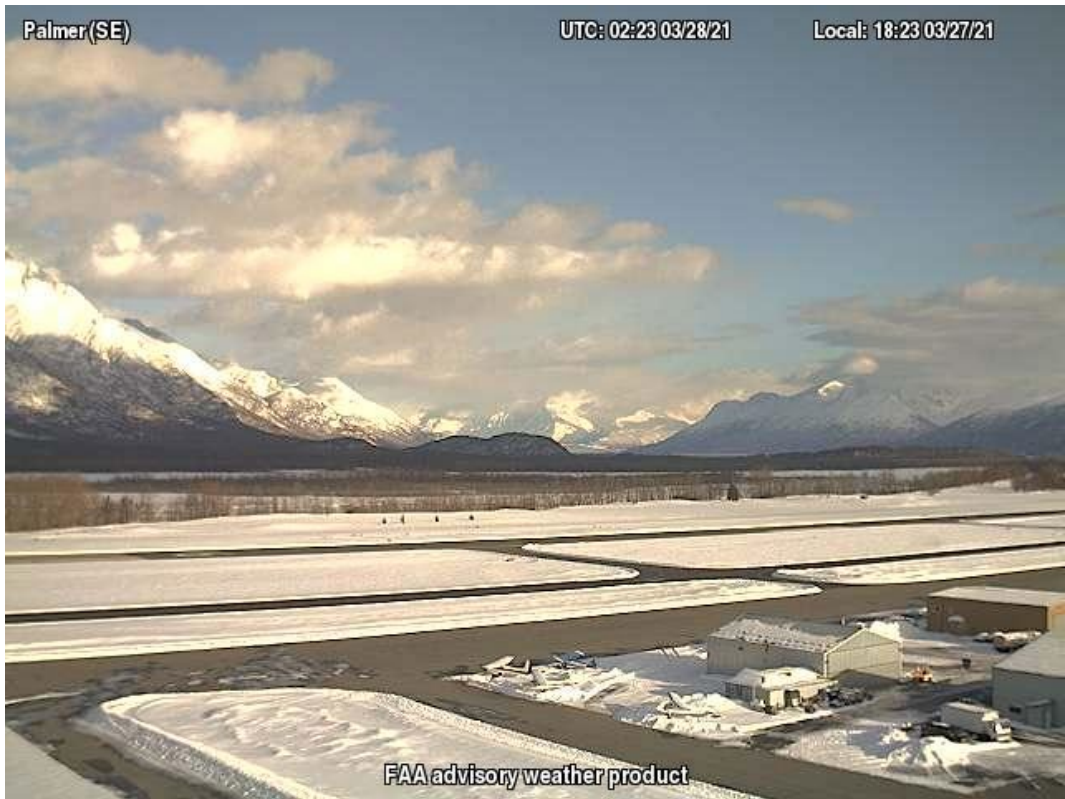
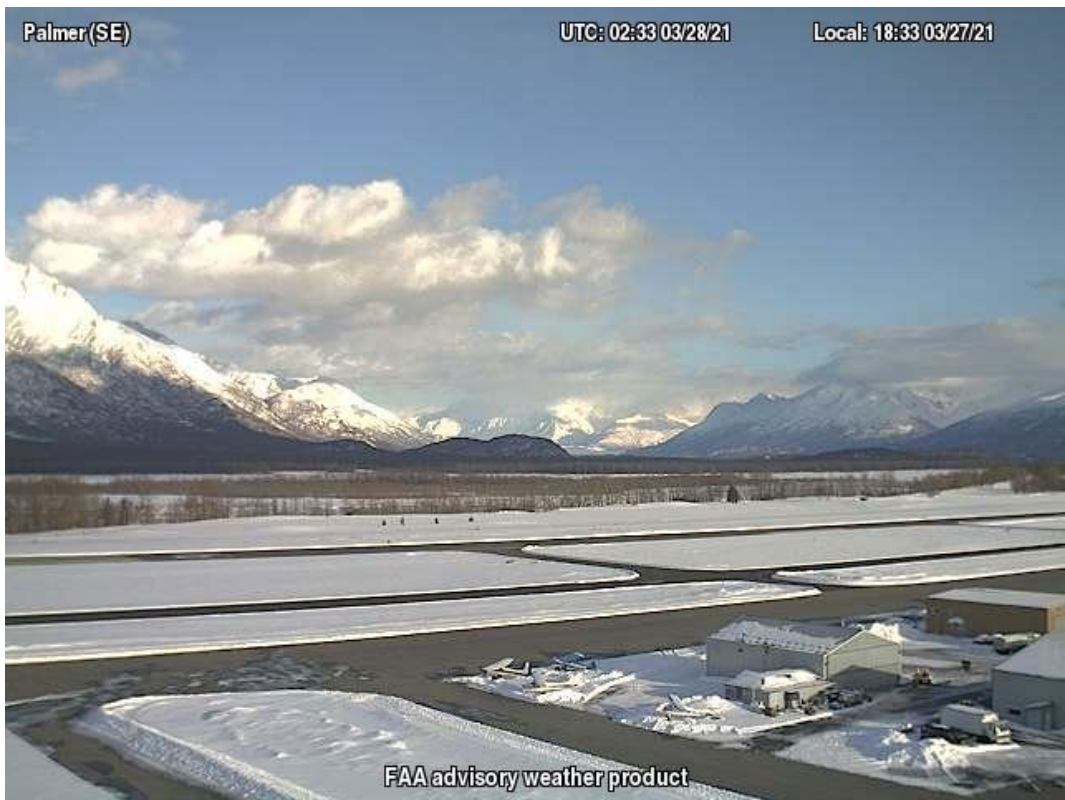
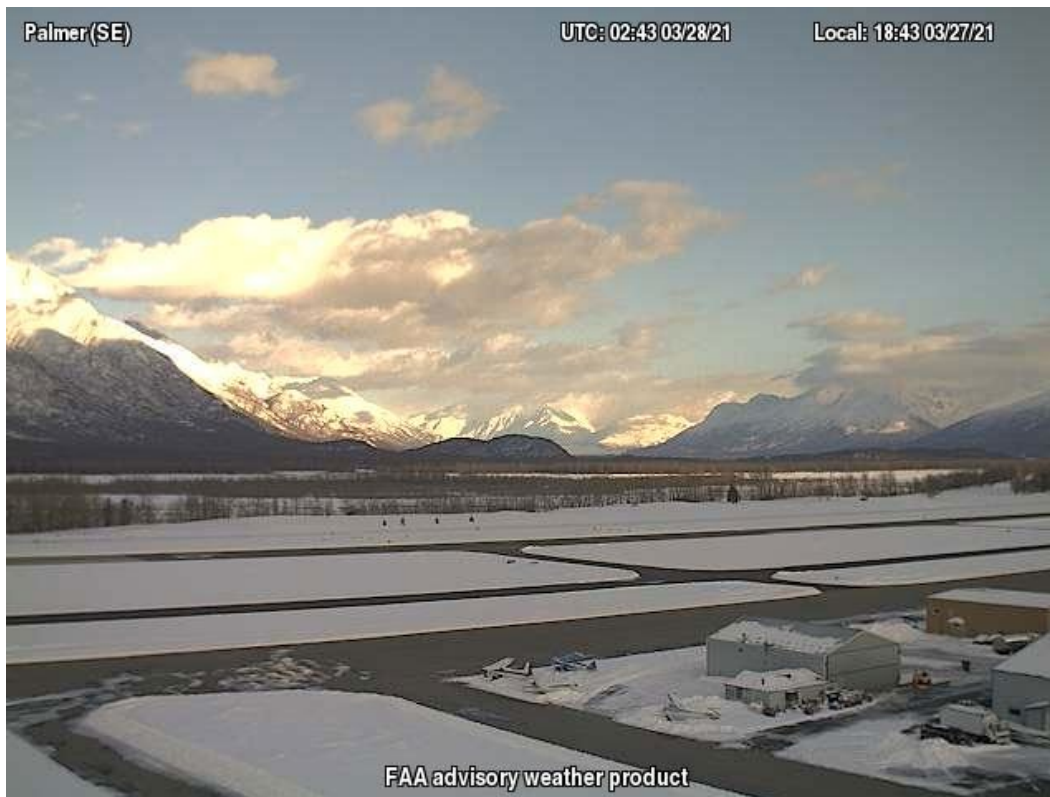
Figures 13 through 17 are the Palmer southeast camera pictures from 1803 through 1843 AKDT at 10-minute intervals surrounding the time of the accident. A 6-hour animation of the Palmer southeast camera view is included as Attachment 1.

Figure 16 - FAA Weather Camera from Palmer looking southeast at 1833 AKDT prior to the accident

Figure 17 - FAA Weather Camera from Palmer looking southeast at 1843 AKDT after the accident

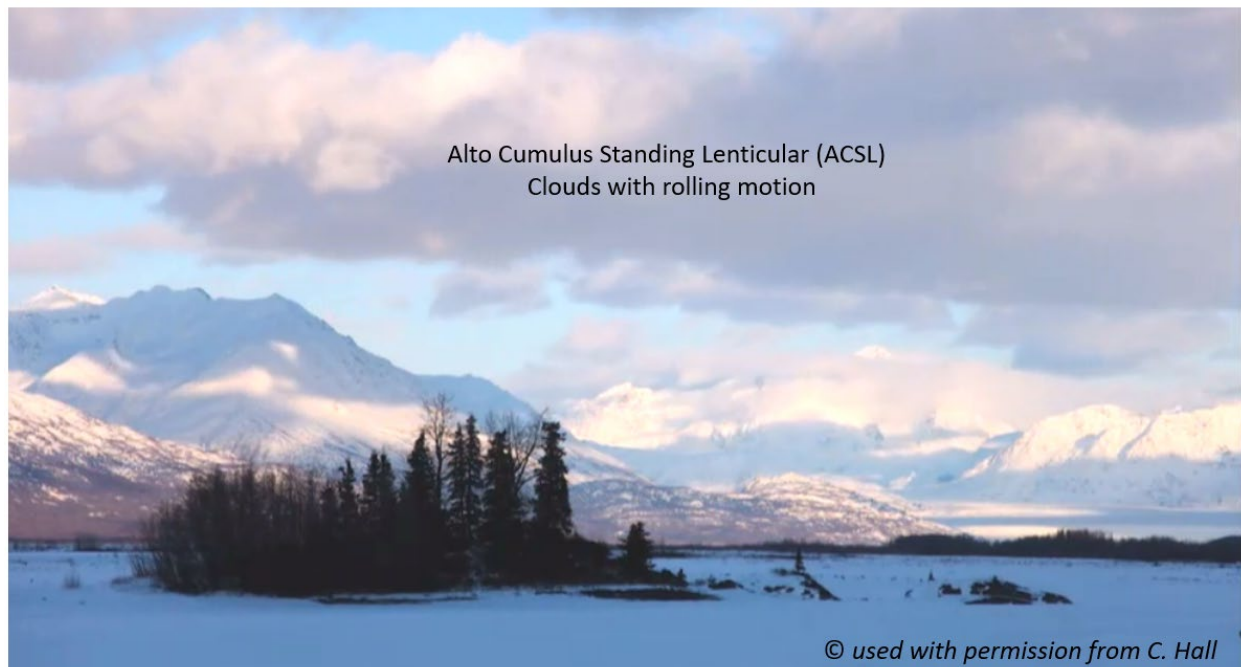
Another individual located in the Knik Valley looking north of the Glacier took time lapse photographs<sup>17</sup> approximately 45 minutes after the accident. His time lapse imagery caught several images of ACSL clouds. Figure 18 is a still image of the ACSL clouds which in the animation are observed to develop or form on the northern side (left), dissipate on the southern side (right), and remain relatively stationary with time and not move with the upper-level winds at their altitude. A defined rolling or overturning motion could be seen in the animation about the cloud's main horizontal axis. Based on the PANC sounding and the observations from PAAQ the base of the scattered to broken cloud layer was approximately 6,500 ft.

**Figure 18 - Still photograph of lenticular clouds over the Chugach Mountains north of Knik Glacier**
