NATIONAL TRANSPORTATION SAFETY BOARD

Specialist's Report

SURVIVAL FACTORS

WPR21FA143

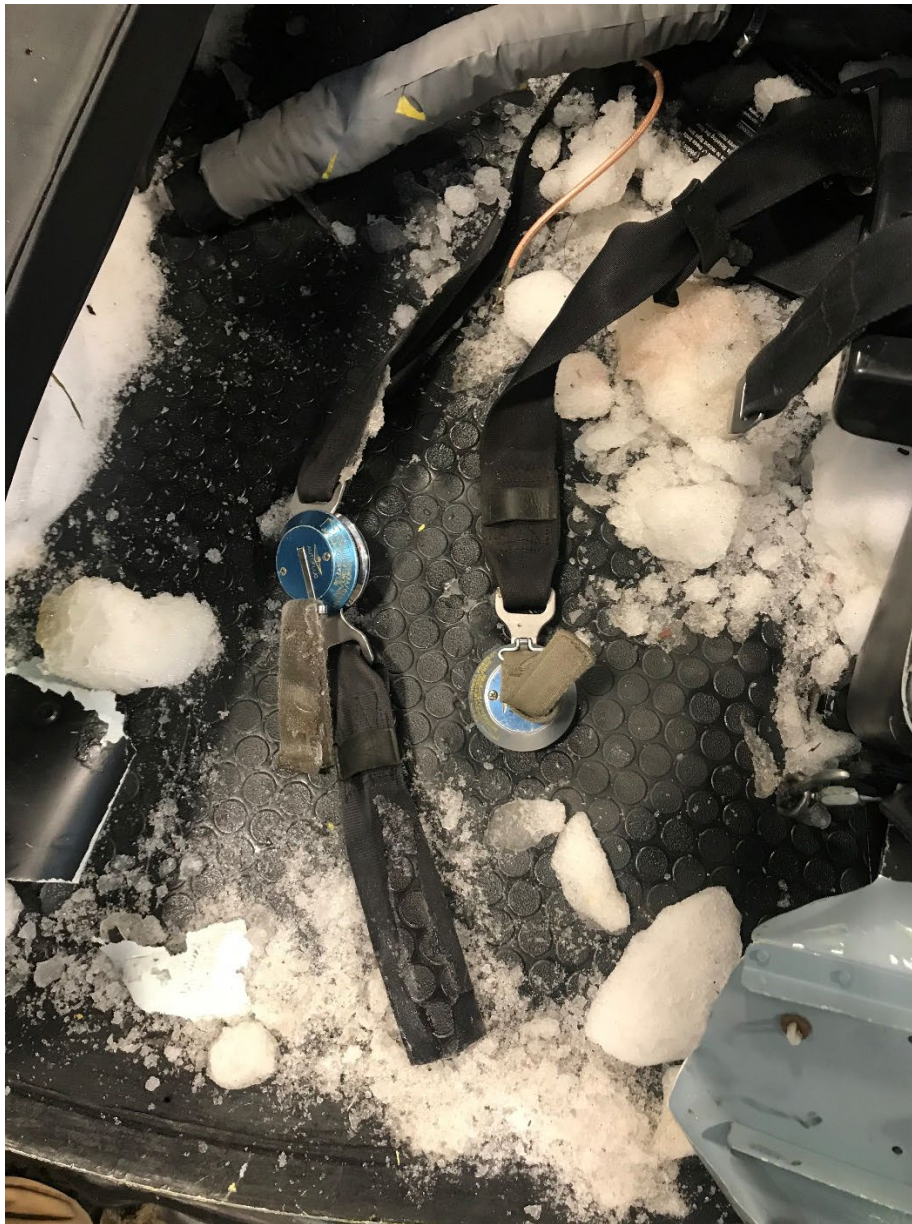
Figure 3. The front seat lap belts (pilot belt on the right).

The pilot (front, right) seat base (bucket) remained attached to the airframe via its sliding track, and the seat back was fractured and separated just above the inertia reel housing but remained connected to the seat back via the shoulder harness. The back cushion was separated from the seat back. The bottom cushion was present on the seat base. The entire four-point restraint system was present. All points of the restraint system were unclashed, and the buckle remained attached to the left lap belt. The left and right lap belts remained connected to the floor anchor points. Both shoulder harnesses remained connected to the (single) center inertia reel. There was no evidence of webbing separations on any of the restraints. The inertia reel functioned normally but a portion of the belt was twisted and folded on itself in the reel. A gel lumbar support cushion was observed on the pilot seat.

The front, left seat base remained attached to the airframe via its sliding track, and the seat back was fractured and separated just above the inertia reel housing. The shoulder harness restraint had an unfrayed linear separation at the inertial reel housing, and the left lap belt had an unfrayed linear separation about 10 inches from the buckle. The length of the shoulder harness from its buckle tangs to the unfrayed linear separation (near the inertia reel) was about 5' 2" in length. No portions of the restraint system were missing. Only the left and right lap belts remained connected to the buckle; the two shoulder harnesses were not connected to the buckle. The left and right lap belts remained connected to the floor anchor points. The left side of the seat bucket was impact-damaged and a portion of it was missing. The seat back and bottom cushion remained attached to their respective portion of the seat structure.

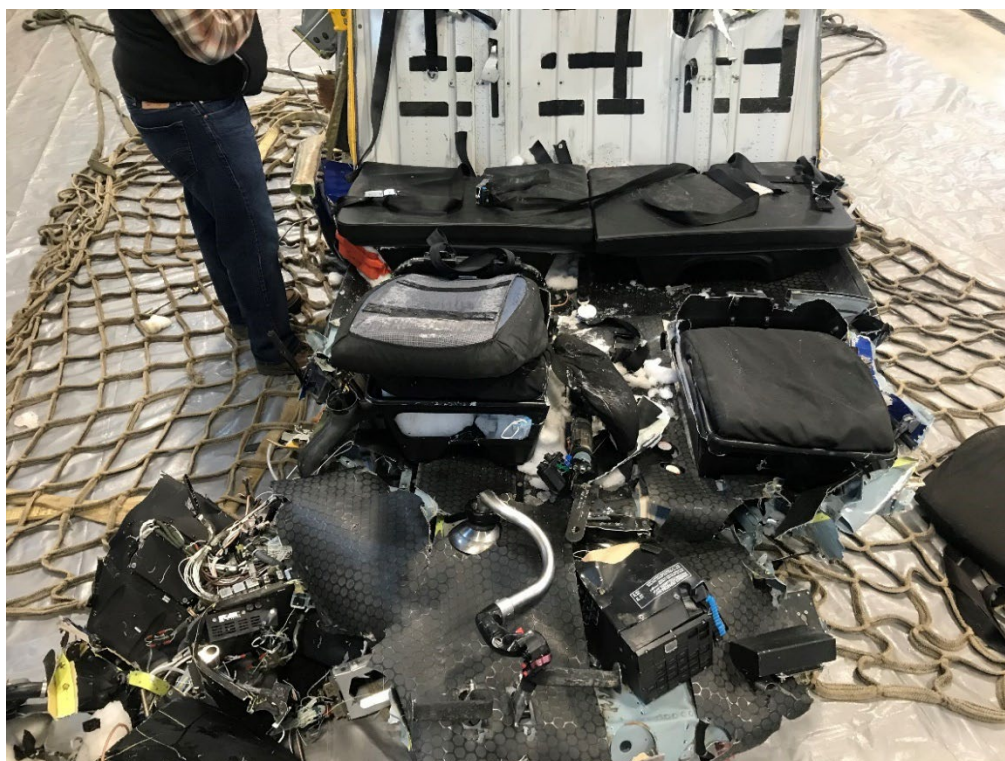
Figure 4. The two front seats of N351SH.

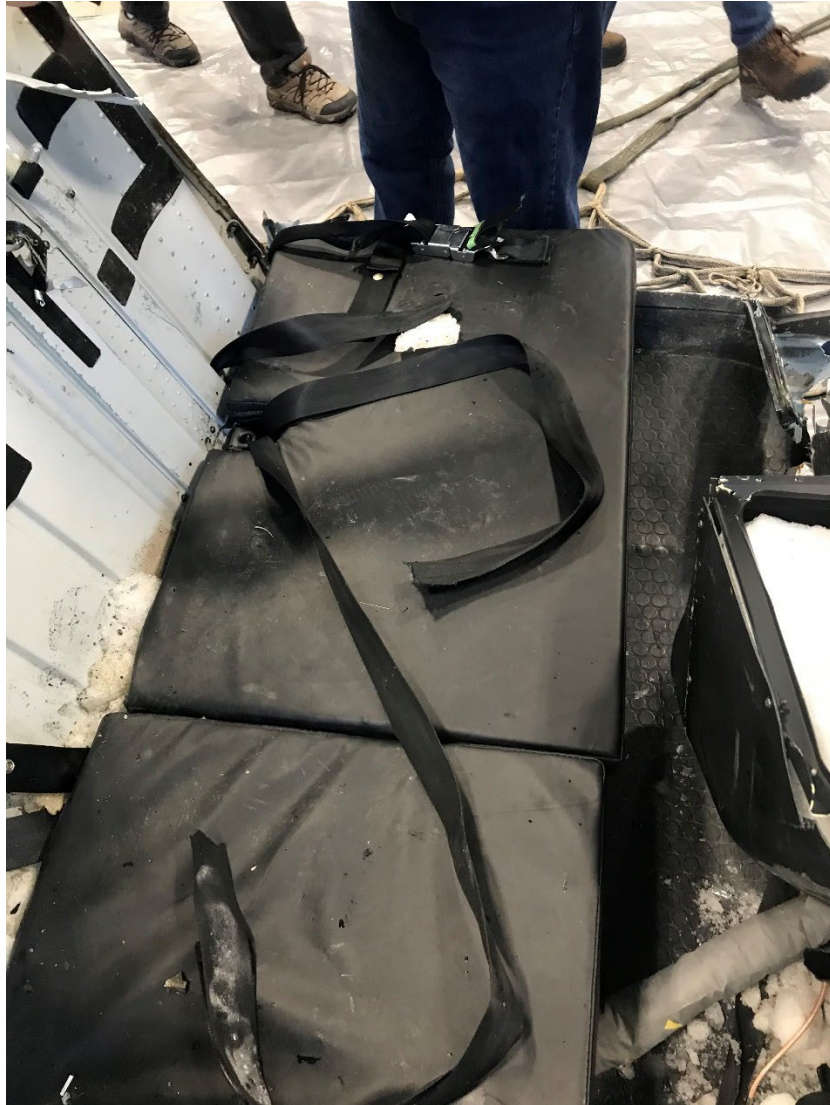
Aft-left outboard seat (#1) restraints (buckle on left lap belt): The buckle was clasped but the right lap belt had an unfrayed linear separation about 4 inches from the belt loop (on the belt tang). The shoulder harness clasp remained attached to the fitting on the right lap belt. The shoulder harness had an unfrayed linear separation about 3 inches from the belt loop. A 3' 2" length segment of the shoulder harness remained routed through the belt pulley fitting on the upper wall, with unfrayed linear separations at both ends. On this 3' 2" segment, overload-type damage was observed on the outboard edge of the belt, about 9 inches from the inertia reel side. The remainder of the shoulder harness was outside of its aft bulkhead routing channel to the bottom of the channel. The inertia reel remained installed on the aft cabin bulkhead. A portion of the outboard side of the shoulder harness channel was peeled downward, consistent with the shoulder harness pulled out from the channel. The left and right lap belts remained attached to their respective floor anchor points. The inertia reel could not be functionally tested due to the shoulder harness being stuck within the channel.

Aft-left inboard seat (#2) restraints (buckle on right lap belt): The buckle was clasped but the right lap belt had an unfrayed linear separation about 8.5 inches from the buckle (there was a 5 inch "tail" from the buckle). The shoulder harness was not attached to the fitting on the left lap belt. The shoulder harness remained routed through the belt pulley fitting on the upper wall, with an unfrayed linear separation at the inertia reel end. From the shoulder harness tang to the unfrayed linear separation, the segment was about 3' 1" long. The shoulder harness channel was peeled downward and the channel was partially separated from the aft cabin bulkhead. The remainder of the shoulder harness was not visible on the aft cabin bulkhead. The left and right lap belts remained attached to their respective floor anchor points. The inertia reel for the shoulder harness could not be functionally tested due to the belt being retracted into the reel.

Figure 5. The lap belts for aft passenger seats #1 and #2.

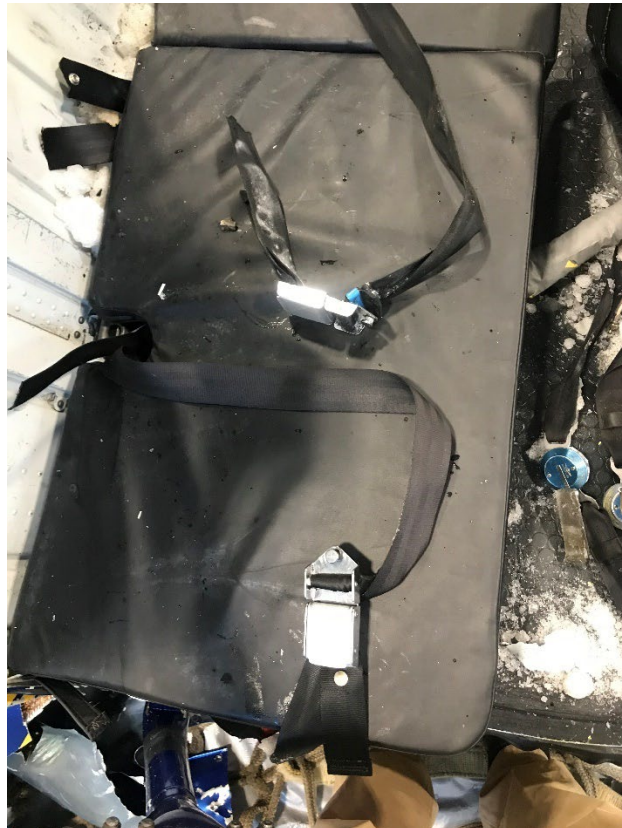
Aft-right inboard seat (#3) restraints (buckle on the left lap belt): the buckle was not present in the recovered wreckage. There were cuts on both the left and right lap belts that extended from their floor mounts. The left and right lap belts remained attached to their respective floor anchor points. The shoulder harness was present and routed through its belt pulley fitting and through the channel (on the aft cabin bulkhead). The shoulder harness webbing was twisted between the pulley and the channel. An upper portion of the channel was fractured but remained retained via adhesive on a strip of Velcro. The inertia reel functioned normally.

Aft-right outboard seat (#4) restraints (buckle on the right lap belt): the buckle was clasped and there was no evidence of unfrayed linear separations on the lap belt. The right belt webbing exhibited damage about 8-10 inches from the belt loop on the buckle (there was about a 5.5" tail on the right lap belt at the buckle). The shoulder

harness was not attached to its buckle attachment. The left side of the lap belt was at its fullest extension. The left and right lap belts remained attached to their respective floor anchor points. The shoulder harness was present and routed through its belt pulley fitting and through the channel on the aft cabin bulkhead. The inertia reel functioned normally. An upper portion of the channel was fractured and partially separated.

Figure 6. The lap belts for aft passenger seats #3 and #4. The upper buckle belongs to the restraint system for aft passenger seat #2.

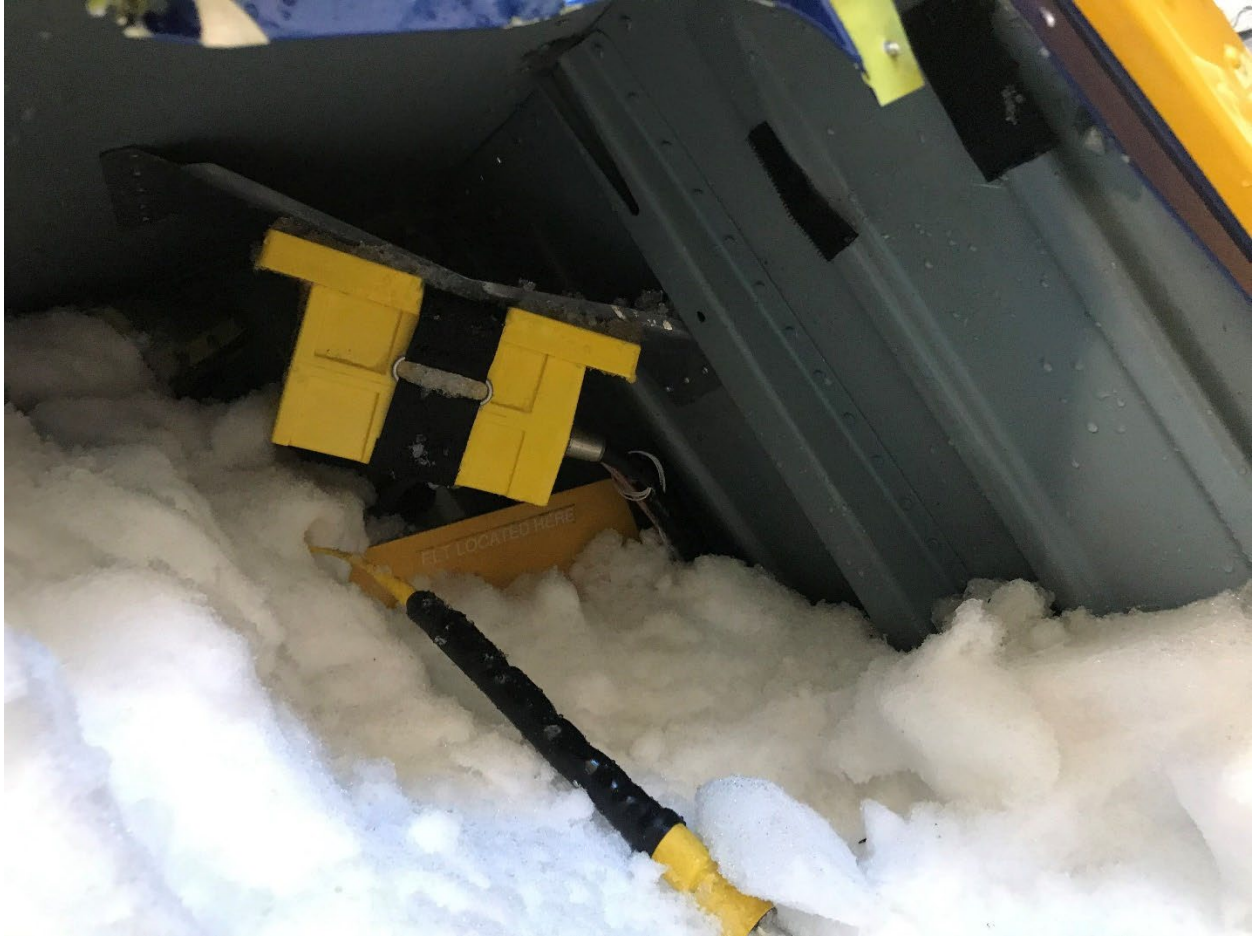
On the aft side of the aft cabin bulkhead, a Kannad 406 MHz AF-Compact ELT was installed on the upper-right side of the right baggage compartment. (The right baggage compartment was packed with snow.) The ELT remained secured to its airframe mount via a Velcro strap.

Figure 7. The ELT and portable antenna, as found in the right baggage compartment.

The antenna coaxial cable and remote cockpit control wiring remained connected to the ELT. The ELT switch was in the "ARM" position. After removal from the wreckage, the ELT switch was moved to the "OFF" position. During manipulation of the ELT switch, a beeping sound was heard momentarily, likely due to the switch inadvertently and temporarily being moved to the "ON" position. The ELT's portable antenna was found in the packed snow next to the ELT. The ELT and portable antenna were retained by the investigation group. The antenna had been fractured from its mount and was not located. The antenna mount and antenna coaxial cable were removed from the airframe and retained.

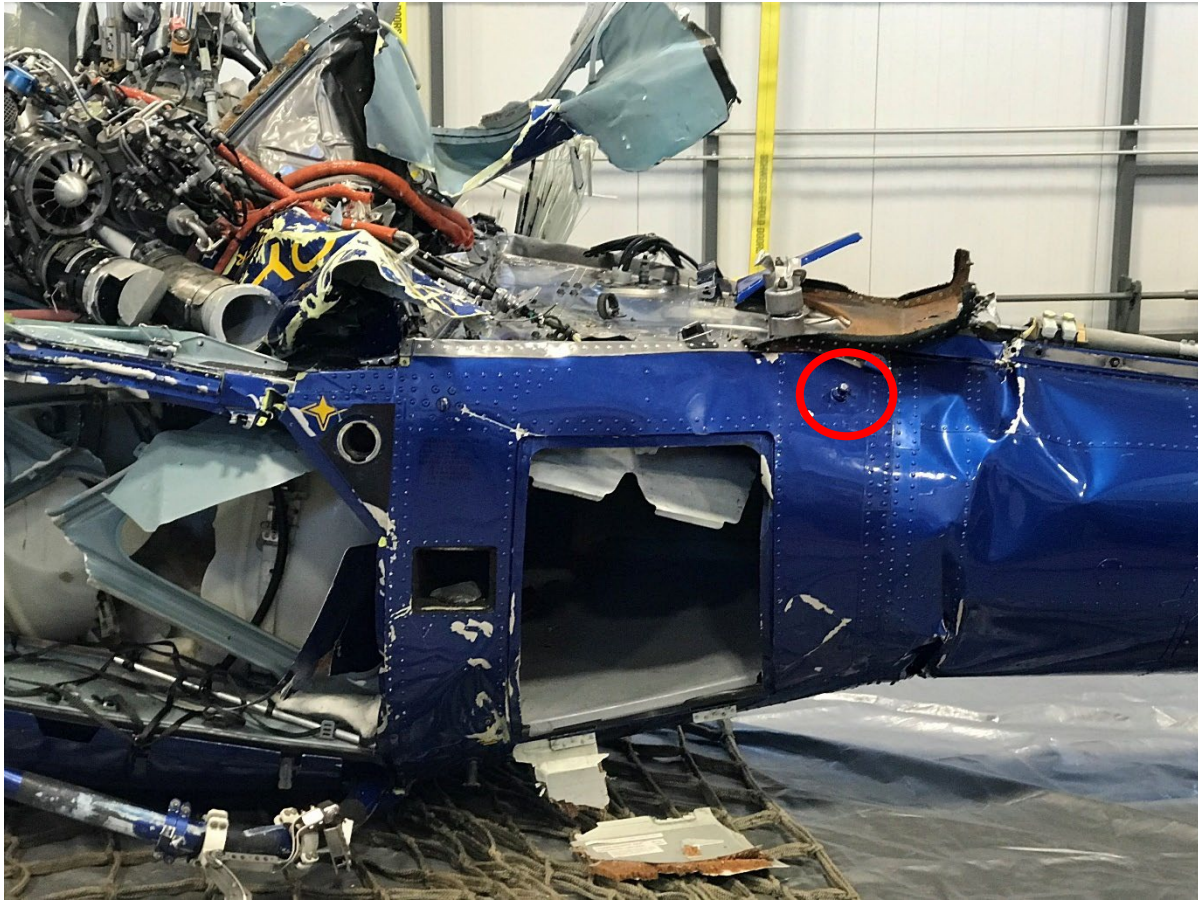
Figure 8. The ELT antenna mount on the upper left side of the tailboom.
