# National Transportation Safety Board

WPR21FA203

## **AIRFRAME EXAMINATION SUMMARY REPORT**

Location: Las Vegas, Nevada  
Date: 05/24/2021  
Time: 1417 PDT  
2117 UTC  
Airplane: N567EM Mirage F-1

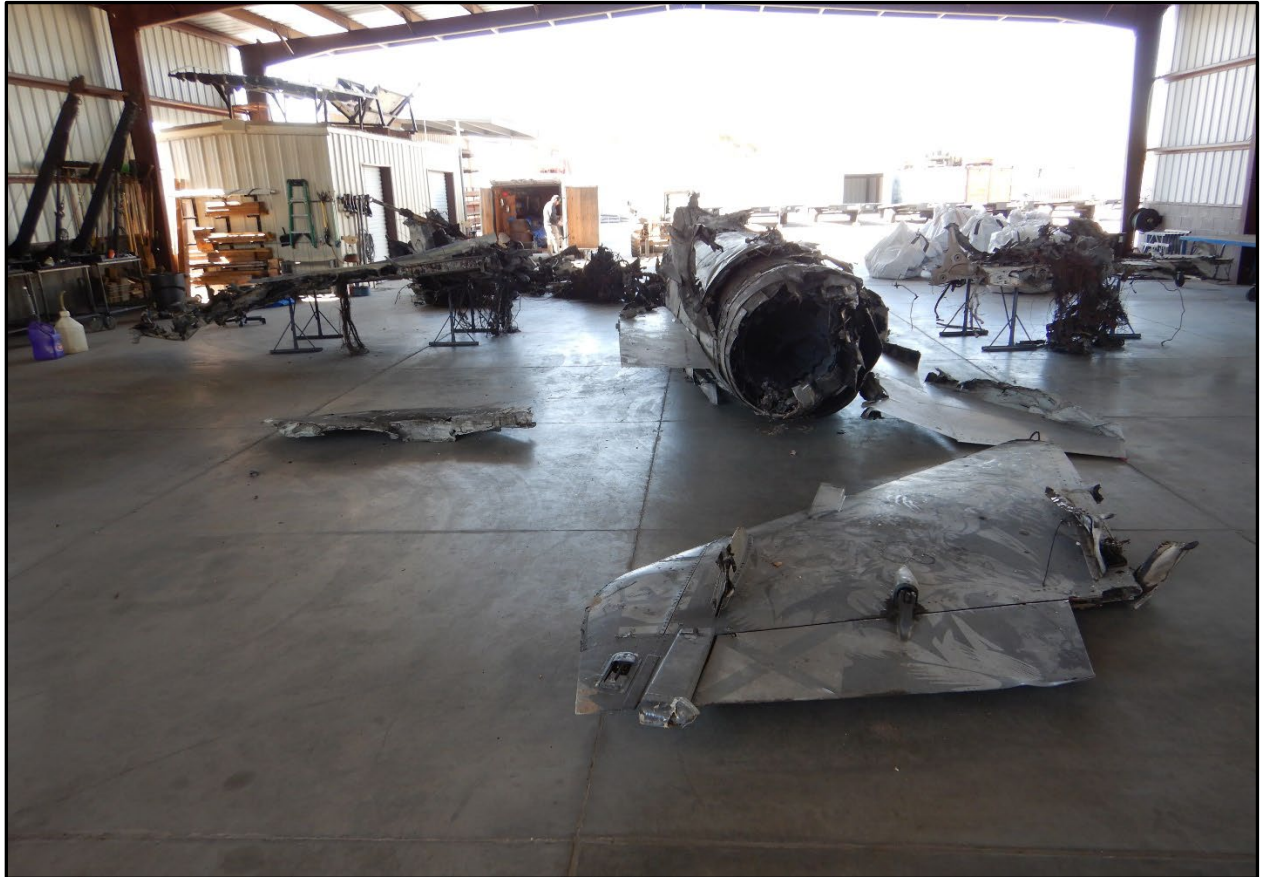
Examination of the airframe and engine was conducted at a secured storage facility at the Air Transport in Phoenix, Arizona, on May 28 and May 29, 2021. The examination of the airframe was conducted by technicians from Draken International with oversight from the NTSB. The wreckage was displayed on the examination floor and revealed extensive impact and thermal damage. Both wings separated from the fuselage and engine. Both wings had impact and thermal damage. The left aileron separated from the wing and was found in the wreckage debris. Both stabilators remained attached to the fuselage and were cut during the wreckage recovery process. The stabilators had leading edge damage and the left stabilator had thermal damage. The vertical stabilizer and rudder separated from the main wreckage. The

forward 2/3rds of the fuselage was separated and was found in multiple recovery bags.

**Figure 1: Airplane wreckage arranged for the examination.**

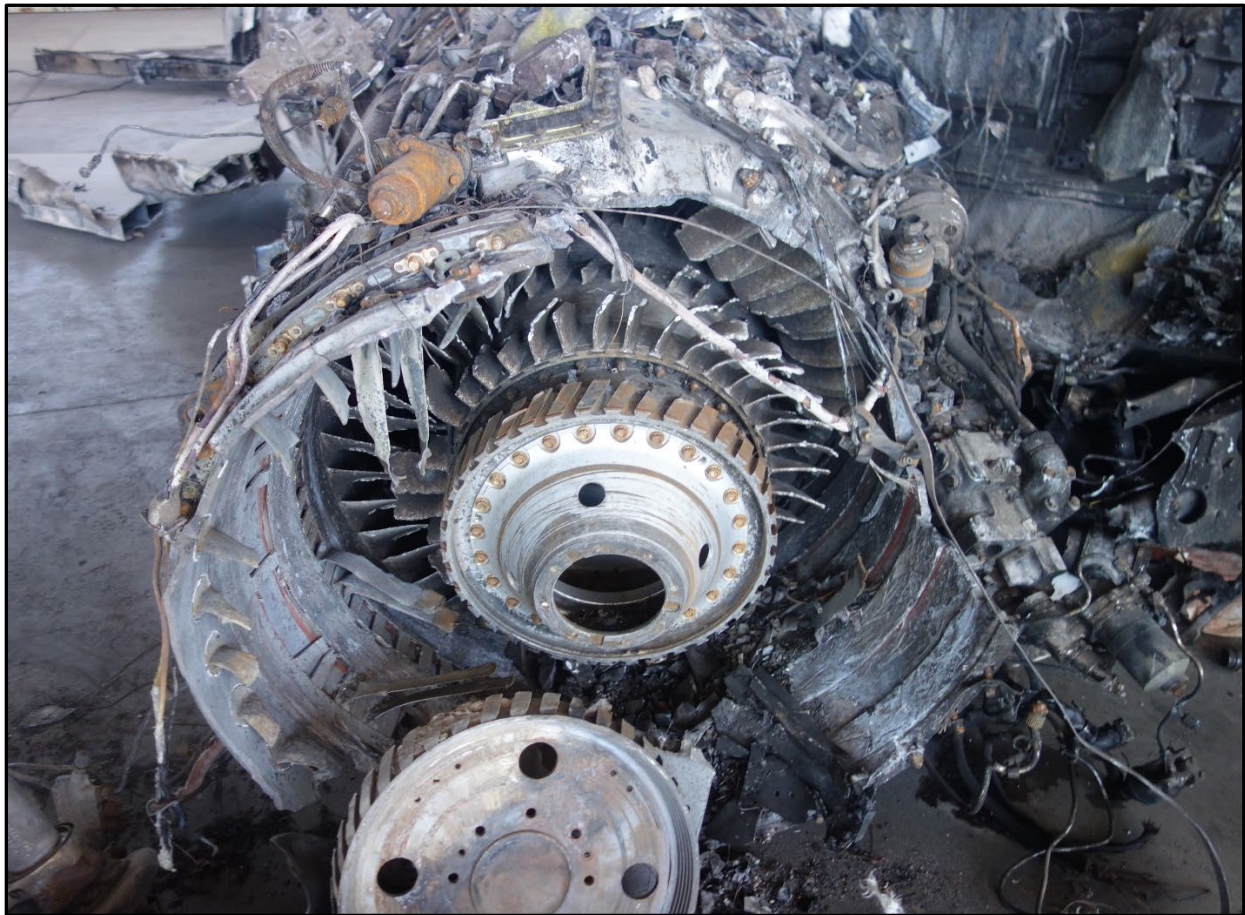
The engine had extensive impact damage to the intake and compressor section. The induction inlet separated, and the rotor disk No. 1 was found with the wreckage debris. The engine was bent to one side near the exhaust section. The fuselage

remained partially attached to the exhaust section. The exhaust section had impact damage to the upper side. The starter, turbogenerator, single lever control box, both hydraulic pumps, both alternators, pto shaft and accessory gear box, ab pump, ac bleed-air line, and all four engine mounts separated from the engine. The fuel control partially separated. The central casing was ripped open and was found in multiple pieces.

A walkaround of the engine was accomplished on a live video platform with a National Transportation Safety Board Aerospace Engineer - Powerplants lead. Damage observed was consistent with high rotational signatures at impact.

**Figure 2: Engine arranged for examination.**

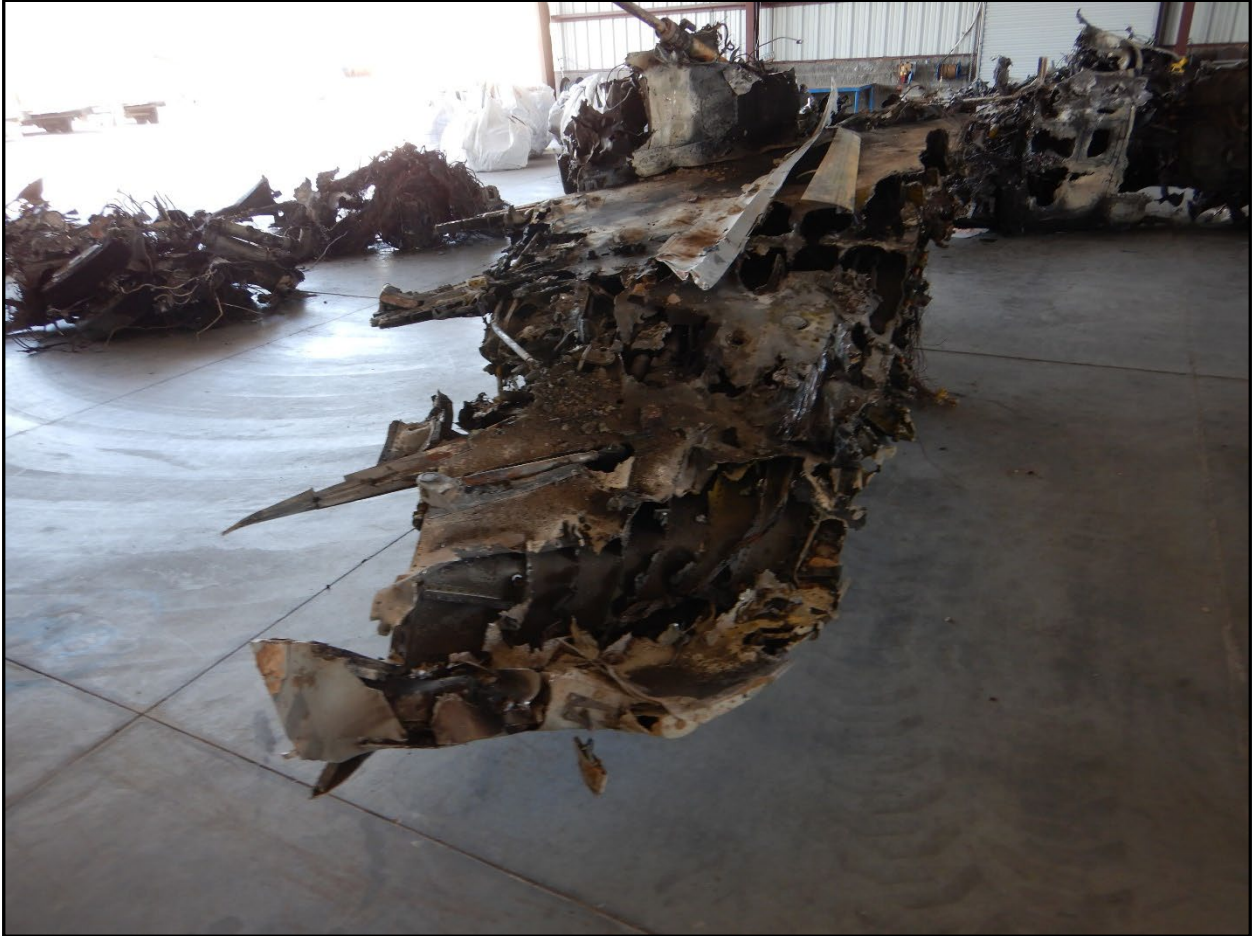
The right wing separated from the main wreckage and remained attached to the section of frame 25B. The wing pins pulled through section 25A about 4 inches. The secondary pin separated from the wing and the aft secondary pin separated from the fuselage. The flap surface separated from the wing and only the actuating linkages remained attached. The linkages revealed the flaps were near the retracted position. A large section of the trailing edge, outboard flap area, separated from the wing. The aileron remained attached to its hinge points and control and had impact damage. A small section of the spoilers remained attached to the inboard side. During aileron movement linkage remained attached. The droop slats separated from the leading edge and attached linkages revealed the slats were in the extended position. The slotted slats separated from the wing and attached linkages separated from the wing and were found with the loose wreckage debris. The slot slat jackscrews were found in the extended position. Excessive leading edge damaged was found outboard of the slot slat area. The outboard leading edge had missing material.

**Figure 3: Picture of wing showing the extent of thermal and impact damage sustained.**
