# National Transportation Safety Board

WPR21FA233

## **ACCIDENT SITE EXAMINATION**

Location: White City, Oregon  
Date: June 20, 2021  
Time: 1440 Pacific daylight time  
Airplane: Piper PA-22-135, N2618A

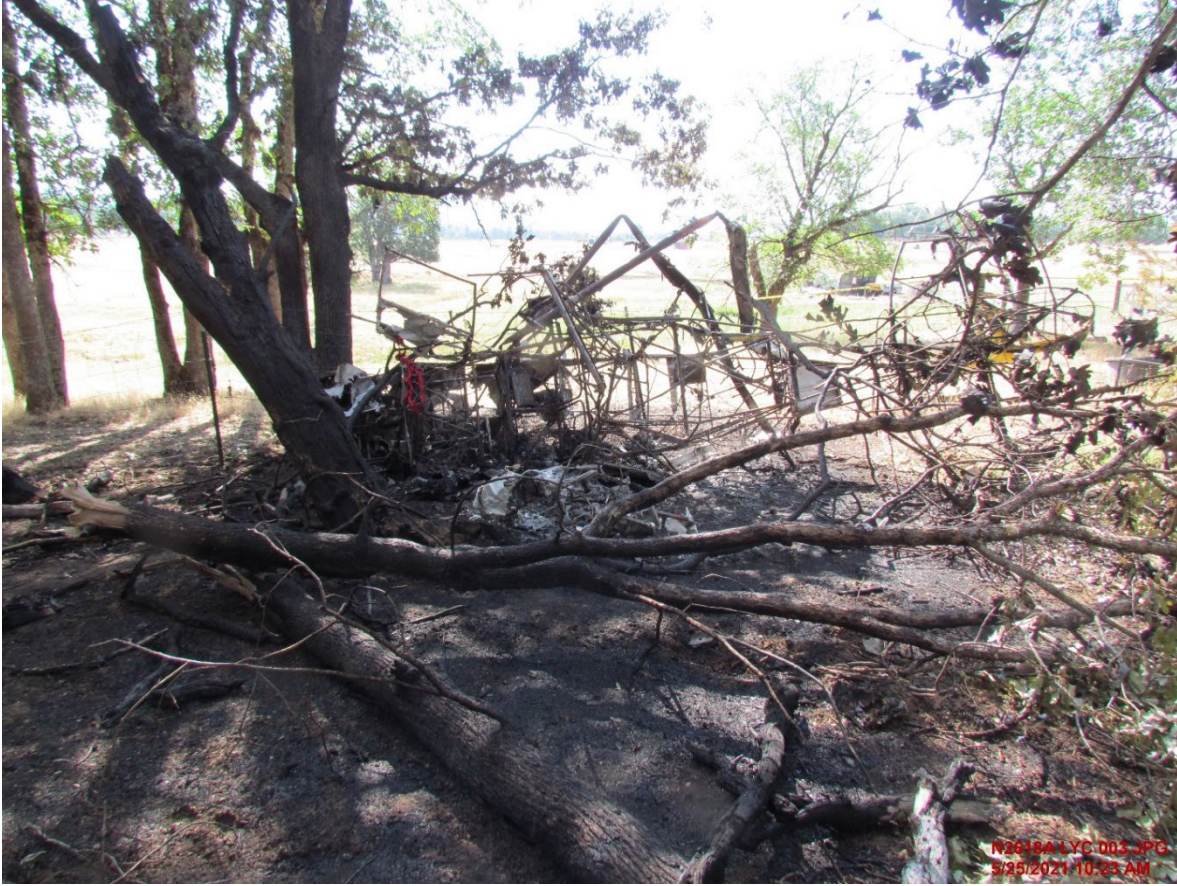
Photo 1 - View of the Accident Site (Photo Courtesy of Lycoming)

The accident site was in the side yard of a residence. The first identified point of impact (FIPC) were the tops of 75-ft-tall trees about 205 ft east of the approach end of runway 33. The airplane continued in an arc-trajectory, where it travelled across a street, over a house, and impacted the side yard of a residence, where a post-crash fire ensued. The entire airplane came to rest on its left side against a wire fence oriented along a heading of 021°. There were several felled trees adjacent to the wreckage with one of the trees exhibiting a clean cut to its trunk. Piper estimated it to be 8 inches in diameter, consistent with a moving propeller strike.

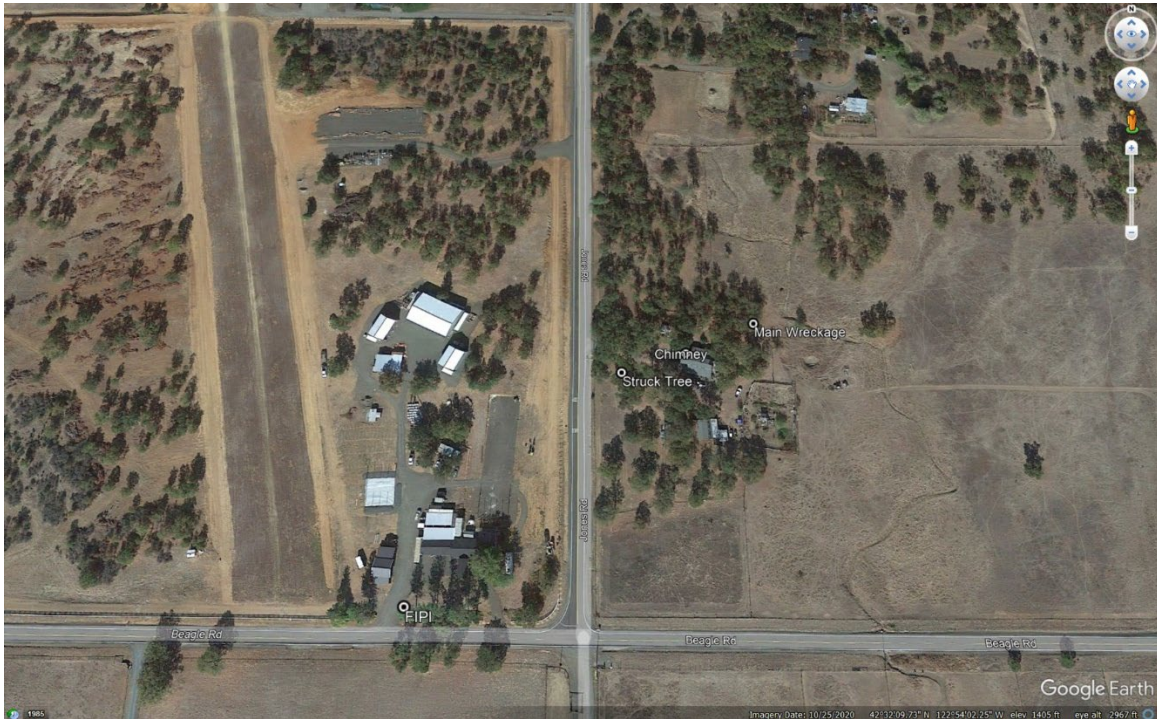
The airport is privately owned and requires prior permission to land. The runway surface is of turf/dirt construction that is 3,000 ft long and 130 ft wide. The airport facility directory states that departures are to the south and approaches are to the north.

Photo 2 - View of Airport and Accident Site (Photo Courtesy Piper)

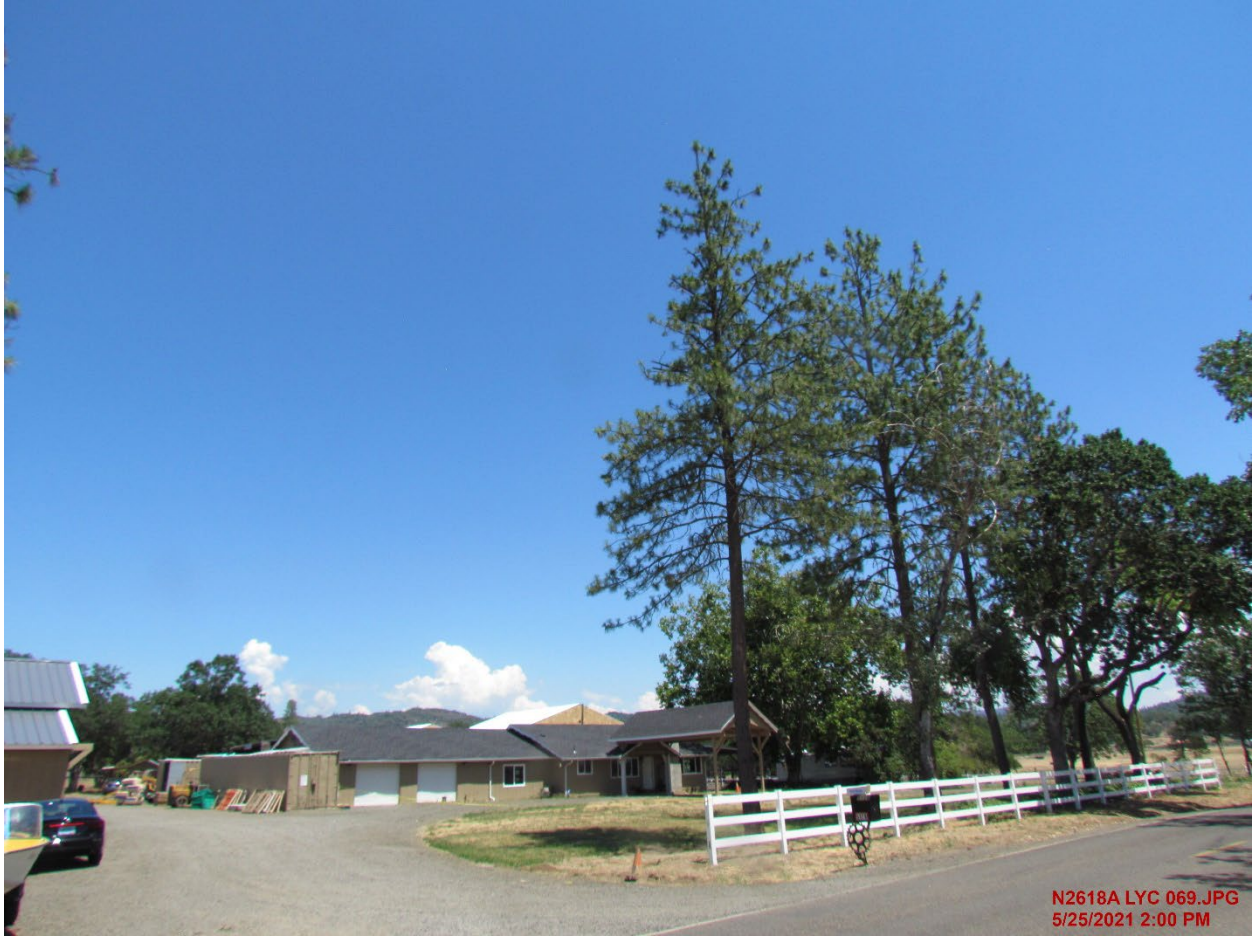
Photo 3 - Trees at end of Runway (Photo Courtesy of Lycoming)

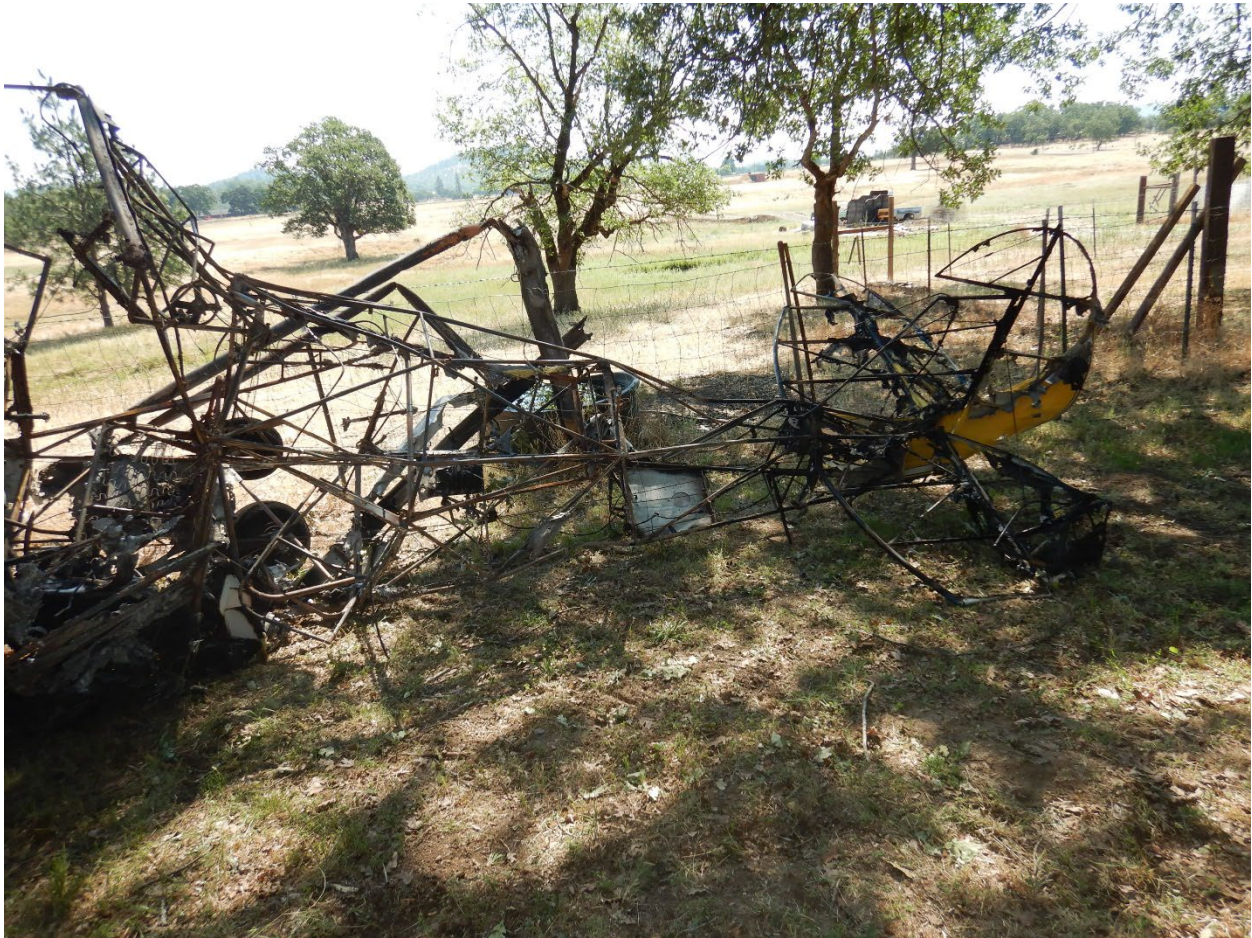
The entire airplane came to rest abut a barb-wire fence on its left side and was relatively intact. The fabric covering of the airplane, interior, windows, and instrument panel had burned away in the postcrash fire and exposed the inner frame of the airplane. There were some cuts to the frame but established that the cuts were made during the recovery of the pilot. There was impact damage to the left lower firewall aft to the cabin door.

Photo 4 - Left Side View of Airplane (Photo Courtesy of Piper)

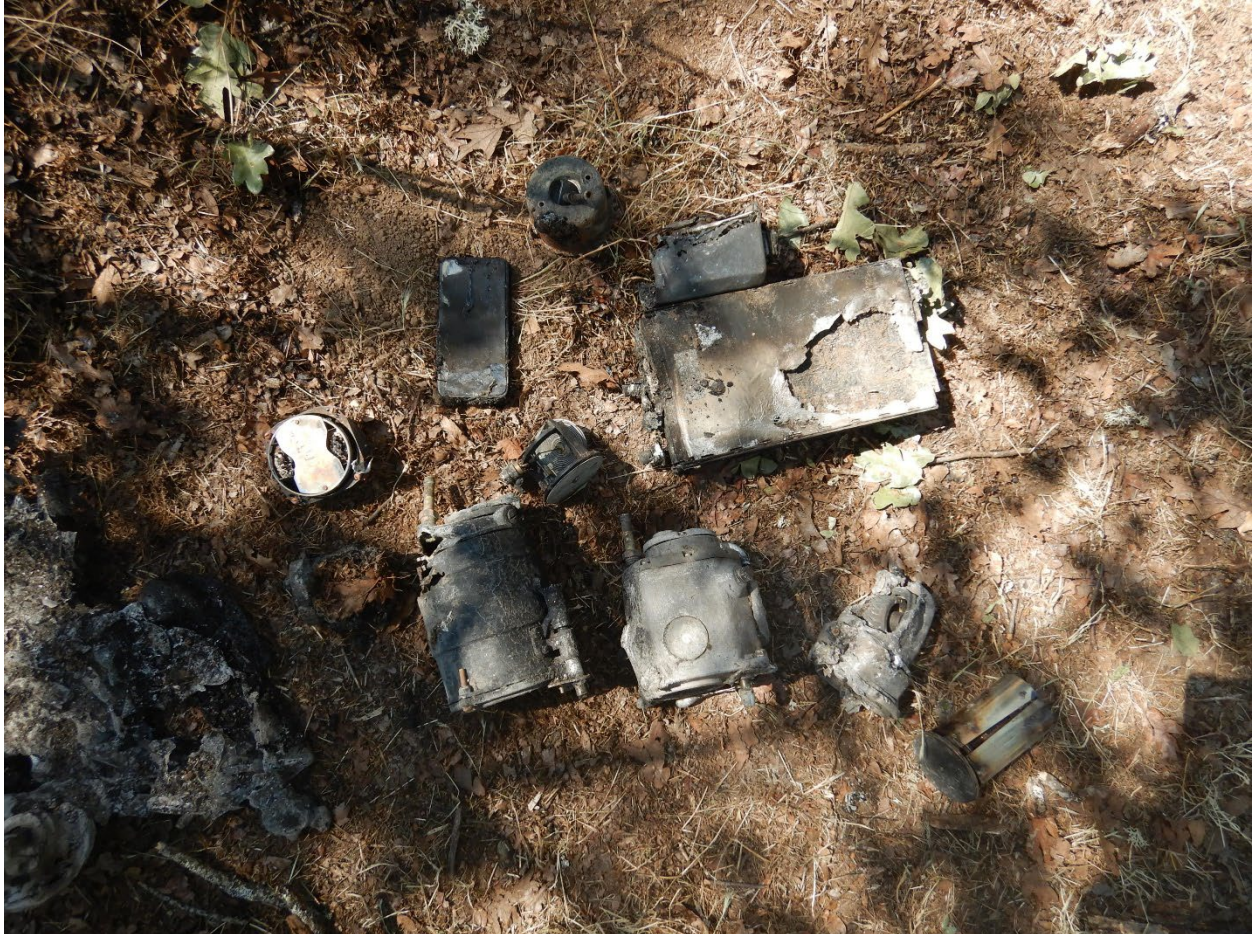
The instrument panel and instruments were thermally destroyed. The throttle and mixture knobs were positioned full forward, and the primer pump and magneto switch were thermally destroyed. Flight control continuity established from cabin controls via the control cables and associated hardware that remained in their relative normal positions. The T-bar remained in place and the aileron control chain remained routed over the sprockets. The aileron cable and associated hardware was continuous through the cabin. The elevator cables and associated hardware was traced from the fuselage to the aft elevator bellcrank. The rudder control cables, and

hardware remained attached to the outboard ends of the impact damaged rudder pedal bar and the cables were traced from the fuselage to the rudder control arms. Elevator trim was neutral to slightly nose up as measured on the trim screw.

Photo 5 - Instruments (Photo Courtesy of Piper)

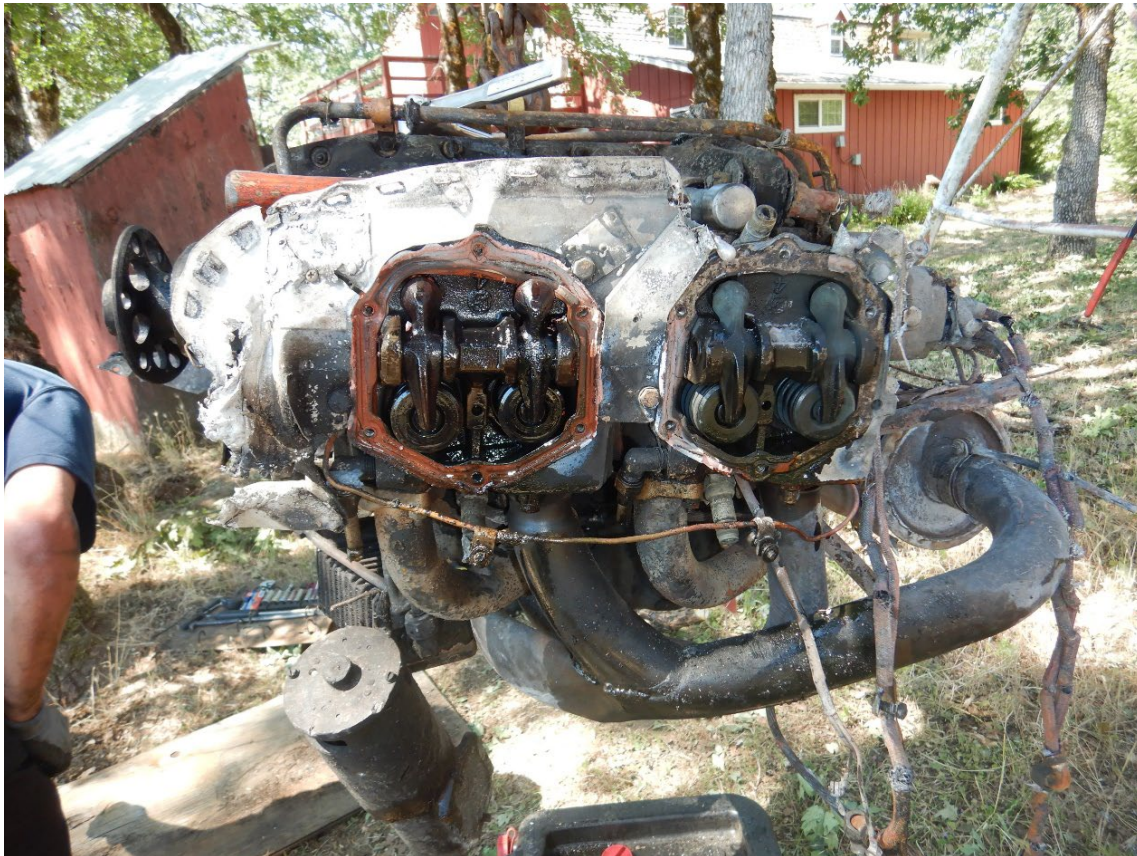
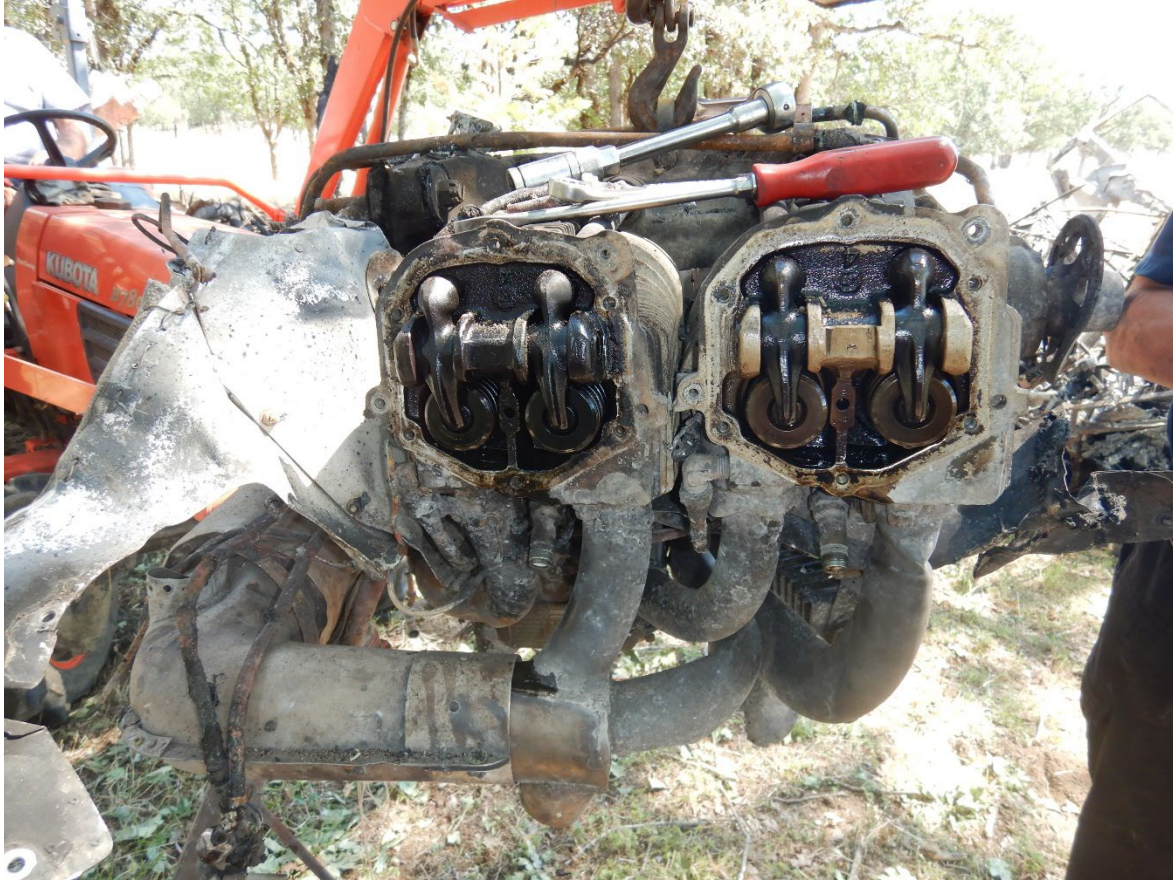
Visual inspection of the engine revealed that it remained mounted to the engine mounts, with impact damage to the oil pan area.

Photo 6 - View of Engine from the Left Side (Photo Courtesy of Piper)

Photo 7 - View of Engine from the Right Side (Photo Courtesy of Piper)

The engine was borescoped with no anomalies identified. Mechanical and valve train continuity was established. The engine was manually rotated from the propeller shaft, thumb compression was obtained on all cylinders in firing order. The cam shaft valves moved the same amount.

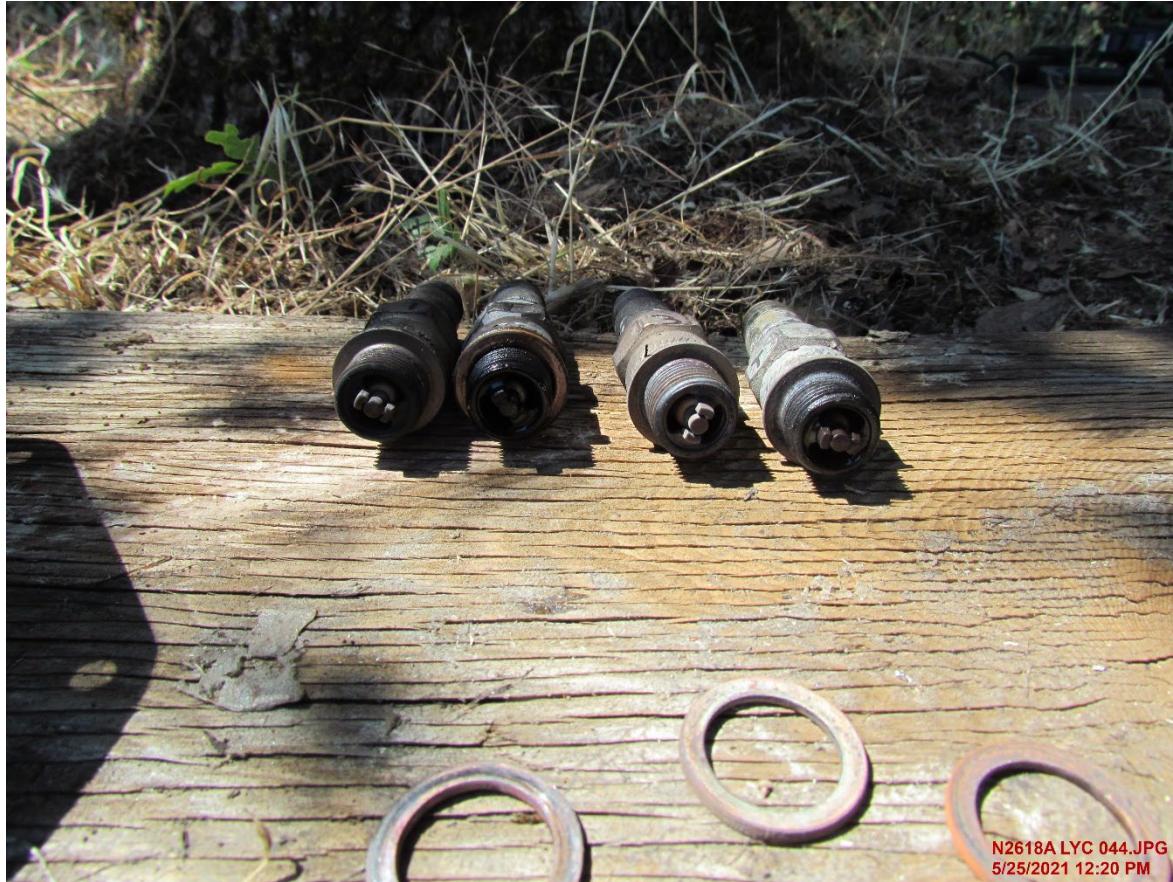
The carburetor had separated from its mounts. According to the Champion Aviation check-a-plug chart AV-27, the spark plugs exhibited normal operating signatures; Nos 2 and 4 were oil soaked, but the engine was positioned on its left side at the accident site. The magnetos remained secure at their respective mounting pads on the engine. The left magneto was thermally damaged/deformed and would not rotate. The right magneto sustained thermal damage and the capacitor was melted and would not rotate.

Photo 8 - View of Spark Plugs (Photo Courtesy of Lycoming)

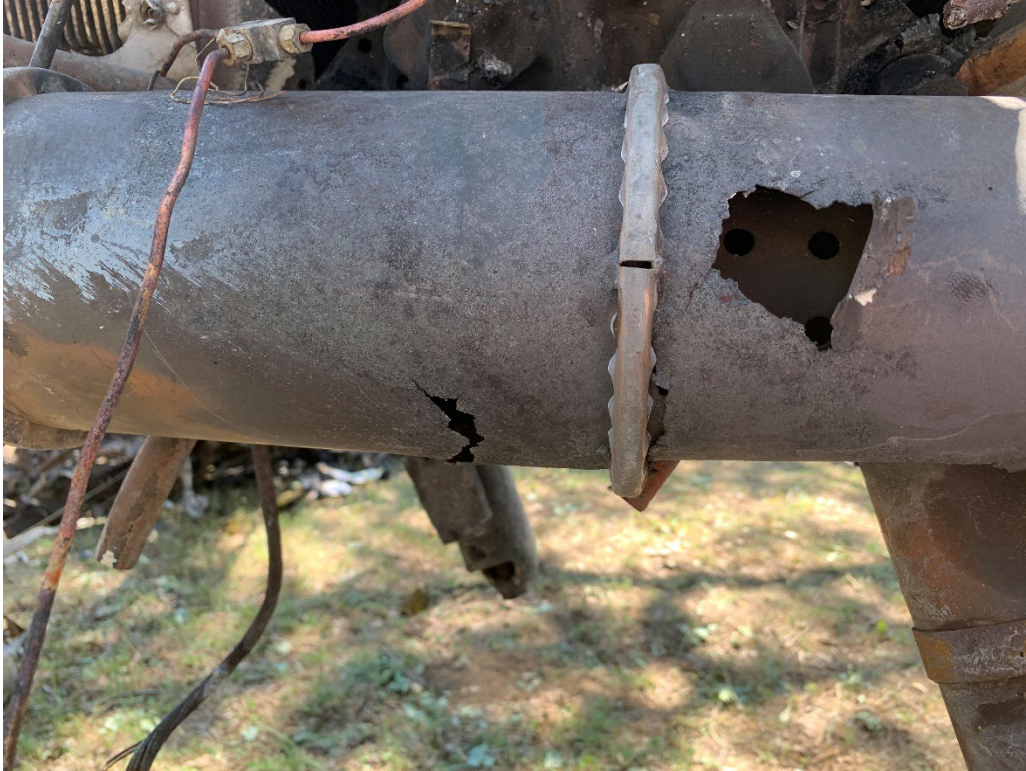
View of Muffler

The muffler showed evidence of thinning and cracks associated with fire damage. The interior manifold baffles were normal with no blockages. Exhaust marks were observed on the shroud as well as ductile bending on the exhaust.

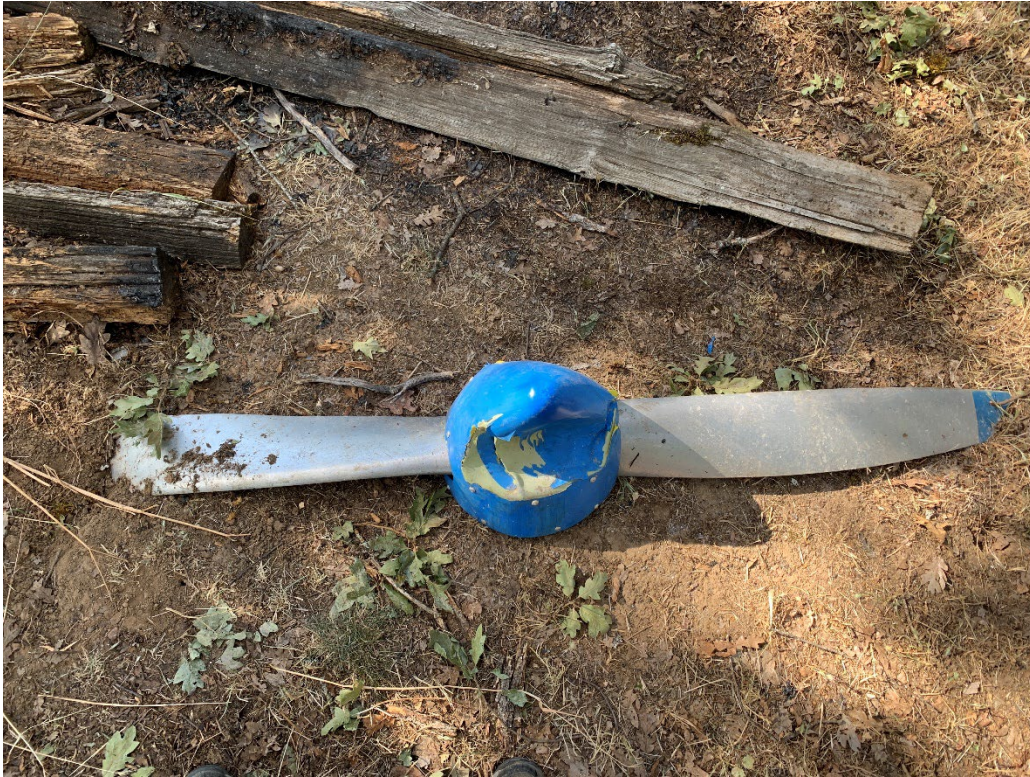
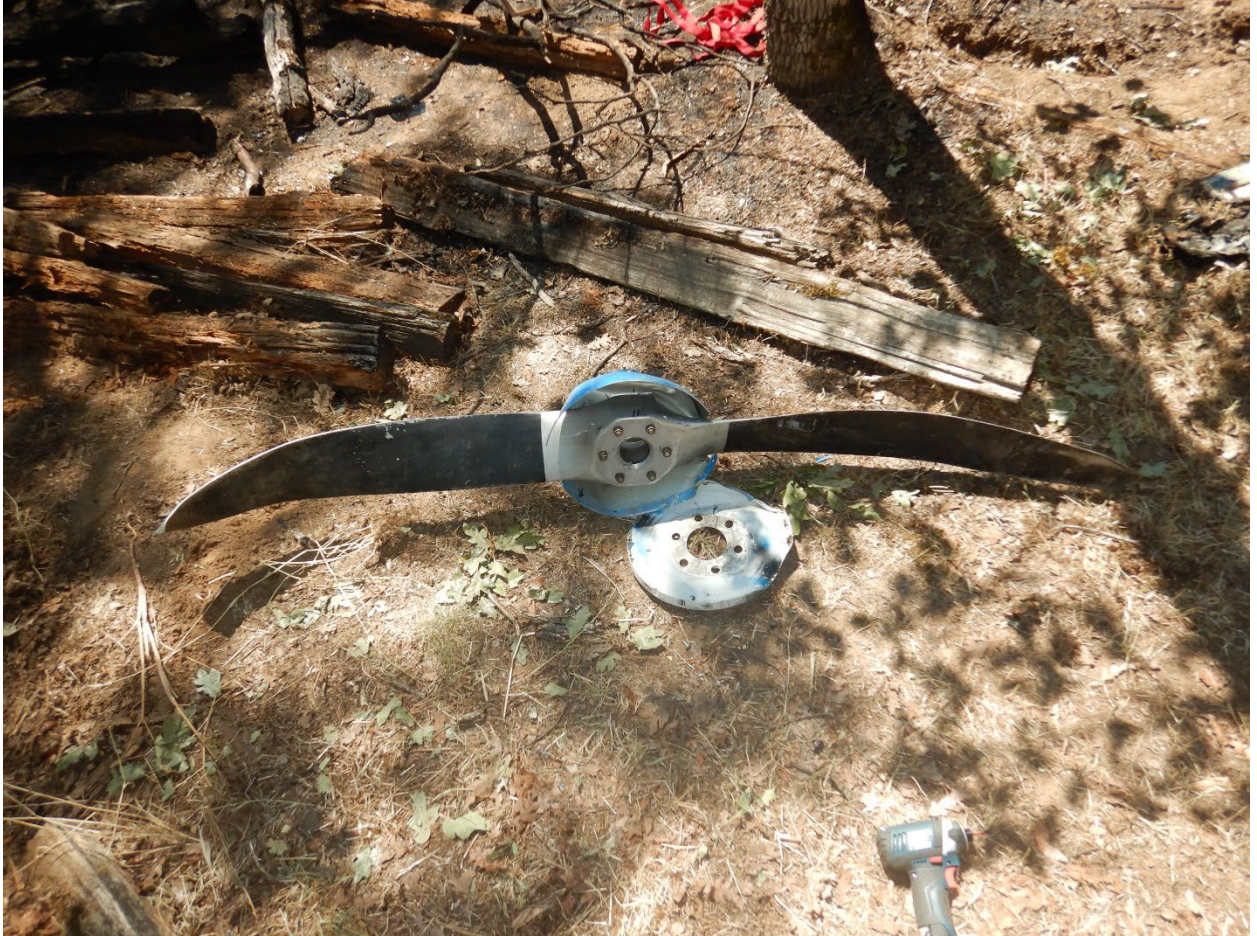
The propeller assembly including the propeller blades separated from the crankshaft; the crankshaft bolts were broken. Propeller flange was bent aft. One of the propeller blades had a broken tip that was not located; a search was conducted.

Photo 3 - View of Propeller

View of Propeller (Photo Courtesy of Piper)
