**NATIONAL TRANSPORTATION SAFETY BOARD**  
Vehicle Recorder Division  
Washington, DC 20594

## **Security Camera Recording**

Location:	Dinsmore, CA
Date:	July 15, 2021
Aircraft:	Mooney M20J
Registration:	N4474H
Operator:	Private
NTSB Number:	WPR21FA272

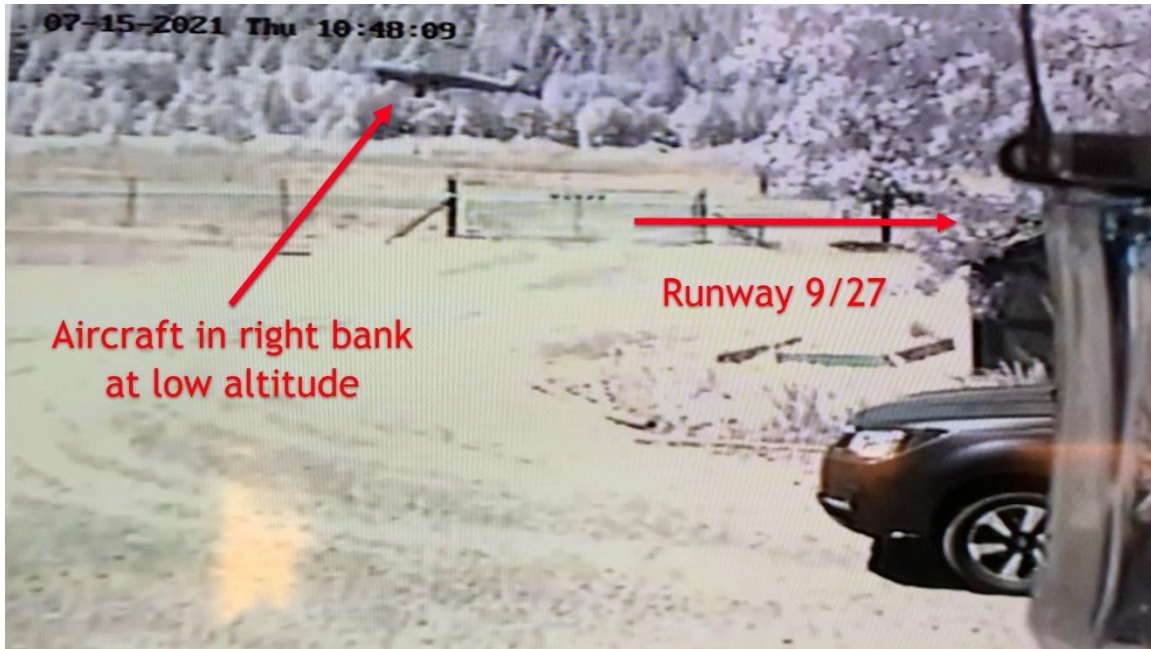
Figure 2 is a photo of the aircraft crossing the position of the camera that recorded IMG\_0187.mov. The still image export shows the aircraft at a low altitude, traveling east. The recording also shows the aircraft in a right bank. An arrow points to the aircraft, and another arrow points to the direction of runway 9/27.

Figure 2. A still image export from the IMG\_0187.mov recording.

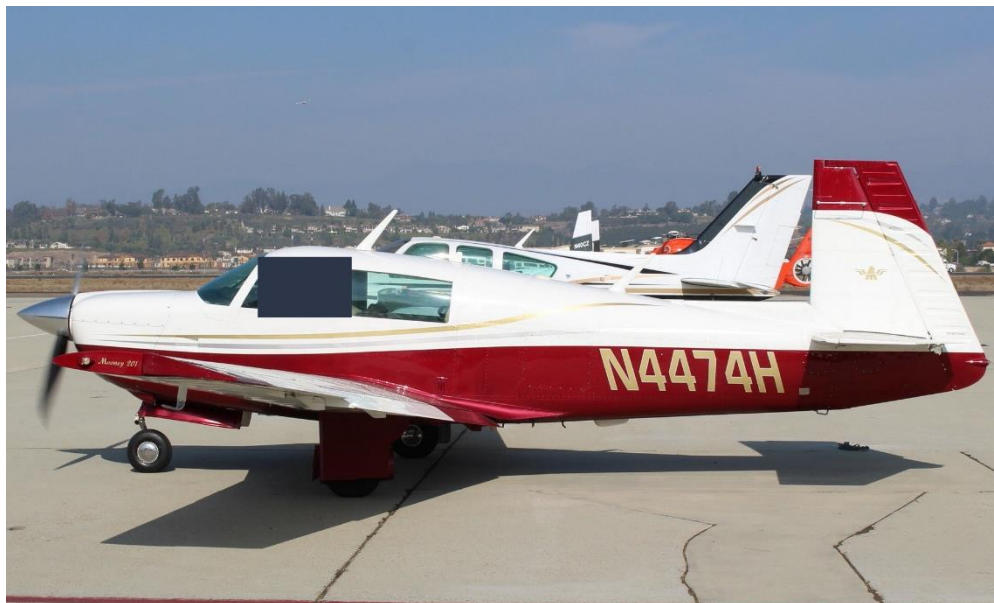
Figure 3 is an exemplar photo of the accident aircraft. Note the accident aircraft's belly is red and the upper fuselage is white.

Figure 3. An exemplar photo of the accident aircraft. Note the color of the accident aircraft's belly.

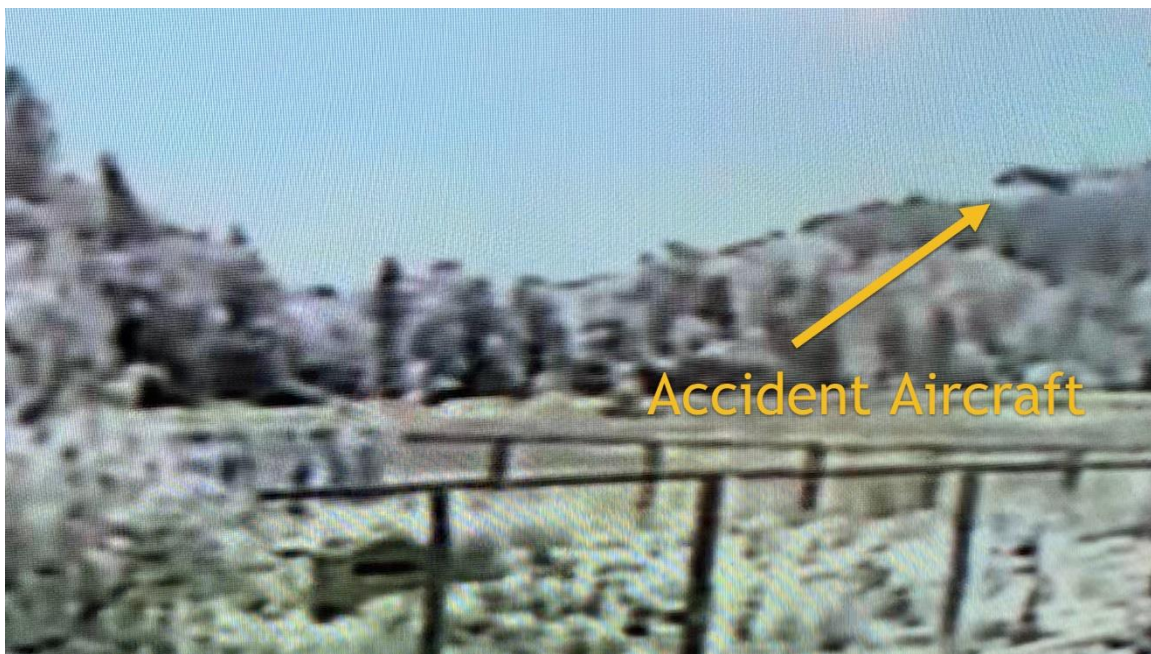
Figure 4 is a still image export of the aircraft entering the field of view in recording IMG\_0188.mov.

Figure 4. A still image export of the aircraft entering the field of view in IMG\_0188.mov.

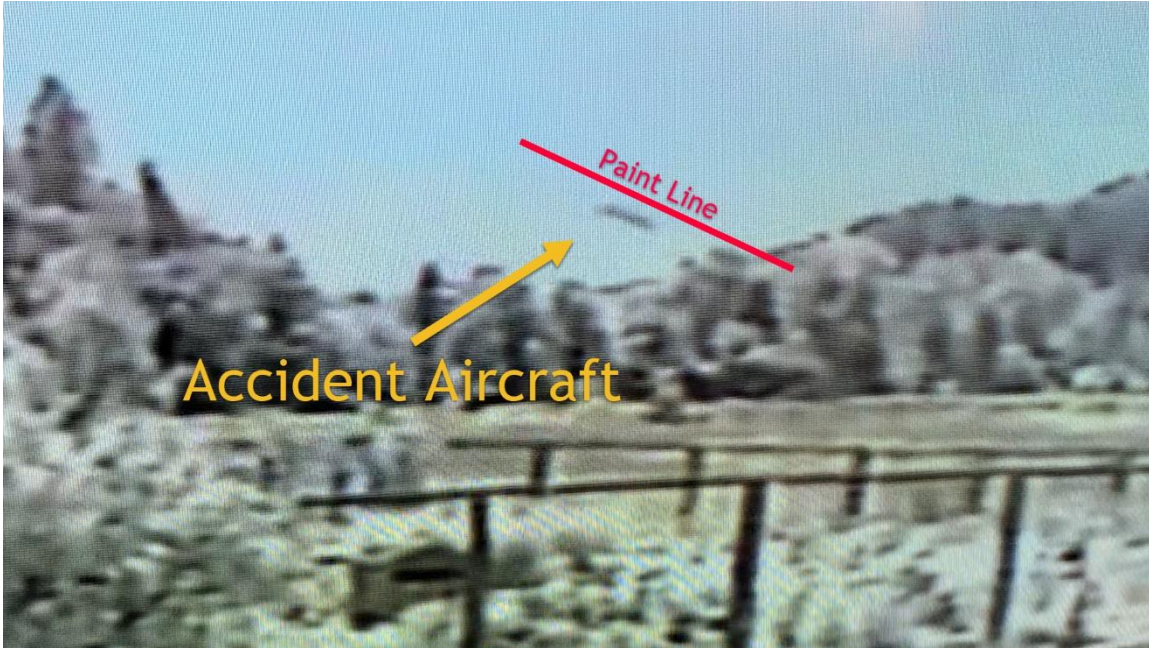
Figure 5 is a still image export of the aircraft further down range from runway 9/27. Noted earlier was the accident aircraft's color scheme, the belly being red and the upper fuselage being white. The orientation of the colors indicates the aircraft is in a pitch up condition. The image is annotated to show this.

Figure 5. A still image export of the aircraft down range from runway 9/27. The aircraft is in a nose high condition. The paint line is annotated.

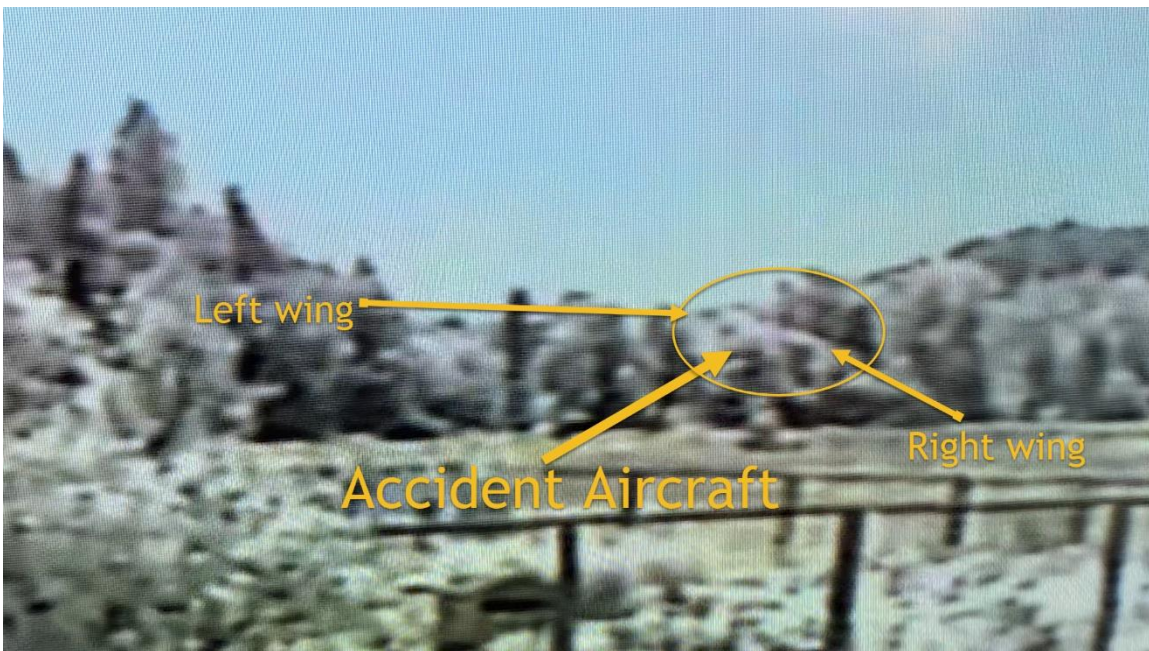
Figure 6 is a still image export of the aircraft after it had banked toward trees toward what was ultimately found to be consistent with the wreckage location. An arrow and reticle denotes the accident aircraft in the still image export.

Figure 6. A still image export of the aircraft as it banked toward trees toward the wreckage location. The left and right wing are visible as the aircraft is viewed from behind.
