NATIONAL TRANSPORTATION SAFETY BOARD

Onboard Image Recorder

Specialist's Factual Report By Sean Payne

Location: Angwin, CA
Date: July 16, 2021
Aircraft: Beech V35, N112TW
Operator: Private
NTSB Number: WPR21FA273

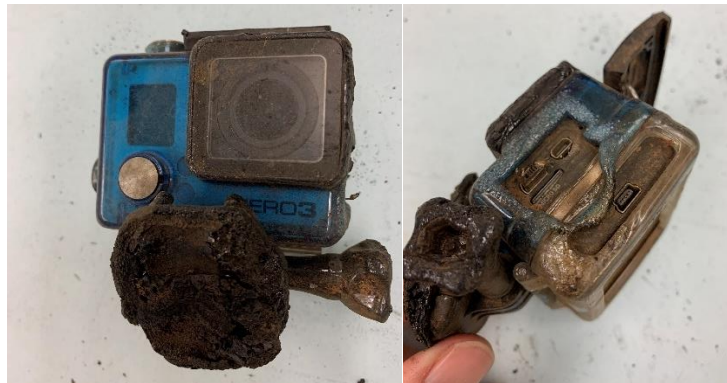
Figure 1 is a photo of the GoPro Hero device at the NTSB lab. The device exhibited characteristics of impact and fire damage, but was otherwise intact. The device's protective outer case was removed, the battery compartment was opened and the removable media card was found to be in good condition. The removable media card was removed and read in a PC via a USB write blocker. Media capturing the accident flight was downloaded and is discussed later in this report.

Figure 1. A photo of the GoPro Hero recovered from the accident.
