NATIONAL TRANSPORTATION SAFETY BOARD

ACCIDENT SITE AND FOLLOW-UP EXAMINATION SUMMARY

WPR21FA283

Location: Lewiston, Idaho
Date: July 25, 2021
Aircraft: N28U, SIAI-Marchetti, SM1019B
NTSB Investigator-in-Charge: Andrew Swick

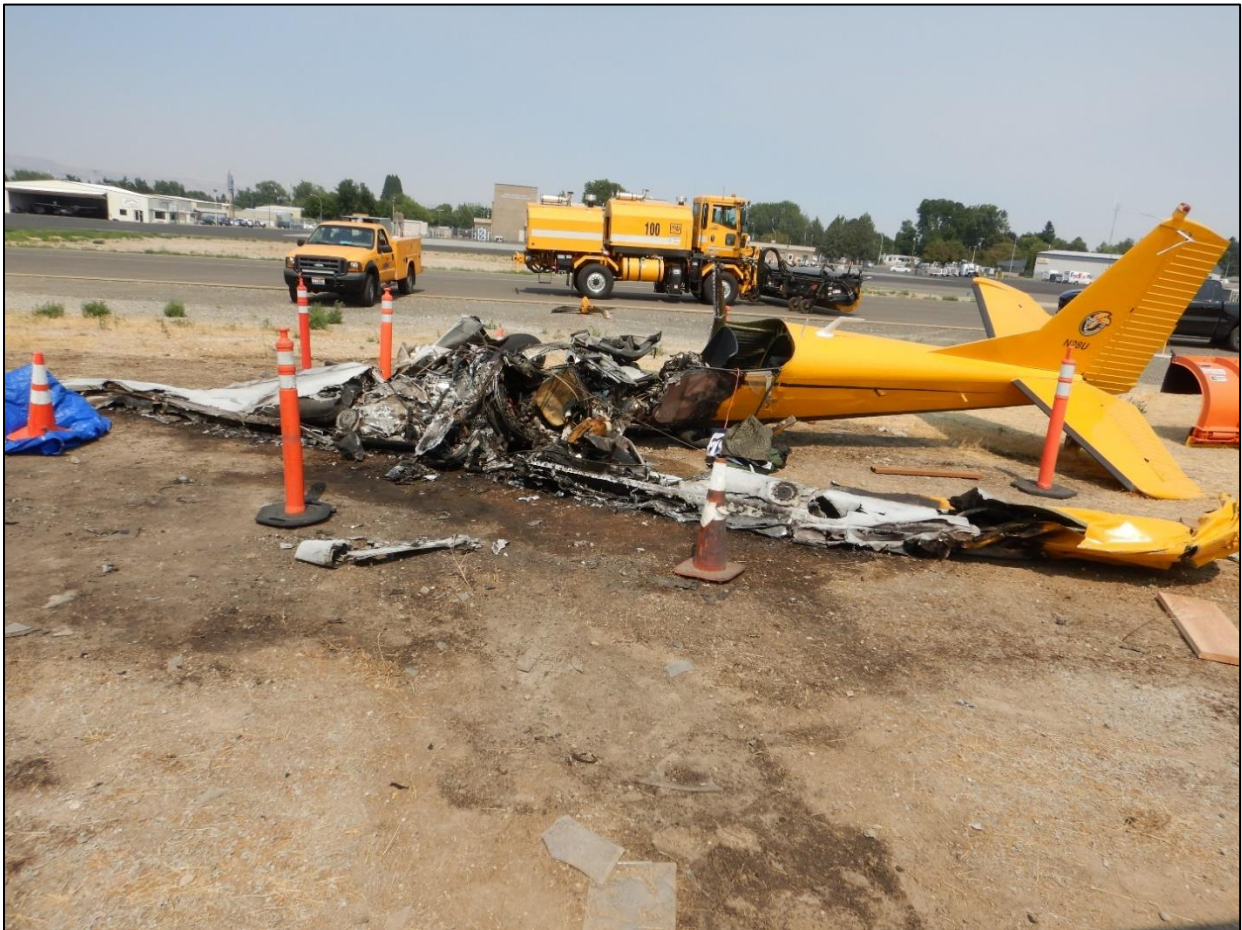
Figure 1-The main wreckage at the accident site location.

Examination of the accident site was conducted on July 25, 2021. The wreckage was located in the runway safety area adjacent to the intersection of taxiway F and taxiway C. The first identified point of contact (FIPC) was an area of disturbed ground consistent with a left wing strike about 30 ft from the main wreckage. Red lens fragments were found near the far end of the FIPC. A large shallow impact crater consistent with impact from the engine, was found between the FIPC and the main wreckage. The ground in the area of the wing fuel tanks was saturated with an oil type residue, that had the odor of jet fuel. The wings remained partially attached to the fuselage with extensive thermal damage to the inboard sections. The cabin and forward fuselage had impact and thermal damage. The aft fuselage and empennage were undamaged with the exception of the left elevator and horizontal stabilizer, which had some slight buckling. The reduction gear from the engine and the propeller assembly separated from the engine. The reduction gear was found near the main wreckage and the propeller assembly was found about 70 ft north of the main wreckage near the side of the taxiway.

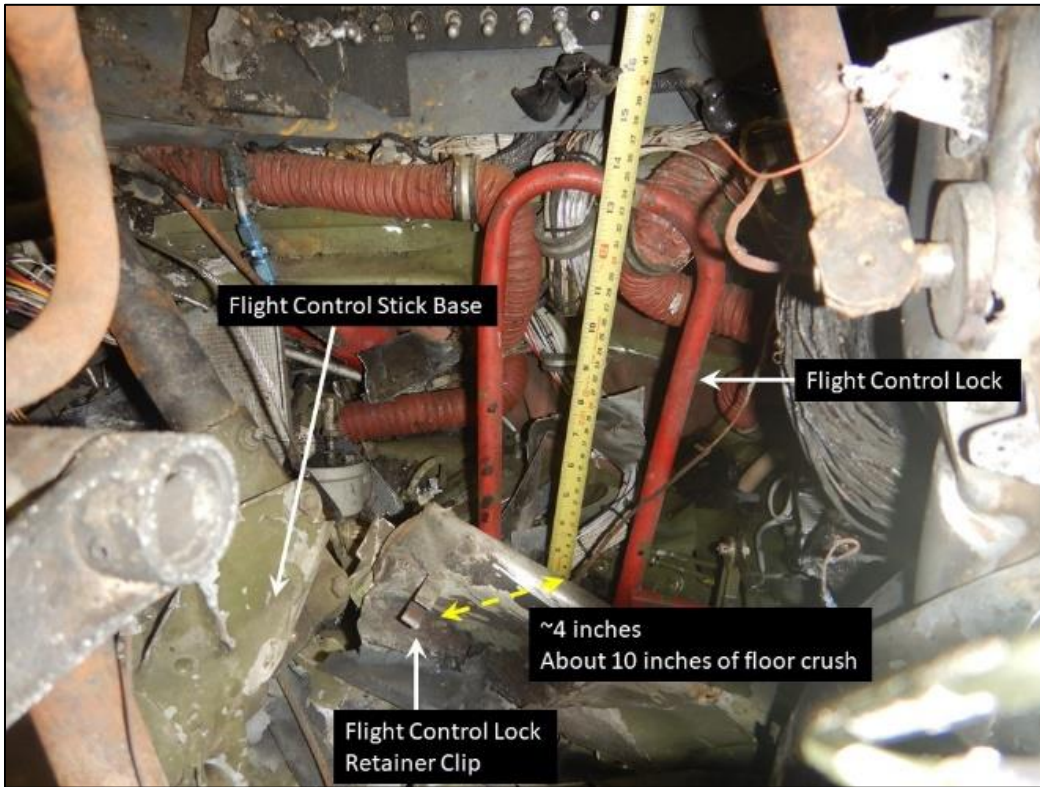
The forward cabin floor and left forward side of the fuselage had impact damage and was twisted to the left side. The rudder pedals were visible and remained attached to their linkages and pivot assemblies, which had twisted with the airframe. The flight control lock was intact, exhibited a slight twist to its left side, and remained connected to the rudder pedal pivot assemblies. The flight control lock was found in the up position near the instrument panel; the lock was measured and appeared to be about 14 inches long. The floor area forward of the control stick, which would have been occupied by the control lock, was compressed aft such that it was 4 inches away from the control lock pivot. The control lock floor clip, which would have been used to lock the control lock for flight, appeared undamaged.

Figure 2-Forward cabin floor and flight control lock position.

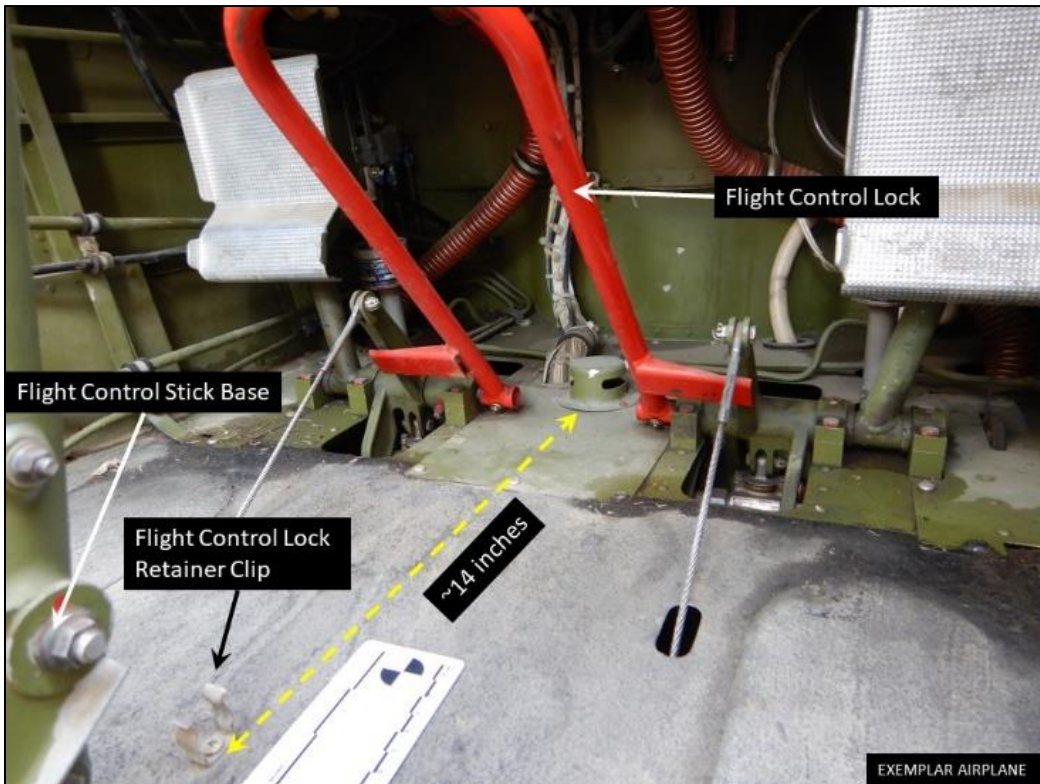
Figure 3-Exemplar airplane, forward cabin floor and flight control lock (engaged on the control stick).

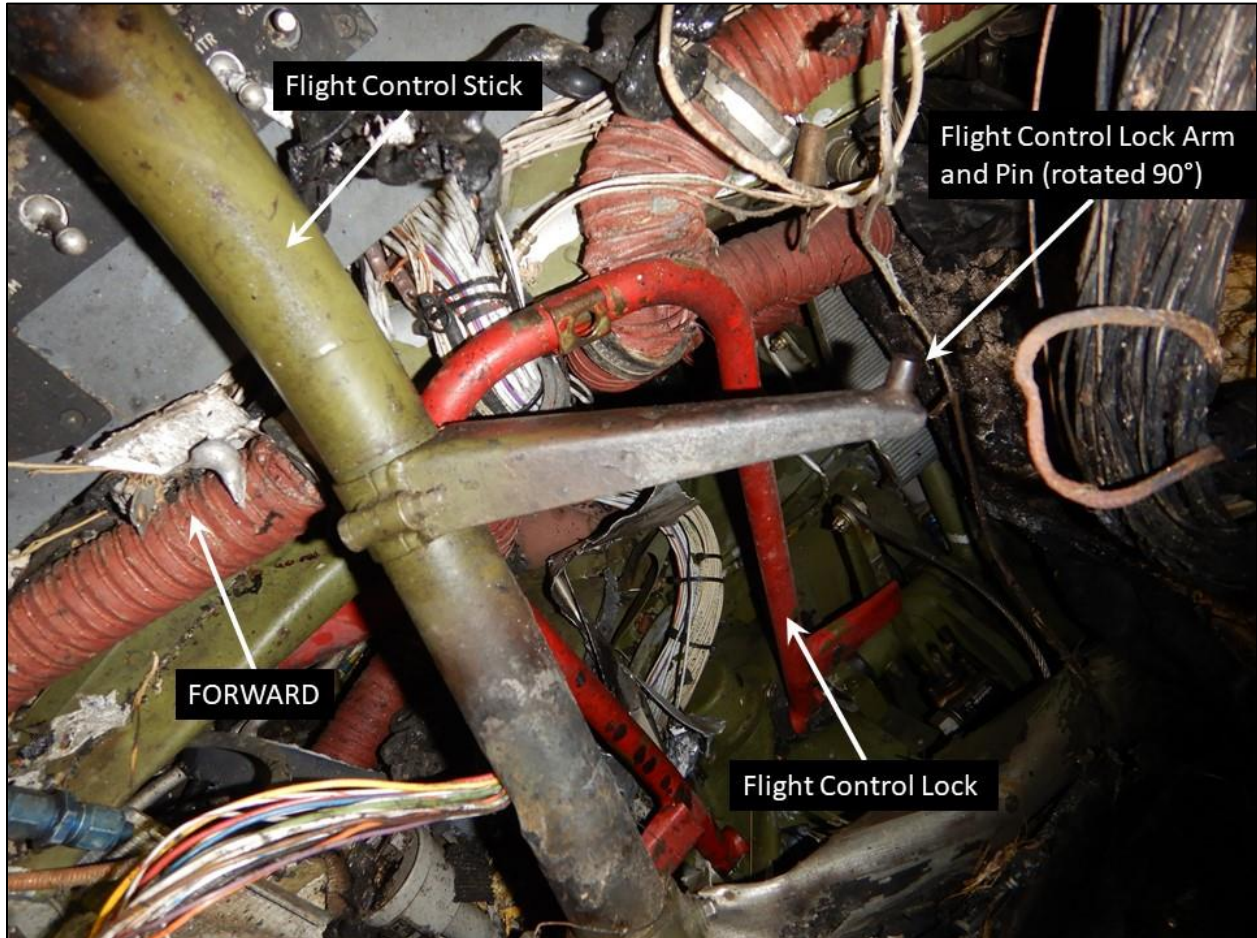
The flight control stick control lock arm and pin remained attached to the control stick, and appeared undamaged, but had rotated 90-degrees to the right of its original position. There was no evidence of contact between the control lock arm and pin and any components or structure in the footwell. The instrument panel had thermal and impact damage. The glass panel of the multifunction device, located in the center of the instrument panel had fractured glass in an area that matched the tip of the control stick.

Figure 4-Flight control stick and control lock arm and pin.
