NATIONAL TRANSPORTATION SAFETY BOARD

SERVO EXAMINATION

WPR21FA283

Location: Lewiston, Idaho
Date: July 25, 2021
Aircraft: N28U, SIAI-Marchetti, SM1019B
NTSB Investigator-in-Charge: Andrew Swick

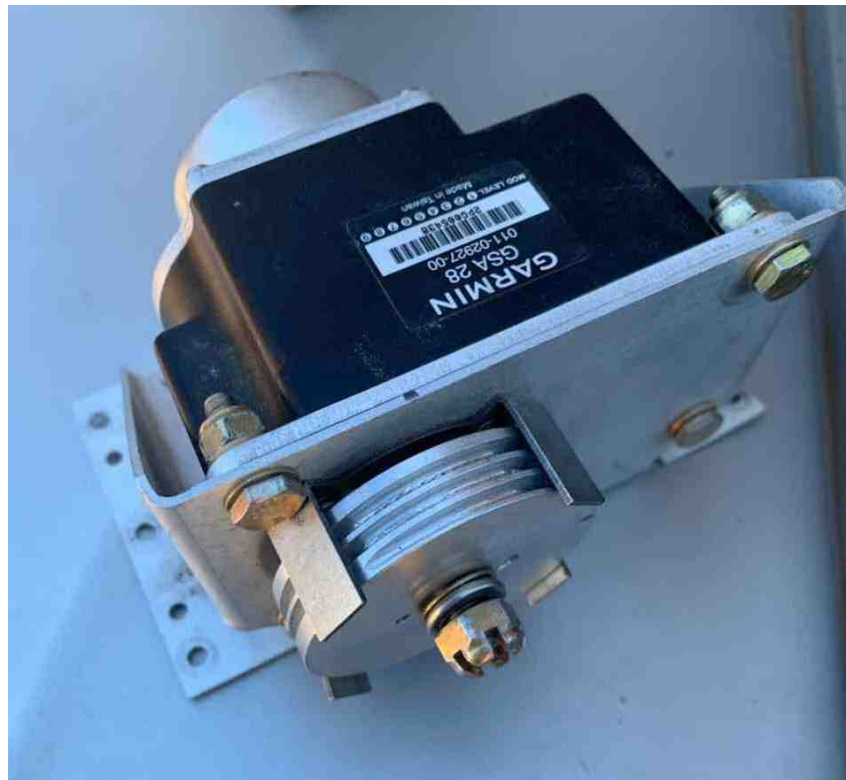
The servo was removed from the airplane and appeared undamaged (photo 1). The drive coupling remained attached to the output shaft and could be rotated by hand with no binding or resistance.

Photo 1 – Servo assembly

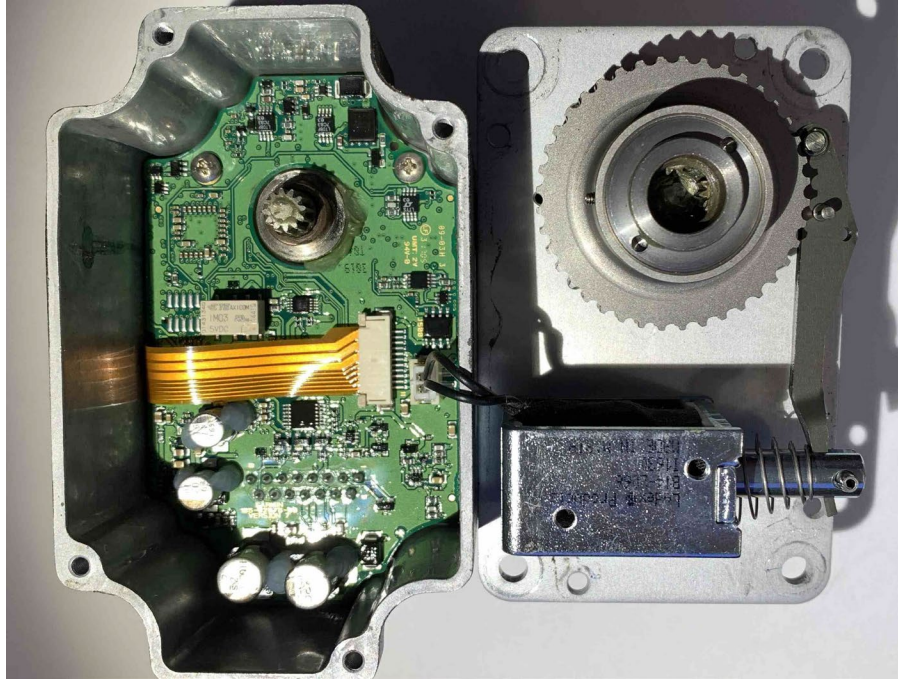
With the mounting plate removed, the inside of the servo was examined. The clutch assembly, which included a pawl and linear actuator (solenoid) were intact (photo 2). The combination pawl and planetary output drive gear could be rotated by hand and would engage with the pawl upon movement of the linear actuator. The planetary gears were still coated in grease, intact and undamaged, and could be moved freely (photo 3).

Within the servo case, the printed circuit control board was intact, there was no evidence of thermal damage, and all surface mount electrical components remained mounted to the printed circuit board (photo 2).

Photo 2 – Servo circuit board and pawl assembly

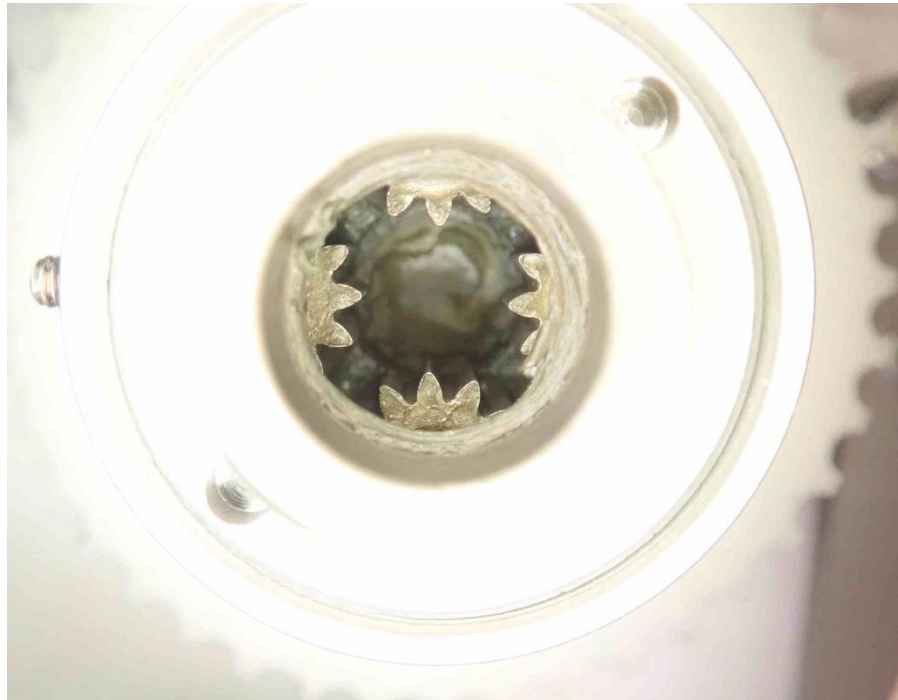
Photo 3 – Planetary gear

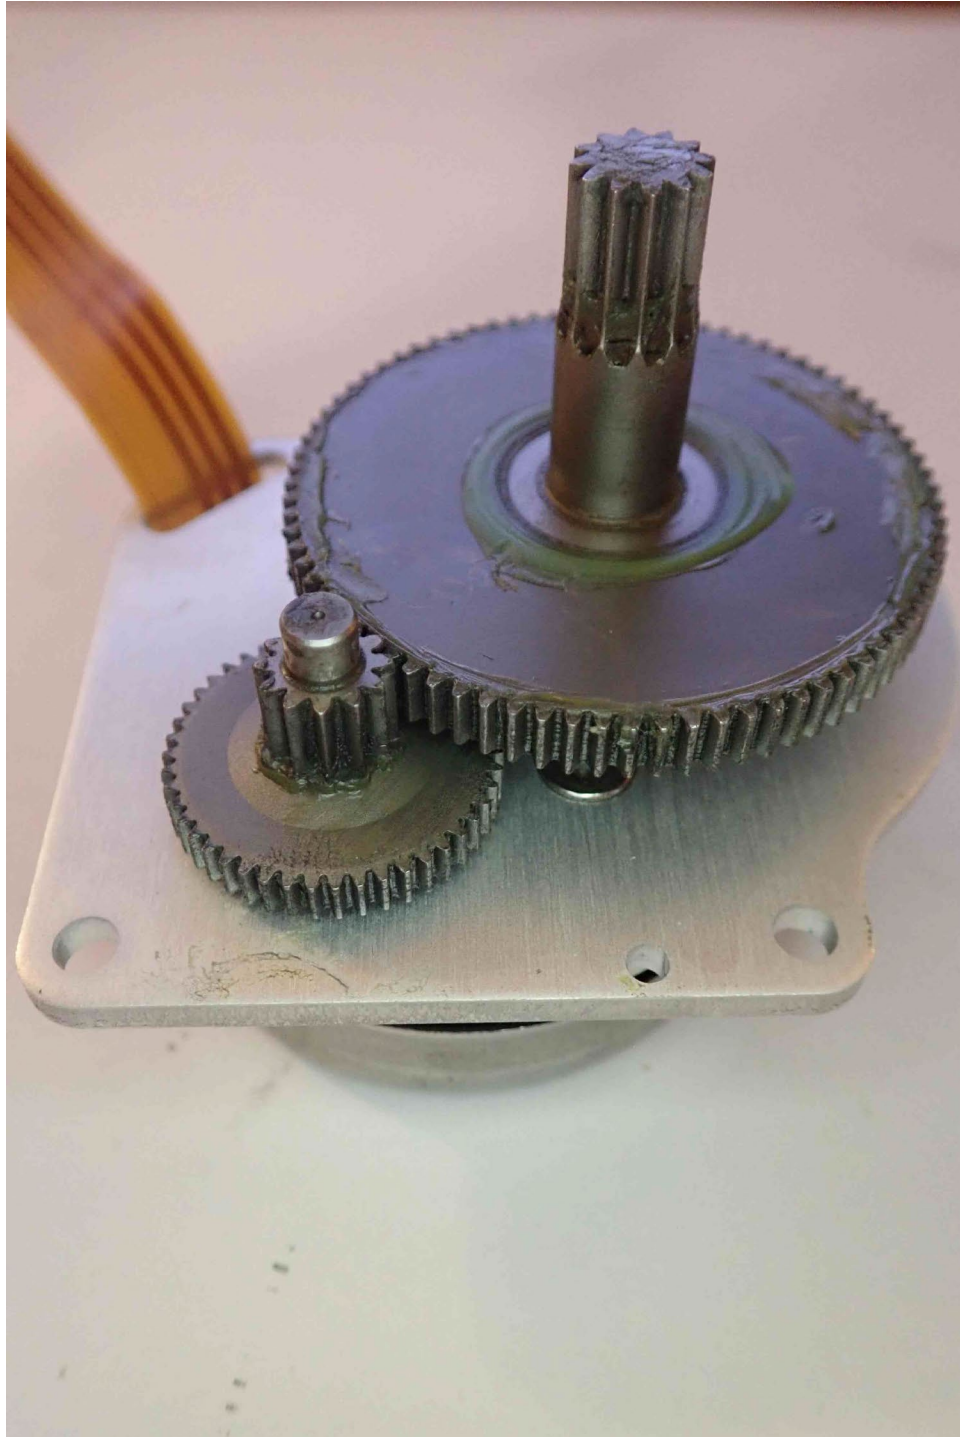
The gearbox case was removed. The reduction gears were coated in grease, intact and undamaged, and moved freely (photo 4). The brushless motor could be spun by hand and did not exhibit any indications of binding (photo 5).

Photo 4 – Reduction gear train

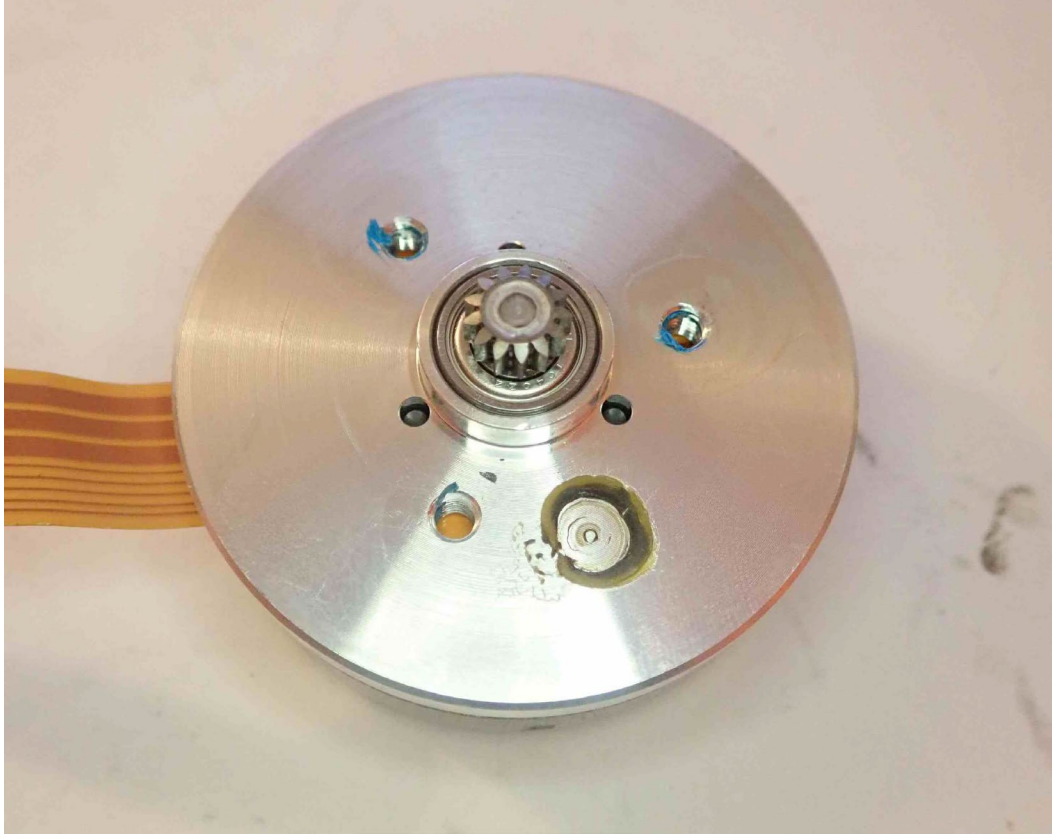
Photo 5 – Drive motor
