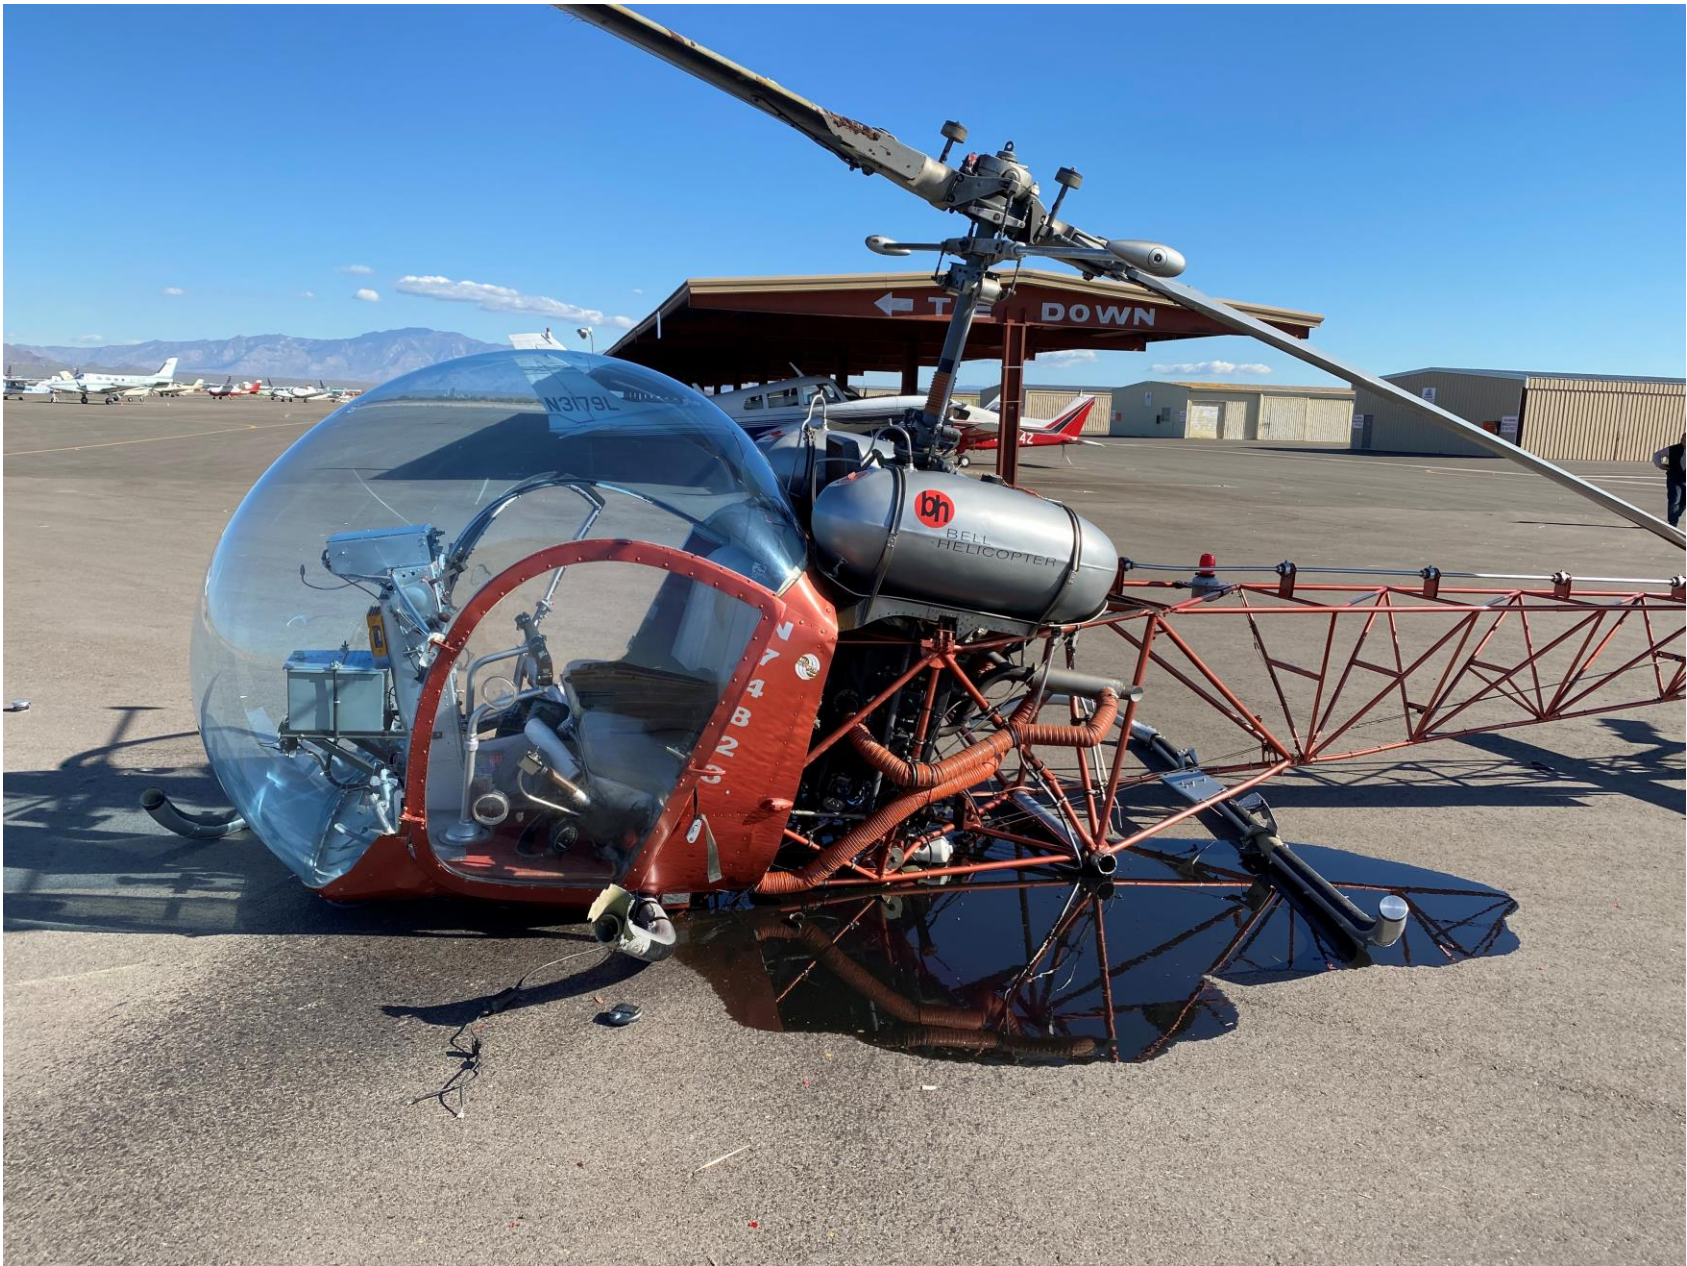
Photo 1 – Damage to cross tubes in tail boom
