National Transportation Safety Board

WPR22FA012

ACCIDENT SITE AND WRECKAGE EXAMINATION REPORT

Location: Three Points, Arizona
Date: 10/17/2021
Time: 1402 Mountain Standard Time
Airplane: Rockwell International 112B

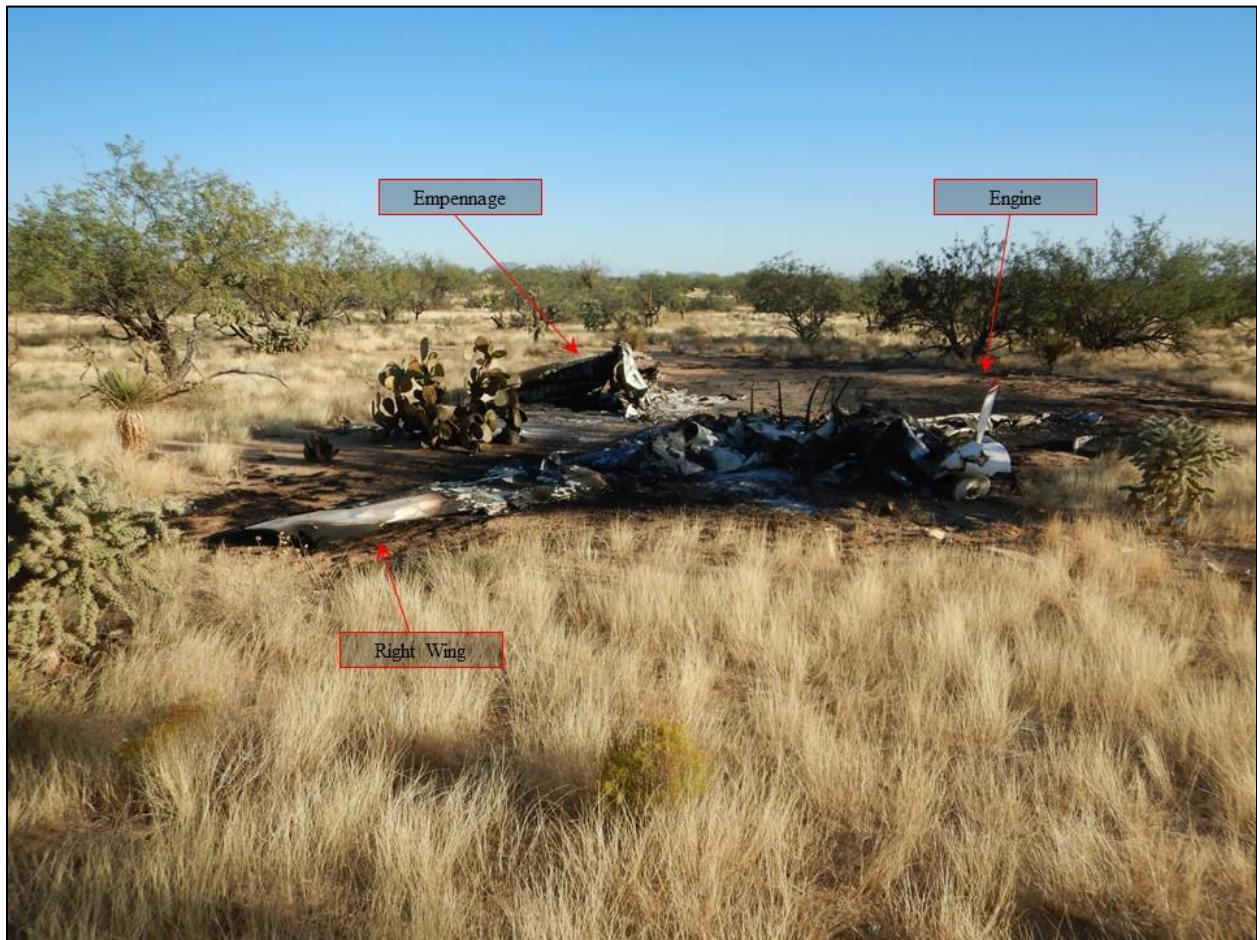
The accident site was about 21 miles southwest of RYN and located on level desert terrain surrounded by sparse desert trees, cacti and dry grass. An area of burned grass extended about 100 ft to the North of the main wreckage. There was no debris field, but the main wreckage was surrounded by broken plexiglass on all sides. The airplane was positioned at a directional heading of about 140 degrees. The wreckage was mostly consumed by postimpact fire. Impact marks in the ground were visible from the right wing tip and propeller assembly. Navigation lens fragments were visible near both of the wing tips. The ground impact marks are consistent with the airplane bouncing on impact, moving about 3 ft in a northerly direction.

Figure 1. Accident site with a view to the North.

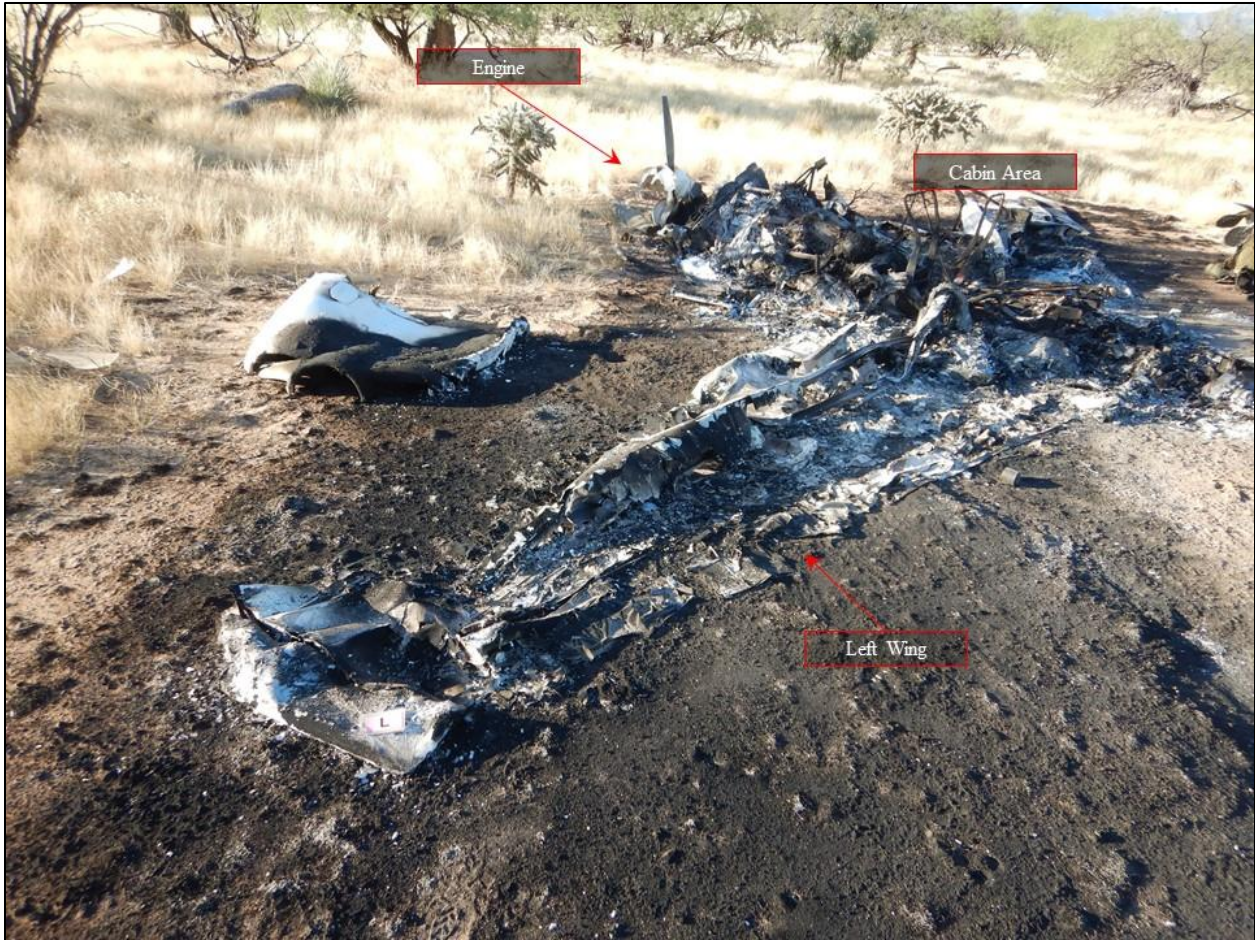
Figure 2. Aft view of the left wing.

The left wing had excessive thermal damage. Small portions of the leading edge showed impact damage consistent with the wing impacting the ground in a flat upright position. The aileron control cables were identified, connected to the aileron bell cranks and cable control continuity was established to the forward cabin area. The flap position was not determined due to the excessive thermal damage. The landing gear appeared to be in the retracted position. Actuator position was not obtained.

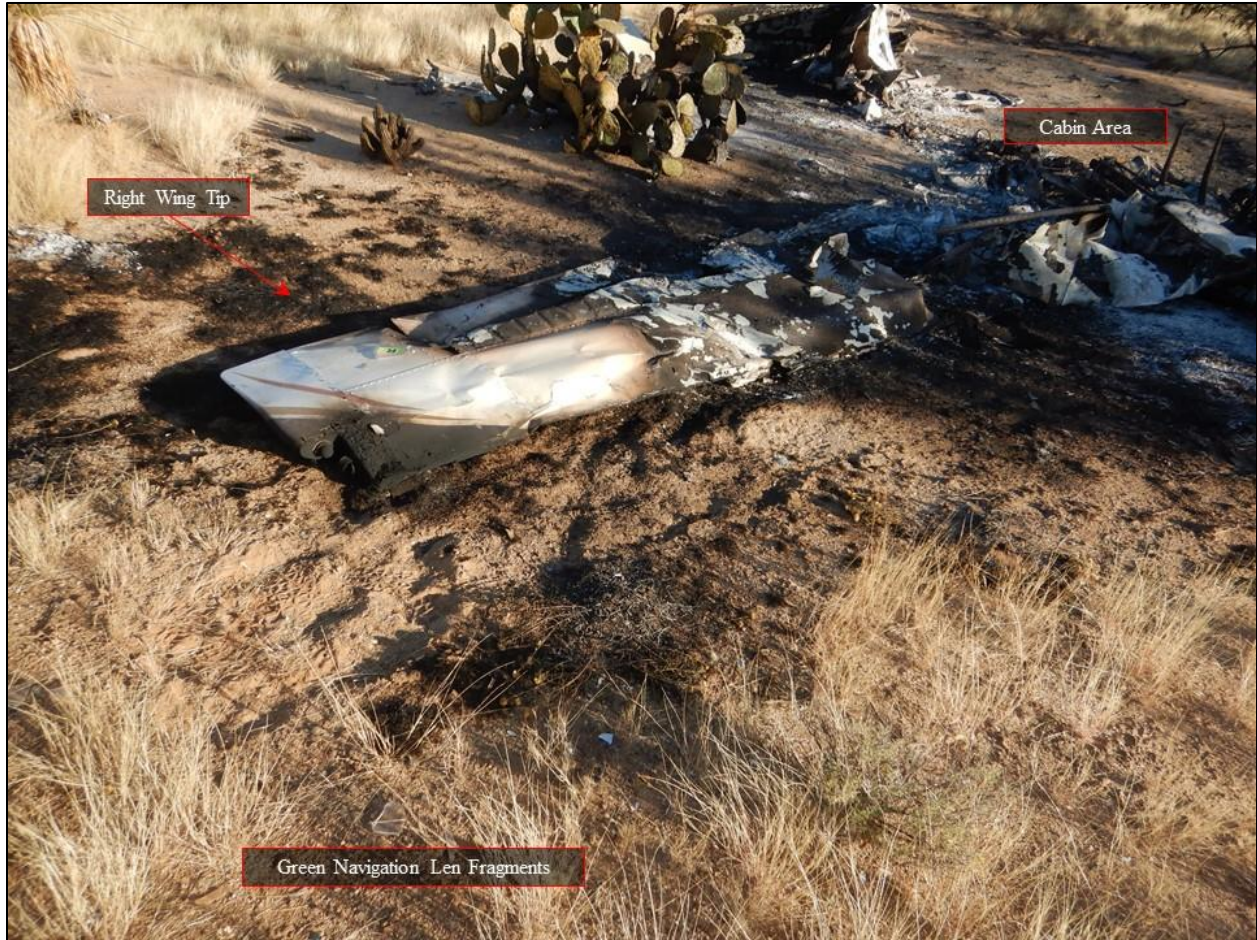
Figure 3. Forward view of the right wing.

The right wing had excessive thermal damage. Only a small portion of the outboard side of the wing including the outboard side of the aileron was not burned. Small portions of the leading edge shows impact damage consistent with the wing impacting the ground in a flat upright position. The aileron control cables were identified, connected to the aileron bell cranks and cable control continuity was established to the forward cabin area. The flap position was not determined due to the excessive thermal damage. A large section of main spar was bent upward near the landing gear area and had separated from the outboard end near the wheel well area. A large divot was found in the ground near the leading edge of the wing and wheel well area. The landing gear followup door was found partially buried in the divot. The landing gear position was not determined due to impact and thermal damage. Flap position was not determined due to the excessive thermal and impact damage.

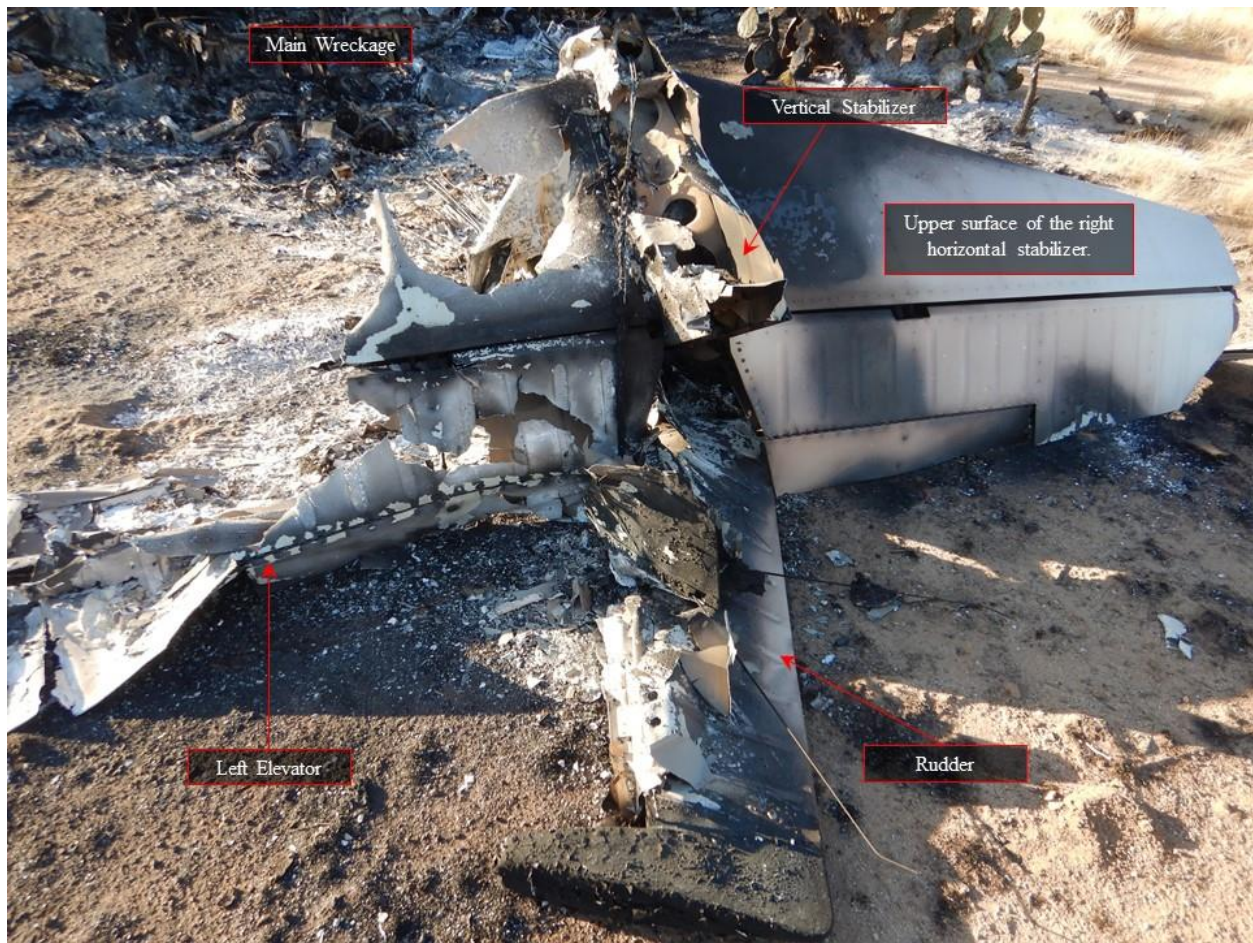
Figure 4. Empennage.

The empennage remained attached to the main wreckage by its elevator and rudder control cables. The fuselage forward of the empennage was consumed by the postimpact fire. The left horizontal stabilizer and left elevator remained partially attached and was mostly consumed by postimpact fire. Only a small portion of the horizontal stabilizer remained attached to the vertical stabilizer. The right horizontal stabilizer and right elevator remained attached and had thermal discoloration. The elevator control cable and control tube continuity was established to the cabin controls. The elevator control tube remained attached to each upper and lower bellcrank. The upper portion of the vertical stabilizer was consumed by postimpact fire. The rudder separated from the vertical stabilizer, had impact and thermal damage and was positioned between the elevators. Rudder cable control continuity was attained to the cabin area.

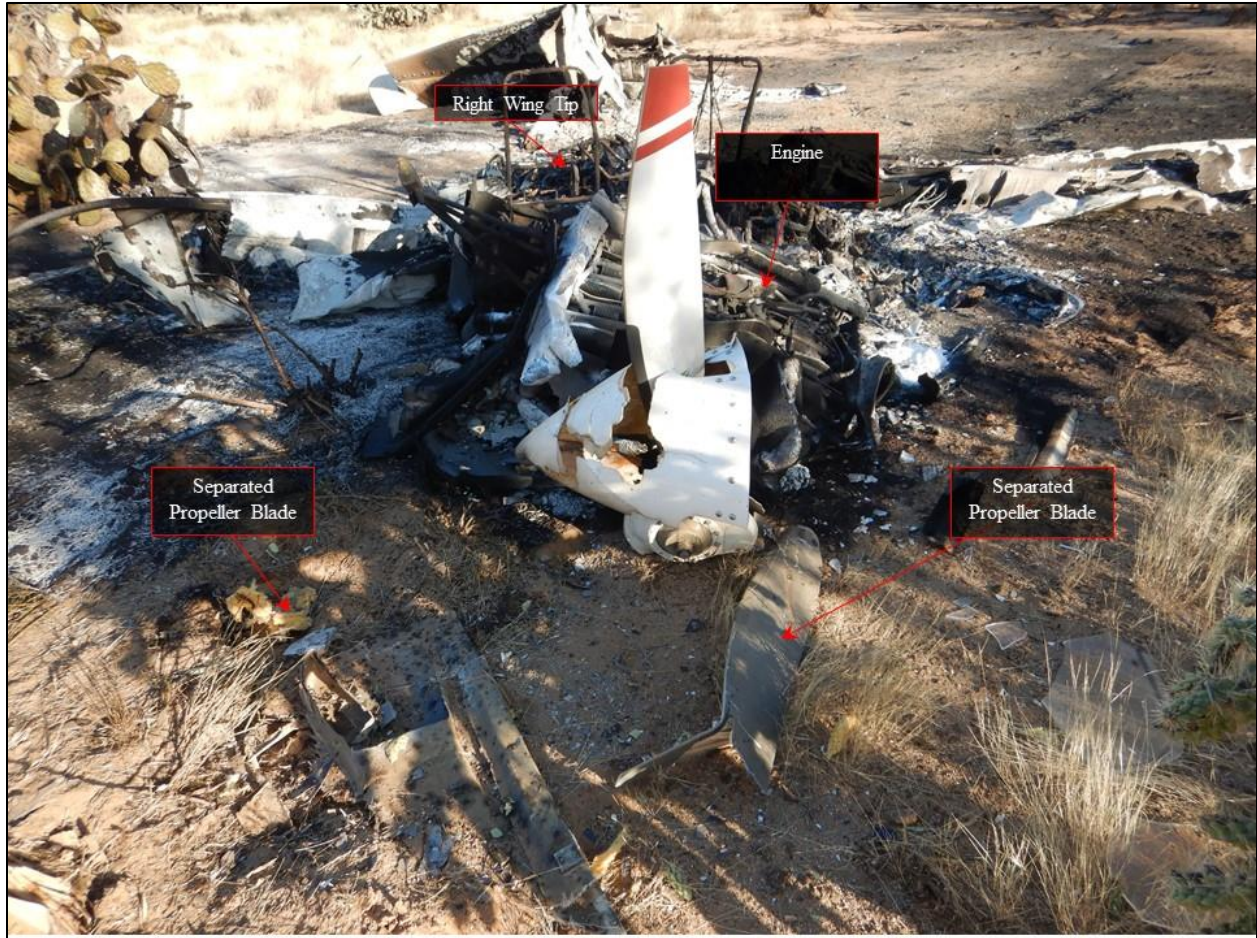
Figure 5. Propeller and engine assembly.

The propeller assembly remained attached to the engine. Two of the propeller blades separated at the hub and were found in the surrounding area. One blade was found partially buried and was in multiple sections. The other blade was found near the hub and remained mostly intact. The spinner was broken and was separated from its hub attachment. The spinner remained hooked to the one remaining attached blade. The attached blade was undamaged and revealed no impact related damage. The engine remained attached to the airframe by control cables and burned tubes and wires. The engine mounting carriage had impact damage. The accessory section of the engine was visible and had excessive thermal damage. The internal accessory drive gears were visible and both magnetos were thermally damaged. The lower side of the engine had excessive thermal damage. The nose landing gear was not visible during the onsite examination.

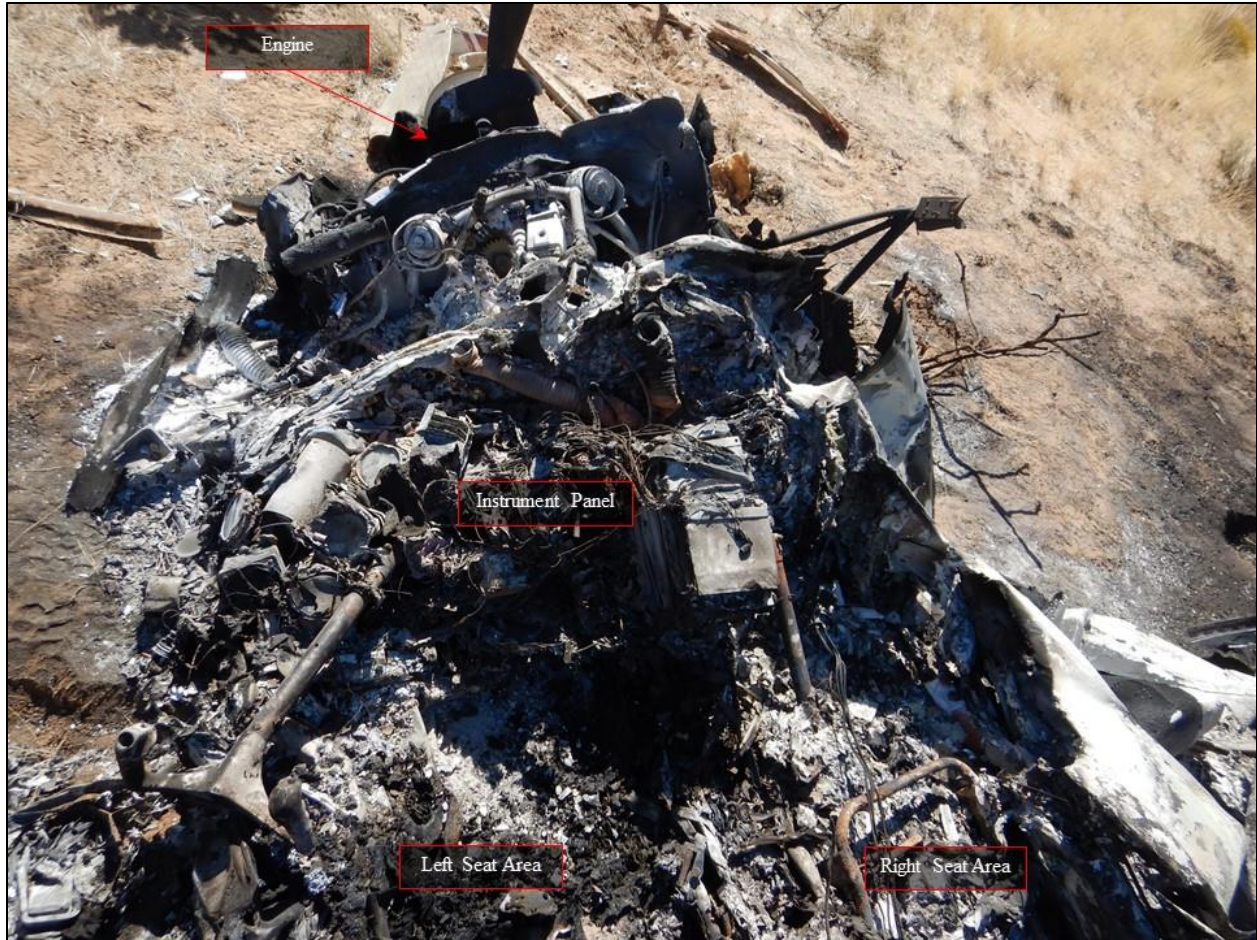
Figure 6. View of the forward cabin area.

The cabin area had excessive impact damage. The instrument panel had excessive thermal damage and no switches or instrument offered any data or positions. Flight control cable continuity was established to the central cabin area and associated bellcranks and attachments.

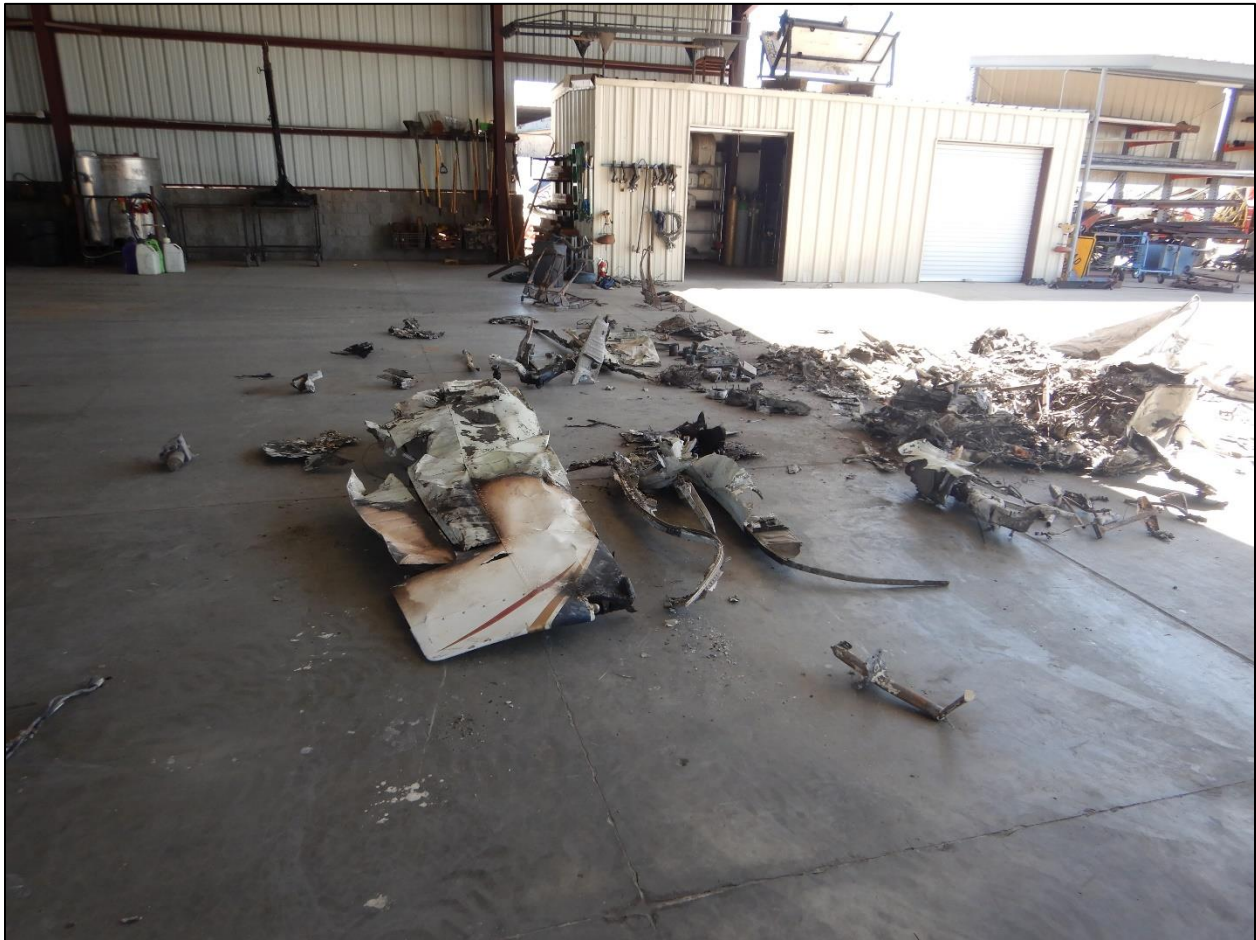
Figure 7. Wreckage examination layout.

Fuel selector valve was found in the "Both" position.

Aileron, rudder and elevator trim positions were undetermined due to thermal and impact damage.

Flaps position was undetermined due to thermal and impact damage.
