National Transportation Safety Board

WPR22FA012

AUTOMATIC DEPENDENT SURVEILLANCE- BROADCAST (ADS-B) STUDY

Aircraft Performance Study

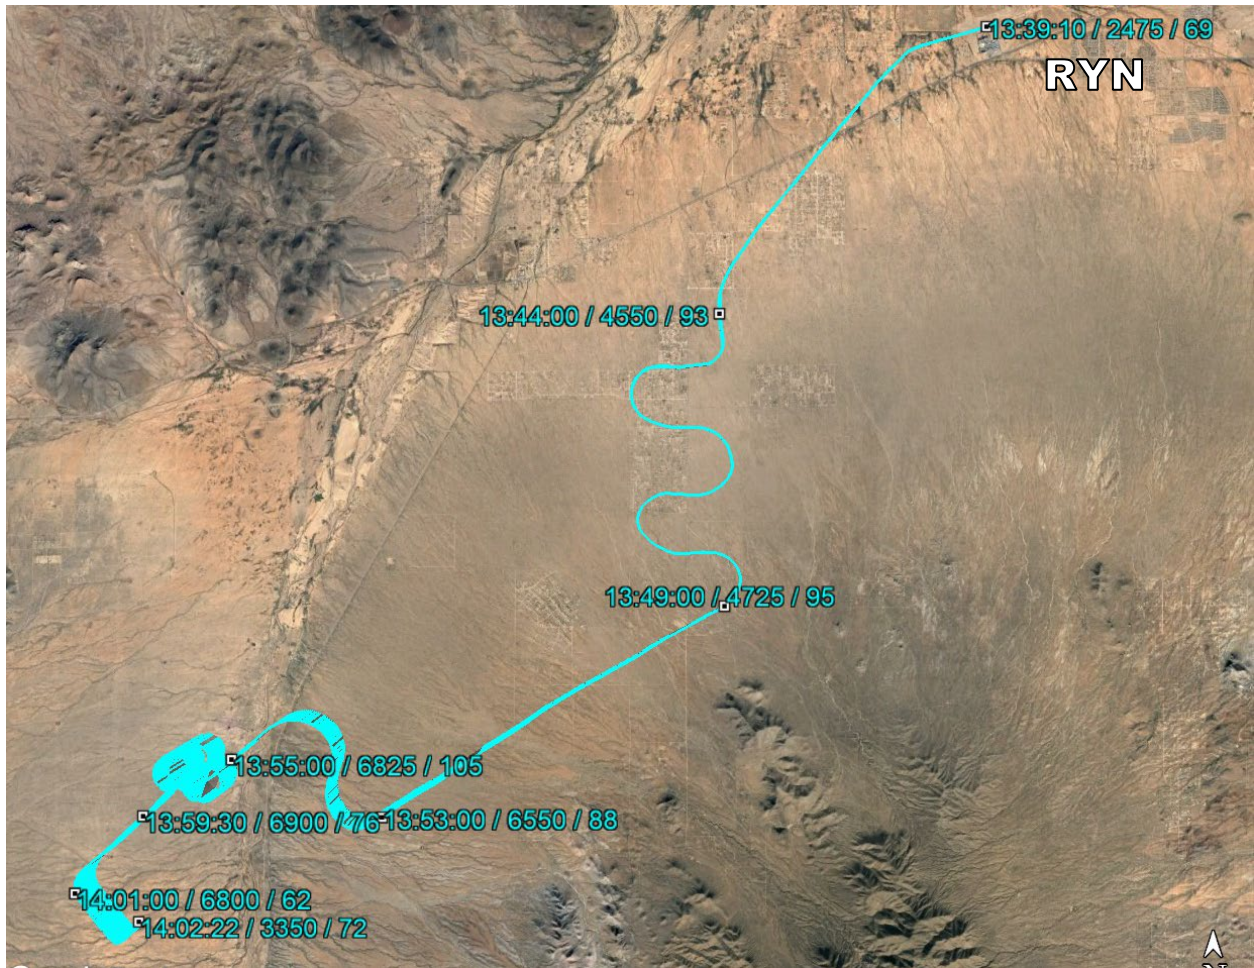
Figure 2. ADS-B flight path with selected times / altitude (msl) in ft / airspeed in kts annotated.

The airplane took off from RYN at 13:39:10 (Figure 2). It flew southwest and climbed to about 4,600 ft mean sea level (msl) (Figure 3). Between 13:44 and 13:49 the airplane completed a series of turns at speeds between 90 and 110 kts calibrated airspeed. The airplane then climbed to above 6,600 ft and completed a series of circles at speeds between 90 and 110 kts calibrated airspeed.

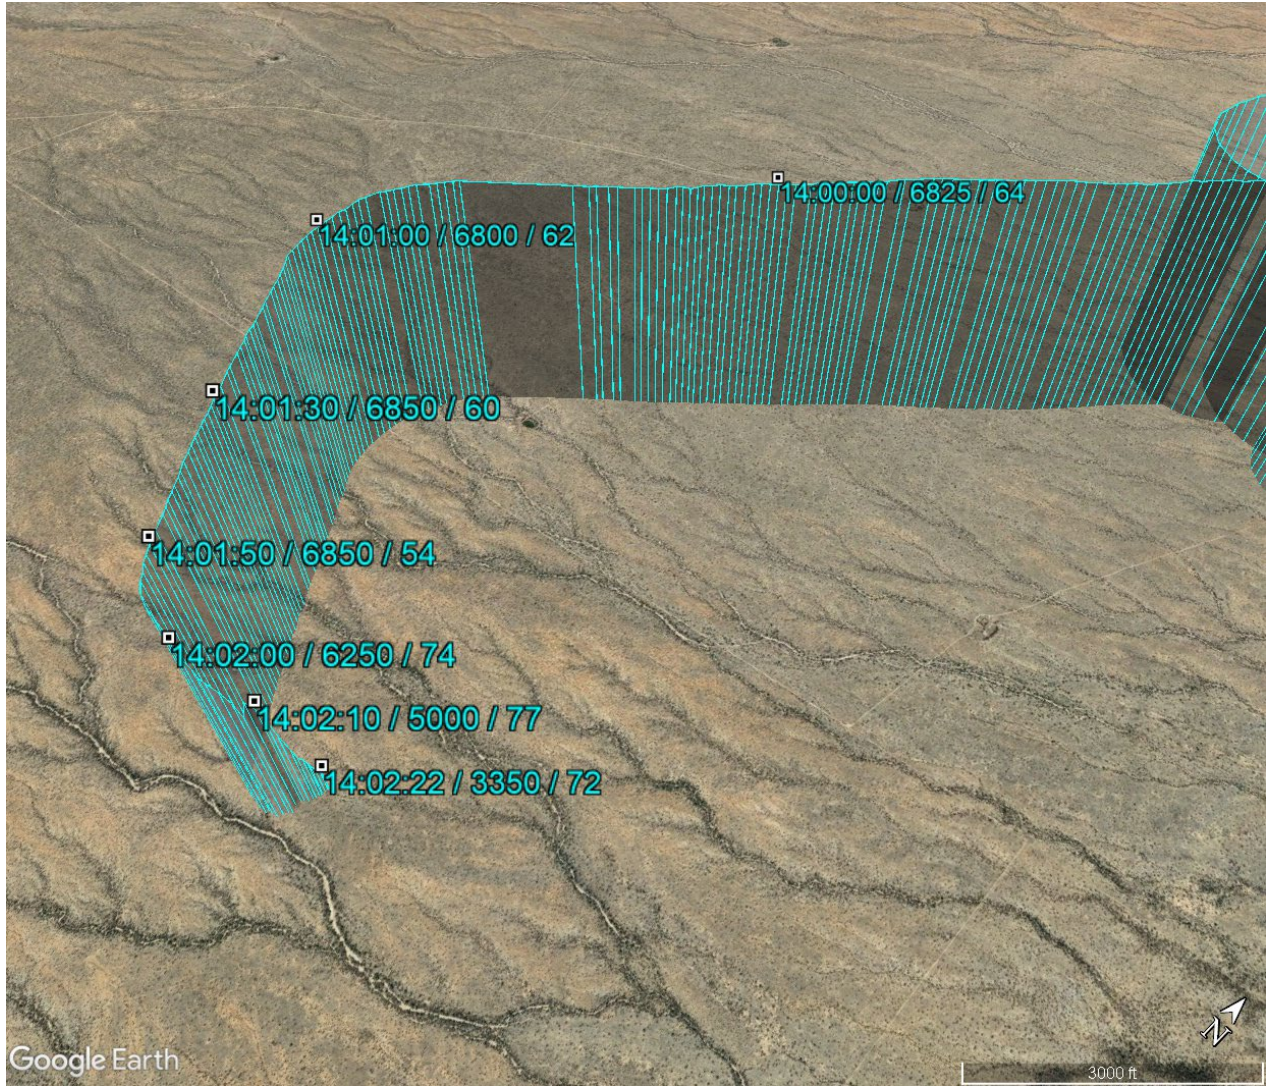
Figure 4. ADS-B flight path with selected times / altitude (msl) in ft / airspeed in kts annotated.

Just after 14:01:50, the airplane’s calibrated airspeed slowed below 57 kts and the airplane began rapidly losing altitude. The airplane entered a tight left turn as it descended. Slowing below reported stall speed followed by a sudden loss of altitude, and tight turn is consistent with the airplane experiencing aerodynamic stall.

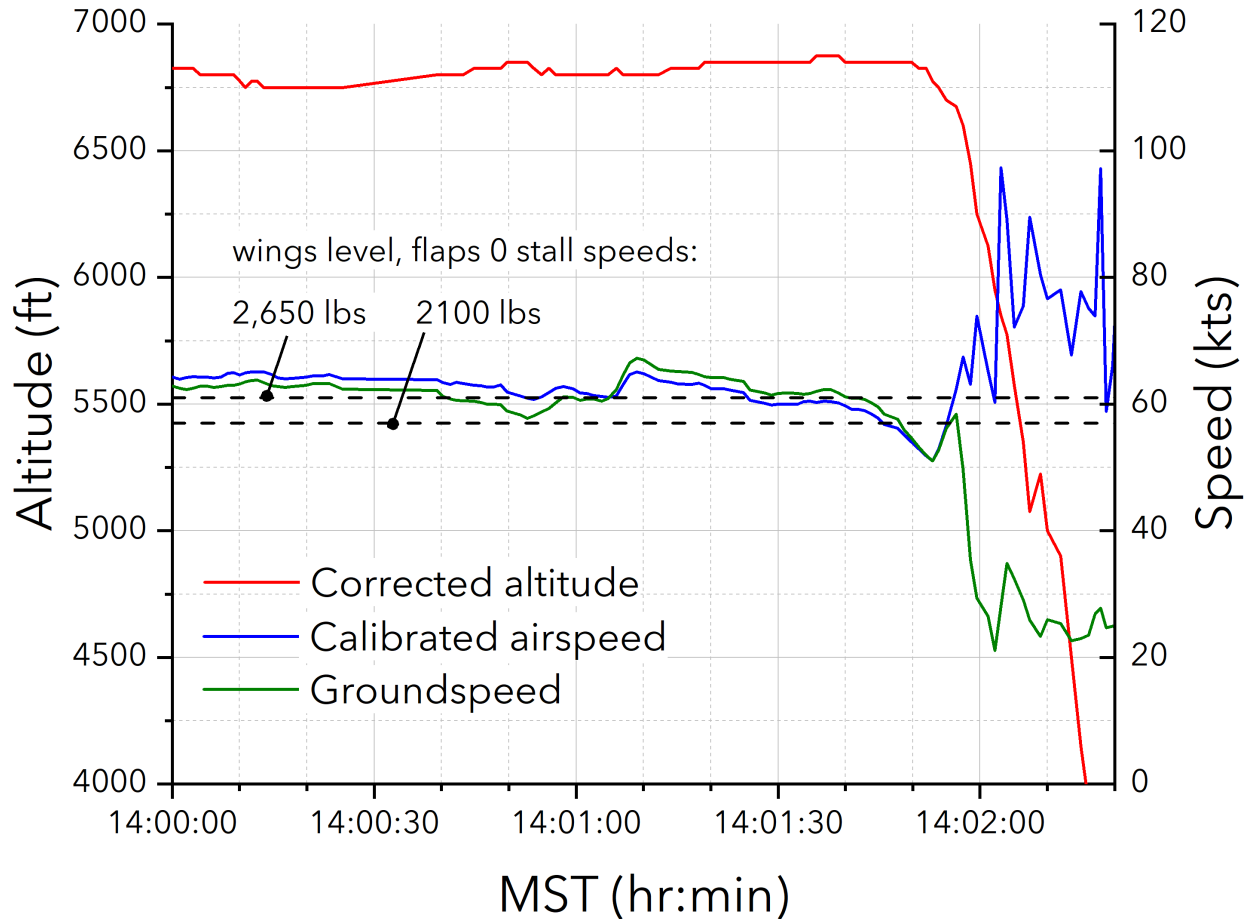
Figure 5. ADS-B altitude (msl) with calculated ground and airspeed.

After 13:59, the airplane slowed to just above 60 kts calibrated airspeed while maintaining an altitude above 6,600 ft. Figure 5 shows the airplane’s altitude and calculated groundspeed and airspeed for the end of flight. The Airplane Flight Manual [1] reported the wings-level, power-off stall speeds as 57 kts light and 61 kts heavy, calibrated airspeed. The airplane was flying only 4-7 kts above its reported stall speed during the final two minutes of flight.
