National Transportation Safety Board

WPR22FA068

OPERATIONAL FACTORS

Group Chair's Factual Report

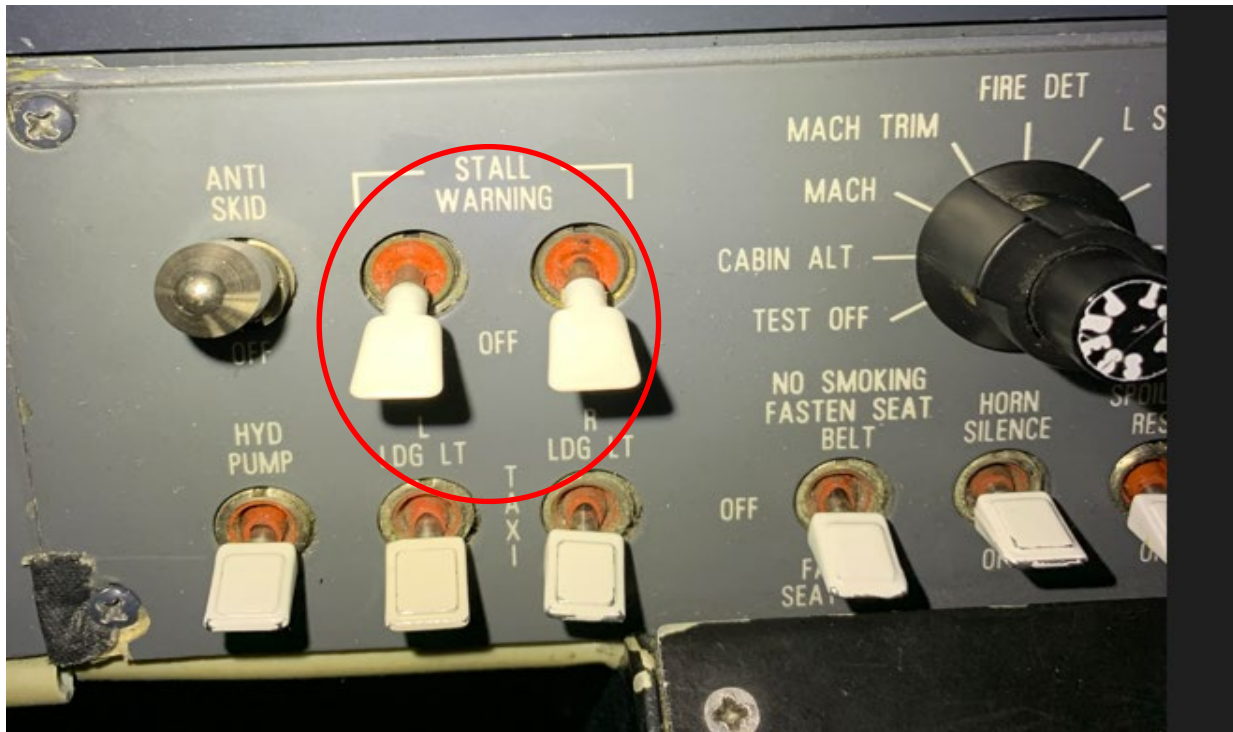
The L and R STALL WARNING switches, located on the center switch panel, provided power to the corresponding stall warning system. Each switch had two positions: On and Off. The L STALL WARNING switch also provided power for the

stick puller.³³ From the wreckage examination, we were unable to tell if the stall warning switches were on or off at the time of the accident.

Figure 10: Source: NTSB Photo. Lear 35A Stall Warning Switches on Captains side forward instrument panel, indicated by red circle.³⁴ Picture taken inside an exemplar Lear 35.
