# National Transportation Safety Board

WPR22FA094

## **ACCIDENT SITE SUMMARY**

Location: Glendale, Arizona  
Date: 02/10/2022  
Time: 1105 MST  
1805 UTC  
Airplane: N633AX, Mirage F1

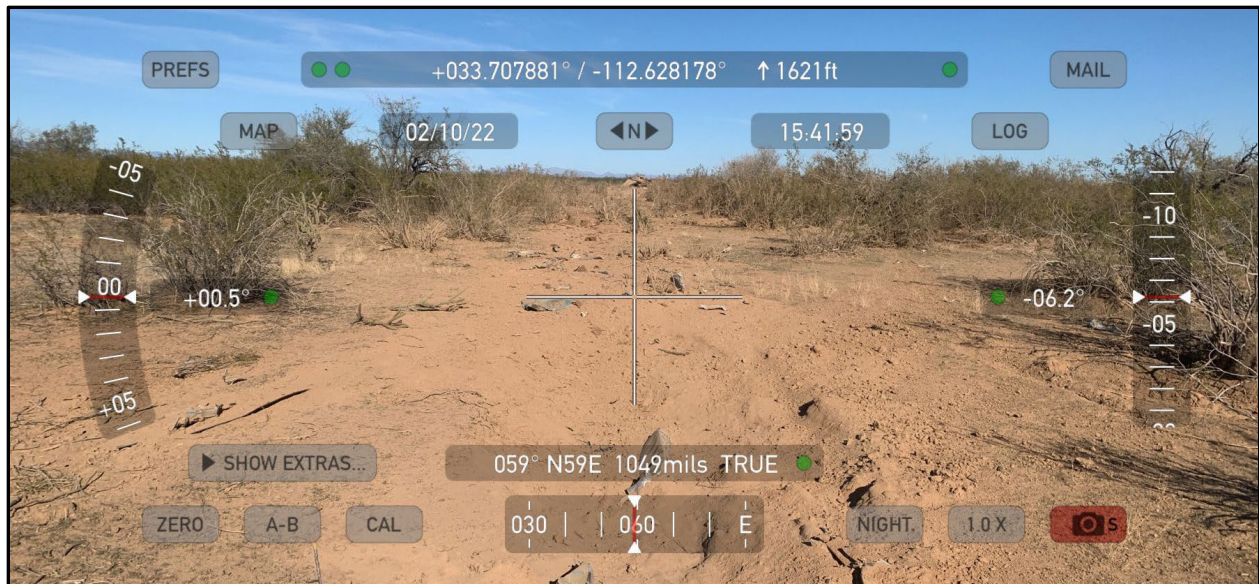
Examination of the accident site revealed that the fighter jet airplane impacted flat desert terrain in a large unoccupied area situated between two residential areas. A large ground disturbance consistent with the initial point of impact of the airplane was observed that led to the main wreckage. The initial point of impact was oriented on a heading of about 060°magnetic. Several fragments of the external centerline fuel tank and airplane were located in the disturbance. The length of the debris path, from the initial point of impact to where the major components of the wreckage were found, was about 600 ft.

**Figure 1: The initial point of impact.**

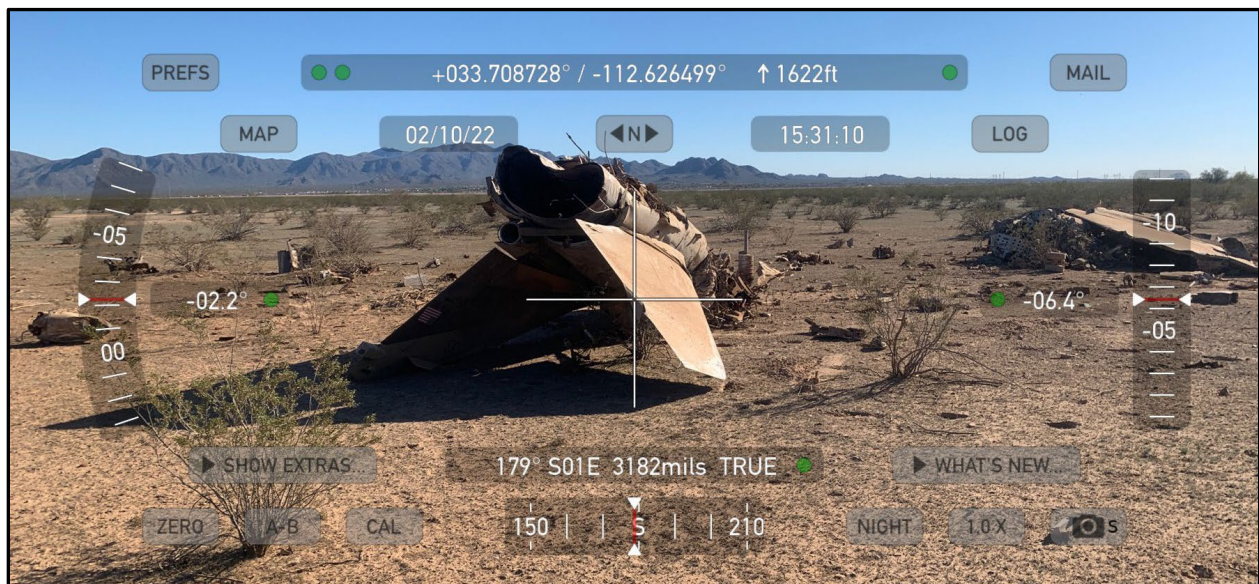
**Figure 2: Main portions of the airplane wreckage.**

All major components of the airplane were found at the main wreckage site. The largest wreckage section consisted of the aft section of the fuselage that contained the engine and tail section, which came to rest inverted. The wings and the fuselage section that they were attached to, separated, and was found about 60 ft southwest of the aft fuselage section. Numerous fragments of aircraft debris were scattered throughout the debris trail and on the site about 100 ft - 200 ft from the main wreckage. There was no post-crash fire. Additionally, there was no smell of fuel or fuel staining at the site.

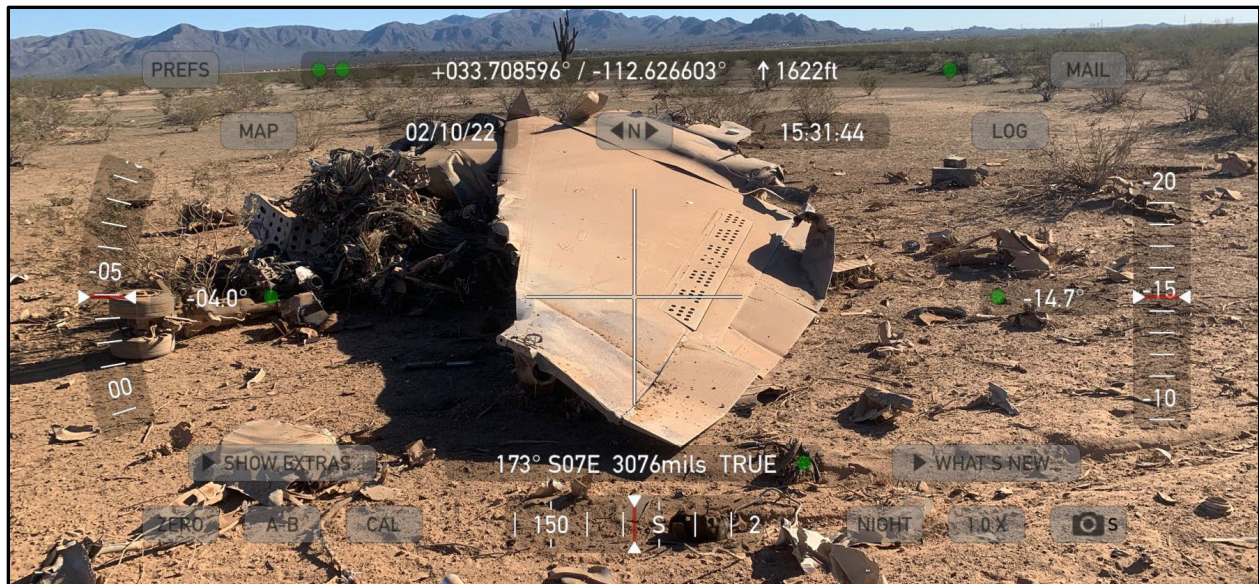
**Figure 3: The wings of the airplane.**

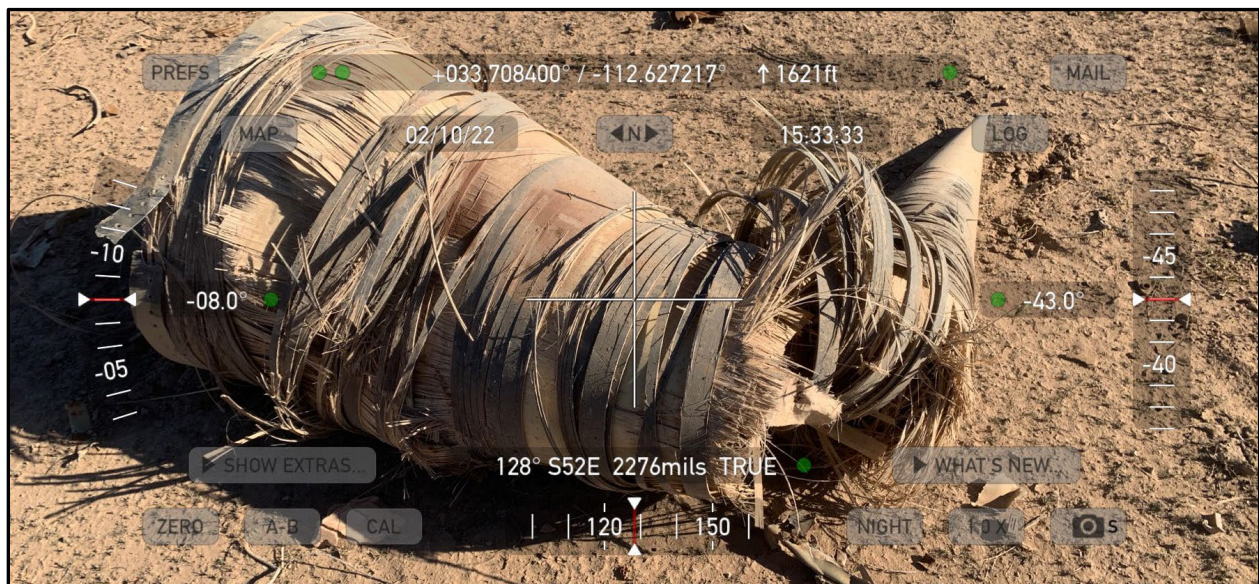
**Figure 4: The nose cone of the airplane.**
