National Transportation Safety Board

WPR22FA094

AIRFRAME EXAMINATION SUMMARY REPORT

Location: Glendale, Arizona
Date: 02/10/2022
Time: 1105 MST
1805 UTC
Airplane: N633AX Mirage F-1

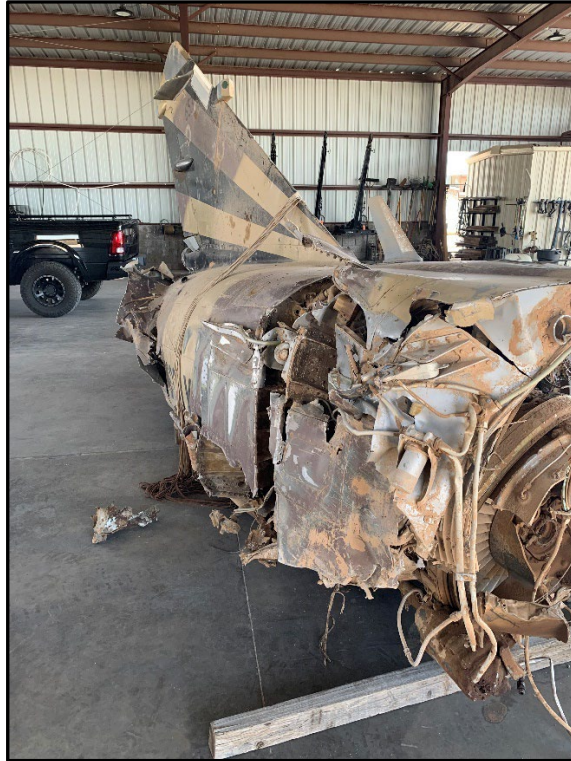
Figure 1: Airplane wreckage arranged for the examination as viewed from the right side.

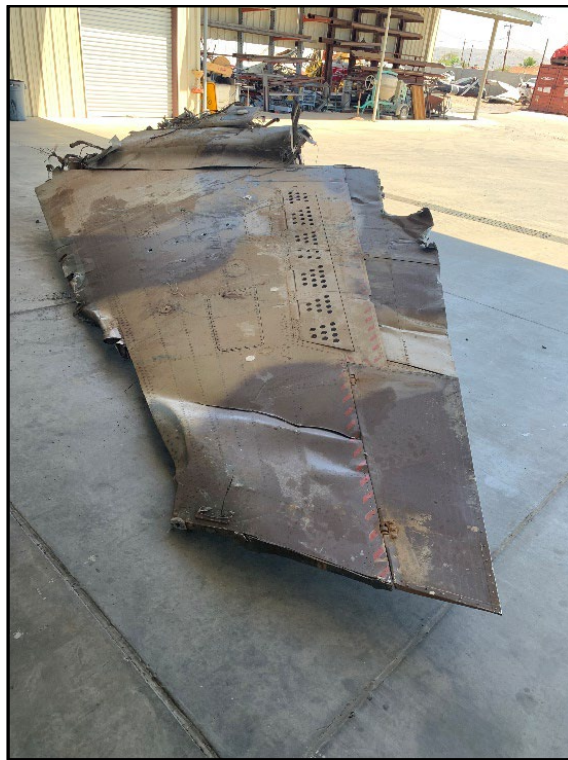
Figure 2: Left wing as viewed from the left side.

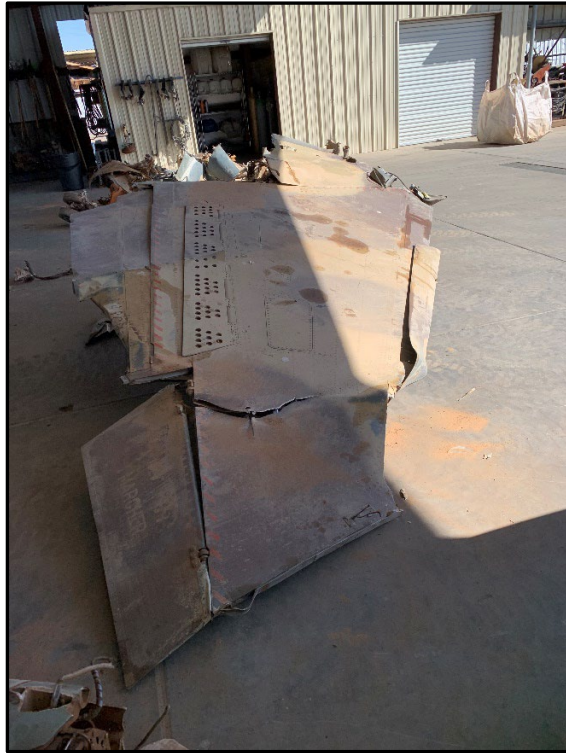
- Left tank No. 3 and No. 5 transfer valves - screens clear no anomalies.
- Right wing No. 2 fuel tank. Holes were drilled into the wing to borescope tanks - all four sections no anomalies.
- Right feeder tanks transfer tanks had small screw stuck near valve.

Figure 3: Right wing as viewed from the right side.

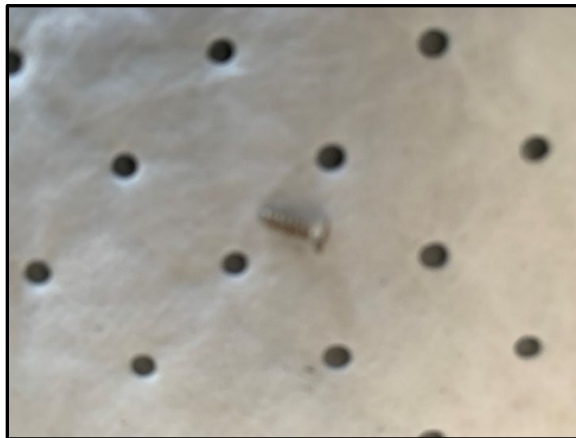
Overall, the examination of the aircraft revealed that the fuel tanks transfer valves screens were clear, however, the right feed tank was observed to have a small screw stuck near the valve and loose sealant material was found in the tanks. No additional preimpact mechanical failures or malfunctions that would have precluded normal operation were observed.

Figure 4: FOD (screw) found in right feeder tank.

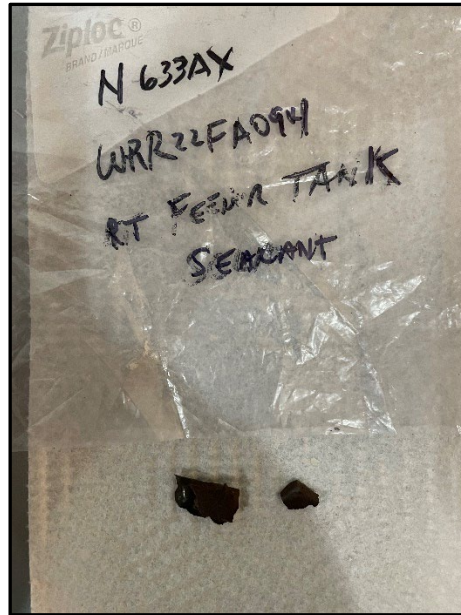
Figure 5: Sealant material that was loose.

- Left wing No.1 fuel tank - Holes were drilled into the wing to borescope tanks - all four sections no anomalies.
- Inboard of maintenance access panel on bottom, excess amount of black covered sealant observed with top finger becoming loose.
- Borescope of main tanks revealed similar excess amount of black colored sealant with some fingers becoming loose.
- No. 2 and No. 4 transfer valves outer and inner screens were clear of contaminants.
- Left No. 1 transfer valves clear of contamination.
- Remaining portion of fuel vents left in fuselage were borescoped and no anomalies noted and were free of obstructions.
- Single point cap seal was intact, and no anomalies noted.
- Fuel instrumentation in the cockpit was observed to be destroyed by impact damage.
- Refueling panel was not found.
