National Transportation Safety Board

WPR22FA101

Group Chair's Factual Report

Location: Newport Beach, CA
Date: February 19, 2022
Time: 1833 Pacific standard time (PST)
0233 universal coordinated time (UTC)
Helicopter: MD Helicopter / 500N / N521HB

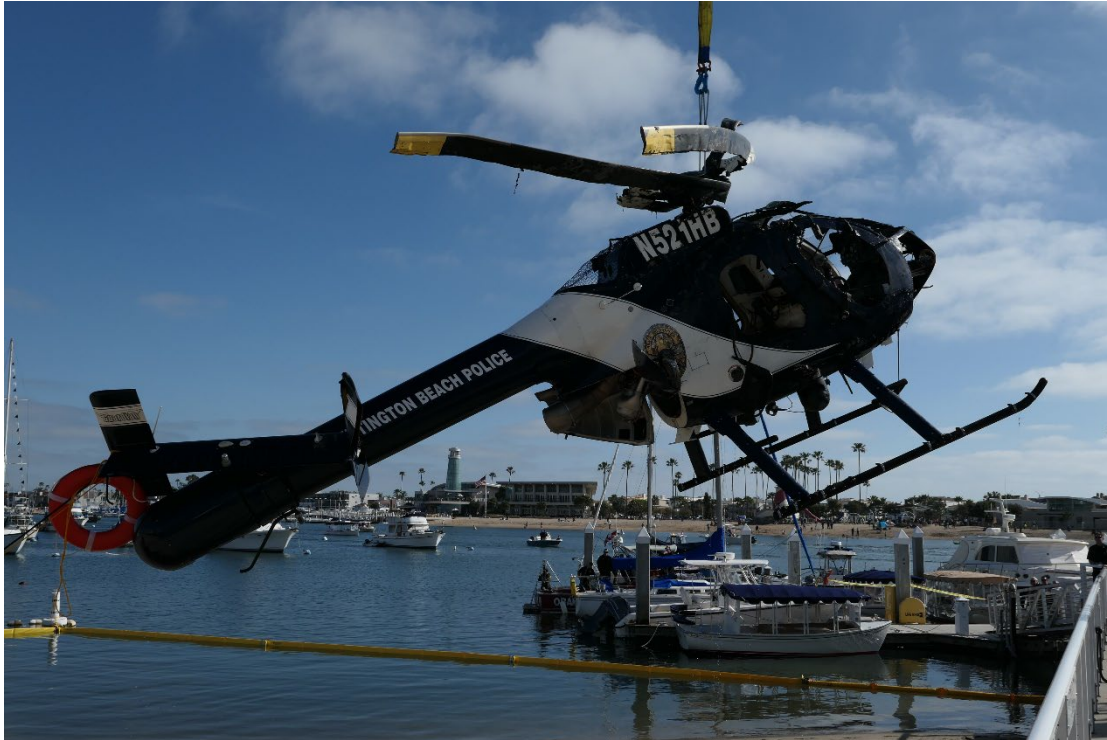
The fuselage was intact, with landing skids, cockpit, cabin, and tailboom. The horizontal and vertical stabilizer assembly mounts had fractured. The stinger remained attached to the tail and had been displaced to the left. Main rotor was attached to the mast, and 3 of the 5 rotor blades remained attached to the rotor head (Figure 2).

Figure 2. Helicopter being lifted out of the water.

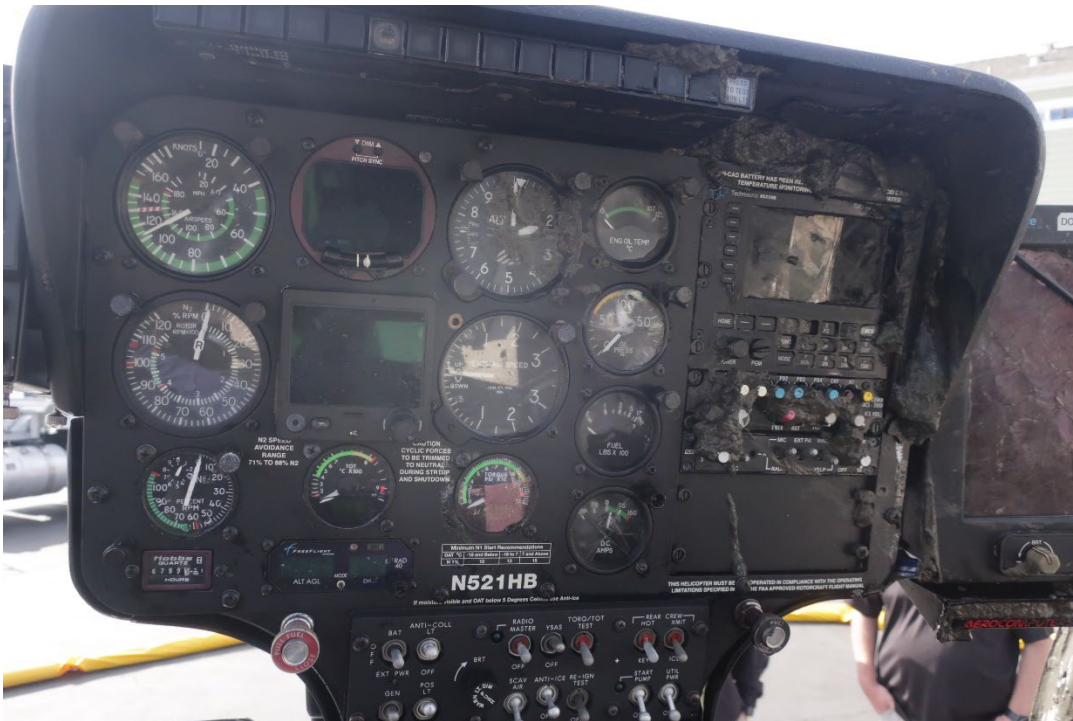
The cabin was intact. The wind screen on both pilot and copilot sides had broken out leaving only the frame. The front frame was fractured just below the upper deck. Both cyclics and collectives were in place. The left cockpit had the antitorque pedals installed, but the right cockpit's were not. Figure 3 is a photo of the instrument panel as found.

Figure 3. Cockpit instrument panel.

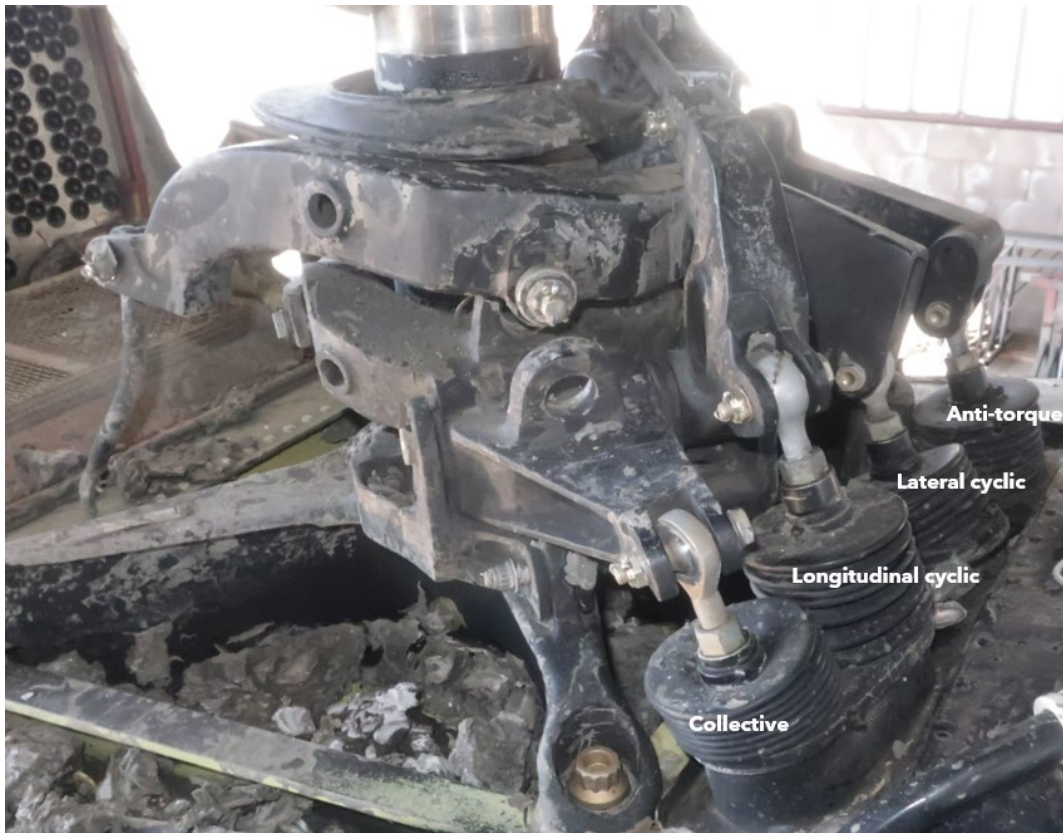
Cyclic continuity was confirmed from both pilot and copilot's cyclic to the stationary swash plate (Figure 4). Lateral and longitudinal pitch control rods were all connected from the cockpit, lower control connections in the broom closet, and the upper control connections (upper broom closet). Both cyclic control rods (lateral and longitudinal) were connected to the upper bell cranks. Lateral cyclic mixer bell crank had been liberated from the stationary swash plate. Both swash plate links were fractured at the lower ends.

Collective continuity was confirmed from both pilot and copilot's collective from the cockpit to the stationary swash plate (Figure 4). The collective control rod was connected from the cockpit to the lower control connections in the broom closet, and to the upper control connections (upper broom closet). The collective control rod was connected to the upper bell crank. The drive link was fractured at the slider but remained attached to the stationary swash plate.

Figure 4. Photo of the upper control connections.

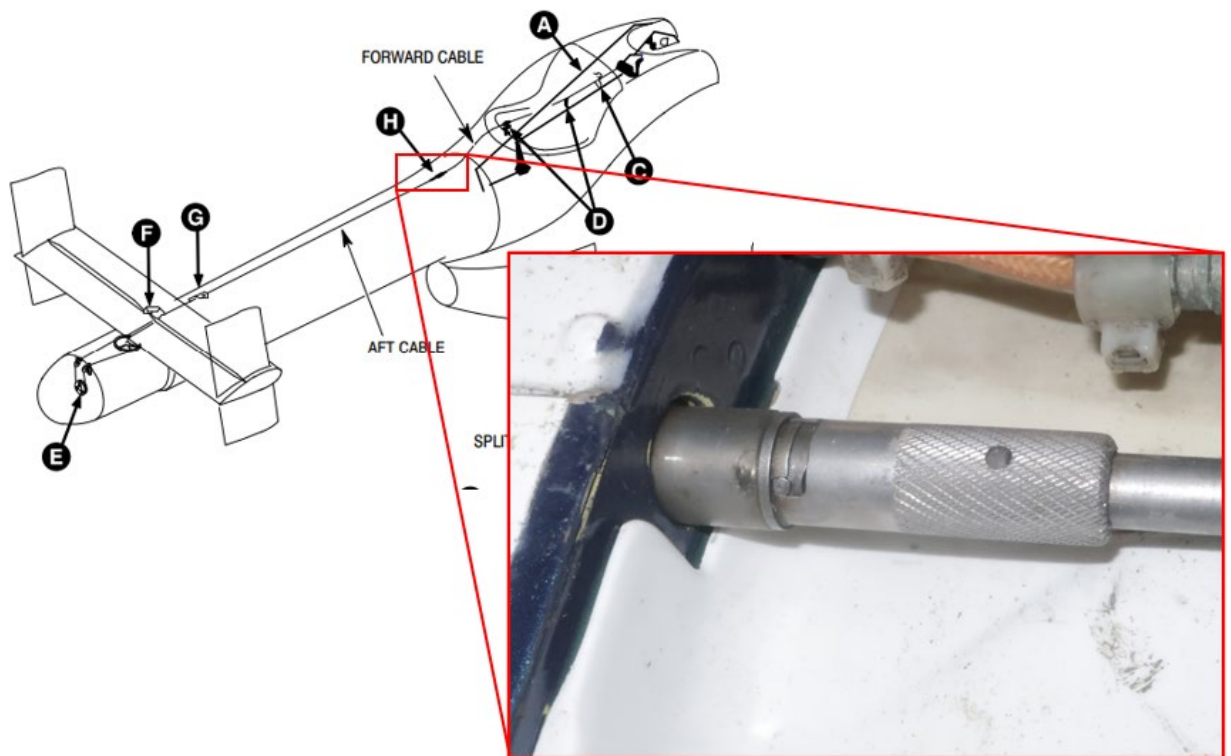
Anti-torque system continuity from the pilot's pedals to the rotating cone and left vertical stabilizer bell crank was confirmed. The anti-torque fan blades changed pitch in concert when anti-torque pedals were moved. The pilot and copilot pedal control rods were all connected from the cockpit to the lower control connections in the broom closet, and to the upper control connections (upper broom closet). The anti-torque control rod was connected to the upper bell crank, and the anti-torque sector. The splitter assembly remained in place with all connections in place. The morse cable (teleflex) cable remained connected to the anti-torque sector via the forward to aft cable connection (Figure 5).

Figure 5³. Forward to aft cable connection (Source: MD Helicopters).

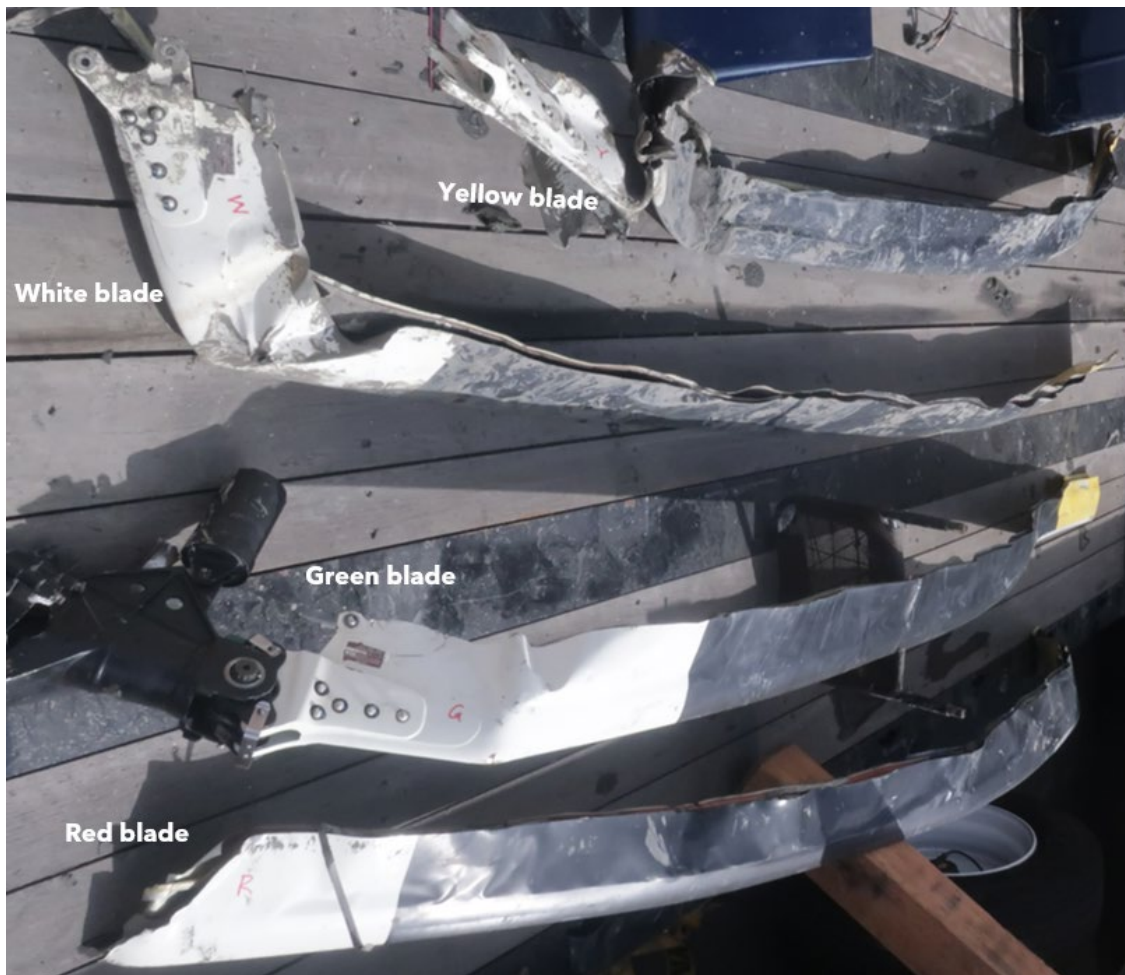
The yellow blade (Figure 6), PN 500P2300-505, SN 634T, the entire blade remained attached to the rotor hub. There was a chord wise fracture about 12 inches outboard of the blade attach pins and a longitudinal s-bend along the entire length of blade. There was trailing edge buckling along the entire length and the trailing edge was split open.

The green blade (Figure 6), PN 500P2300-505, SN 681T, and pitch change housing had separated from the hub with fracture signatures consistent with overload. The blade was attached to its housing with both blade pins. The tension torsion (TT) straps were present on the housing, deformed, and separated in shear. The pitch change link was attached to the pitch change arm and the opposite end rod end was bent and fractured. The blade damper was attached to the housing, and the damper arm was not present. The damper arm clevis was not present on the

blade, but the attachment flange and bearing were present. The blade was deformed in a downward arc and bent aft about 20°, 12 inches outboard of the blade pins. There was trailing edge buckling along the entire length and the trailing edge was split open.

The red blade (Figure 6), PN 500P2300-505, SN 632T, had separated with a 45° fracture line about 12 inches outboard of the blade attachment pins. The blade was curved downward in a single arc. There was trailing edge buckling along the entire length and the trailing edge was split open.

The white blade (Figure 6), PN 500P2300-505, SN 692T, remained attached to the rotor hub. The damper rod clevis was attached to the blade root trailing edge, its rod was fractured at the nut. The blade was bent aft about 30°, 12-inches outboard of the blade pins. There was lengthwise trailing edge buckling and the trailing edge was split open the entire length of the blade. Three feet of the blade tip was deformed downward.

Figure 6. Rotor blades and horizontal stabilizer laid out. The blue blade remained connected to the main rotor hub.

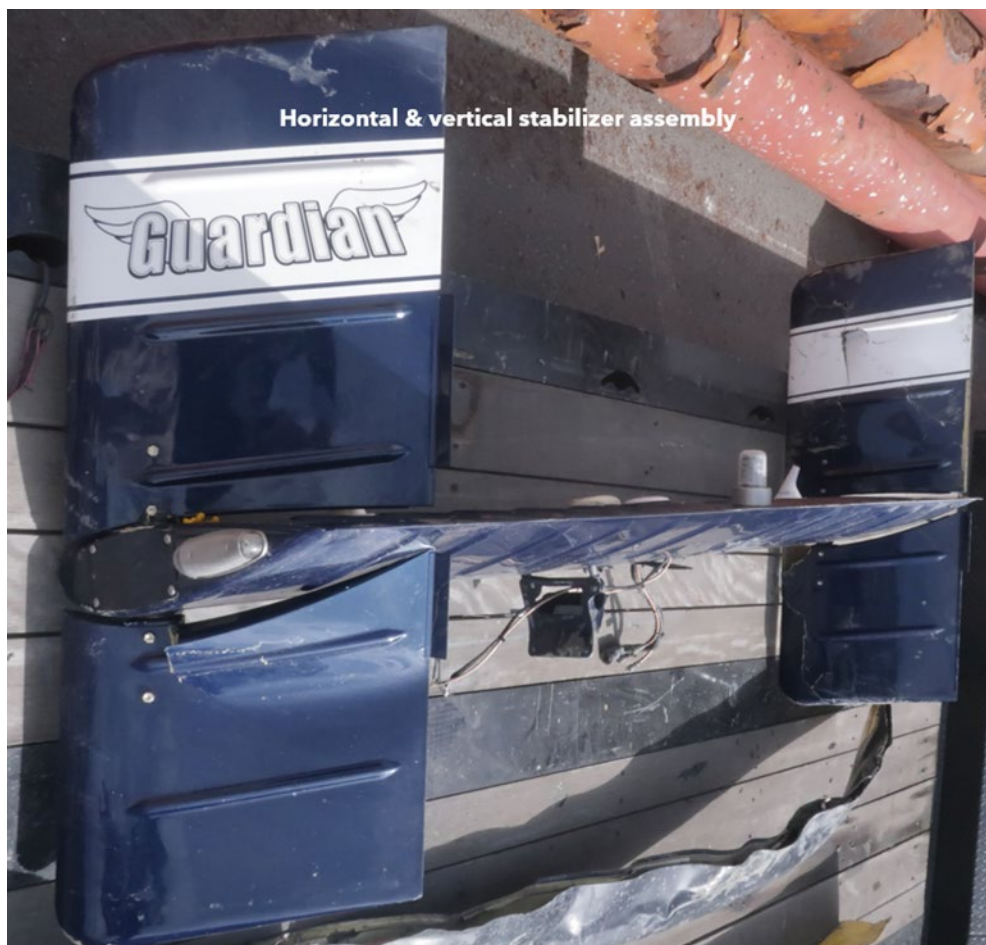
The horizontal and vertical stabilizer assembly (Figure 7) mounts had broken from the tail boom in a right to left direction, but the assembly remained connected by the YSAS electrical cables. The left vertical stabilizer center control bell crank had fractured at the push-pull rod attach clevis. The left vertical stabilizer control linkages were connected, and continuity was established thru the fractured bell crank. A yellow rescue line had jammed into the left vertical stabilizer bearing/hinge. The left vertical control linkage had separated from the bell crank, the fracture surface was bright and granular in texture, consistent with overload. The left vertical stabilizer rotated on its hinge freely. The right vertical stabilizer exhibited surface fractures, and the upper portion was split along the trailing edge. The YSAS actuator was extended 2.8 cm from actuator to the rod end plate. Safety wire was not present on the actuator bolt; however, the bolt was found to be torqued tight when investigators removed the actuator.

Figure 7. Horizontal and vertical stabilizer assembly.

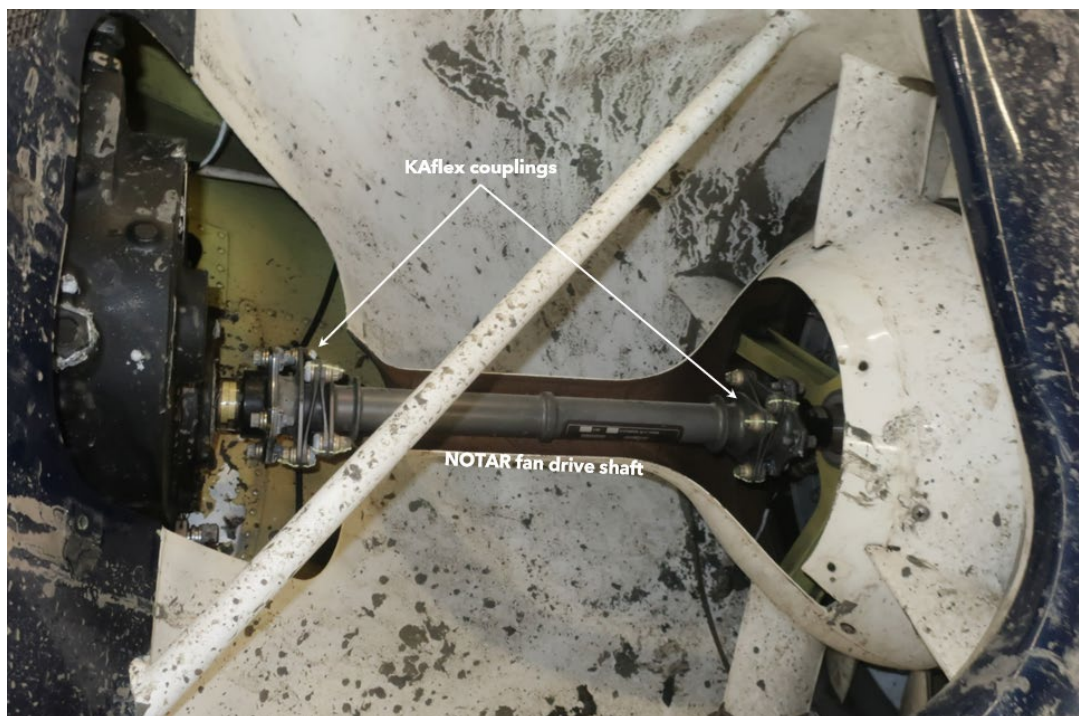
The tail boom remained attached to the fuselage. The NOTAR fan drive shaft was connected at both ends via KAflex couplings with no visible damage (Figure 8).

Figure 8. NOTAR fan drive shaft.

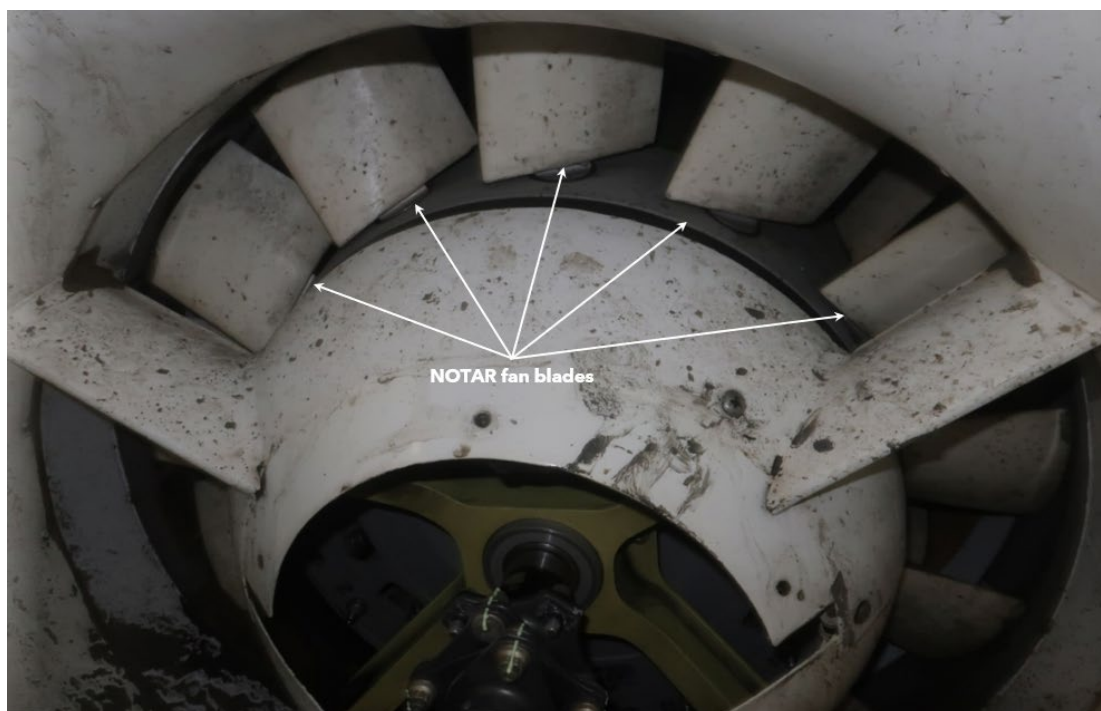
The drive shaft and fan rotated in concert with the main rotor and gearbox. The pitch on all fan blades appeared similar and moved in concert with pedal application (Figure 9). Anti-torque system rigging was verified by confirming all 3 rigging pin locations could be lined up and pinned simultaneously. The fan pitch rigging was verified as set to 27°.

Figure 9. NOTAR fan

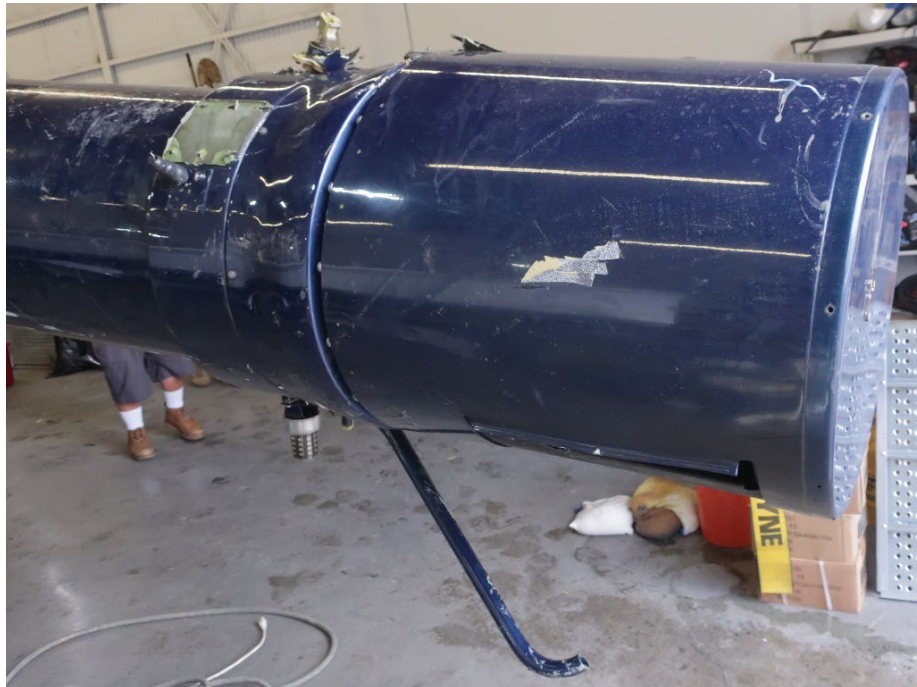
The rotating cone exhibited external damage on its upper surface (Figure 10), deforming the bearing ring at one location, and had been displaced aft off the roller bearings. The cone thrust opening was measured about 5.5 inches. The 3 bolts retaining the cone were in place, keeping the cone attached to the drum assembly. The tail boom assembly interior was clear of debris. No internal damage was observed. The tail duct inlet area has 11 guide vanes, none of which exhibited damage. The central forward diffuser cone was undamaged, no debris observed. The stationary thruster was attached and all thruster vanes in place. The aft control rod was connected the aft sector assembly, cables remained attached and routed to the rotating cone assembly through the idler pulley.

Figure 10. Rotating cone.
