# National Transportation Safety Board

WPR22FA101

## **AUTOMATIC DEPENDENT SURVEILLANCE- BROADCAST (ADS-B) STUDY**

Aircraft Performance Study

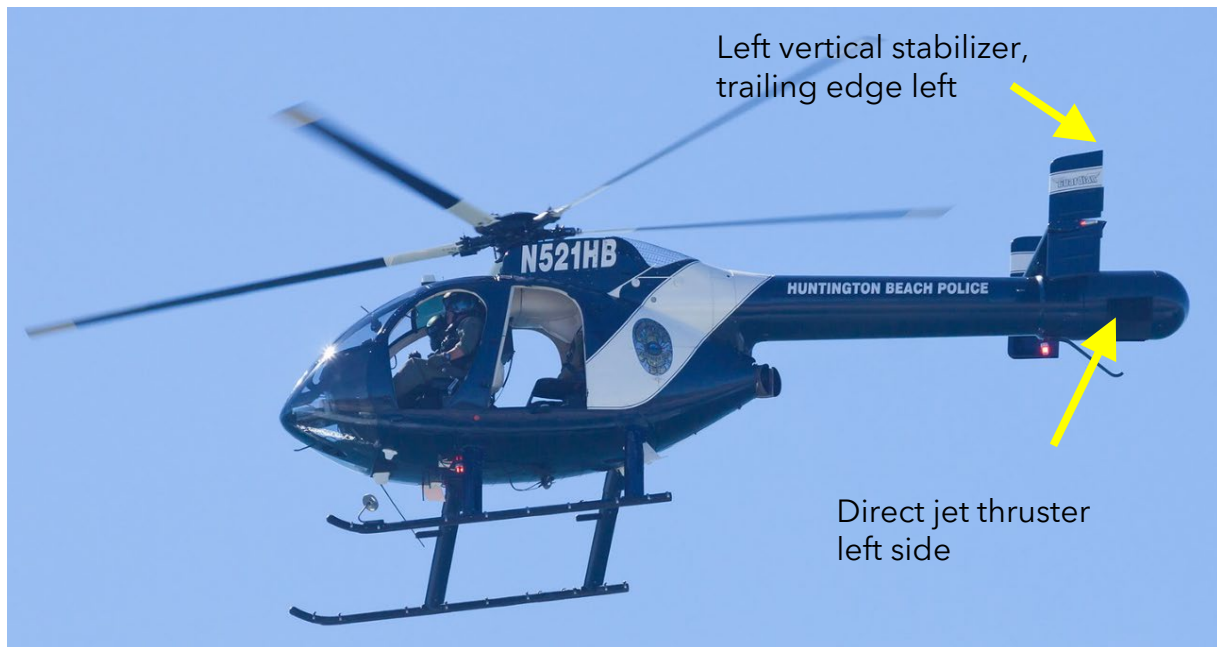
**Figure 1.** Photograph of accident helicopter.

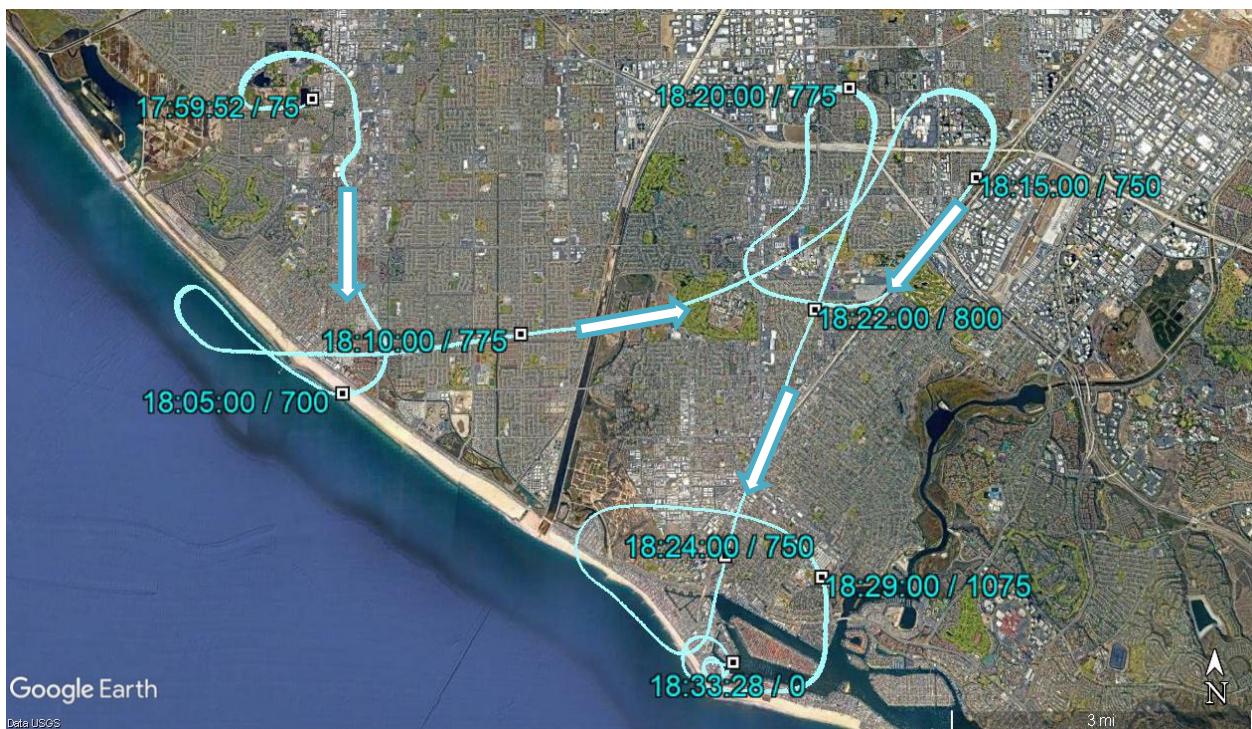
The helicopter took off from the Huntington Beach Police Department air support unit base at 17:59. For the first 30 minutes of flight, the helicopter was between 500 and 1,100 ft msl and at groundspeeds above 50 kts. Figure 2 shows the ADS-B flight path on a map and Figure 3 shows the helicopter's altitude and calculated groundspeed.

**Figure 2.** Helicopter's flight path with selected times and altitudes (msl) noted.

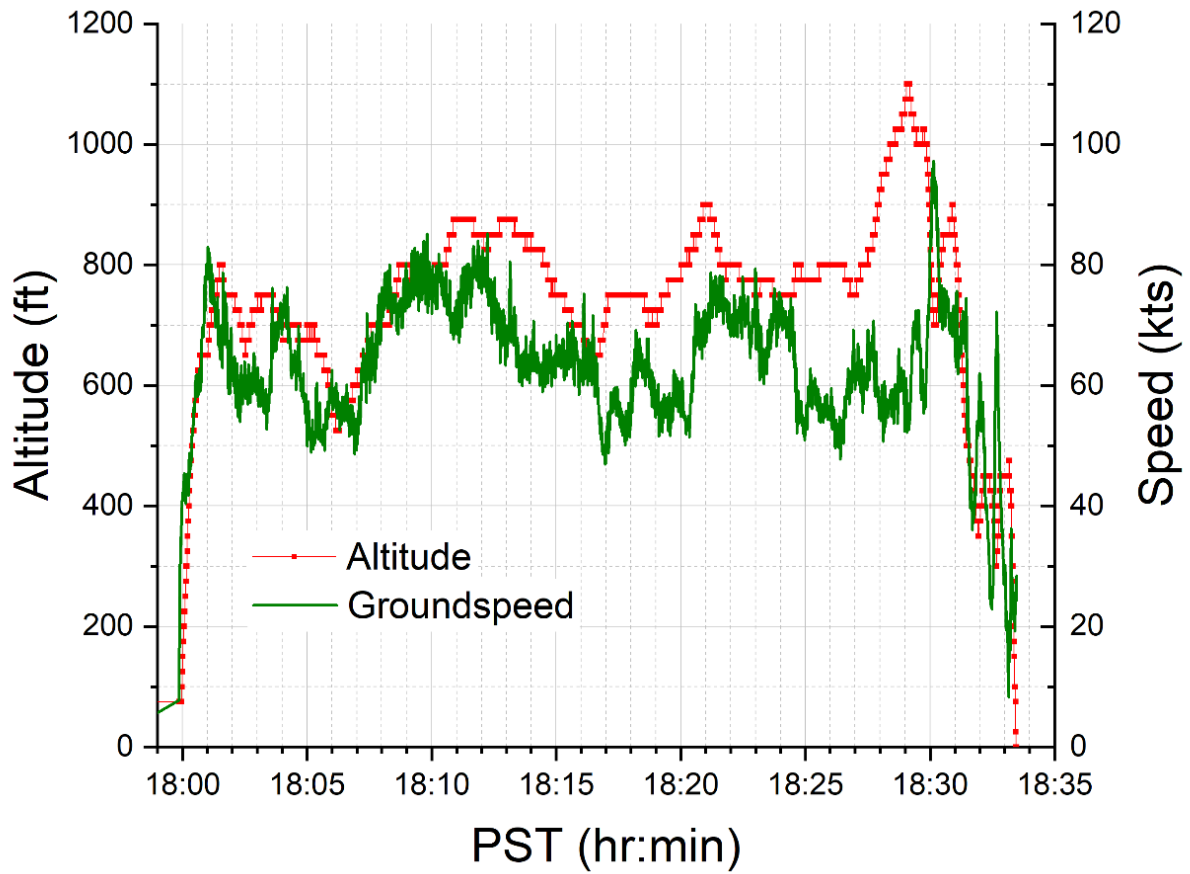
**Figure 3.** ADS-B altitude (msl) and calculated groundspeed for full flight.

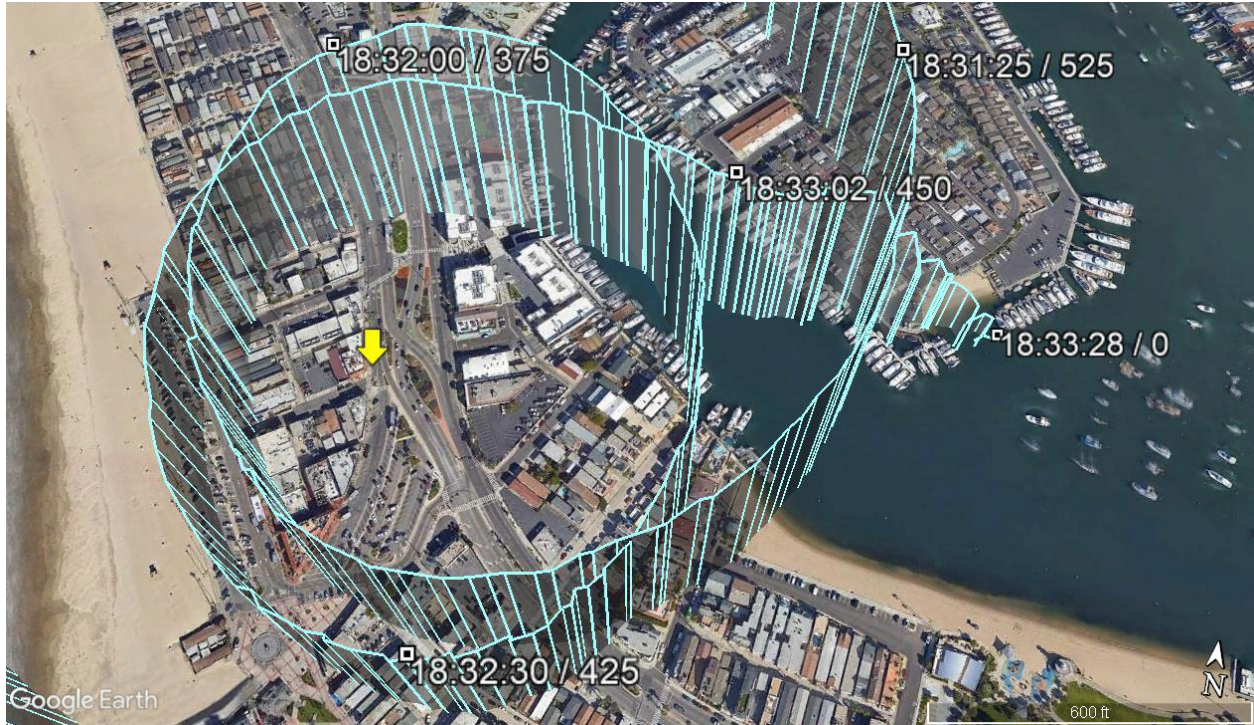
After 18:30 the helicopter approached the area in Newport Beach where it was to orbit an area of interest and film (Figure 4). The helicopter proceeded to make a series of right turns over the area.

**Figure 4.** Final three minutes of flight with selected times and altitudes noted. The yellow arrow marks the location being filmed by the onboard camera.

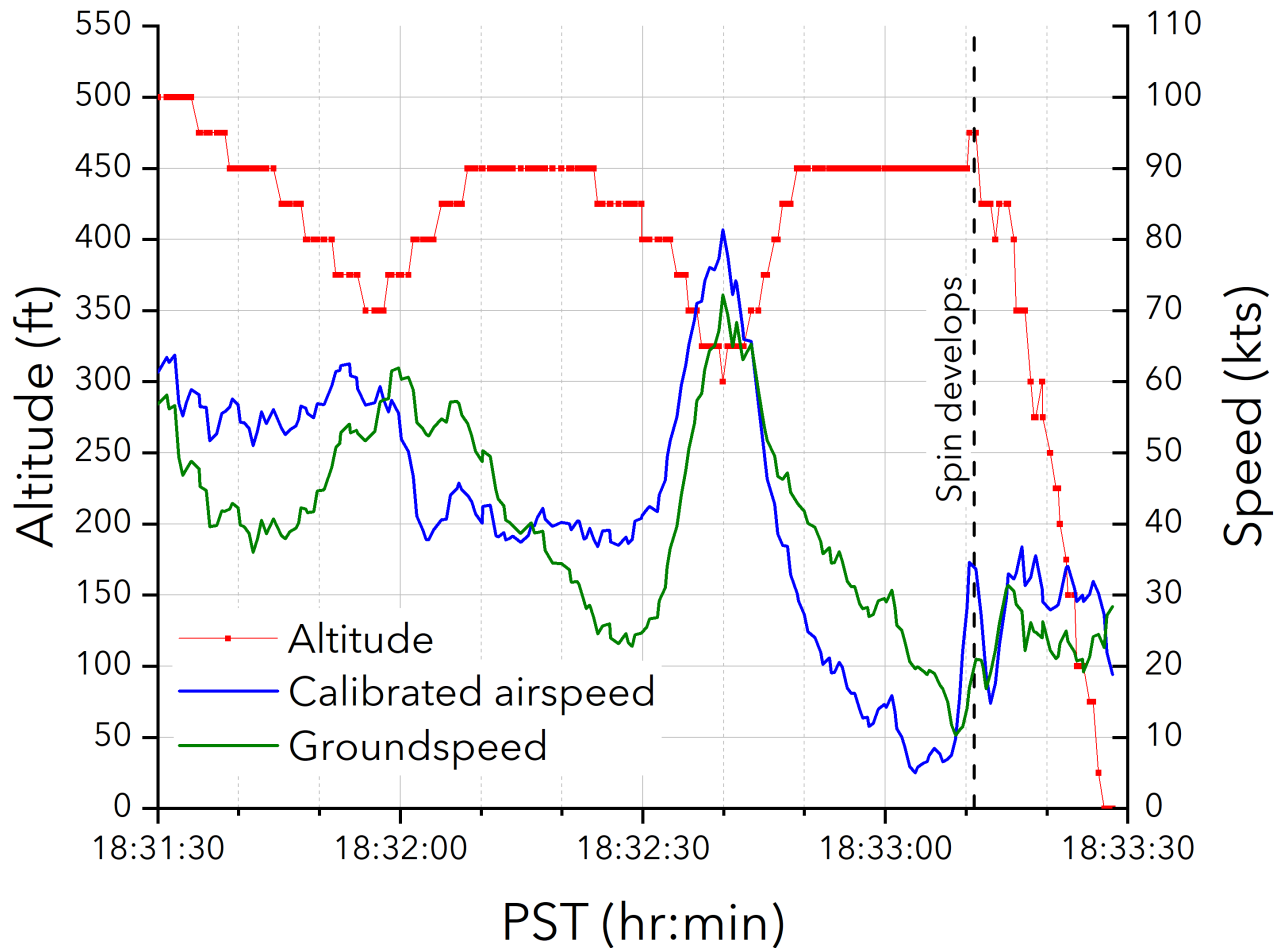
The Video Study used the video filmed onboard to determine the helicopter's heading from time 18:33:02 until 18:33:11. The study found that after 18:33:11 (shown in Figure 5) the helicopter's right yaw rate rapidly increased and that the helicopter was spinning. The yaw rate increased to a yaw rate greater than 130°/s in less than three seconds. This corresponded with the loss of altitude at the end of the flight as seen in Figure 5.

**Figure 5.** Altitude (msl), calibrated airspeed, and groundspeed of the end of flight.

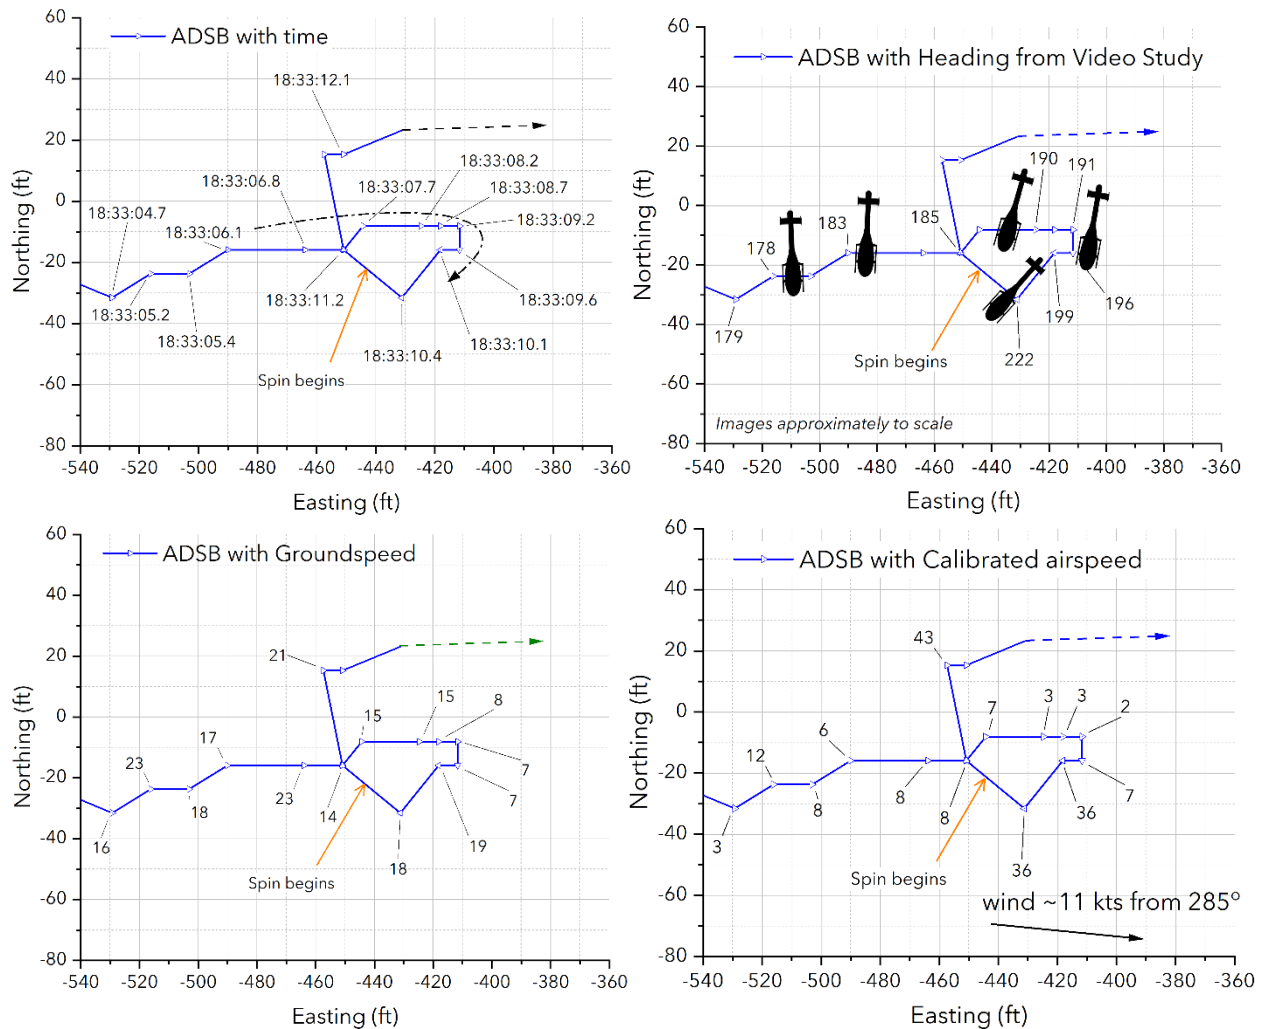
Figure 6 shows the flight path in the area where the spin developed in detail. The four plots are annotated with time, heading from the Video Study, groundspeed, and calibrated airspeed. The ADS-B path shows the helicopter entering from the left, completing a small circle, and then exiting the plot to the top right. The approximate point where the spin began to develop according to the Video Study is shown in all plots. As discussed in section 2.0 Available Data, the resolution on ADS-B position data is 65 ft. The small squares in Figure 6 are 10 ft by 10 ft and the approximate size of the accident helicopter can be seen in the top right plot. The approximately 40 ft by 20 ft circle could reflect a flight path where the helicopter was initially moving to the east before slowing, changing direction, and returning west.

**Figure 6.** ADS-B flight path in Northing and Easting with time (top left), heading (top right), groundspeed (bottom left) and calibrated airspeed (bottom right) for each point. Wind direction and magnitude is also noted on calibrated airspeed plot.

The helicopter's groundspeed was between 15-23 kts as it moved east. Winds were 11 kts from 286°, so the resulting calibrated airspeeds were between 3-12 kts. During this time, the helicopter was pointed south on a heading between 178° and 185°. Groundspeed slowed markedly after 18:33:08 as did calibrated airspeed. The helicopter's heading came slightly more to the right. As the helicopter moved back on a westerly course, groundspeed increased to near 20 kts and airspeed to more than 30 kts due to the wind. The last heading determined in the video study before the yaw rate increased significantly was 222°. The helicopter impacted the water approximately 17 seconds after the spin began.

Until 18:33:09, the helicopter's flight path was with the wind and its subsequent airspeed was under 10 kts. The helicopter's forward airspeed began to increase after 18:33:10. As the helicopter accelerated, power would have increased as it approached translational lift, increasing the amount of anti-torque required. As it gained translational lift with increased speed, the helicopter would have encountered the induced right rolling motion which would have needed to be countered. However, since the fuselage was not aligned with the flight path, its induced moment would be about a different axis, complicating the maneuver. A right rolling motion to the rotor coupled with the tendency to yaw right could have been responsible for the helicopter's continuing tight right turn after 18:33:11.

The anti-torque requirements during these few seconds would have been complex and changing. If the anti-torque requirements were not managed in a timely manner, the result could have been an uncontrolled right yaw. Compounding the difficulty of arresting the yaw once it began would have been the dark, night-time conditions and the proximity to the ocean, which would have limited the visual cues for the pilot.
