# National Transportation Safety Board

WPR22FA151

## **OPERATIONAL FACTORS**

Specialist's Factual Report

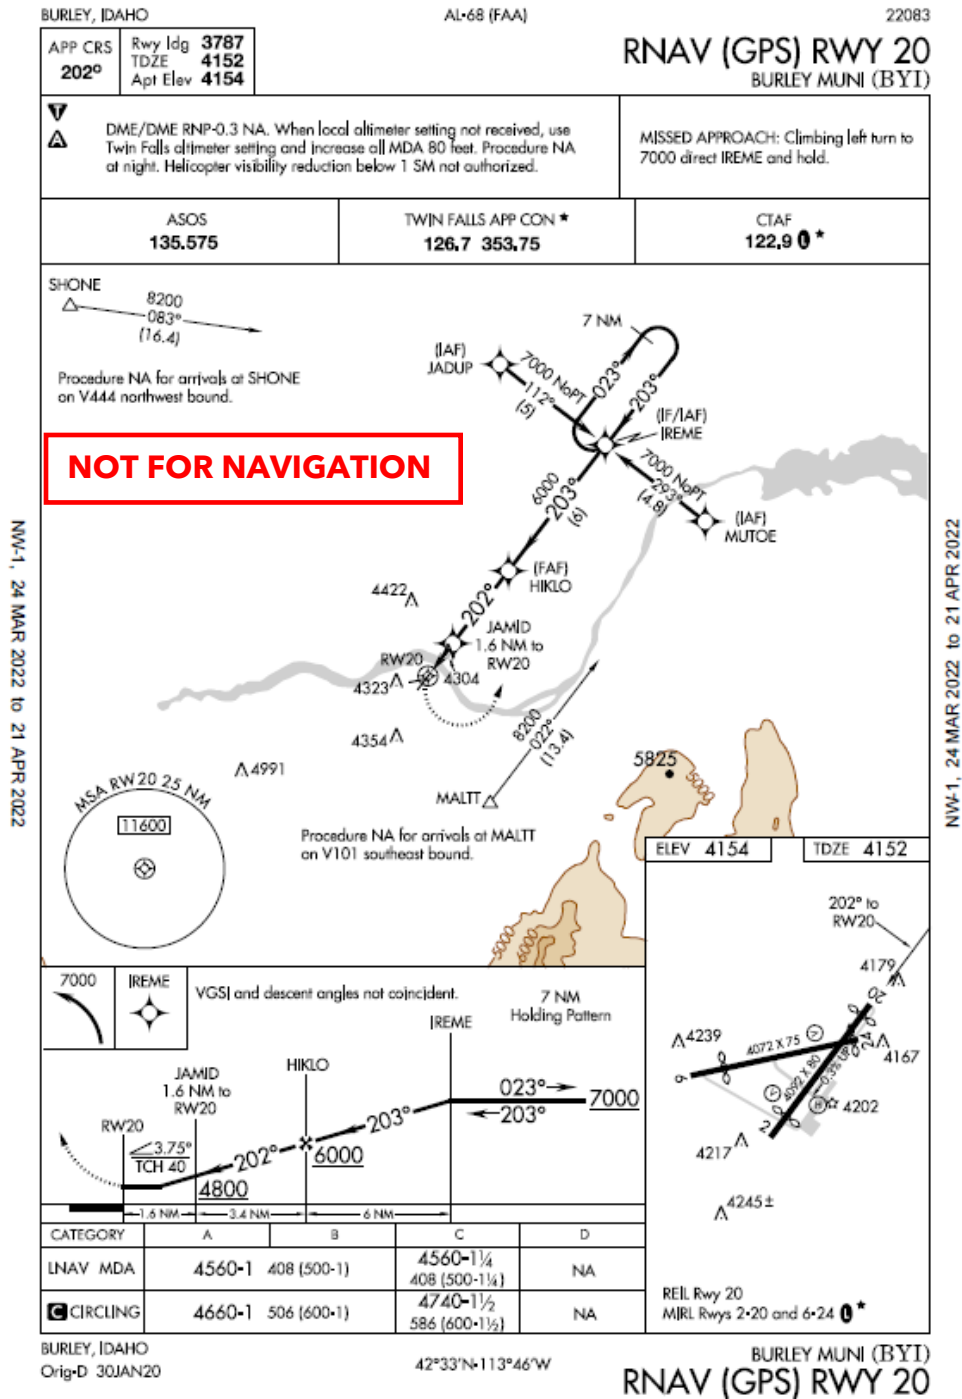
**Figure 6: BYI RNAV (GPS) Runway 20 Approach Chart.**<sup>44</sup>

The approach chart indicated that runway 20 had a visual glide slope indicator (VGSI) such as a VASI or PAPI by the note “VGSI and descent angles not coincident.”

A vertical descent angle (VDA) of 3.75° was depicted on the chart. According to the FAA Instrument Flying Handbook (FAA-H-8083-15B) the VDA found on nonprecision approach charts provides the pilot with information required to establish a stabilized approach descent from the FAF or stepdown fix to the threshold crossing height (TCH). Pilots can use the published angle and estimated or actual groundspeed to find a target rate of descent using the rate of descent table in the back of the Terminal Procedures Publication (TPP).<sup>46</sup>

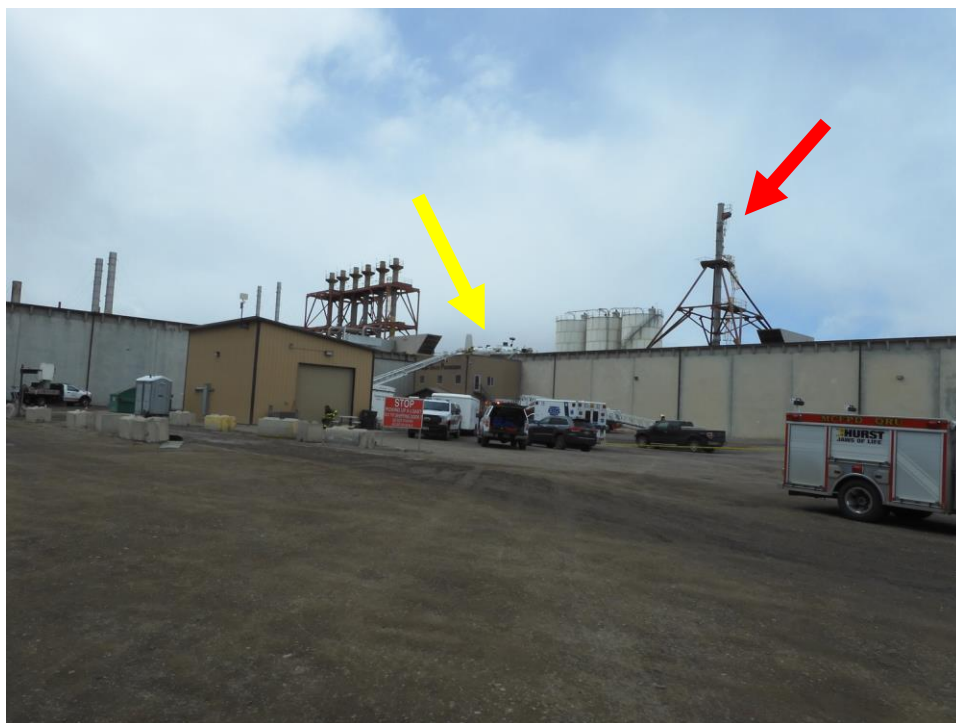
As previously mentioned, there were smokestacks on top of the Gem State Processing building located about ½ nautical miles from the threshold of runway 20 at BYI and along the approach path to the runway. A witness to the accident observed N928JP descend out of the clouds then immediately went into a steam cloud being produced by the set of six smokestacks.

**Photo 2: Photo of the smokestacks on the Gem State Processing building. The red arrow indicates the stack that was struck by the accident airplane, and the yellow arrow indicates where the wreckage was located. The airplane was traveling right to left in the photo.<sup>55</sup>**
